Landslides (2020) 17:1063–1081  
 DOI 10.1007/s10346-019-01338-w  
 Received: 1 August 2019  
 Accepted: 18 December 2019  
 Published online: 10 January 2020  
 © Springer-Verlag GmbH Germany  
 part of Springer Nature 2020

## A quick combined approach for the characterization of a cliff during a post-rockfall emergency

**Abstract** The research presented in this paper is aimed at testing an innovative surveying protocol based the integration of quick methodologies employed for the characterization of a carbonate cliff affected by a rockfall and showing signs of further instability. During a post-rockfall emergency, one of the most important activities is evaluating if reactivation of the movements is possible, and if it may represent a threat for a series of elements at risk. On 5 January 2019, intense rainfalls triggered the detachment of a significant volume of fractured limestone and dolostone below the main square of a historical village located in southern Italy in the municipality of Messina, giving rise to one of the greatest landslides occurred at one of the most tourist areas of northeastern Sicily. Fallen blocks damaged the two main infrastructures of the area reachin

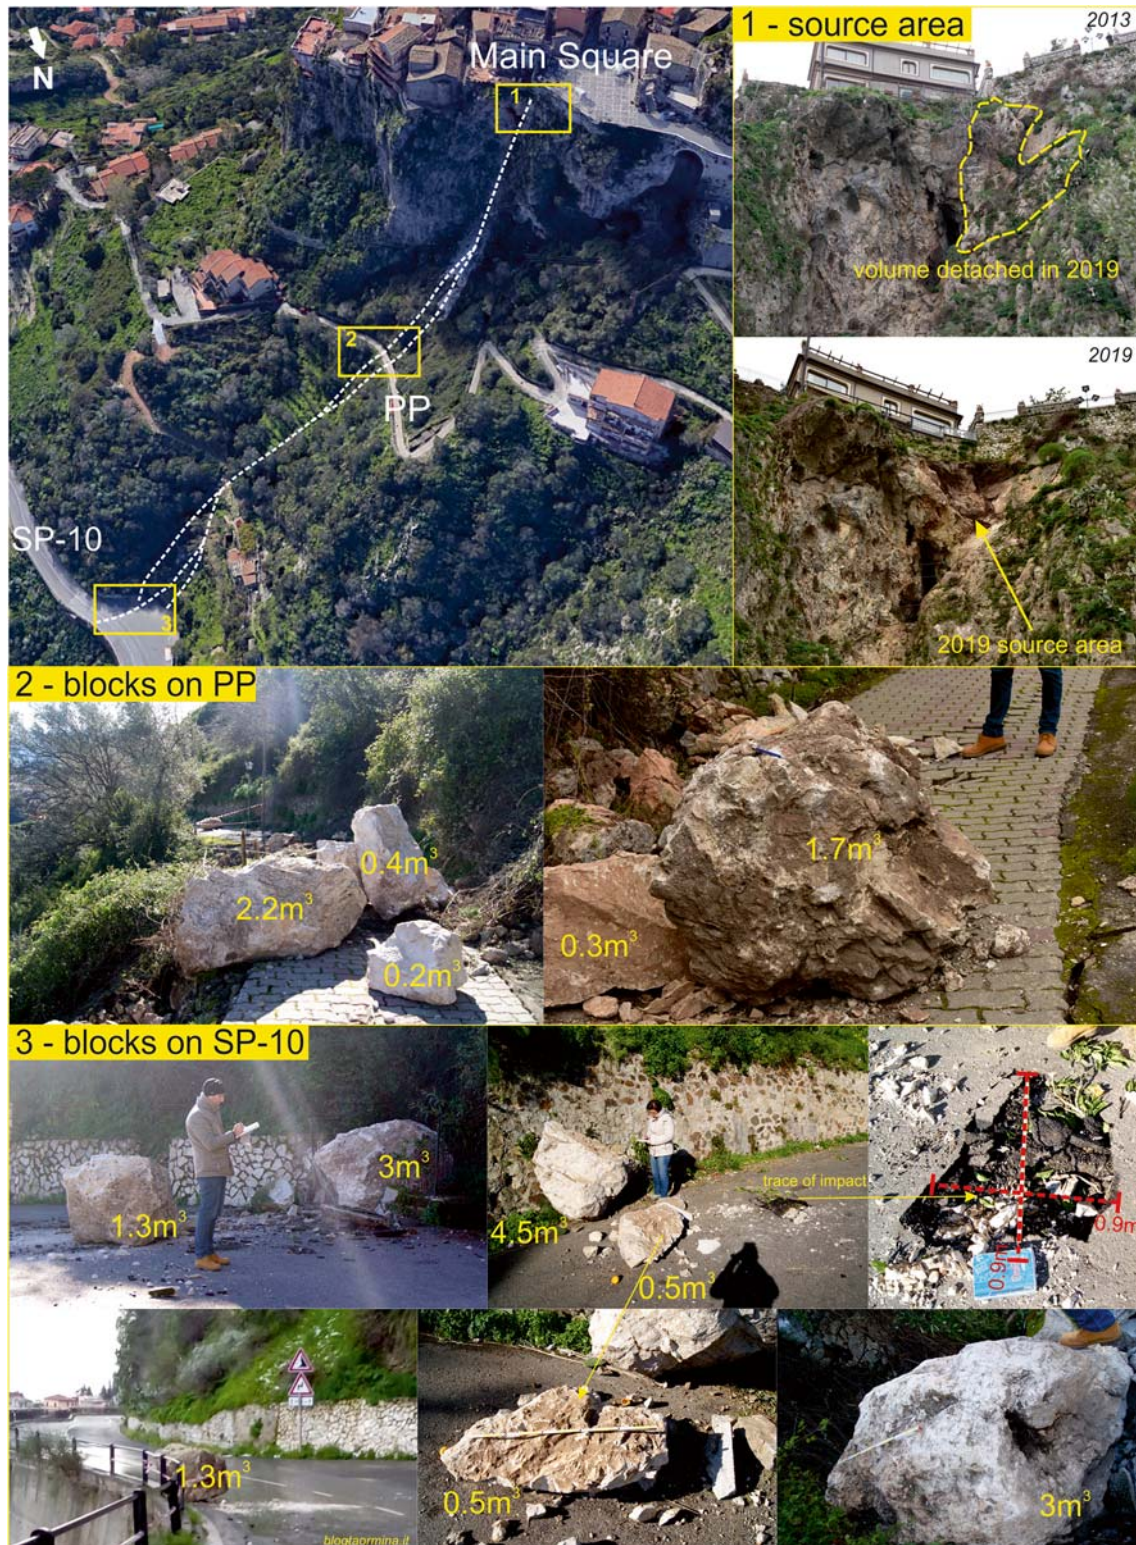
**Fig. 3** Reconstruction of the rockfall trajectory with a focus on the three key spots: 1, source area with a comparison between photos taken in 2013 and 2019; 2, surveyed blocks along PP; 3, surveyed blocks along SP-10

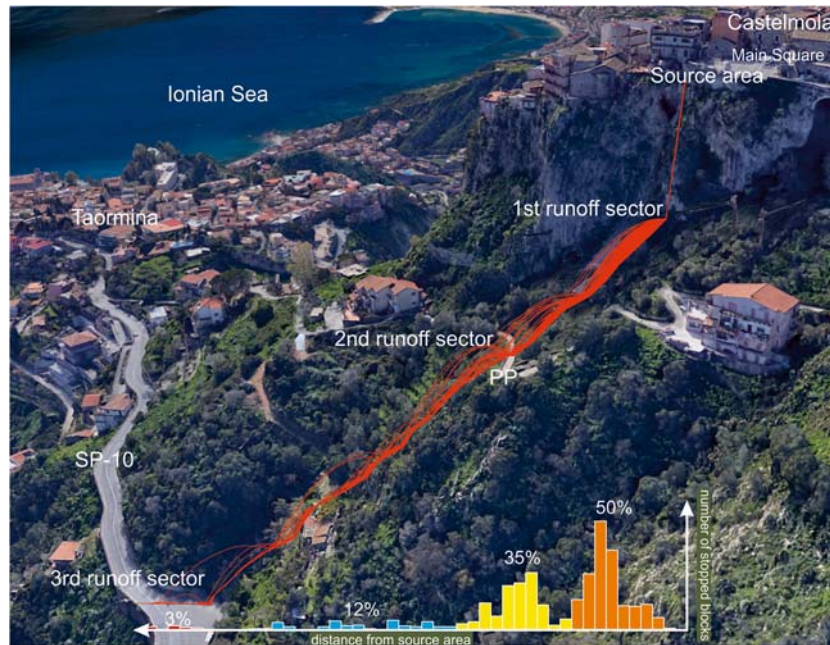
**Fig. 4** 2019 rockfall trajectory simulation with identification of the main runoff sectors

A rockfall simulation was performed along this trajectory, based on the results of a back analysis, by the RocFall computer program (Rocsience) according to the “Lumped Mass” method and considering 10,000 possible trajectories of blocks with a reasonable volume for the 2019 event. This confirmed the presence of three main runoff sectors, located at (Fig. 4):

- the foot of the cliff, where about 50% of blocks stop;
- PP, where about 35% of blocks stop;
- SP-10, reached by about 3% of blocks.

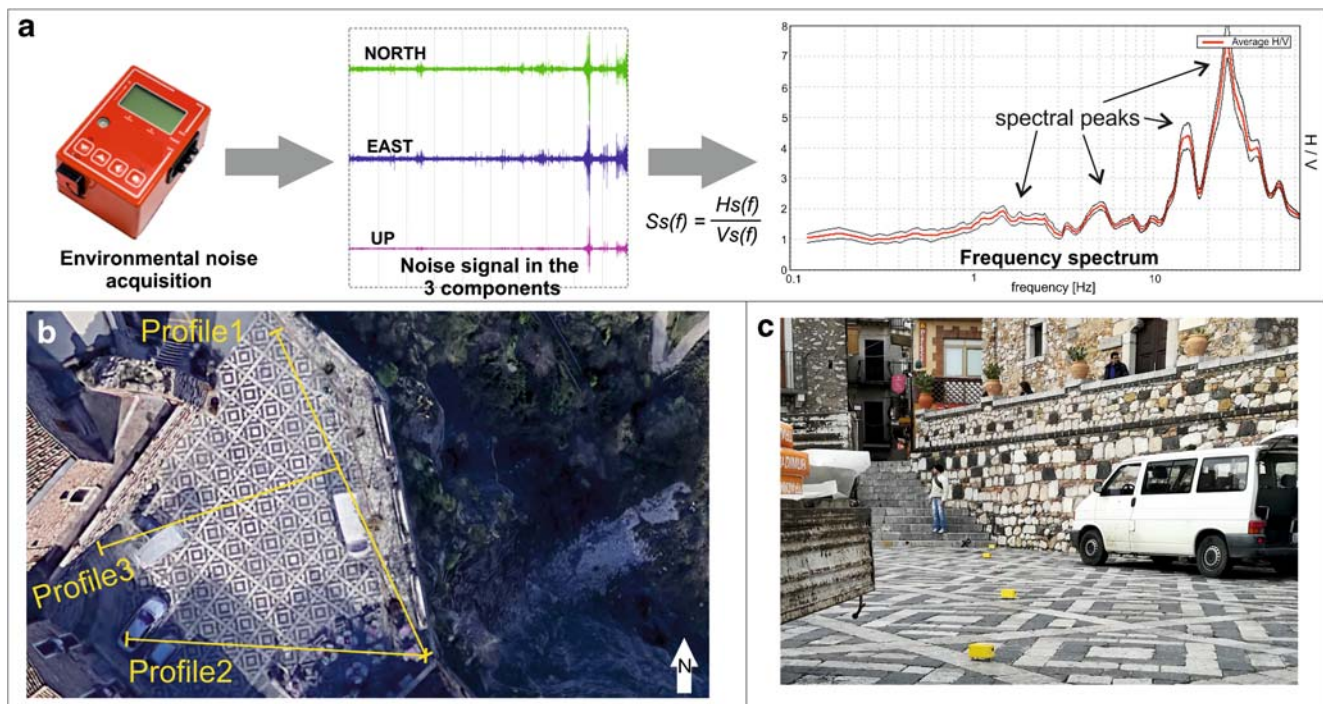
**Fig. 6** a Sketch of the procedure followed for the acquisition and processing of the environmental noise; b location of the measuring alignments on the square; c field setting during the acquisition stage along profile 3

Starting from the acquisition of environmental noise (Okada 2003) in its three spatial components, this technique allows achieving a frequency spectrum, specific for the site (Fig. 6a), which is characterized by one or more peaks. Such peaks can be correlated to some specific features of the subsoil, such as discontinuities, which cause a change in its properties (for example lithological variations or variation in the geomechanical properties of the rock), thus allowing the seismo-stratigraphic reconstruction of the subsoil.

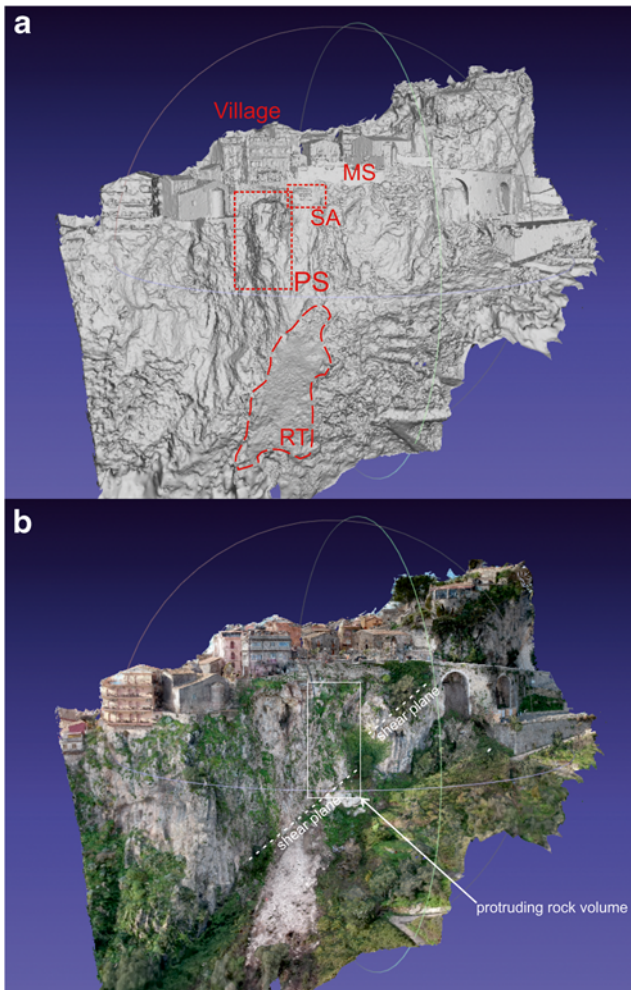
**Fig. 8** 3D mesh obtained by TLS survey: **a** raw mesh of the studied cliff with labels of the main elements (MS, main square; SA, 2019 source area; PS, past source area of 2015 and previous undefined events; RT, rockfall talus of 2019, 2015 and undefined past events); **b** 3D model of the cliff with a texture arising from aerial photos acquired by an unmanned aerial vehicle

recognizable on the 3D model of the cliff achieved by the TLS survey (Fig. 8a), where the talus of all the past rockfalls occurred at this sector can be mapped. The model shows also the presence of a shear plane at the foot of the cliff affecting the Triassic formation of limestone and dolostone (dashed line in Fig. 8b). This shear plane seems to be crossed by a tectonic structure, with a direction likely similar to F<sub>1</sub>, which causes a throw visible in the model. Above this plane, a further protruding rock volume stands below the 2019 source area. Its evidence is poor in the model due to the presence of vegetation, but its unstable condition must be reported. In fact, the dip slope geometry of the shear plane suggests a kinematically hazardous incipient movement involving about 450 m<sup>3</sup> of rocks (white rectangle in Fig. 8b). Furthermore, this volume is sided by the presence of cavities developed along the aforesaid tectonic structure with direction similar to F<sub>1</sub>, which can be regarded as enhancement features of a forthcoming instability.

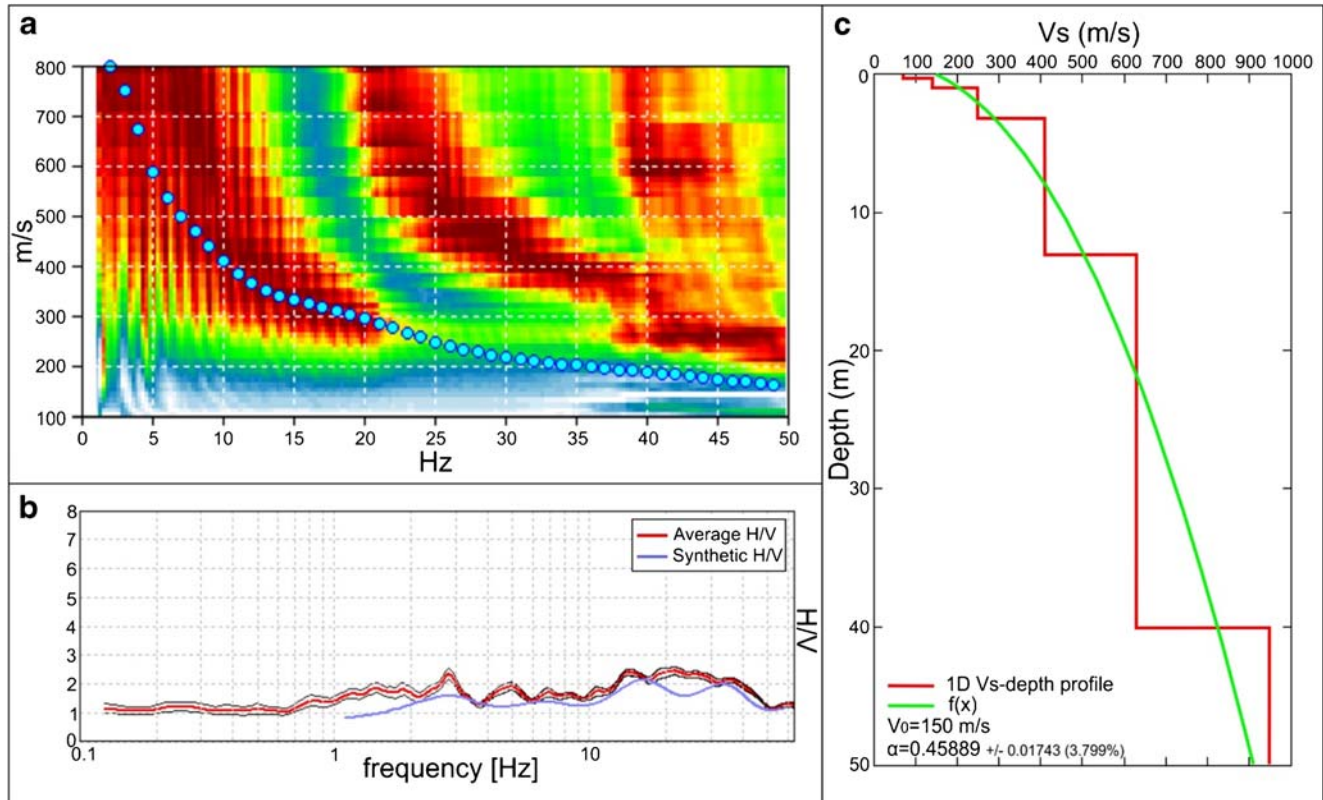
**Fig. 11** a Rayleigh waves dispersion curve obtained from the MASW survey; b HVSR spectrum, relating to N5 environmental noise record; c 1D velocity–depth profile obtained from MASW–HVSR joint fit: the green curve represents the function  $V_s(Z) = V_0 (1 + Z)^\alpha$  that has the minimum misfit with the data of the 1D Vs–depth profile

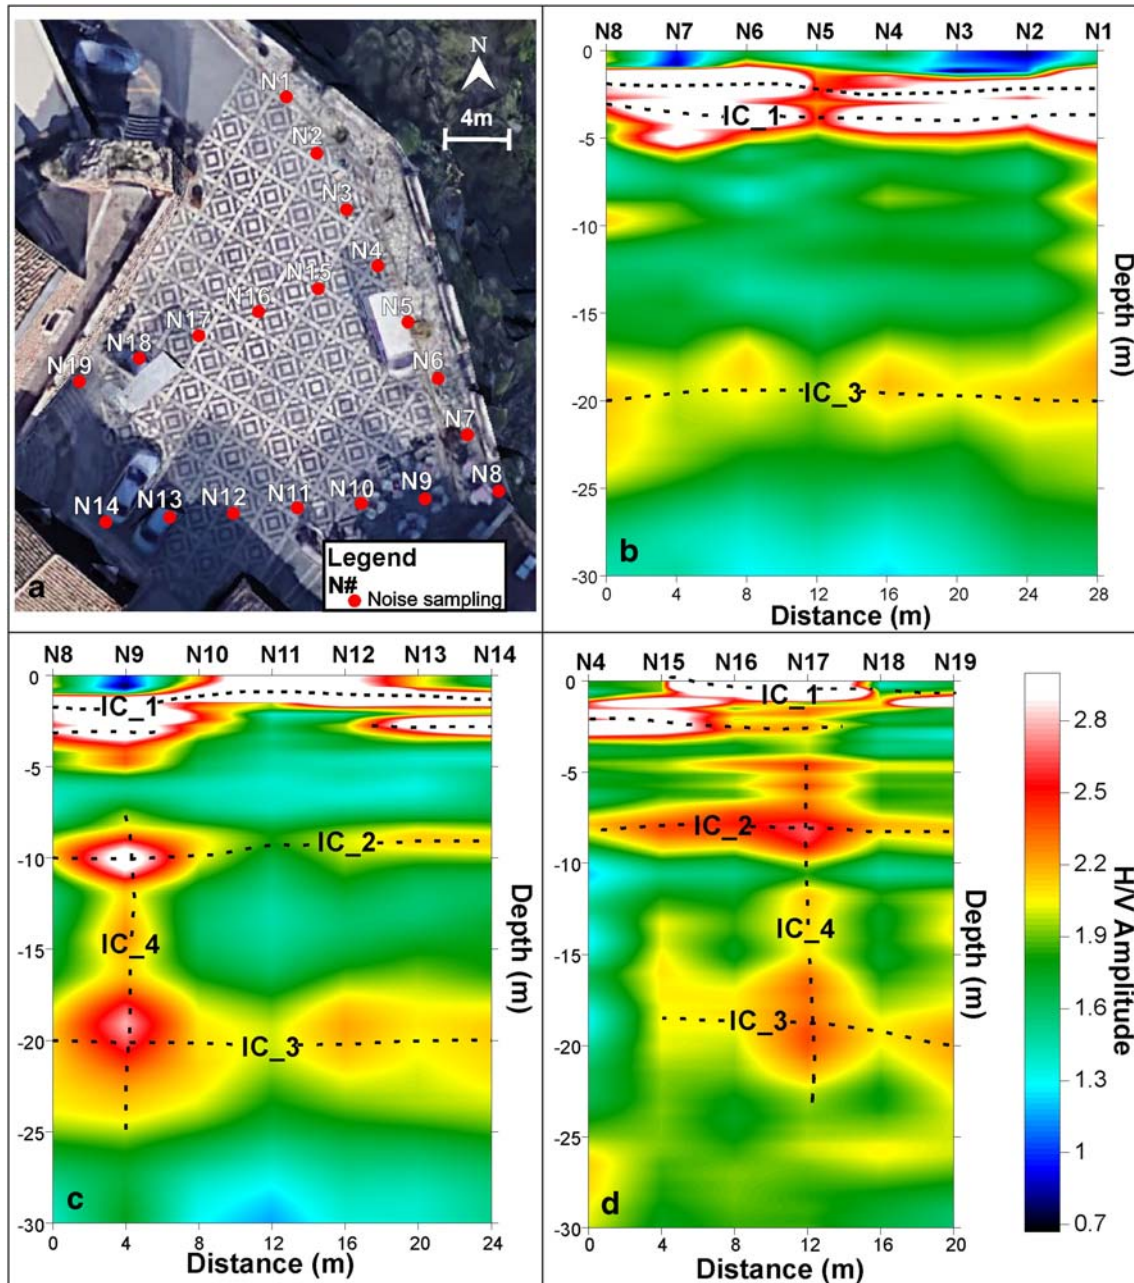
**Fig. 12** Location of the environmental noise samplings; a photo of environmental noise measuring stations along a survey profile; b impedance contrast section 1 parallel to the cliff face; c impedance contrast section 2; d impedance contrast section 3

An interesting outcome is the presence of a vertical impedance contrast (IC4) occurring at sections 2 and 3, well visible in the depth interval 5–25 m. Such contrast is found 4 and 12 m away from the cliff edge at sections 2 and 3, respectively (Fig. 12). This suggests the presence of a vertical structure crossing the sections at about N9 and N17 sampling points. A reasonable interpretation of this outcome is the presence in the subsoil of a mechanical discontinuity (crack, joint, fault), which crosses the main square, with a direction well matching with the F3 discontinuity surveyed along the cliff and driving the instability of the wedge within the past source area. Due to the relevance of this outcome, which could play a key role in the stability of the main square in case of cliff retreat, we have investigated on the directional effects found at some noise measurement points. The occurrence rates of some environmental noise recordings along the different alignments are shown in Fig. 13. The directional effect affects the frequency range in which the resonance peaks fall. By analyzing the 3D histograms,

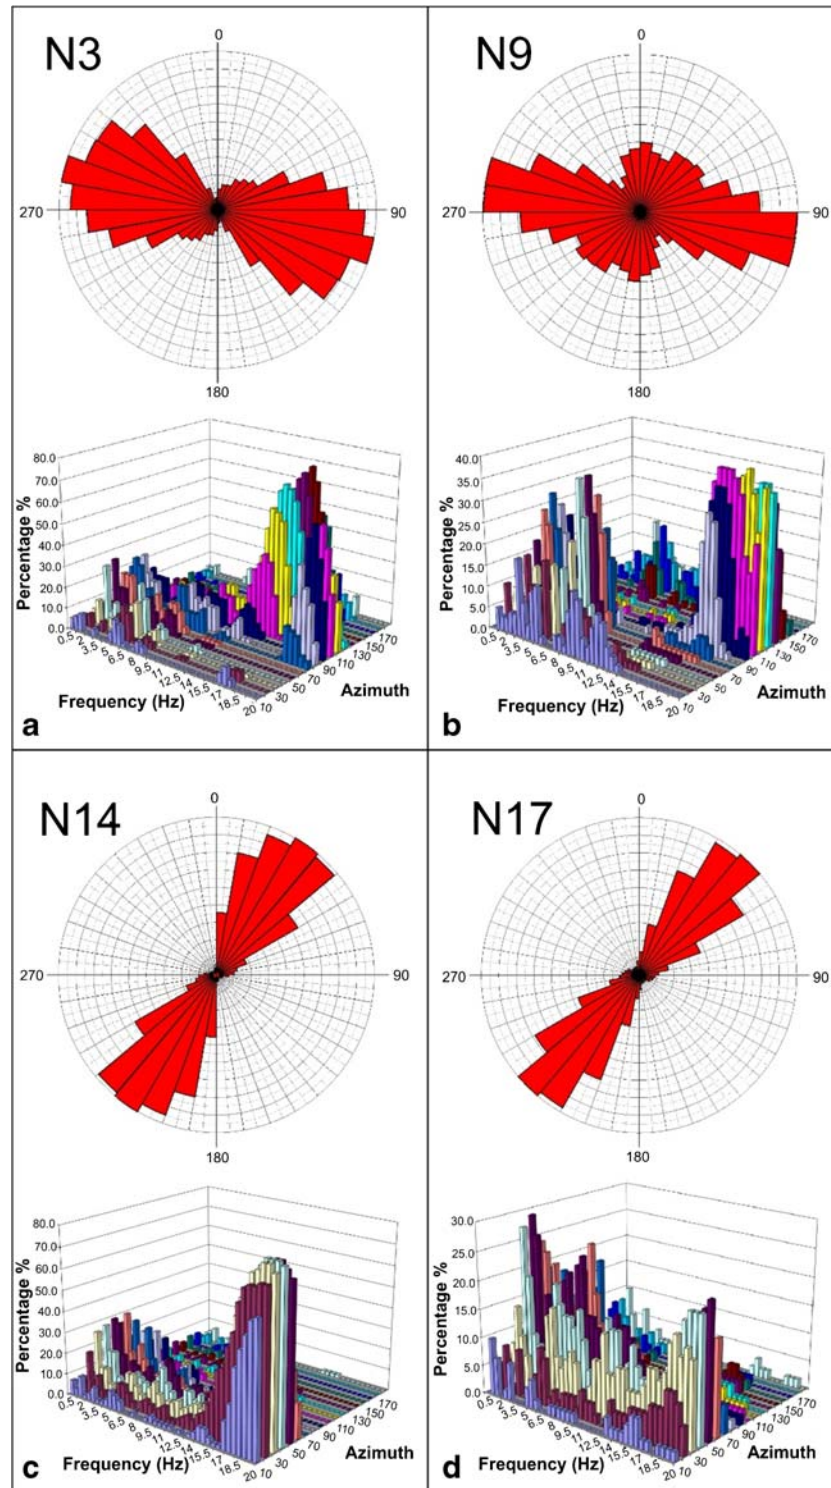
**Fig. 13** Rose diagrams of directional effects and histograms of DHPOR values related to some environmental noise acquisitions carried out in the main square of Castelmola village: a N3; b N9; c N14; d N17

two different directional effects, affecting two different ranges of frequency, can be noted. In particular, N<sub>3</sub> and N<sub>9</sub> measuring points (Fig. 13a, b) show at high frequency an azimuth between 100° and 140° N; the occurrence rate percentage is around 75% at N<sub>3</sub>, which is the closer to the edge of the cliff, and around 40% for N<sub>9</sub> point (Fig. 13a, b). Such directional effect can be related to the topographic effect induced by the proximity of the edge of the cliff with reference to the sampling points.
