New insights into the occurrence of the Baige landslide along the Jinsha River in Tibet

Keywords Baige landslide · Slope seepage · Tectonics · Groundwater · Rainfall · Risk management

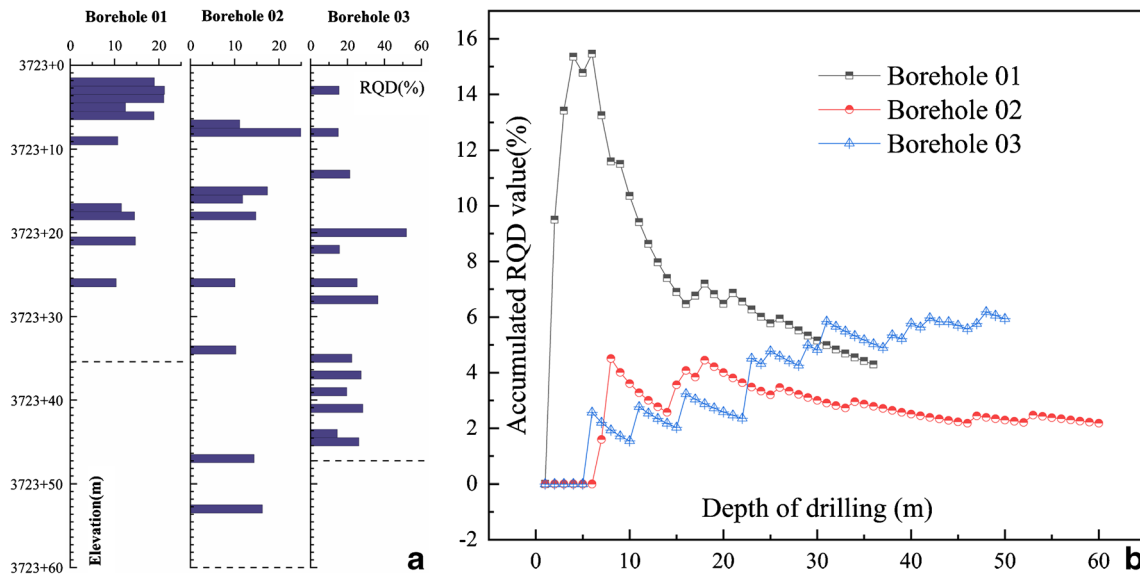
Fig. 6 Relationships between borehole depth, Rock Quality Designation (RQD) value, and accumulated RQD value. **a** Relationship between borehole depth and RQD value, the dotted line represents the depth of the borehole. **b** Relationship between borehole depth and accumulated RQD value

A Rock Quality Designation (RQD) value was used in this study to evaluate the quality of the rock mass. This method is widely employed by engineering geologists (Deere et al. 1967, Ietto et al. 2017). The RQD values of the B01, B02, and B03 in the same soil profile show that the points with an RQD value of 0% occur intermittently, and these points are concentrated in the elevations of 3711–3714 m, 3698–3700 m, 3690 m–3694 m (Fig. 6a). This phenomenon may be caused by the fluctuation of the incision velocity in Bogong Gully. The accumulated RQD value was used to better show the relationship between the drill depth and the fracturing of the rock mass (Cui et al. 2018). The accumulated RQD values of the three boreholes at the top of the slope revealed that the rock quality first increases and then decreases with borehole depth, especially in B01 and B02. The accumulated RQD value of B01 is higher than those of B02 and B03 at a depth of 10 m, while the value of B03 (7%) is higher than those of B01 and B02 at a depth greater than 40 m,

showing that the integrity of the rock mass is extremely poor (Fig. 6b).

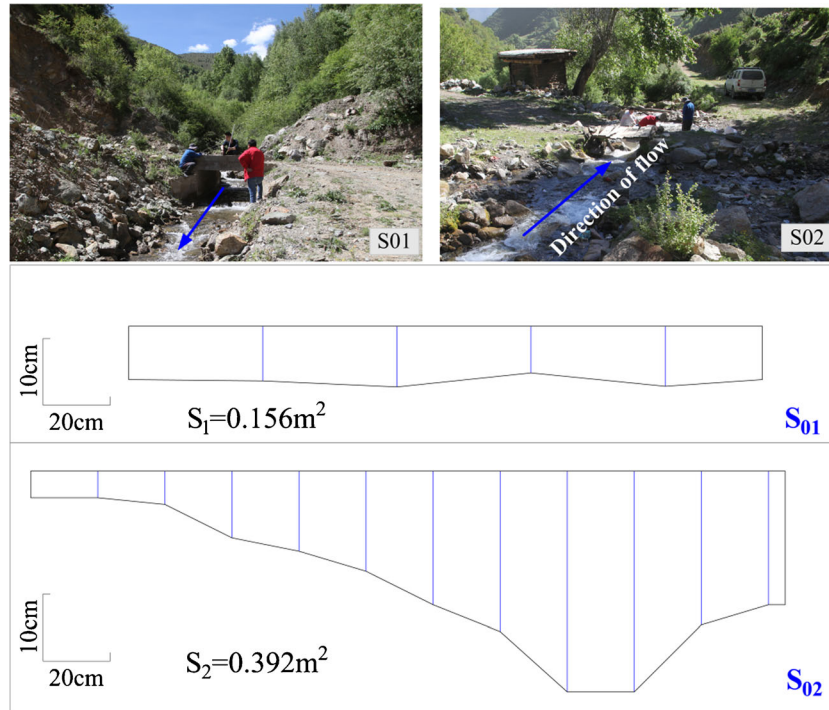
Fig. 8 Field survey (S01 and S02 in Fig. 3) and cross-sectional morphology in the Bogong Gully

The drainage area of the Bogong Gully is 23.2 m², and the length of the main channel is 8.55 km. The gully converges into the Jinsha River on the northern side of the Baige landslide. The discharges of two representative cross-sections (So1 and So2) along the back of the Baige landslide were calculated using a morphological surveying method in which the discharge is the product of the velocity and the cross-sectional area. The shape of the cross-section was obtained by field measurements, and the flow velocity was obtained by measuring the time over which a buoy passed a certain distance (Fig. 8). The calculated flow results are shown in Table 1.

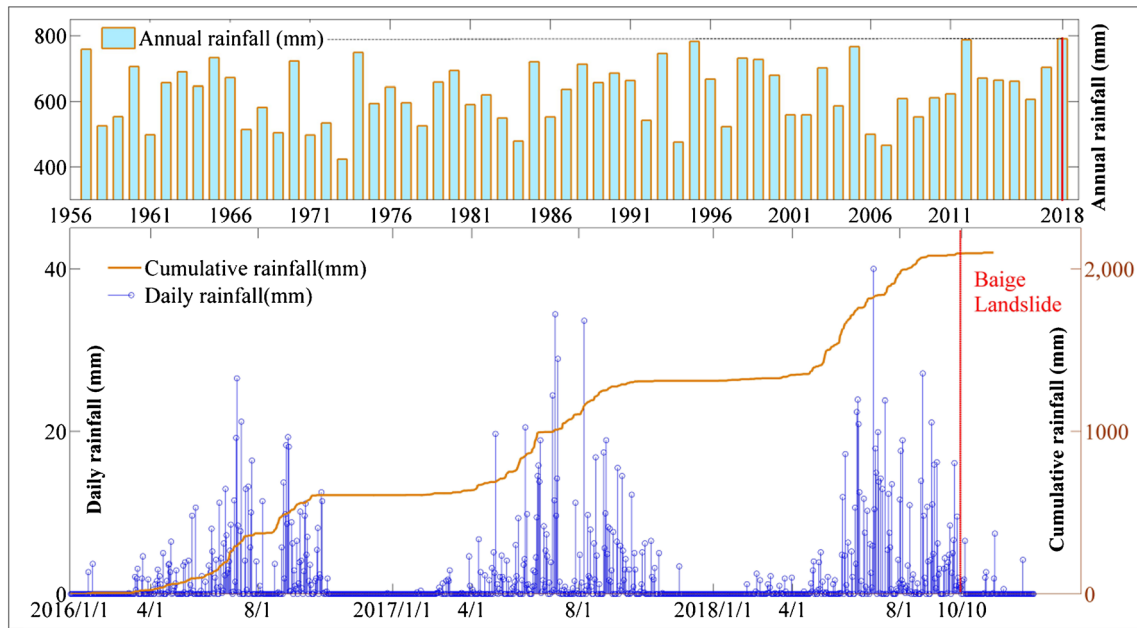
Fig. 11 Rainfall from the Dege County Meteorological Station near the study area from 1957 to 2018. The upper part is the annual rainfall from 1957 to 2018, and the lower part is the daily and accumulated daily rainfalls from 2016 until landslide occurrence

2018. Thus, the daily rainfall in October did not immediately lead to the occurrence of landslides. However, rainfall data from 1957 to 2018 show that the annual rainfall in 2018 was 790.4 mm, having reached a low-frequency rainfall, with a frequency of at least < 62 years. Also, the research suggests that daily rainfall did not directly trigger the Baige landslide, while the annual rainfall affected the strength and stability of the rock mass by increasing the infiltration volume caused by the increased discharge of the Bogong Gully. The rainfall characteristics and a hysteresis effect between the heavy daily rainfall and the timing of landslide are shown in Fig. 11.

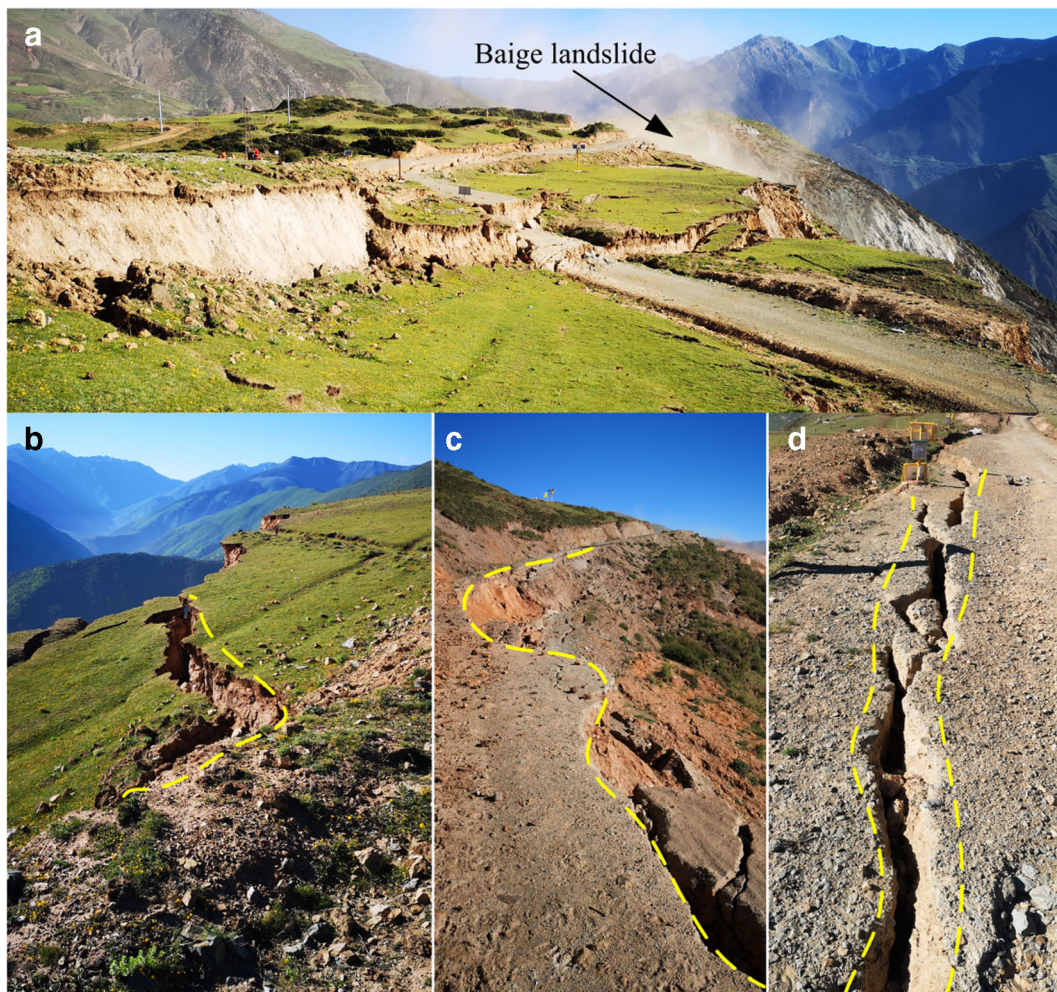
Fig. 12 Tensile cracks on the slope after the Baige landslide

At present, there is a potentially high landslide risk on the slope on the southern side of the Baige landslide. A number of cracks formed on the top of the slope after the Baige landslide (Fig. 12), and borehole B03 shows that the rock mass is strongly weathered. The groundwater remains active in the areas where no landslide had occurred on the southern end of the Baige landslide. Efforts are currently being made to reduce the disaster risk by dredging deposits and reducing the potential landslide volume. However, due to the limitations imposed by limited accessibility and the low geological exploration depth, the generative characteristics of the Baige landslide have not been fully clarified. Additionally, current

The potential risk posed by the slope near the Baige landslide has not been eliminated, and the risk is likely to remain high in the future. Moreover, a series of tensile cracks generated at the top of the slope after the Baige landslide will lead to increased seepage at the top of the slope, further impacting groundwater activities. Thus, additional drainage measures and deep explorations must be implemented on the basis of existing prevention and control measures.
