## Rainfall-induced reactivation mechanism of a landslide with multiple-soft layers

**Abstract** A study on the site investigation data from the Chengnan landslide, which was a partially reactivated ancient landslide in Meigu County, Xichang City, China, is presented. To explore the reactivation mechanism of the Chengnan landslide, we conducted site investigation, surface displacement monitoring, deep displacement monitoring, finite element analysis, and limit equilibrium analysis of the Chengnan landslide. The results indicated that the Chengnan landslide experienced multiple reactivations. It was initially reactivated in 2002 along the first clay layer at a depth of 14 m; after comprehensive treatment measures, which included excavating to reduce loads, improving the drainage system, and installing anti-sliding piles in 2006, further deformation was prevented. However, heavy rainfall in 2007 caused groundwater infiltration, softening the second clay layer at a depth of 28 m and transforming it into a new sliding surface (i.e., the second sliding surface). Consequently, Chengnan landslide was reactivated again along the second sliding surface, and the anti-sliding piles moved tog

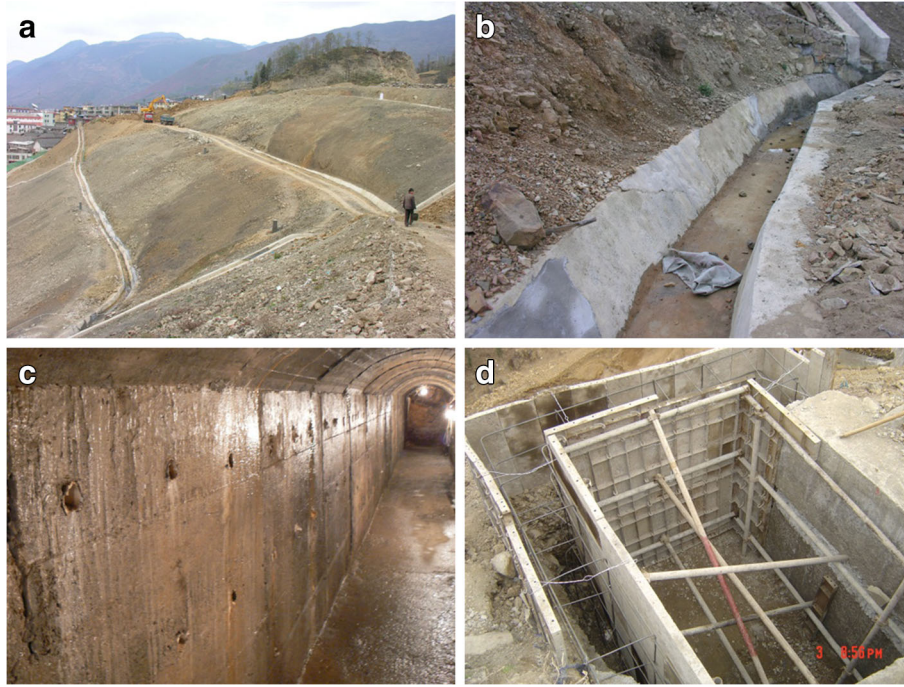
**Fig. 4** Treatment projects. (a) Stair shape after reducing load. (b) Drainage channel on the slope surface. (c) Adit inside the slope body. (d) Construction of anti-sliding piles

The depth of the sliding surface was determined to be 14 m according to the 2005 site investigation results; no signs of deeper sliding were evident at that time. Therefore, treatment projects were initiated to stabilize the sliding mass above the sliding surface at a depth of 14 m. Treatment projects were undertaken since 2006, including measures to reduce loads, improve the drainage system, and to install anti-sliding piles (Fig. 4). After the load-reduction project, the slope body above the Xichang–Meigu road was shaped like a staircase with six steps. The drainage system included

drainage channels on the ground surface and adit. A total of 32 anti-sliding piles were constructed beneath the Xichang–Meigu road; the pile spacing was 5 m, sectional dimension was  $2 \times 3 \text{ m}^2$ , and their lengths were 18–22 m. In August 2006, the landslide treatment projects were completed. Surface displacement monitoring data from August 2006 to July 2007 demonstrated that the treatment measures had a positive effect.

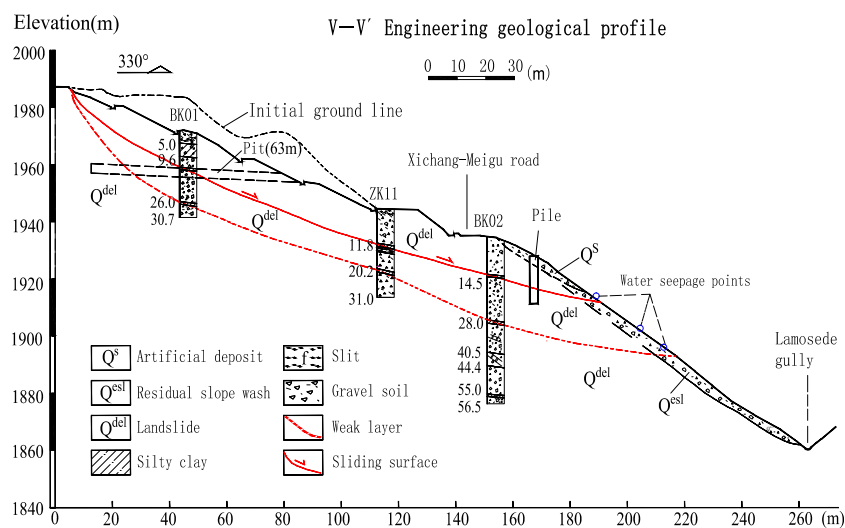
**Fig. 5** V-V' engineering geological profile

The main composition materials include cobbles and boulders, silt with multiple soft layers, human-activity deposits, and residual diluvium. These materials were complexly distributed inside the landslide body, as shown in Fig. 5. Special attention should be paid

Based on the site investigation and exploration results (Fig. 2), the engineering geological profile V-V' (Fig. 5) was used to analyze the stability of Chengnan landslide. Finite element model was built based on the site characteristics of Chengnan landslide as well as the morphological character of this landslide before Chengnan landslide was reactivated. The components of the simulated model included excavated mass, three gravel soil layers, and two clay layers (Fig. 12).

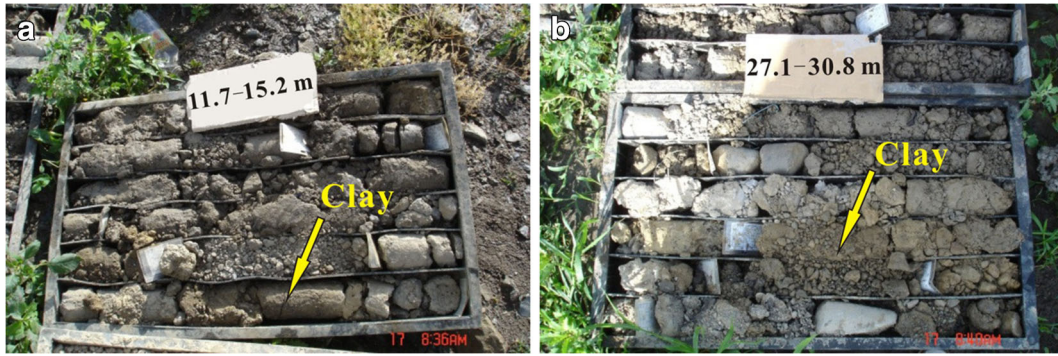
to the findings from BK02 borehole. Among the gravel soil layers, four soft layers were recorded. The first soft layer was at a depth of 14 m and had a thickness of 0.6 m. The second soft layer was at a depth of 28 m and had a thickness of 0.6–0.8 m. The third soft layer was at a depth of 40.5 m and had a thickness of 4 m. The fourth soft layer was at a depth of 55 m and had a thickness of 0.6–1 m. Partial borehole samples from BK02 borehole are shown in Fig. 6. The soft layers are indicated by a yellow arrow.

**Fig. 6** (a) BK02 borehole sample, where the first soft layer was found at 14 m. (b) BK02 borehole sample, where the second soft layer was found at 28 m

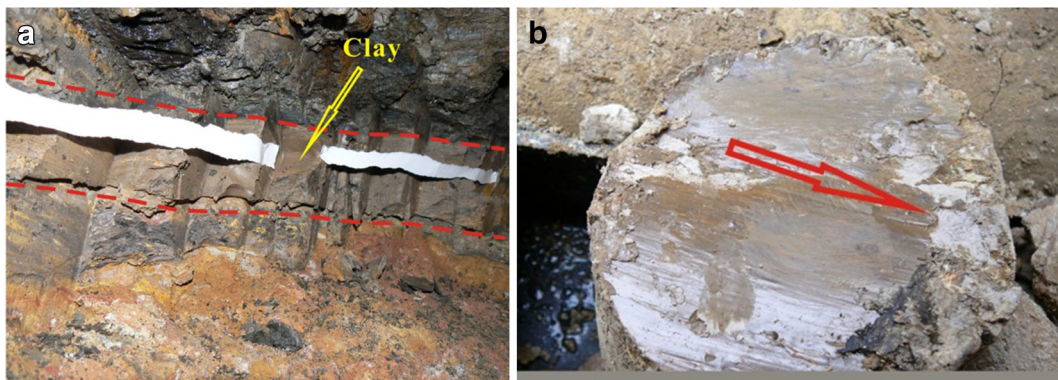
Scratches on the clay layer at a depth of 14 m are shown in Fig. 7b. A borehole sample from BK02 shows that the clay was yellow and gray in color and was in a plastic state. The dip/dip direction of the striated surface was  $15^{\circ}/330^{\circ}$ , basically coincident with the dip/dip direction of the Chengnan landslide sliding surface. Both borehole data and observations from the adit revealed that several soft layers exist inside the sliding body of the Chengnan landslide. Although several soft layers were found, most of these were stable, except for one, the first sliding surface of the Chengnan landslide, which was at a depth of 14 m under the ground surface. Treatment projects were undertaken from 2005 to 2006 to inhibit the further slide of the Chengnan landslide along this sliding surface.

**Fig. 7** (a) Broken scrip at the soft layer at a depth of 36 m of the adit. (b) Borehole sample from BK02 at a depth of 14 m, showing striation on clay

Deformation of the landslide mass continued to become more serious, eventually breaking the adit. The breakage occurred at the first sliding surface. Therefore, the groundwater inside the adit permeated the first sliding surface and penetrated into the deeper part of the landslide body. Later, this issue contributed to the formation of a deeper sliding surface in the Chengnan landslide.

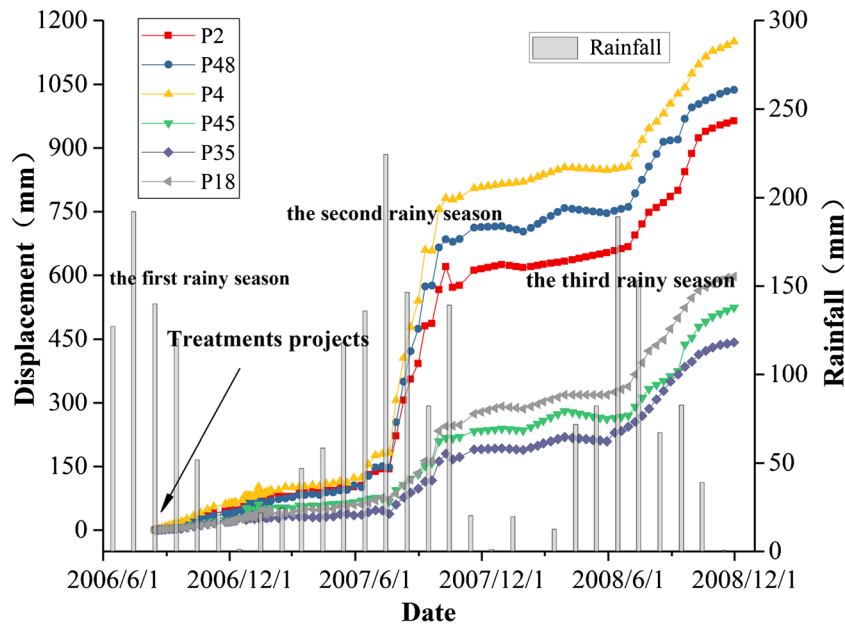
The first raining season after the treatment projects were completed ran from August, 2006 and May, 2007. According to the surface displacement monitoring data (Fig. 9), the P4 point which

was located in the head area of Chengnan landslide showed the cumulative displacement was 120 mm, while the P18 point which was located above the anti-sliding pile at the Chengnan landslide toe showed the cumulative displacement was 65 mm. After such interval, the displacement increment tended to be zero, which showed the treatment projects had stabilized the sliding mass above the sliding surface at a depth of 14 m.

During the second rainy season, from June 2007 to June 2008, the study area experienced extremely heavy rainfall, often lasting for several days. The highest amount of precipitation recorded in July was 240 mm. The values exceeded all average precipitation records in Meigu County. Consequently, the increment of surface deformation of P4 was 730 mm, with the cumulative displacement up to 850 mm, while the increment of surface deformation of P18 was 240 mm, with the cumulative displacement up to 300 mm. These monitoring data showed that the Chengnan landslide was reactivated again.

Fig. 9 Combined graphs of surface displacement data and precipitation record

The third rainy season ran from June 2008. The displacement increment at P4 is 300 mm, the cumulative displacement was up to 1150 mm. The displacement at P18 showed a clear increase, with cumulative displacement up to 600 mm.

In conclusion, from the surface displacement data, it can be seen that heavy rainfall had a significant influence on the deformation of Chengnan landslide. The displacement of Chengnan landslide increased sharply just after each rainy season. The deformation at the trailing edge of the landslide was greater than that at the frontal part.

Rainfall is considered as the main factor that triggered the reactivation of the Chengnan landslide. Based on the displacement data analysis, slope deformation mainly depended on the effect of rainfall. Observations made outside the rainy season reveal no groundwater table, a dry adit, and a lack of groundwater at the landslide toe. However, during the rainy season, several groundwater overflow points were found at the toe area. After the construction of anti-sliding piles, groundwater was collected in the foundation of the anti-sliding piles; groundwater was also found inside the adit (Fig. 8). Additionally, ground displacement monitoring data (Fig. 9) showed corresponding

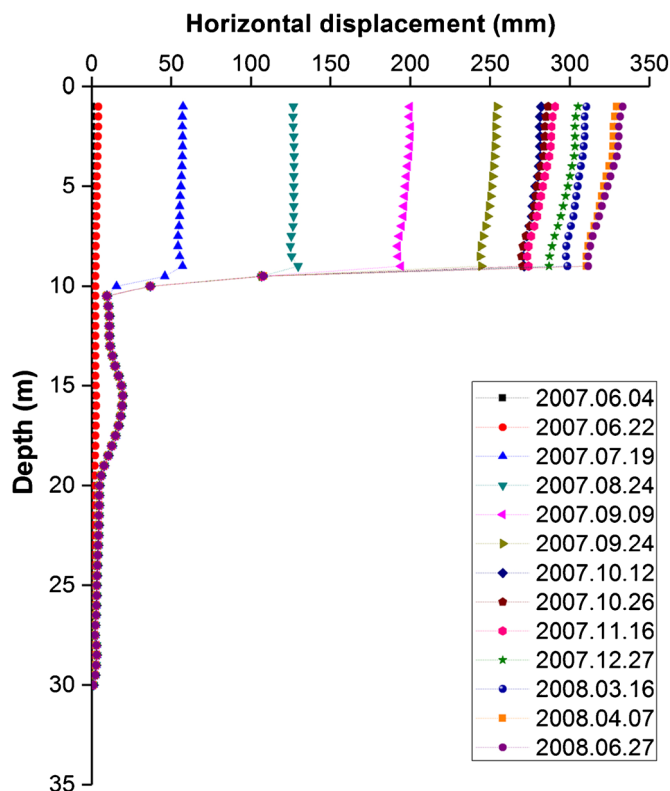
The cumulative displacement data for BK01 are shown in Fig. 10. Monitoring began on June 22, 2007, with displacement at 4 mm. However, during the rainy season, data obtained on July 19, August 24, and September 9 indicated that the cumulative displacement had increased to 200 mm. The gradually increasing trend became more subtle after the rainy season. By June 27, 2008, the cumulative displacement for BK01 reached 330 mm. By

analyzing the curve of cumulative displacement, one can identify an obvious turning point at a depth of 9.6 m; this position was also found to be that of the first sliding surface. The cumulative horizontal displacement at this depth was 300 mm. This displacement was very close to the surface displacement of the monitoring hole, indicating that the first sliding surface was active during the monitoring period. At the end of the monitoring project, a probe rod could not reach the bottom of the monitoring hole; it got stuck at a depth of 9.6 m. As a result, no further data were obtained after this event.

Fig. 10 Cumulative displacement of BK01

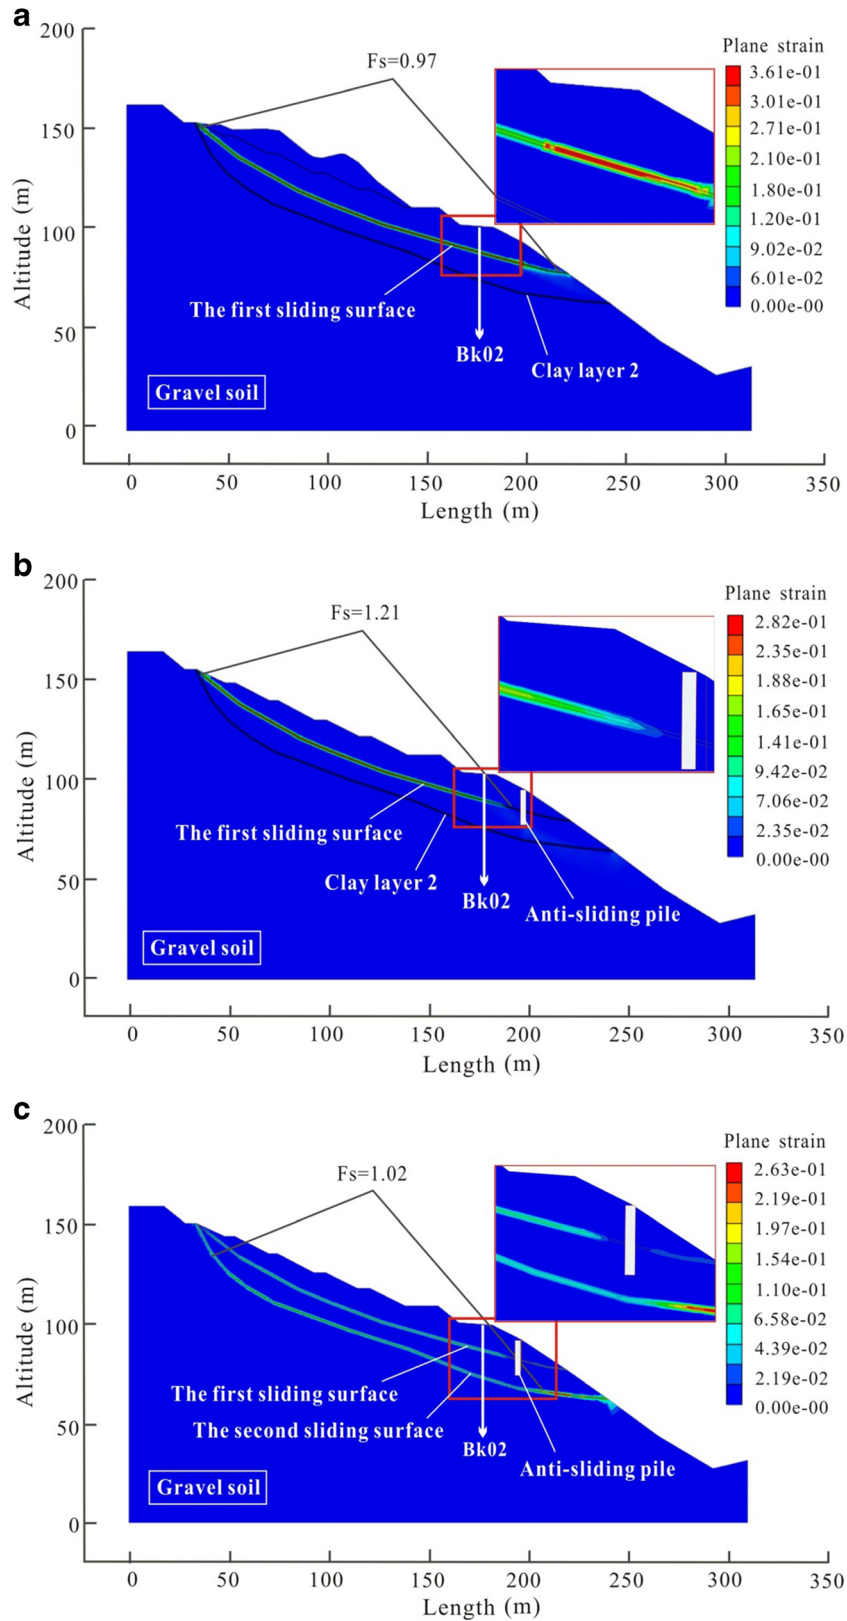
The stress–strain distribution results at every stage and the safety factor ( $F_s$ ) were calculated, as shown in Fig. 13. **The first stage:** Chengnan landslide slid along the first clay layer (i.e., the first sliding surface) at a depth of 14 m, and the safety factor was 0.97 (Fig. 13a). **The second stage:** after the treatment projects were undertaken, a safety factor of 1.21 was calculated for the first sliding surface (Fig. 13b). **The third stage:** After heavy rainfall, groundwater infiltrated into the deeper landslide body and softened the second clay layer, which was located at a depth of 28 m, lowering the shear strength of the second softened layer. Consequently, a new sliding surface was well developed, and the corresponding safety factor of the Chengnan landslide along this sliding surface was 1.02. Because the second sliding surface was deeper than the anti-sliding piles, the anti-sliding piles had no beneficial effect on the stability of landslide along this sliding surface, as shown in Fig. 13c.

**Fig. 13** Finite element calculation results of the Chengnan landslide. (a) The first stage, the Chengnan landslide slid along the first sliding surface at a depth of 14 m. (b) The second stage, after treatment projects were undertaken, the Chengnan landslide became stable. (c) The third stage, the Chengnan landslide slid along the second sliding surface at a depth of 28 m; the anti-sliding piles failed

- (1) The Chengnan landslide was initially reactivated in 2002, sliding along the first soft layer (i.e., the first sliding surface) at a depth of 14 m; at this stage, the safety factor was 0.97 (Fig. 13a). After the formation of the first sliding surface at a depth of 14 m, treatment measures were undertaken in 2006, which included reducing loads, improving drainage channel, and installing barrette piles (Figs. 4 and 5); these measures yielded a positive result, stabilizing the Chengnan landslide, and at this stage, the safety factor was 1.21 (Fig. 13b).

- (2) Since 2007, more and more cracks were developed in the upper part and the ground surface of landslide, and the adit and other drainage channels were also damaged. Through these cracks, the heavy rainfalls significantly enhance the rainwater infiltration into the interior of landslide body. On the one hand, it makes for saturation and triggers a high pore water pressure in slip mass, finally increasing the downslope strength of slide (Xia et al. 2013; Liu and Li 2015; Christofer et al. 2017; Tu et al. 2019); on the other hand, the softening effects of water reduce the mechanical strength of the second clay layer (Locat et al. 2014; Valore et al. 2017; Ziccarelli et al. 2017). Consequently, a new sliding surface (i.e., the second sliding surface) at a depth of 28 m was developed (Figs. 11 and 13c), the Chengnan landslide was reactivated again in 2007 along the second sliding surface. Because the second sliding surface was deeper than the anti-sliding piles, the anti-sliding piles failed. At this stage, the safety factor of Chengnan landslide was 1.02 (Fig. 13c).

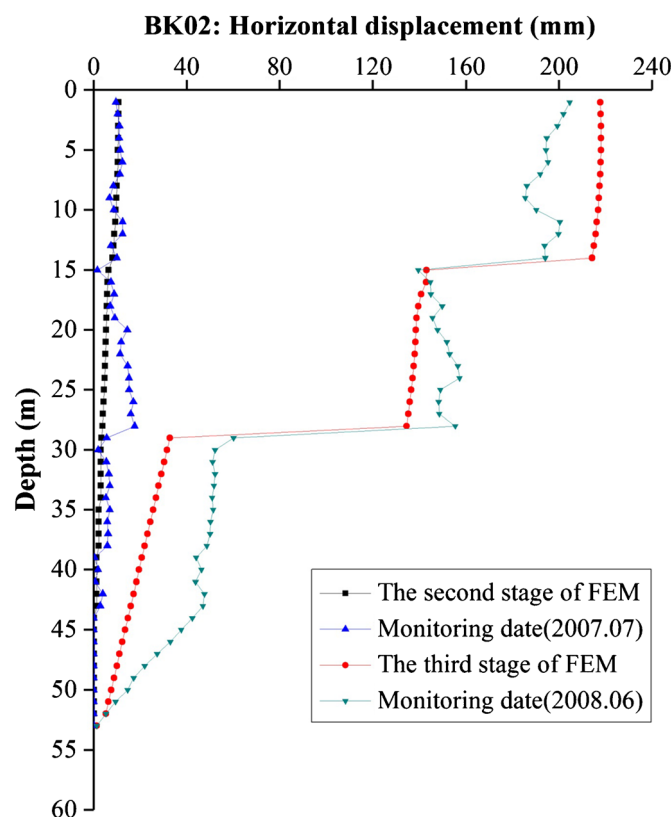
The results obtained from the FEM analysis on the second and third stages are in good agreement with the deep displacement monitoring dates of BK02 borehole (Fig. 14). It also indicates the results of FEM simulation are reasonable.

Fig. 14 Comparison between the FEM simulated data and the site measured displacement data from deep borehole-BK02
