Landslides (2020) 17:2689–2697
 DOI 10.1007/s10346-020-01520-5
 Received: 22 April 2020
 Accepted: 18 August 2020
 Published online: 1 September 2020
 © Springer-Verlag GmbH Germany
 part of Springer Nature 2020

Causative factors of landslides 2019: case study in Malappuram and Wayanad districts of Kerala, India

Keywords Landslides · Floods · Multi-hazard · Chaliyar River basin · Kerala

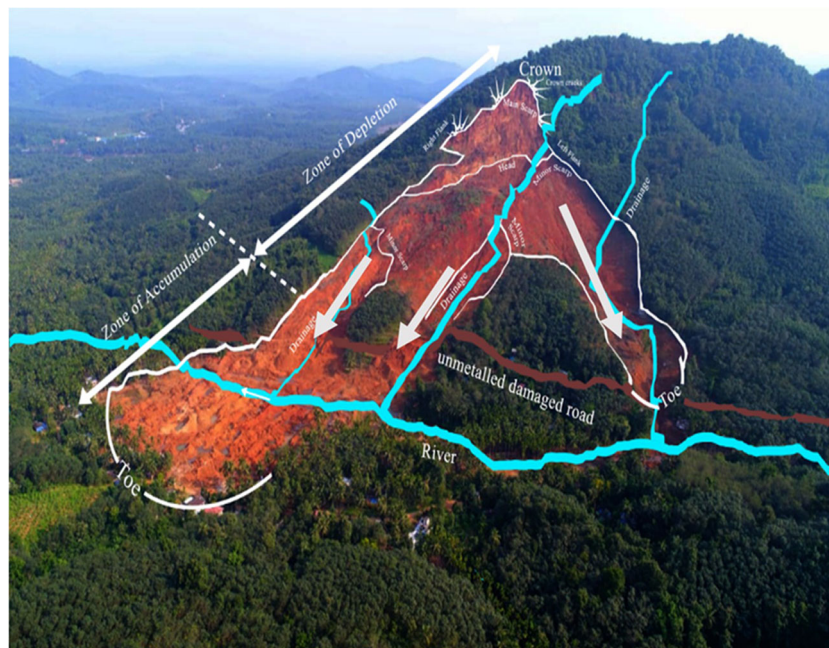
Fig. 3 2019 landslides at site 1: Kavalappara, Malappuram District, Kerala

The nature and type of landslides at site 1 (Kavalappara) were unique, as it occurred along trifurcated downslope segments. The consequent three steep 1st order drainage courses acted as the rejuvenated favorable carriers for the discharge of large water-saturated material and rocky debris. The lengths of trapeze-shaped landslides are roughly 300 m, 400 m, and 380 m, respectively (from left to right in Fig. 3), narrow at the top and widening downslope at the base. The dimensions of the major landslide were 80 m wide at the top, 100 m in the middle, and 300 m wide at the bottom. Other associated downslope routes of landslides were approximately 50 to 60 m wide. All the landslides were of the type of debris and earth flow. The

runoff material extended over a distance of 250 m that transgressed the channel course and temporarily blocked the southerly flowing river, at the base (Fig. 3).

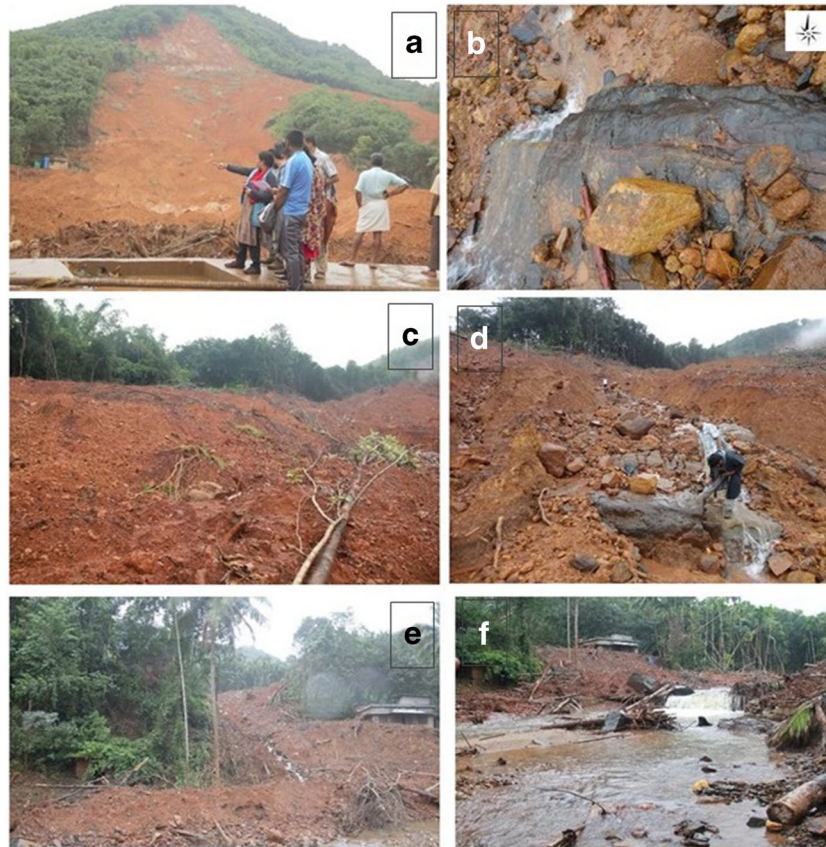
Fig. 4 Effects of landslides at site 1: Kavalappara. **a** Synoptic view of the major landslide. **b** Prominent dip-slope joints in the bedrock exposed after stripping away of overburden at Kavalappara major landslide. **c** Debris-covered run-out material at middle reaches to downslope. **d** Sediment-charged activated stream dislodging large boulders along the joints and resulted in formation of cascading rapids. **e** Western part of landslide where large blocks of rocks rolled down the slope. **f** Bank erosion and channel bed-load forming a channel bar, thus bifurcating the channel carved during the flooding of the Chaliyar River. (Photo source: author's personal collection at Amrita Vishwa Vidyapeetham, Kerala)

- Site 1: At Kavalappara, the land was wet, with runoff water flowing over in a network of small streams (Fig. 4 d and e). The exceptionally high flood levels in the Chaliyar River resulted in overflows of its own banks and created post-flood braided channels, showing several channel bars of very coarse gravel and boulders.
- Site 2: At Puthumala, drainage courses of the runoff water, flowing through the channel, were obstructed by the human

within active floodplain of higher order streams, were vulnerable to natural processes of erosion and destruction, precipitated by heavy downpour. At Kavalappara (site 1), the land was observed to be wet, with surface runoffs flowing in a network of small streams (Fig. 4d, e). The exceptionally high flood levels in the river resulted in cutting through its own banks and creation of post-flood braided channels that course through several channel bars of the bed-load of very coarse gravel and boulders. At the Puthumala (site 2), the water flows through the channel, where the drainage courses were obstructed by careless human interventions. The houses constructed within the active river floodplain were dislodged by the onrush of floodwaters; the drainage culverts across the road were not properly located to drain effectively (Fig. 8e). Therefore, a lot of damage to property could have been avoided by proper application of sound civil geotechnical engineering. Secondly, plenty of rainwater was observed running over the sloping mountainous roads due to lack of properly engineered drainage system which is needed to be laid through well-maintained hill-side trenches

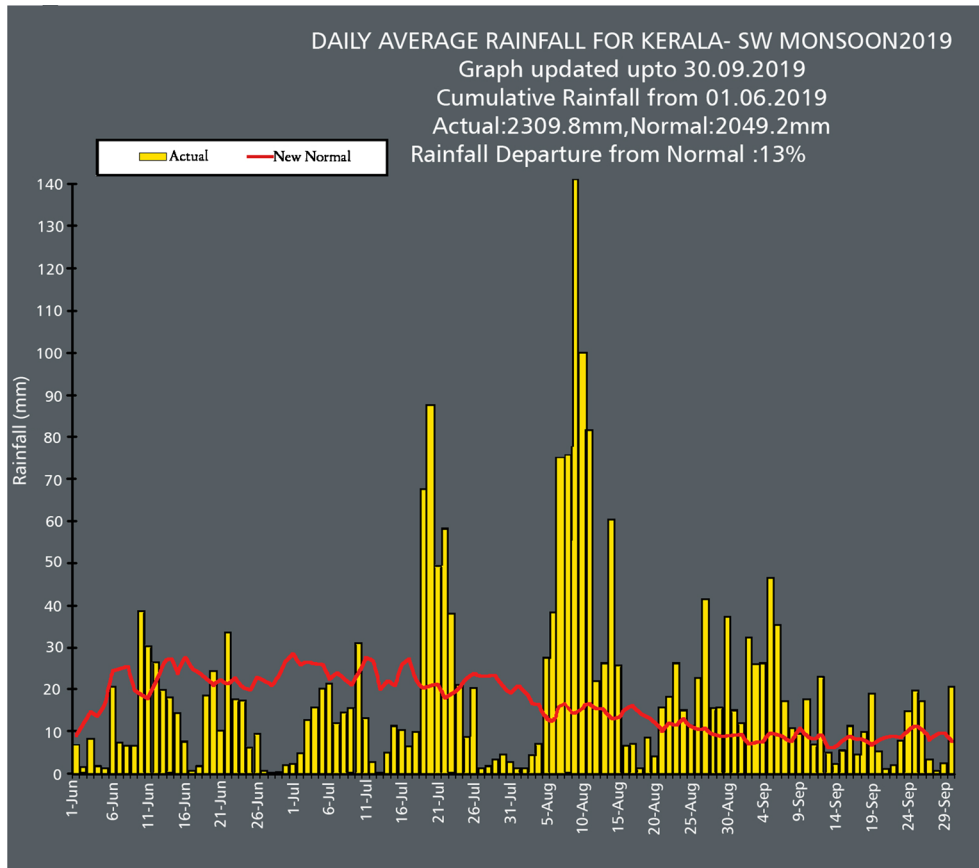
Fig. 5 Daily average rainfall during southwest monsoon season 2019. Modified image, Source: IMD 2019

According to the Indian Meteorology Department's (IMD's) data, there was a prolonged heavy rainfall from 4 August 2019 onwards, with very heavy torrential downpour on 8 August 2019 (Fig. 5) in most places across the state of Kerala, with exceptionally heavier rainfall at several places. Figure 5 also shows that the rainfall was about 400% in excess of the normal average rainfall, for five consecutive days between 4 and 8 August 2019. The rains reportedly triggered more than 24 small and big landslides across entire Kerala (<https://www.downtoearth.org.in/news/india/kerala-rains-24-landslides-in-24-hours-22-killed-22-165-moved-66107>).

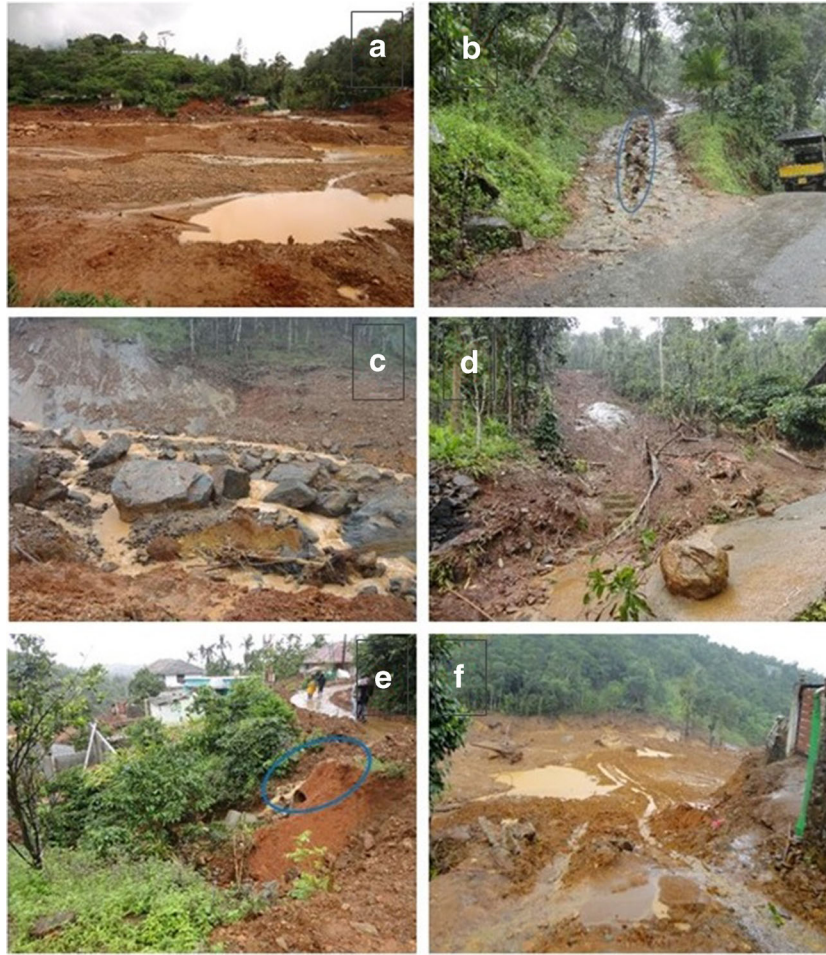
Fig. 8 The landslide and floods at Puthumala, Wayanad (site 2). **a** The damages due the flood in the tributary of the Chaliyar River. **b** Rain water draining downslope carved its own new consequent course along the leveled and stone paved path resulting in the caving-in or sinking of path in the middle. **c** Large boulder blocks of freshly cut rocks transported as rolling bed-load by floodwaters in the river. **d** One of the landslides at Puthumala, showing rolled boulder and exposed bedrock after stripped-off of its overlying weathered zone and soil cover. **e** Improper hill-side drainage of storm/rainwater and improperly placed culvert. **f** View from downslope of a landslide at Puthumala that washed away houses built within the channel course. Photo source: Authors

developmental interventions (Fig. 7). People had constructed houses within the active river floodplains (Fig. 7a). Some of the constructed houses were damaged by the onrush of floodwaters (Fig. 7b). The culverts across the road were not properly located, to drain smoothly and discharge effectively (Fig. 8e). Overlying soils and weathered material were observed to have been washed away by the floodwaters, along the banks of the river, exposing the bed rocks (Fig. 8c). The soil cover was approximately 2 m thick over the closely spaced, jointed and weathered bedrocks with one set of the joint planes dipping downslope, along the gradient of the tributary stream.

power of the deluge. Angularity of well-cut large blocks of rocks indicates original structural influence on dislodgement and transport of rock boulders, under rapid, forceful flow of water. The presence of large boulders, seen as rolling and traction load, had the potential to down-cut slopes during sheet wash, and ferociously erode the stream banks causing aggravated devastation in the floodplains, further down-stream (Fig. 8).
