Kun Song · Fawu Wang · Qingjun Zuo · Bolin Huang · Wuwei Mao · Hu Zheng

Successful disaster management of the July 2020 Shaziba landslide triggered by heavy rainfall in Mazhe Village, Enshi City, Hubei Province, China

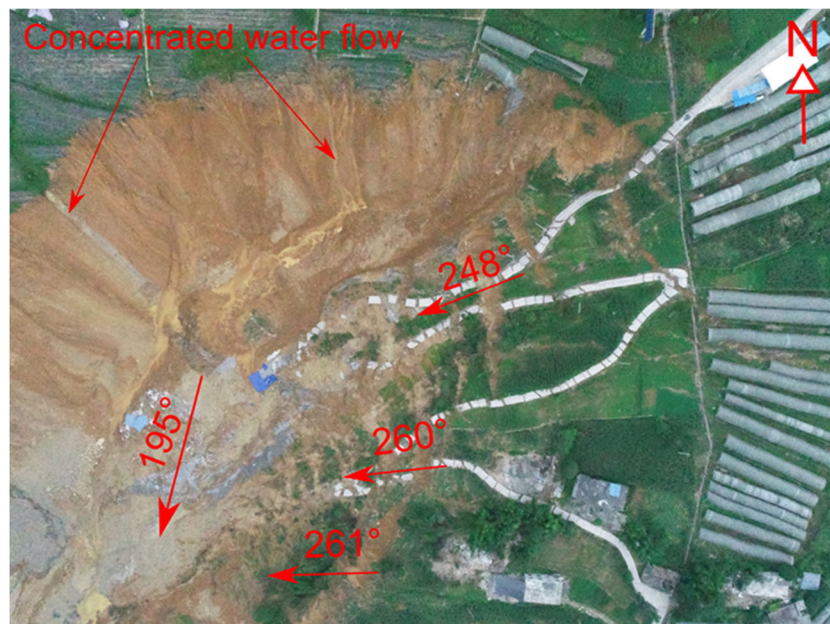
Fig. 4 Minor scarps at the head, showing the displacement of the sliding mass to the gully on the west side

Figure 4 shows the situation at the head of the landslide area. The fresh cliff in the west flank was formed by this event and reaches a maximum height of 71 m; several minor scarps are identified near the detached white line, which indicates a road winding over the western part of the landslide mass. From the cracks between the minor scarps, the moving direction of the landslide, which is the compound of main sliding direction to the south and the local sliding direction to the west, was measured between 248° and 261°. At the central part and west part of the

main scarp, there are two concentrated water flows, which resulted from the surface water flow during the heavy rainfall.

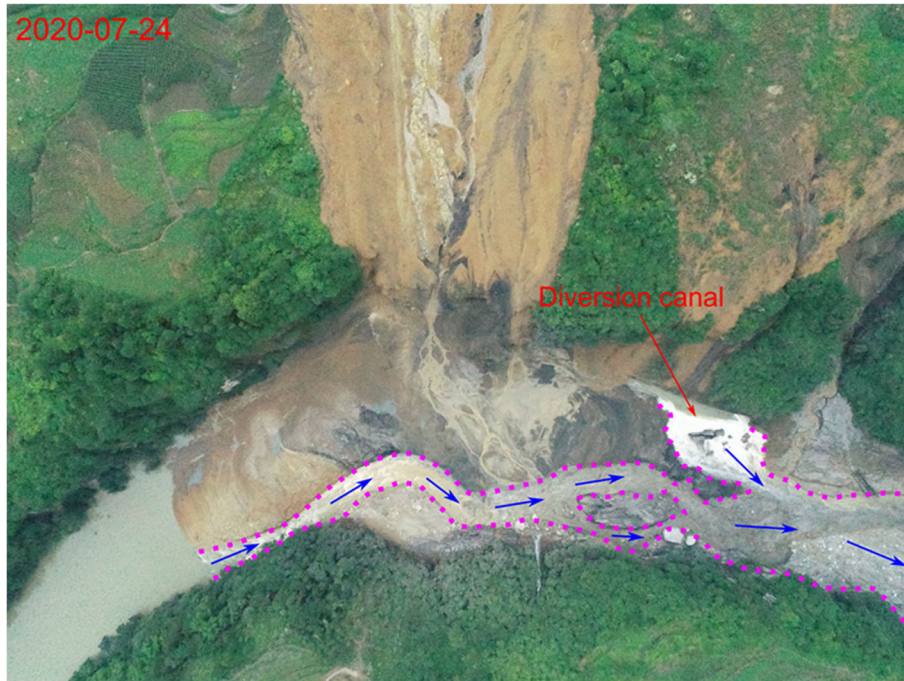
Fig. 5 Spillway formed on the top of the landslide dam

In the early morning of 21 July, the Qingjiang River was blocked by the sliding mass, and a landslide dam was formed. If the landslide dam continued to increase its height, the upstream water level would have risen further; if the dam were to break, it would possibly affect Enshi City, located downstream. Considering that the landslide is located between the Dalongtan and Yunlonghe dams (Fig. 1), a disaster management plan was adopted to decrease the landslide risk. The plan involved two primary precautions: emptying the storage capacity of the downstream Dalongtan

reservoir to avoid the flood threat to the downstream Enshi City if the landslide dam broke, and using strong runoff to flush the landslide dam to stop the increase of the landslide dam height by increasing the discharge of the upstream Yunlonghe reservoir. At 10:15 am on 21 July, the Yunlonghe reservoir increased its discharge, broke through the top of the landslide dam, and formed a spillway for flood discharge (Fig. 5). The water level gradually decreased and alleviated the danger of the landslide dam breaking instantly. This operation successfully reduced the potential threat of disasters caused by the landslide; details of this success were reported by China Daily (2020).
