Landslides (2022) 19:1717–1734
 DOI 10.1007/s10346-022-01877-9
 Received: 3 January 2022
 Accepted: 10 March 2022
 Published online: 2 May 2022
 © The Author(s) 2022

UAV applications to assess short-term dynamics of slow-moving landslides under dense forest cover

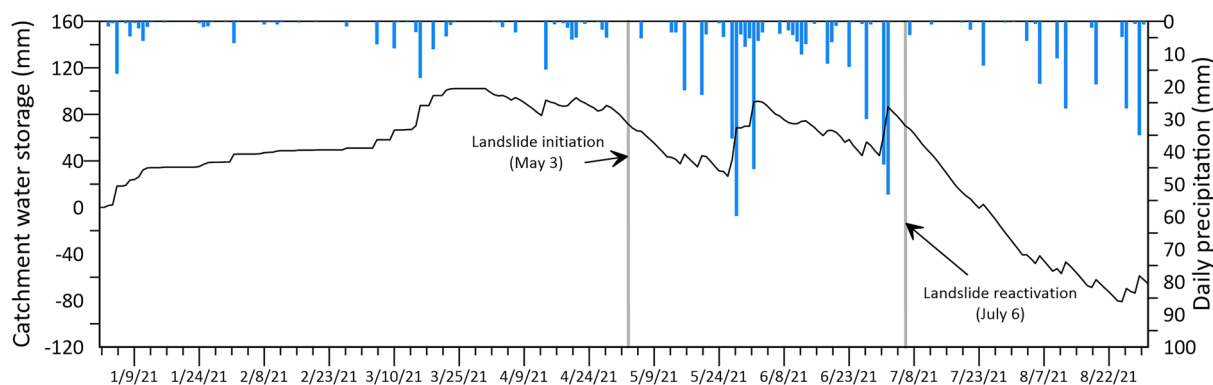
Fig. 4 Hydro-meteorological conditions between 1 January and 31 August, 2021, Vârbilău catchment

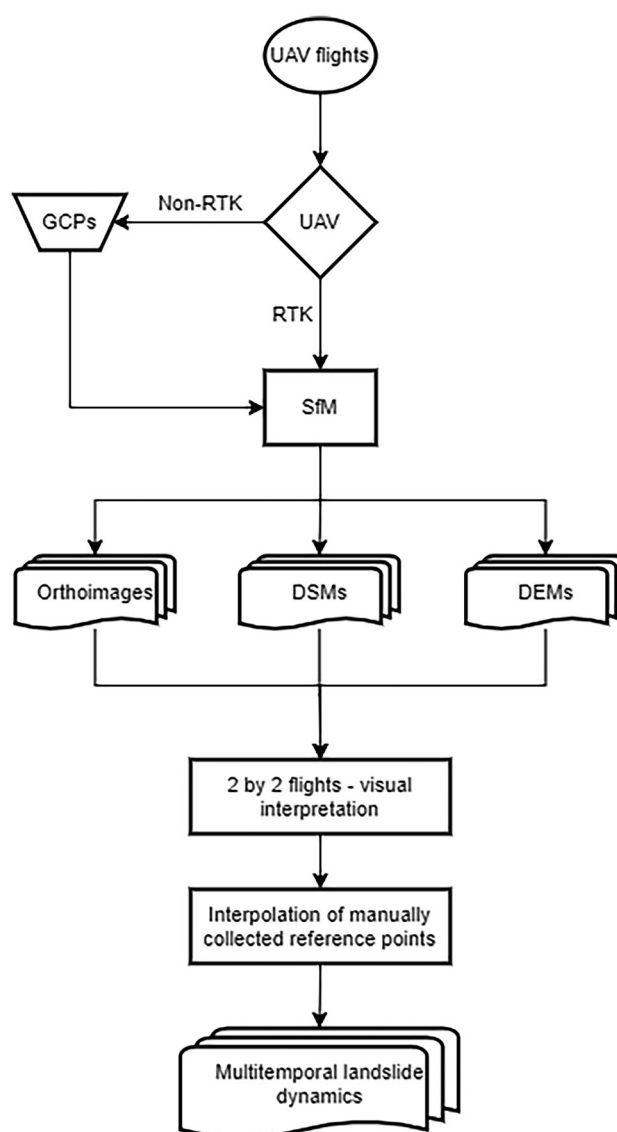
Fig. 5 Flow chart of the conceptual model used to assess the kinematics of the Livadea landslide

The workflow used in the current paper (Fig. 5) is based on UAV imagery collection and processing with the structure from motion (SfM) technique to produce high spatial resolution orthophotos, digital surface and elevation models. The structure from motion is a method from computer vision that uses multiple stereo images, which have a side and forward overlap of at least 70%, to reconstruct the 3D surface of the objects. It has been around since 1976 (Ullman 1983, 1976), and it was used sporadically in the 1980s (Bolles et al. 1987; Fischler and Bolles 1981). With the recent acceleration in computing performance and the

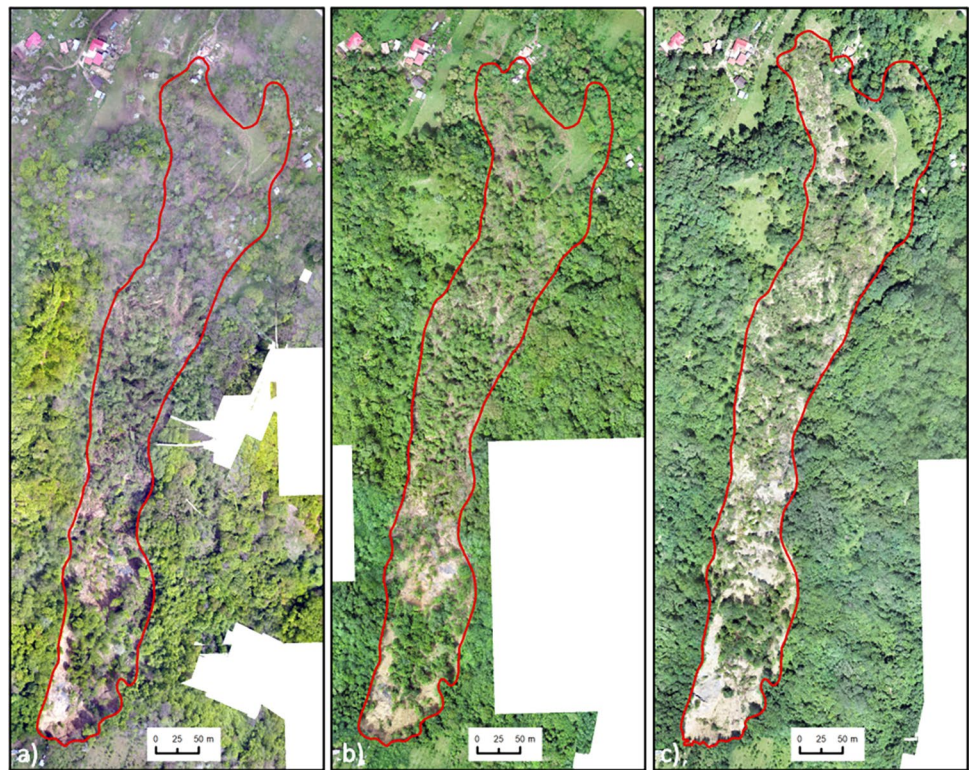
Fig. 6 Landslide spatial distribution mapped on orthophotos obtained by drone flights: (a) 6 May; (b) 25 May; (c) 10 July 2021

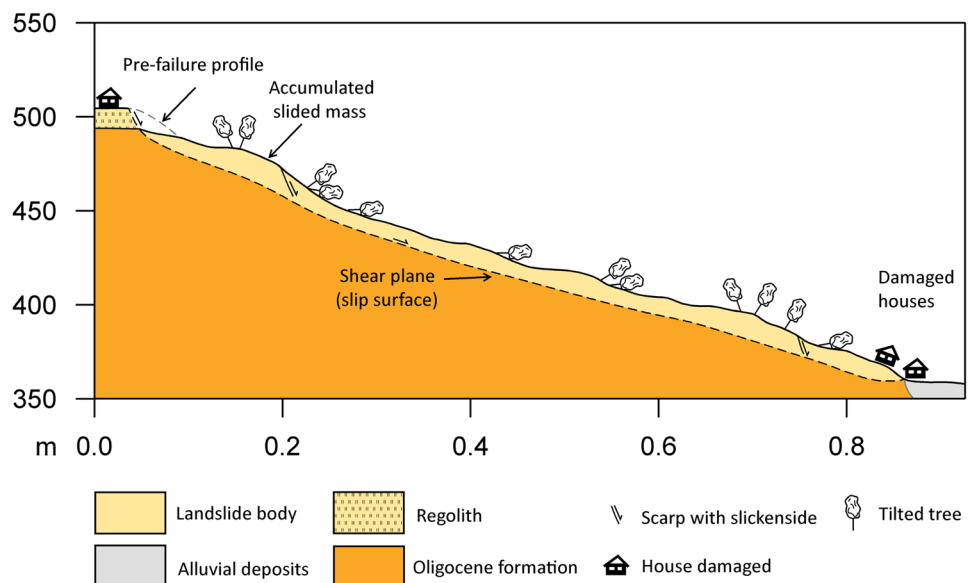
Fig. 7 Synthetic geologic cross-section through Livadea landslide

The landslide morphology (Figs. 7 and 8) is quite complex. Besides the headscarp, several secondary scarps are distributed along with the longitudinal profile, with areas of stretching and shortening and the presence of slickensides.

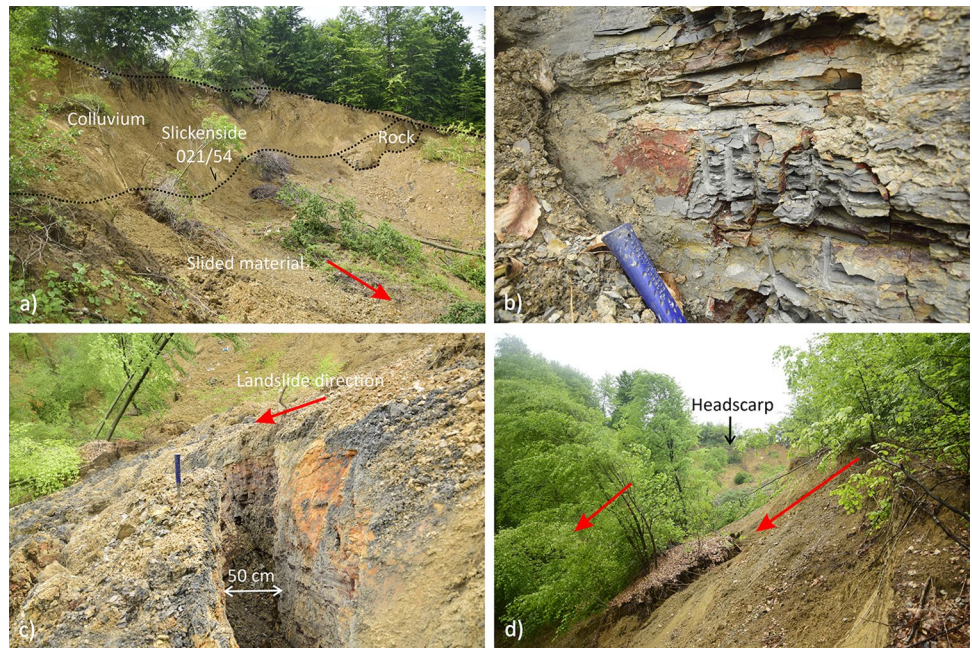
Fig. 9 Headscarp characteristics: (a) overview of the headscarp; (b) outcrop with grey marls and thin intercalation of disodilic schists; (c) fracture in the basal shear plane (grey marls); lateral landslide (soil and colluvium with trees) feeding the main landslide. The red arrows indicate the landslide direction

The geological formations presented above are covered by superficial deposits such as soil and regolith, as seen in the landslide scarp (see Fig. 9a). It consists of fine materials such as silt and clay. A relatively large volume of these deposits was entrained in the landslide mass. The map presented in Fig. 2a was slightly adjusted using the high-resolution aerial imagery and the field observations. The modifications of the map consist of the following: the adjustment of the Quaternary deposit limits (qh₁, qh₂ and qp₃); of the geologic limit between Pg₃p and Pg₃di based on the new outcrops provided by the landslide scarp; one structural measurement point (dip/dip angle) located on the landslide scarp was added; the latest landslide body was drawn

The headscarp (Fig. 9a–d) has a typical arched shape having a height of about 10 m and a maximum width of about 90 m. The field surveys revealed that it was developed in a sequence of sedimentary rocks, mostly composed of layered grey marls with thin intercalations (subcentimetric) of disodic schist. Almost the entire headscarp is covered by soil and colluvium, with the bedrock appearing

only in a few outcrops. The field measurements in two of the outcrops located on the landslide scarp showed that the bedding dips to 110° (east-southeast) with values between 15 and 23° , while the detachment area slides to 20° (north). Therefore, the detachment occurred on an orthoclinal slope (the slide is perpendicular to the bedding). This is specific to the Curvature Subcarpathians, where, among lithology, the landslide occurrences are strongly related to the geological structure (Ilinca et al. 2021).

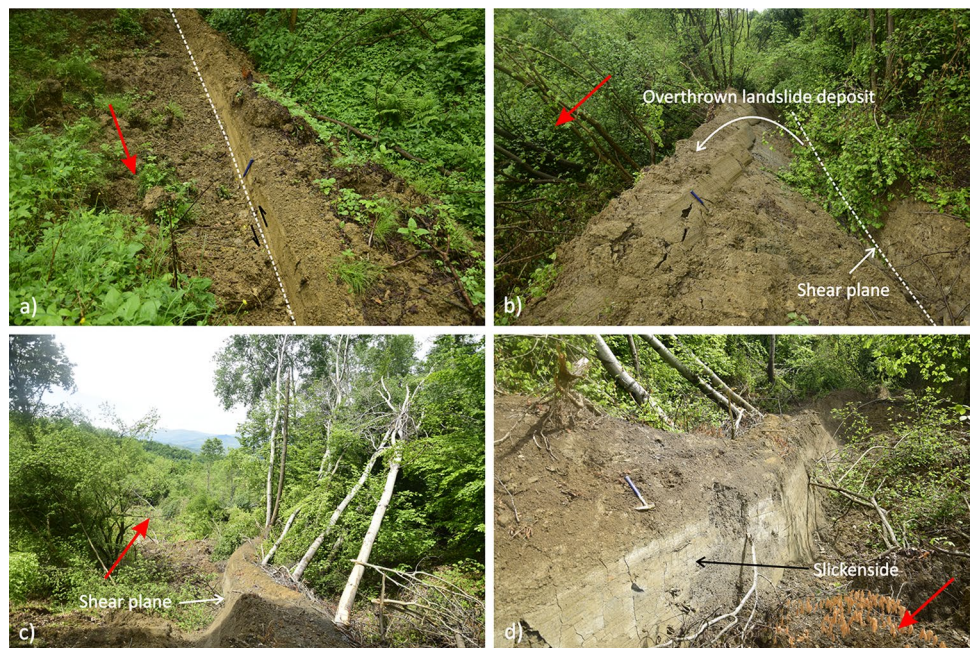
Fig. 10 Left flank with slickenside (a, b); right flank with share plane (c, d). The red arrow indicates de landslide direction

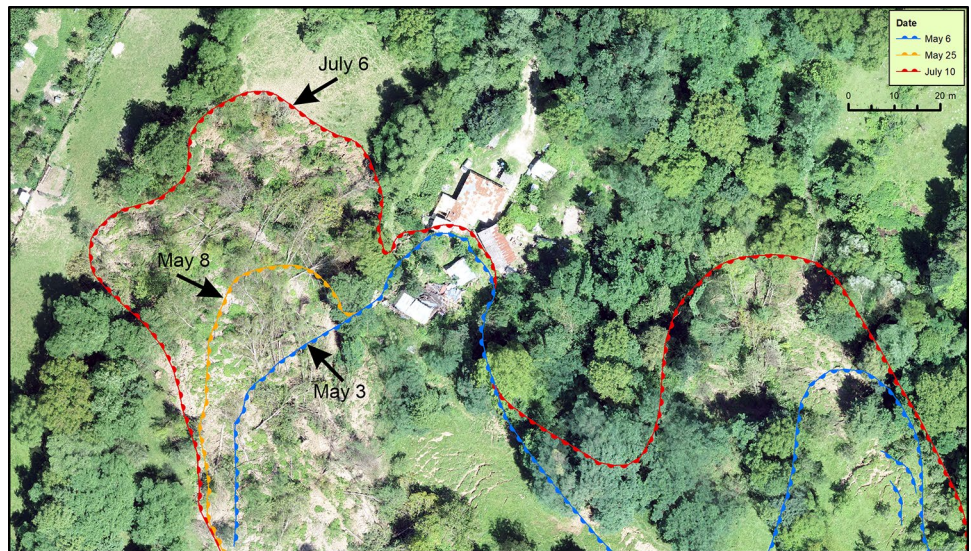
Fig. 11 The landslide toe in different periods. The coloured line represents the location and extension of each lobe as mapped on the UAV aerial images. The dates with black arrows indicate the exact date of the event based on information obtained from the local inhabitants. The background image is from 10 July 2021 flight

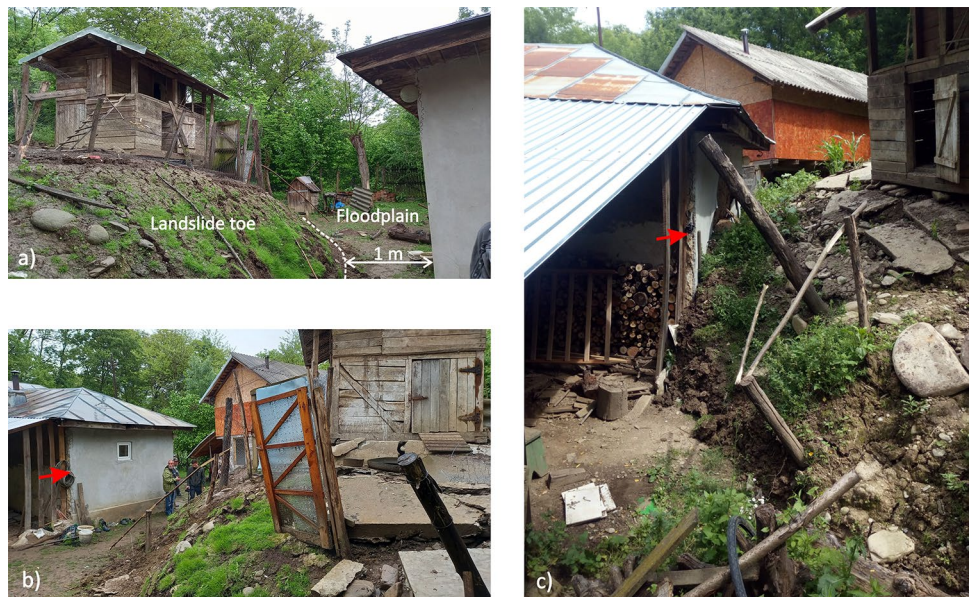
Fig. 12 The landslide toe: (a) view to upslope and (b) view to downslope (photo taken on 25 May 2021); (c) the landslide toe reached the house on 6 July 2021 (photo credit: Daniel Ioniță). The red arrow indicates the same corner of the house

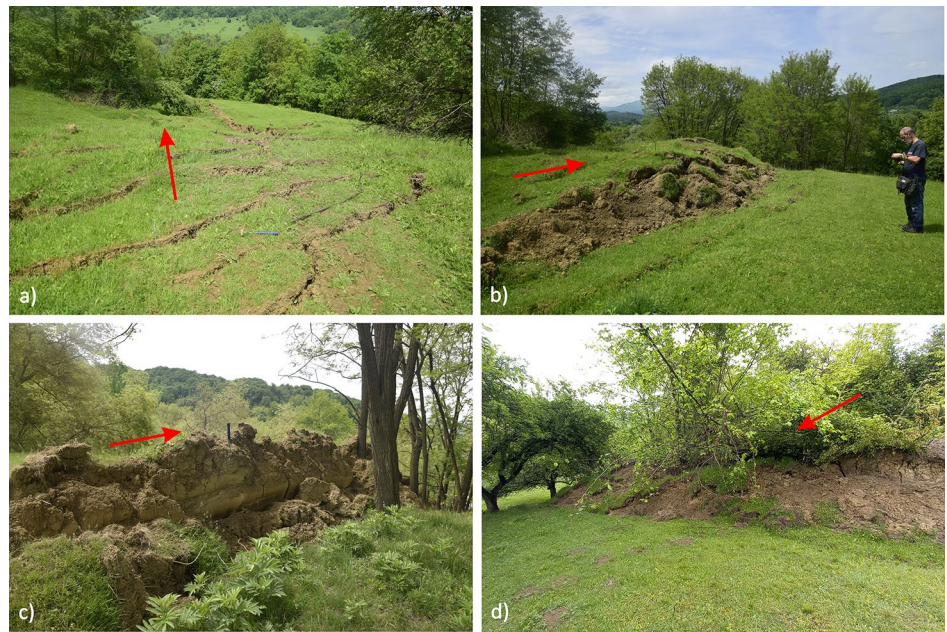
Fig. 13 Landslide features from the depletion area: (a) echelon fractures along the shear plane; (b) buckle fold or bulge; (c) right-lateral share plane that tends to overthrust the adjacent area (shear surface dip with 77° into the landslide body); (d) the eastern lobe of the landslide that thrust old landslide deposits. The red arrows indicate the landslide direction

body with a SE-NW strike. Many echelon fractures (Fig. 13a) occur along the right flank at an angle that usually ranges between 20° and nearly perpendicular, being a typical shear zone in these types of landslides. Other features such as bulges, thrust along lateral strike-slip flank and lobes were also identified and mapped within this zone (Fig. 13b–d). Herein, while the landslide direction is generally from south to north (Figs. 14a and 15a), the cracks and fractures are oriented obliquely (Figs. 14b and 15b).
