Landslides (2022) 19:2177–2188
 DOI 10.1007/s10346-022-01899-3
 Received: 24 January 2022
 Accepted: 1 May 2022
 Published online: 1 June 2022
 © The Author(s) 2022

Geomorphology and initiation mechanisms of the 2020 Haines, Alaska landslide

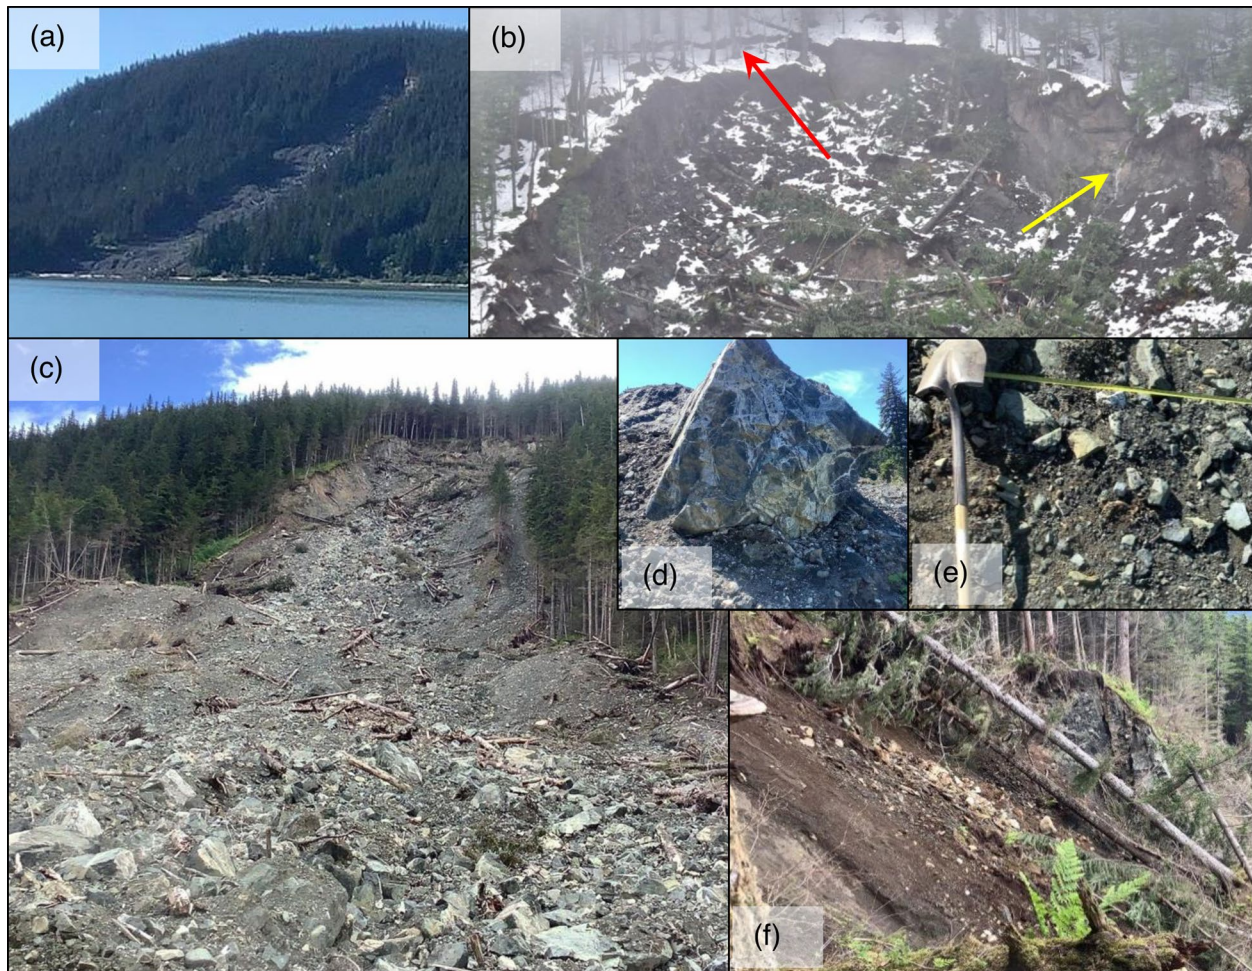
Fig. 1 Beach Road Landslide (BRLS): (a) view from Nukdik Point approximately 2.3 km to the NW (the city of Haines is to the right out of the photograph); (b) image of the head scarp area taken on December 8, 2020 (red arrow points to crack and yellow arrow points to waterfall; image by E. Stevens); (c) looking up towards the head

scarp from the pioneer road across the landslide body; (d) ultramafic boulder (~5 m in diameter) on lower landslide body; (e) example of landslide matrix; (f) smooth joint surface exposed in the west to the central portion of the head scarp. All photographs except for (b) were taken in June 2021

within several miles of the area, the vast majority of the impacted structures was swept into the inlet and remains undetected below the deposited landslide debris. This event also impacted adjacent properties, shifting one structure off its foundation and damaging or demolishing smaller out-buildings. After the first major event occurred, a resident captured some subsequent slide movement on mobile phone video. By comparing static features (such as boulders and trees) in the video to the June 2021 lidar data and high-resolution imagery, we approximated the movement velocity. After the initial debris avalanche event, the center of the debris flow traveled at 1.6 m s^{-1} (based on movement of a $\sim 0.5\text{-m}$ -diameter rock relative to a static $\sim 5\text{-m}$ -diameter boulder). Within a few minutes of the first event, a debris flood initiated along the east side of the landslide scar. Timing the movement of a tree transported in the flow, we estimate the debris flood's velocity at 5.5 m s^{-1} . Photographs of the landslide taken on December 8 captured a waterfall flowing over and down the western portion of the head scarp, approximately where the drainage from the uphill pond enters the area (see yellow arrow in Fig. 1b).

Based on interpretation of the June 2021 lidar data, the subaerial BRLS is approximately 687 m long and 170 m wide, covers $107,099 \text{ m}^2$, and has an overall slope angle of 20° but with local slope angles as high as 88° (Figs. 1a, c, 5a, b; see Online Resource 5 for longitudinal and cross-sectional profiles of the slide area). The landslide scoured down to bedrock in several areas, and deposited debris along both flanks, including piles of trees, rocks, and some debris from structures. The landslide surface consists of large boulders (up to 7 m in diameter; Fig. 1d) as well as a moist, slightly organic, non-plastic matrix of sand with gravel (Fig. 1e; summary of soil data in Online Resource 6). Soil depths averaged $\sim 45 \text{ cm}$ (22 measurements).

The rock component of the landslide body is representative of the bedrock outcrops present within and near the head scarp (Fig. 1f), along the lower right flank, and at the toe. The bedrock contains biotite, hornblende, and pyroxene crystals ($0.5\text{--}3 \text{ cm}$), with a minor magnetite component; this is consistent with the biotite magnetite clinopyroxenite identification by Himmelberg and Loney (1995). For brevity, we will refer to this rock type as “ultramafic” (Fig. 1d). Hand samples easily separate along the biotite crystals. White diorite veins that intrude the ultramafic bedrock consist of quartz, plagioclase, hornblende, and biotite. Cobbles of diorite are also present within the landslide body, with a greater concentration to the east above the Beach Road alignment. We conducted point load strength index tests on diorite and ultramafic rock samples using a portable point load testing device (Wille Geotechnik); currently, we are limited to these strength data, as collecting samples for triaxial testing (for example) was beyond the scope of the initial reconnaissance response. A summary of the point load strength index results, as well as estimated uniaxial compressive strengths (UCS) calculated using a relationship proposed by Kohno and Maeda (2018), is provided in Online Resource 7. The resulting UCS values indicate that the ultramafic rock and diorite have low strength values based on the Unified Rock Classification System (Keaton and DeGraff 1996).

The bedrock within the head scarp area is generally highly fractured and weathered. A smooth bedrock surface is present in the western portion of the head scarp (Fig. 1f) with an average orientation of $292^\circ/45^\circ$ (strike [right-hand rule—RHR]/dip). Based on analysis of 159 structural measurements (see Fig. 5b for locations), the bedrock contains five major joint sets (JS) that have similar trends to the mapped lineament sets (LS) (see Online Resources 3 and 8 for more information). For example, the two lineaments that cross the head of the BRLS (Fig. 5b) have trends of $113^\circ/293^\circ$ (northern) and $108^\circ/288^\circ$ (southern), corresponding to the average orientation of one JS and to the measurements of the planar bedrock surface exposed in the head scarp. A third prominent lineament forms the left (west) flank of the BRLS head and has a trend of $177^\circ/357^\circ$, which is part of one LS and similar in orientation to another JS.

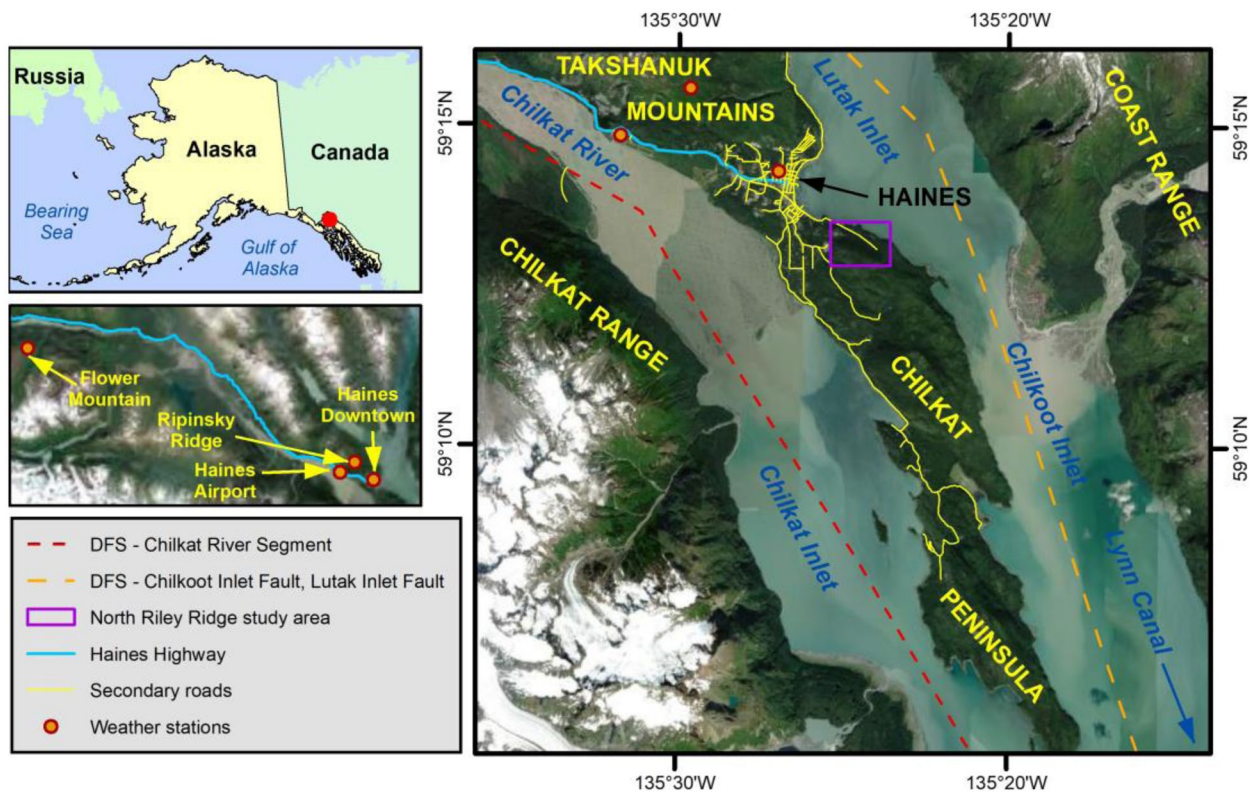
Fig. 2 Location of Haines, Alaska within the Lynn Canal region. Red point in the Alaska map inset identifies project location relative to Alaska and Canada. DFS is the Denali Fault System. Base map

imagery from SOA (2021) and ADNDR (2021); fault data modified from Wilson et al. (2015)

Haines is located in the northern part of Southeast Alaska, approximately 72 km from the US–Canada border at the south terminus of the Haines Highway (Fig. 2). The majority of the Haines community is located on a low-lying saddle between the Takshanuk Mountains to the northwest and the Chilkat Peninsula to the southeast. We focus our analysis on the AOI indicated in Fig. 2, which encompasses North Riley Ridge, Beach Road, and the 2020 BRLS.

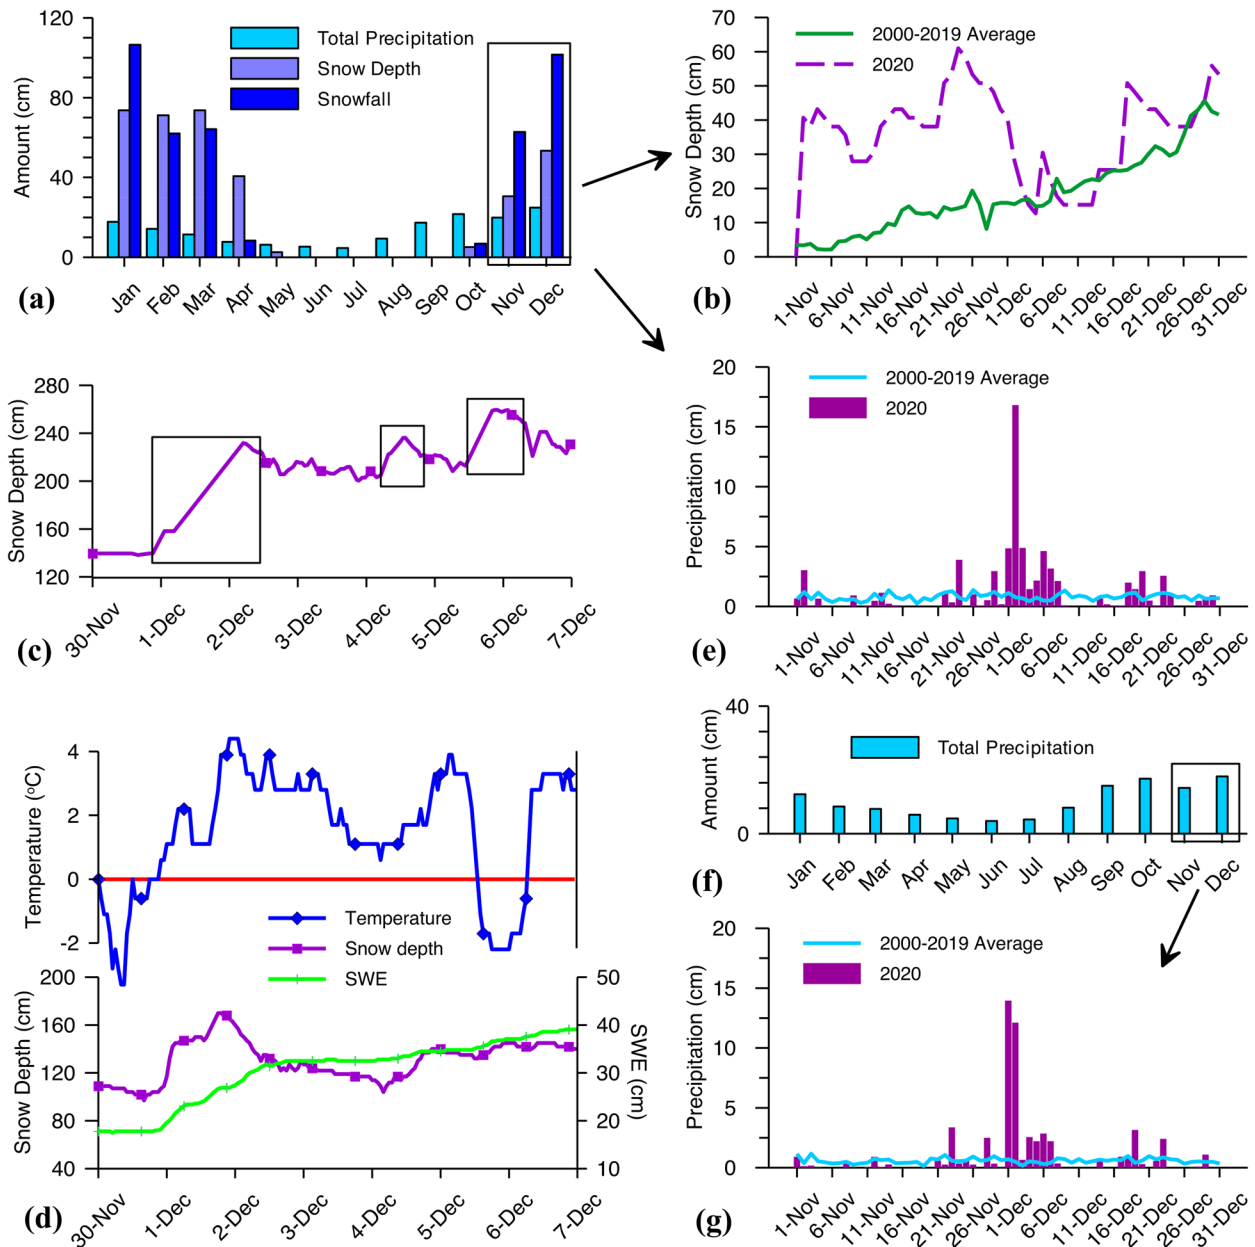
Fig. 3 Precipitation for Haines, Alaska: (a) monthly average total precipitation, snow depth and snowfall from 2000 to 2019 and (b) snow depth for 2020 compared to average values for November and December for the Haines Downtown COOP Station (AHNA2); (c) snow depth for Ripinsky Ridge Weather Station (RRWA2); (d) air temperature, snow depth, and snow water equivalent (SWE) for Flower Mountain Station (SNTL 1285); (e) daily precipitation totals

for 2020 compared to average values for November and December for AHNA2. For the Haines Airport Station (PAHN), (f) monthly average total precipitation from 2000 to 2019 and (g) daily precipitation totals for 2020 compared to average values for November and December. Data from NWS (2021b), NWCC (2021), and MesoWest (2020)

through the area (Fig. 3c). At the Flower Mountain site (Fig. 3d), as temperatures climbed above 0 °C during the first 48 h of the AR event, the SWE increased by 14.7 cm with a loss of 40 cm of snow. This increase in SWE was from ROS and meltwater percolating through the snowpack. Due to this site’s higher elevation, the snowpack was not ripe enough for runoff to make it to the ground surface. Closer to Haines, however, the ripening snowpack produced significant amounts of runoff through the duration of the event.

The rainfall produced by the 2020 AR was unprecedented in historic times. Figure 3e is a summary of both the average daily precipitation totals for November and December from 2000 to 2019, and daily precipitation totals just for 2020 for the AHNA2 station. On December 2, the precipitation received (16.8 cm) significantly exceeded the average value and broke the station’s all-time daily precipitation record. The Haines Airport station (PAHN; N59.2473°, W135.5294°, 14.9 m) recorded similar averages from 2000 to 2019

(Fig. 3f). Using precipitation frequency estimates available for this station (NWS 2021a; Perica et al. 2012), the large 2-day total from December 1–2 (26.1 cm; Fig. 3g) represents a 500-year return interval (RI). After a brief respite from precipitation on December 3, moderate to heavy rain continued from December 4 to 7, as a series of weather fronts moved through the area. The longer duration (4–7 day) precipitation frequencies represented 50–200-year RI (NWS 2021a; Perica et al. 2012). It must be stressed that these RIs only account for the rainfall and not the runoff due to the melted snowpack; thus, the reported RIs are underestimates of the actual values (Brideau et al. 2012).

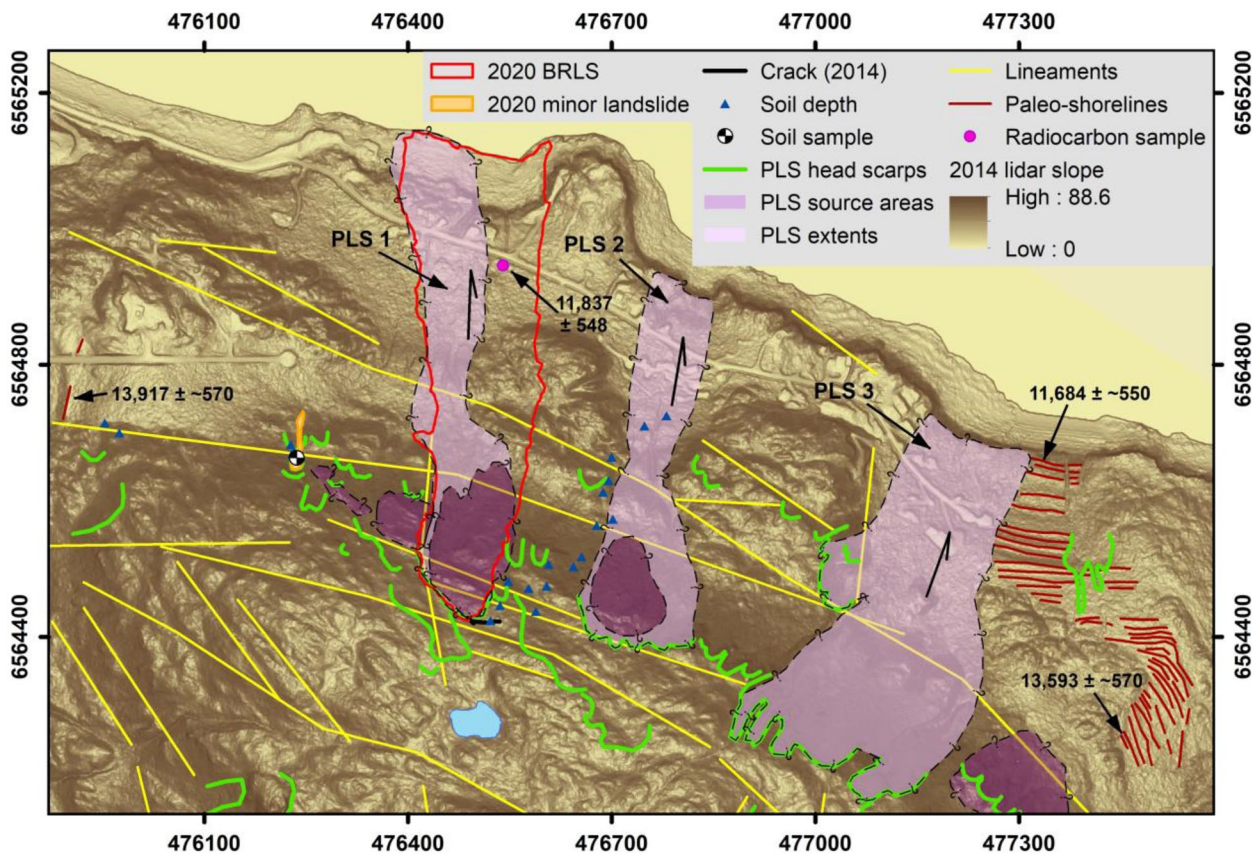
Fig. 4 Geomorphic interpretation of the AOI, including lineaments, paleo-shorelines, and paleo-landslide (PLS) extents, source areas, and head scarps. Dates of selected paleo-shorelines are provided.

Map extents in UTM Z8. Base imagery is slope derived from 2014 lidar (QSI 2014)

There are three major lineament sets in the study area, those running approximately NW–SE, N–S, and E–W (Fig. 4; see Online Resources 2 and 3 for additional information on average lineament trends). Based on their long persistence through the AOI, the lineaments are possibly faults that have been geomorphically enhanced and widened by glacial erosion. Multiple head scarps of PLS are evident in the lidar based on their concave shapes and steep headwalls. We also interpret the possible runout of three large PLS (Fig. 4) based on change in surface roughness and contour line breaks; approximate subaerial extents are provided in Table 1. Each of the inferred PLS extents may represent one landslide or be the accumulation of multiple events. Although the PLS may have run

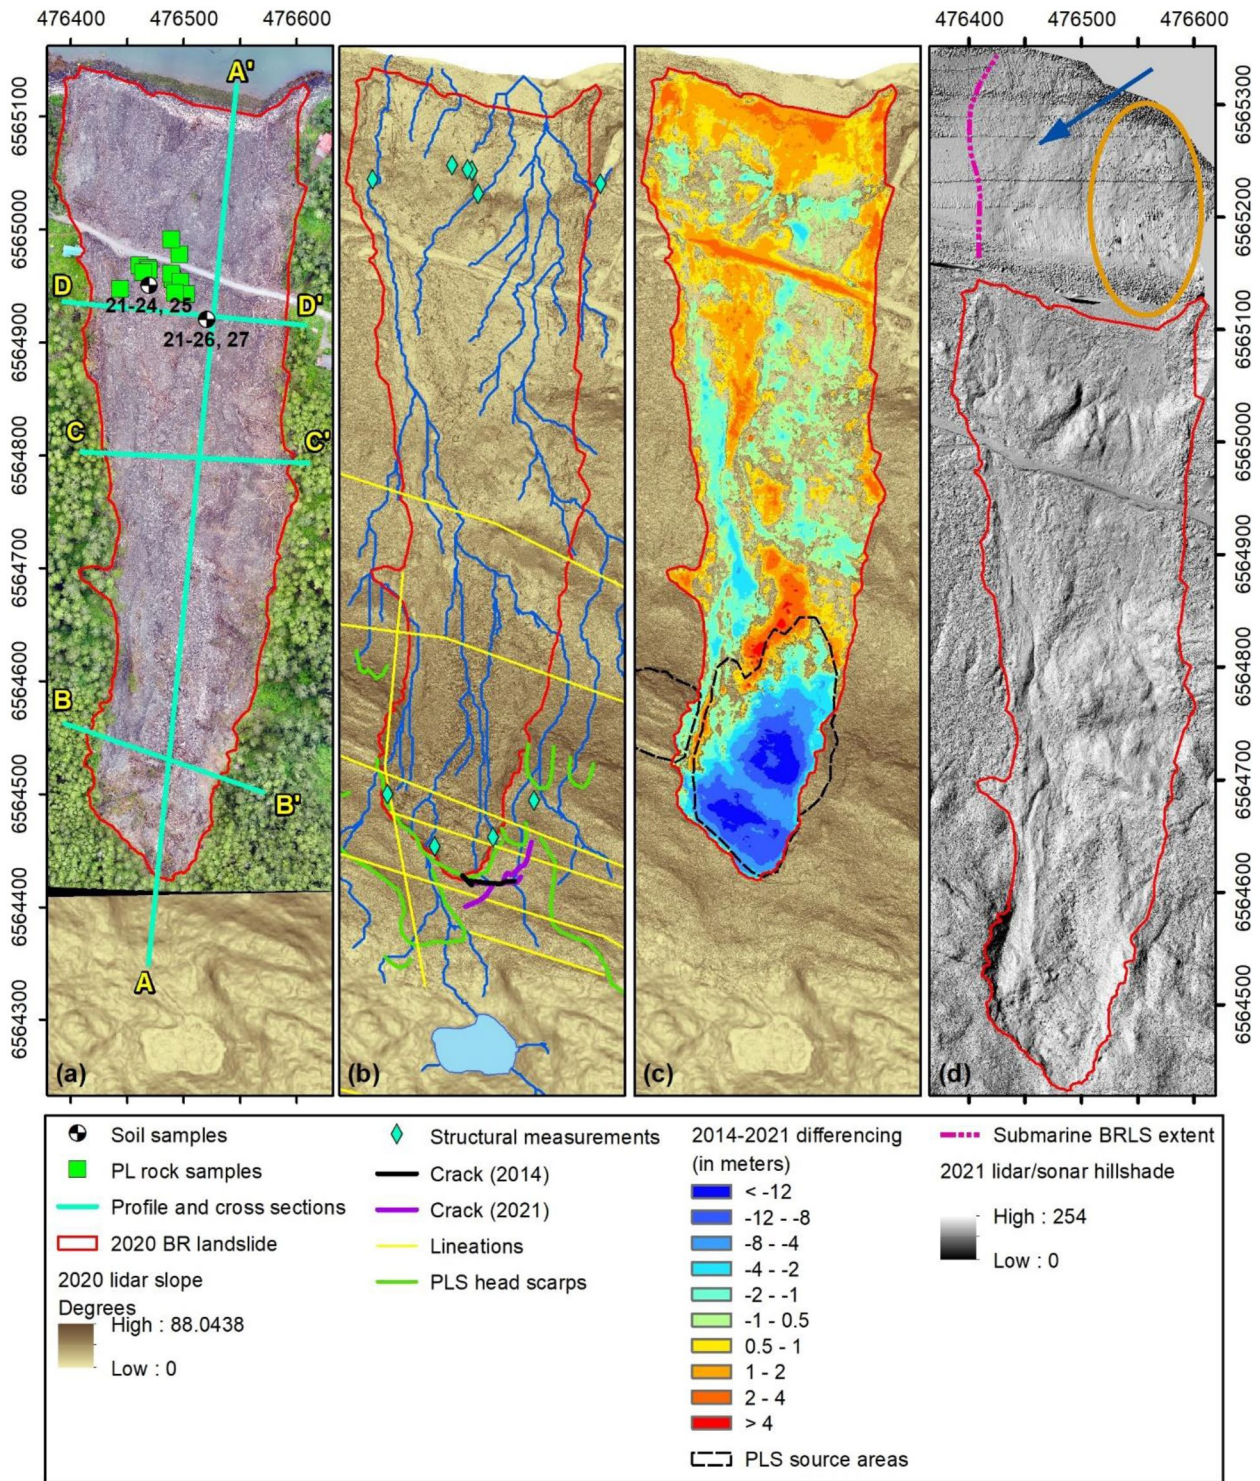
Fig. 5 Beach Road Landslide (BRLS): (a) 2021 optical imagery of slide extent, soil and rock sample locations, and profile locations; (b) geologic features and hydrology; (c) change detection results from 2014 to 2021 lidar epochs; (d) subaerial and submarine landslide extents (dark blue arrow points to submarine channel, and orange oval

indicates area of boulder deposition). Panels (a)–(c) share the same extent, as indicated in (a); all panels are 1:6,500. Base imagery is slope derived from 2020 lidar (Daanen et al. 2021) in (a)–(c), and 2021 lidar in (c) and (d)

Some of the authors and personnel from the Alaska Division of Geological & Geophysical Surveys (DGGs) mobilized to Haines immediately following the landslide event in December 2020 to collect lidar data via a helicopter, and initial observations of the landslide body and head scarp area including structural measurements. In June 2021, the research team performed a reconnaissance of the area and collected 3D point cloud data using a Phoenix LiDAR Systems MiniRanger un-crewed laser scanner (ULS) and high-resolution imagery using a DJI Matrice 210 V2 RTK UAS. We deployed Leica GS18 Global Navigation Satellite System (GNSS) receivers for high-accuracy georeferencing and post-processing. This resulted in data with a ground resolution of 0.1 m for the lidar and 0.03 m for the high-resolution imagery. DGGs personnel collected sonar data of the seafloor immediately adjacent to the BRLS using a SR-Surveyor M1.8 with Edgetech 2205 540 kHz bathy/1600 kHz sidescan transducers. The research team also collected soil and rock samples, structural measurements of the bedrock, and soil depth measurements using a 1-m-long steel probe. Figure 4 contains locations of soil samples and depth measurements collected in the AOI, and Fig. 5a includes the locations of soil and rock samples.

from the 2014 lidar (see dashed black line in Fig. 5c). There was approximately 52,800 m³ of deposition throughout the landslide body including trees deposited along the flanks, with a total landslide volume of about 187,100 m³. The discrepancy between volume displaced and volume deposited indicates that the majority of the landslide debris (or roughly 81,500 m³) entered the inlet. Figure 5d is a combination of hillshades from the 2021 subaerial lidar data and the submarine sonar data. The E-W trending lines in the sonar data are artifacts of data collection and processing; thus, we use these data for qualitative purposes only. The dashed pink line indicates the interpreted western extent of the debris flow path based on change in roughness. To the east, we interpret an area of boulders deposited by the BRLS (indicated by the orange oval). The eastern extent is not definable in the sonar data. Additionally, the inlet floor becomes much deeper to the north, making the full extent of the submarine deposit undefinable using these data. The dark blue arrow in Fig. 5d indicates a prominent submarine channel. This channel may represent the northern extent of the N-S trending lineament that forms the eastern portion of the head scarp.
