Landslides (2022) 19:1913–1934
 DOI 10.1007/s10346-022-01903-w
 Received: 3 November 2021
 Accepted: 12 May 2022
 Published online: 25 May 2022
 © Springer-Verlag GmbH Germany,
 part of Springer Nature 2022

The Wuxie debris flows triggered by a record-breaking rainstorm on 10 June 2021 in Zhuji City, Zhejiang Province, China

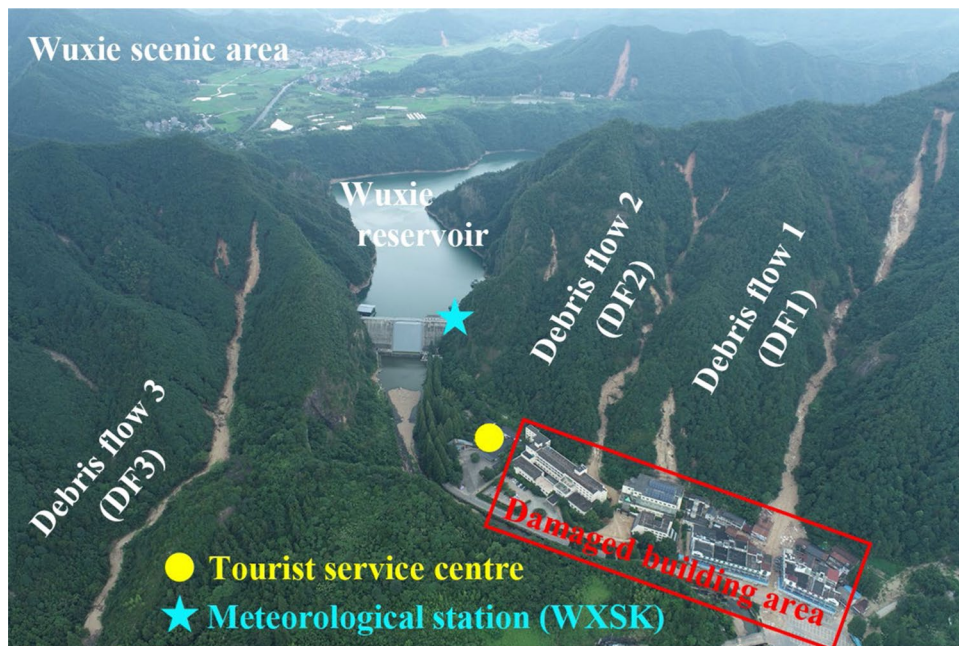
Fig. 2 Overview of the Wuxie debris flows

The Wuxie scenic area was observed to have had enormous rain-storm-triggered debris flows surrounding the Wuxie reservoir, as shown in Fig. 2. Among them, three typical debris flows shown in Fig. 2 were selected as the main targets for our investigation and designated as DF1, DF2 and DF3, respectively. Two of them, DF1 and DF2, occurred on the left side of the Wuxie reservoir, while the third, DF3, occurred on the right side. They were detected by aerial photography, as shown in Fig. 3. From these figures, a large residential building area in front of the tourist service centre was severely damaged by DF1 and DF2. A detailed account of the disastrous

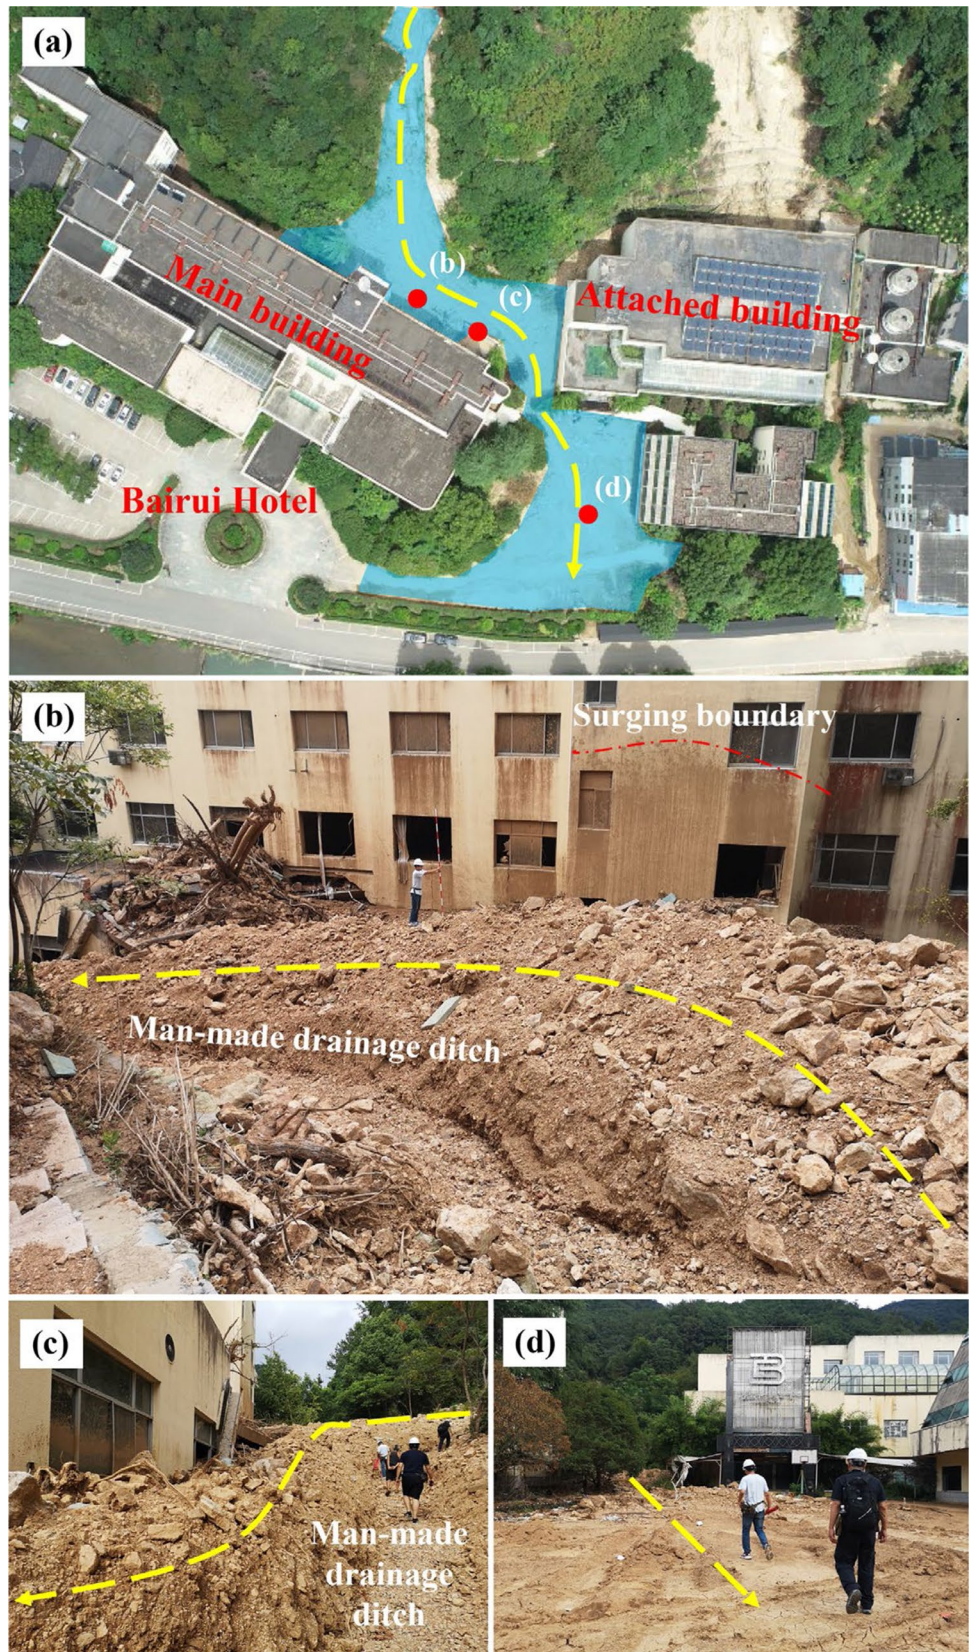
DF2 severely damaged the local Bairui Hotel, which included a five-storey main building and a three-storey attached building, as shown in Fig. 5. In this case, most of the debris, with an estimated height of about 3 m, was deposited behind the main building (see Fig. 5b to c), except for a few fine grain depositions in front of the buildings (see Fig. 5d). In addition to the direct damage, the Wuxie scenic area, a highly ranked national tourist attraction in Zhejiang Province, was closed for over three months, indirectly causing countless economic losses for local tourism development.

Fig. 5 Deposition area and damages caused by DF2, including top view of deposition area (a) and detailed features of the damaged buildings (b–d)

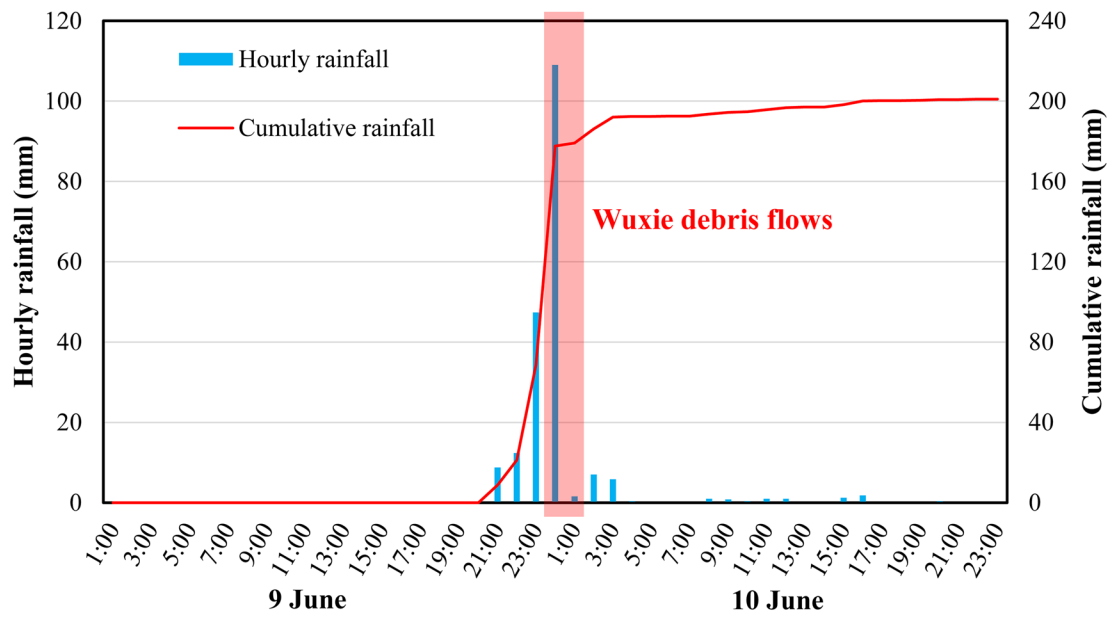
The precipitation data provided by the Zhuji Water Resource Bureau illustrate the hourly and cumulative rainfall in Fig. 6. In this figure, the meteorological station WSK is the nearest station to the debris flow gullies investigated in this study (see Fig. 2). According to rainfall data, this high-intensity rainstorm occurred primarily over 4 h from 20:00 (9 June) to 00:00 (10 June) at this local area, and its 4-h cumulative rainfall reached 178 mm. In particular, the maximum hourly rainfall reached 109 mm at 00:00 (local time) on 10 June, the time at which most of the debris flows occurred.

Fig. 6 Hourly rainfall and cumulative rainfall at the nearest meteorological station (WXSK)

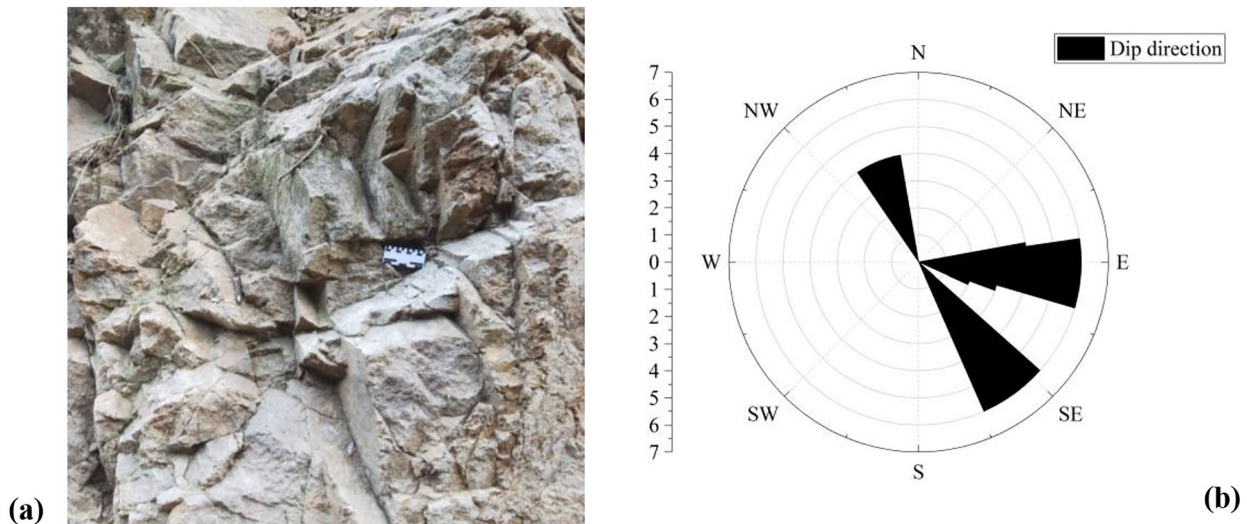
To understand the degree of rock fragmentation, an important geological property of the debris flow gullies, a joint statistic on a side bank of the DF1 gully (at J1 in Fig. 9) was carried out and is shown in Fig. 8 as a representative example. In this case, there were six joints with an estimated spacing of about 50 to 200 mm in three main dip directions, as illustrated by the rose diagram in Fig. 8b.

Fig. 8 Statistics of joints in the DF1 gully. **a** Statistic range (1.5 m × 1.5 m). **b** Rose diagram of dip direction

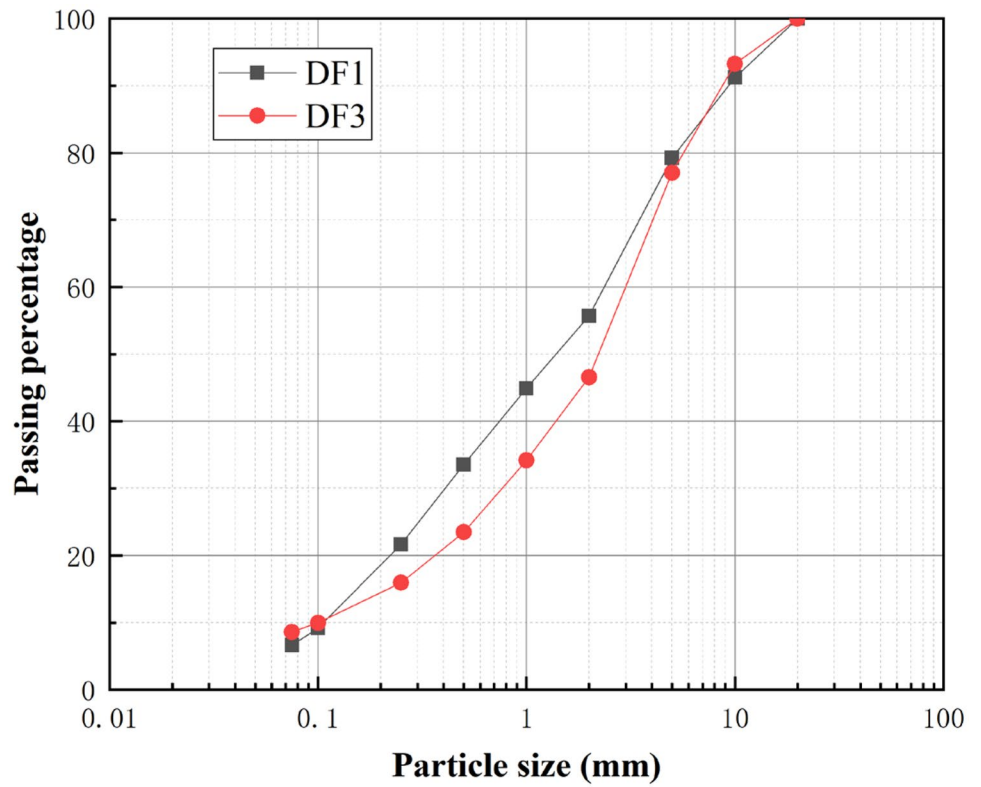
The particle size distributions of the soil samples collected from DF1 (deposition front) and DF3 (source area) are illustrated by the gradation curves shown in Fig. 10. Grading characteristics of the soil samples, determined by the uniformity coefficient (C_u)/curvature coefficient (C_c), were 23.17/0.65 and 33.00/1.94, respectively. The grading property demonstrated that the eluvium in the rhyolitic area

contained a larger proportion of coarse particles, as evidenced by the fact that d_{10} and d_{50} were 0.11 mm and 2.34 mm, respectively. The coarser eluvium had a higher permeability according to the relationship between soil permeability and grain size (Shepherd 1989). In addition, the two debris flows with similar gradation properties demonstrated that their difference in motion style was not determined by the grain size of the debris.

Fig. 10 Particle size distribution of samples in DF1 and DF3

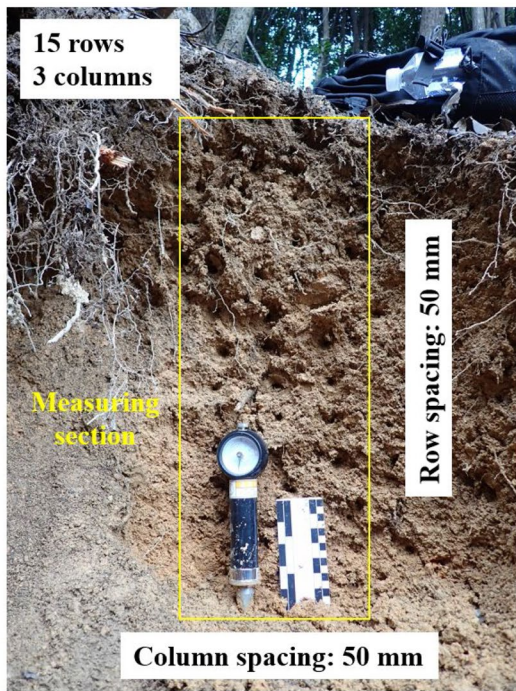
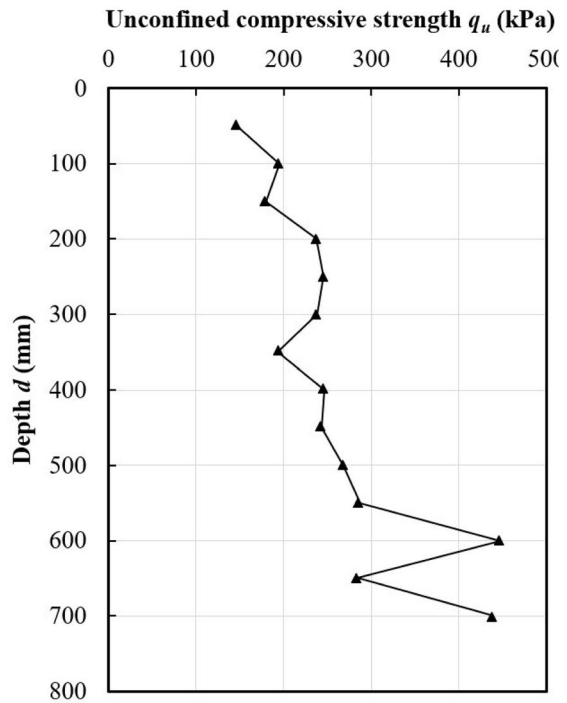
To measure the strength of the soils in the initial eluvium slope, a set of Yamanaka-style soil hardness tests were conducted in the DF3 resource area, as a representative example, and are shown in Fig. 11. The Yamanaka-style soil hardness test is a portable hardness test developed in Japan (Tanaka et al. 2004). There is a relationship between the unconfined compressive strength q_u and the contraction of spring x , modified from Tanaka et al. (2004), which can be written as Eq. (1).

The test results for the soils taken from the DF3 source area are shown in Fig. 11b. It should be noted that the average unconfined compressive strength of the soil within a depth of 550 mm was about 250 kPa. There was an obvious fluctuation in the strength beneath the depth of 600 mm, reaching about 450 kPa, which might indicate that the source area of such debris flow was initiated by a shallow landslide with a thickness of about 600 mm.

Fig. 11 Hardness test of the in situ soils at the DF3 source area: **a** testing ranges and **b** tested results of unconfined compressive strength along the depth

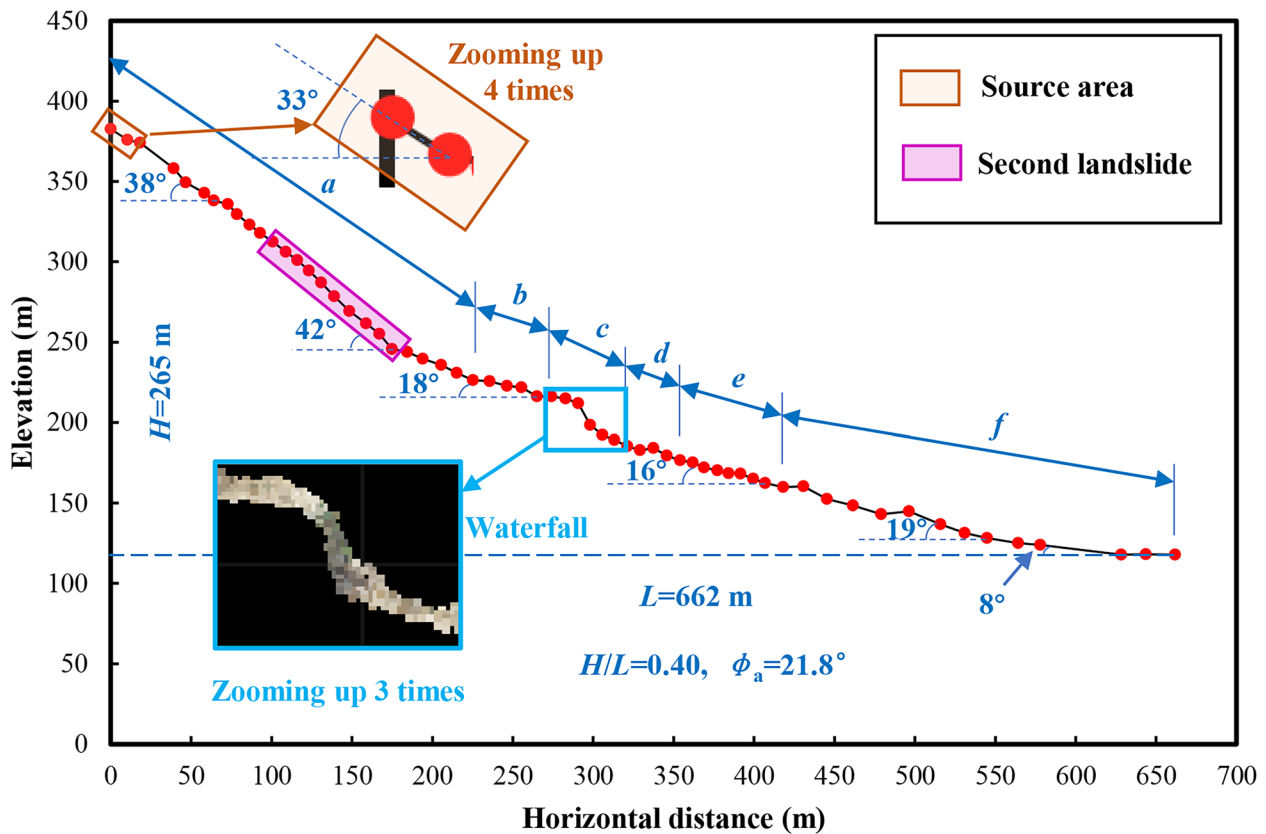
Fig. 13 Longitudinal profile of the DF1 gully

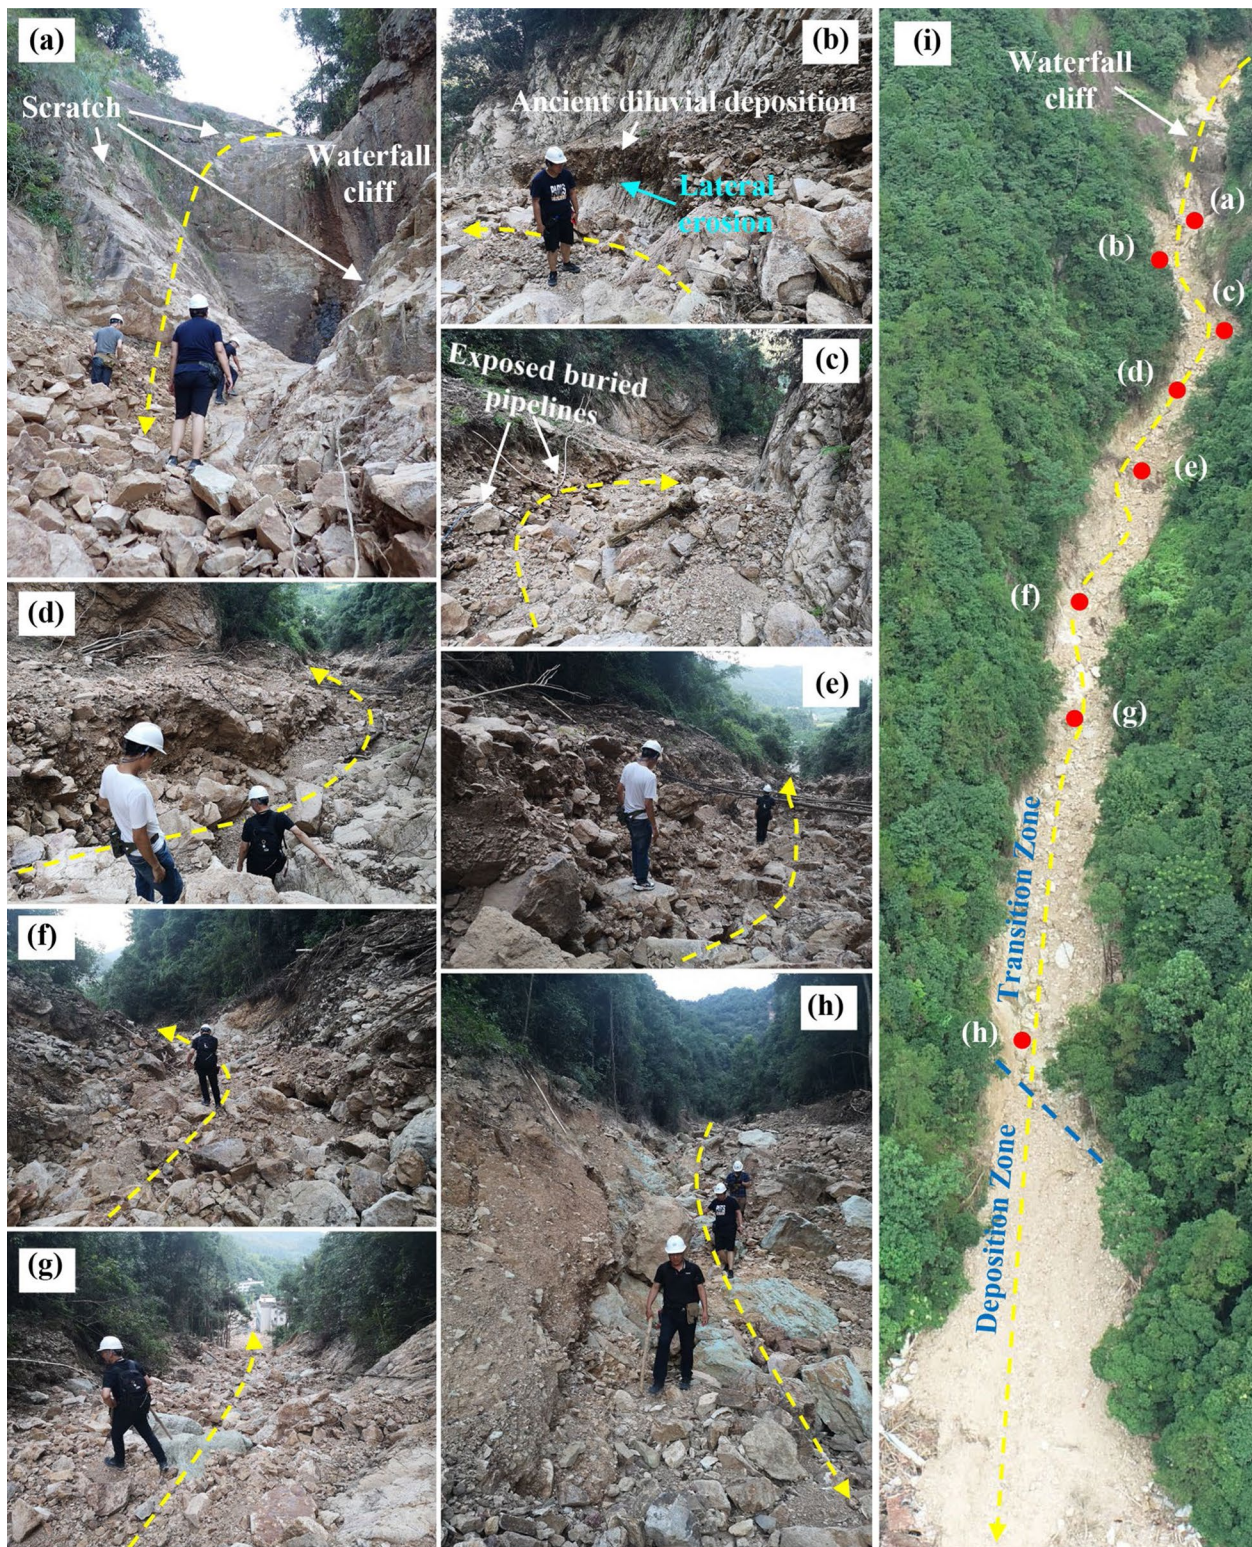
From the waterfall cliff, the lower part of the DF1 gully is illustrated by the photographs shown in Fig. 14. The waterfall cliff (estimated height of 15 m) had clear scratches on the two sidewalls (Fig. 14a) and a little debris left at the bottom. This positioning indicates that the debris flow flew over the cliff at an extremely high velocity. Then, the high-impact energy of the debris flow eroded the gully bed covered by ancient diluvial depositions for about 2 m in depth, as shown in Fig. 14b. Next, the debris flow turned to the left bank (1.5 m-high lateral erosion) and excavated two buried

pipelines, as shown in Fig. 14c. Following the lateral erosion, a small cliff, about 2.5 m high, was created by the bed erosion caused by the debris flow at point (d) in Fig. 14i. From point (d) to point (f), there was an eroded curving channel with a depth of about 2 m. These segments were covered with abundant diluvium, which was partially eroded but not entirely removed by the impact of debris flow. However, from point (g) to the end of the gully (h), rare depositions were left and only boulders remained on the exposed rocky gully bed. The enlarged debris flow mostly removed the ancient diluvium in the lower part of the gully, which directly destroyed or severely damaged the downstream buildings.

Furthermore, there was a clear boundary between the transition zone and the deposition zone at the outlet of the gully, as indicated by a broken blue line in Fig. 14i. The size distributions of the material in the two zones were obviously different. This might have been caused by the width variation at the lower part of the gully. Abrupt increases in width would have reduced the velocity of the debris flow, which could have caused the separation of large boulders from the moving mass and kept them behind the finer debris. This phenomenon was also present in the second investigated gully (DF2), which is illustrated in Fig. 17n.

Fig. 14 Photographs describing the DF1 gully from the waterfall cliff to the gully outlet. These detailed features are illustrated by photos (a–h) taken along the investigation path shown in photo (i)

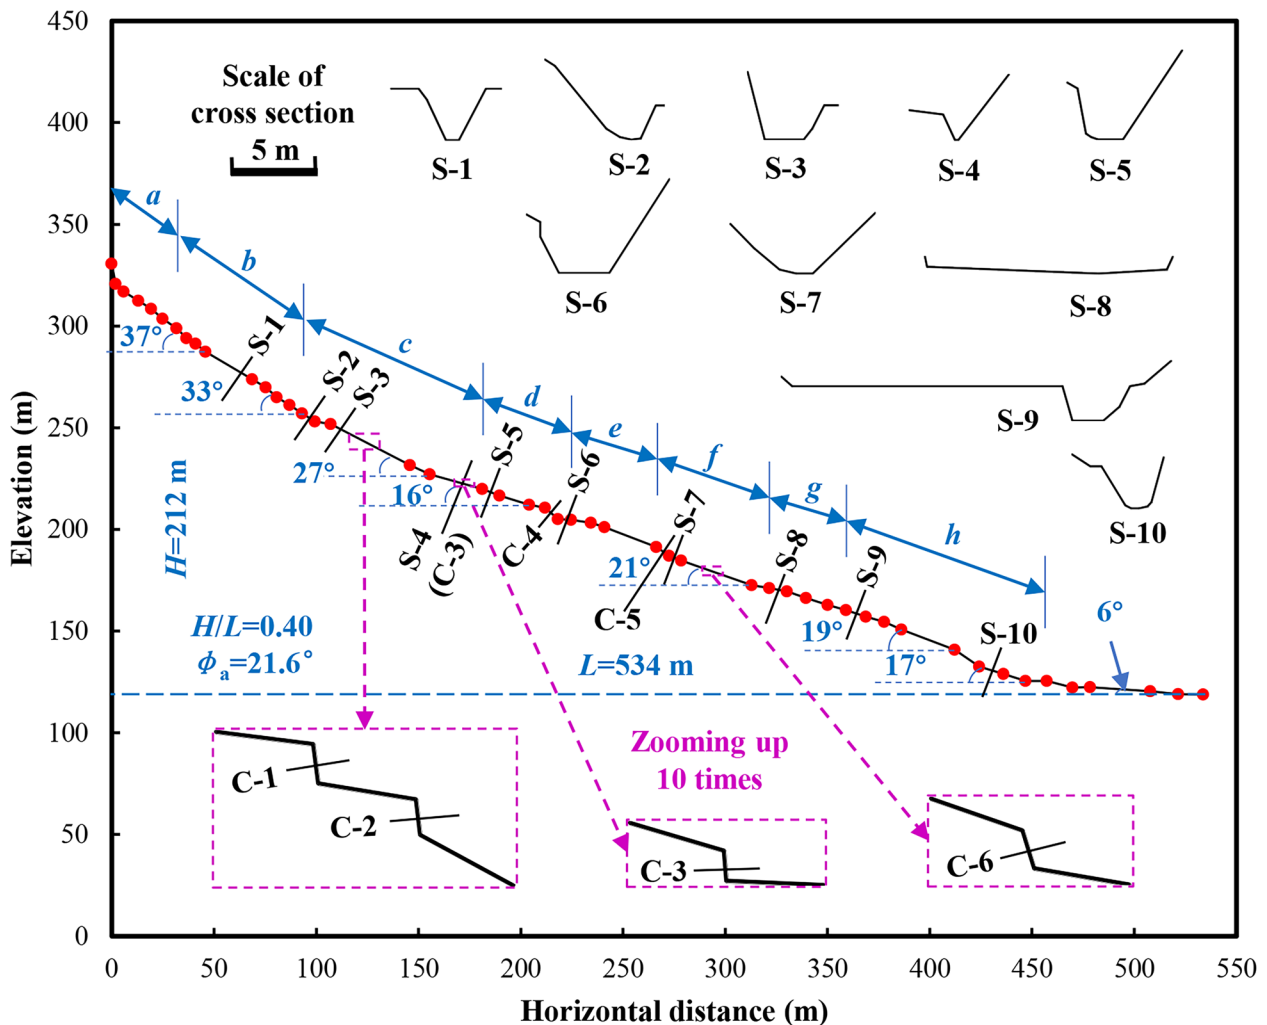
According to Fig. 16, the slope of the gully was initially 37° at the main source area and then reduced to 33° at the merging point. In this case, the slope of the main gully (33°) was the same as that of the parallel source gully (33°) and almost the same as that of the first-side landslides (34°) at the merging point. Then, the slope decreased to 27° involving two natural cliffs with an estimated height of 2–3 m. After that, the slope remained at 18° on average, with a slight fluctuation between 16 and 21° . Overall, DF2 was found to have a longitudinal profile similar to DF1.

The DF2 gully had many more geometric variations, with three main features: the lateral curving path, the natural cliff and the cross-sectional shape. These are sketched in Figs. 16 and 17. Figure 16 shows two types of cross-sectional shapes: V-shape and U-shape. Most of the cross-sections of the gully were V-shaped and mainly located at curved segments, such as S-2, S-4, S-7 and S-9 (see Fig. 17g, j, m and p), in particular. In addition, S-5 and S-6, located at two large bed-eroded gullies (see Fig. 17k–l), were also determined to be V-shaped, although they each had a wide bottom. By contrast, the U-shapes, such as S-3, S-8 and S-10, are generally distributed along straight segments of the gully. In addition, there were six cliffs eroded by the debris flow and contributed significantly to the kinetic energy increase of the debris flow in turn. The mitigating countermeasures shown in Fig. 17o will be addressed in the ‘Discussion’ section.

Fig. 16 Longitudinal section and cross-section of DF2. 'S-' and 'C-' represent cross-sections of 'slope' and 'cliff' positions, respectively

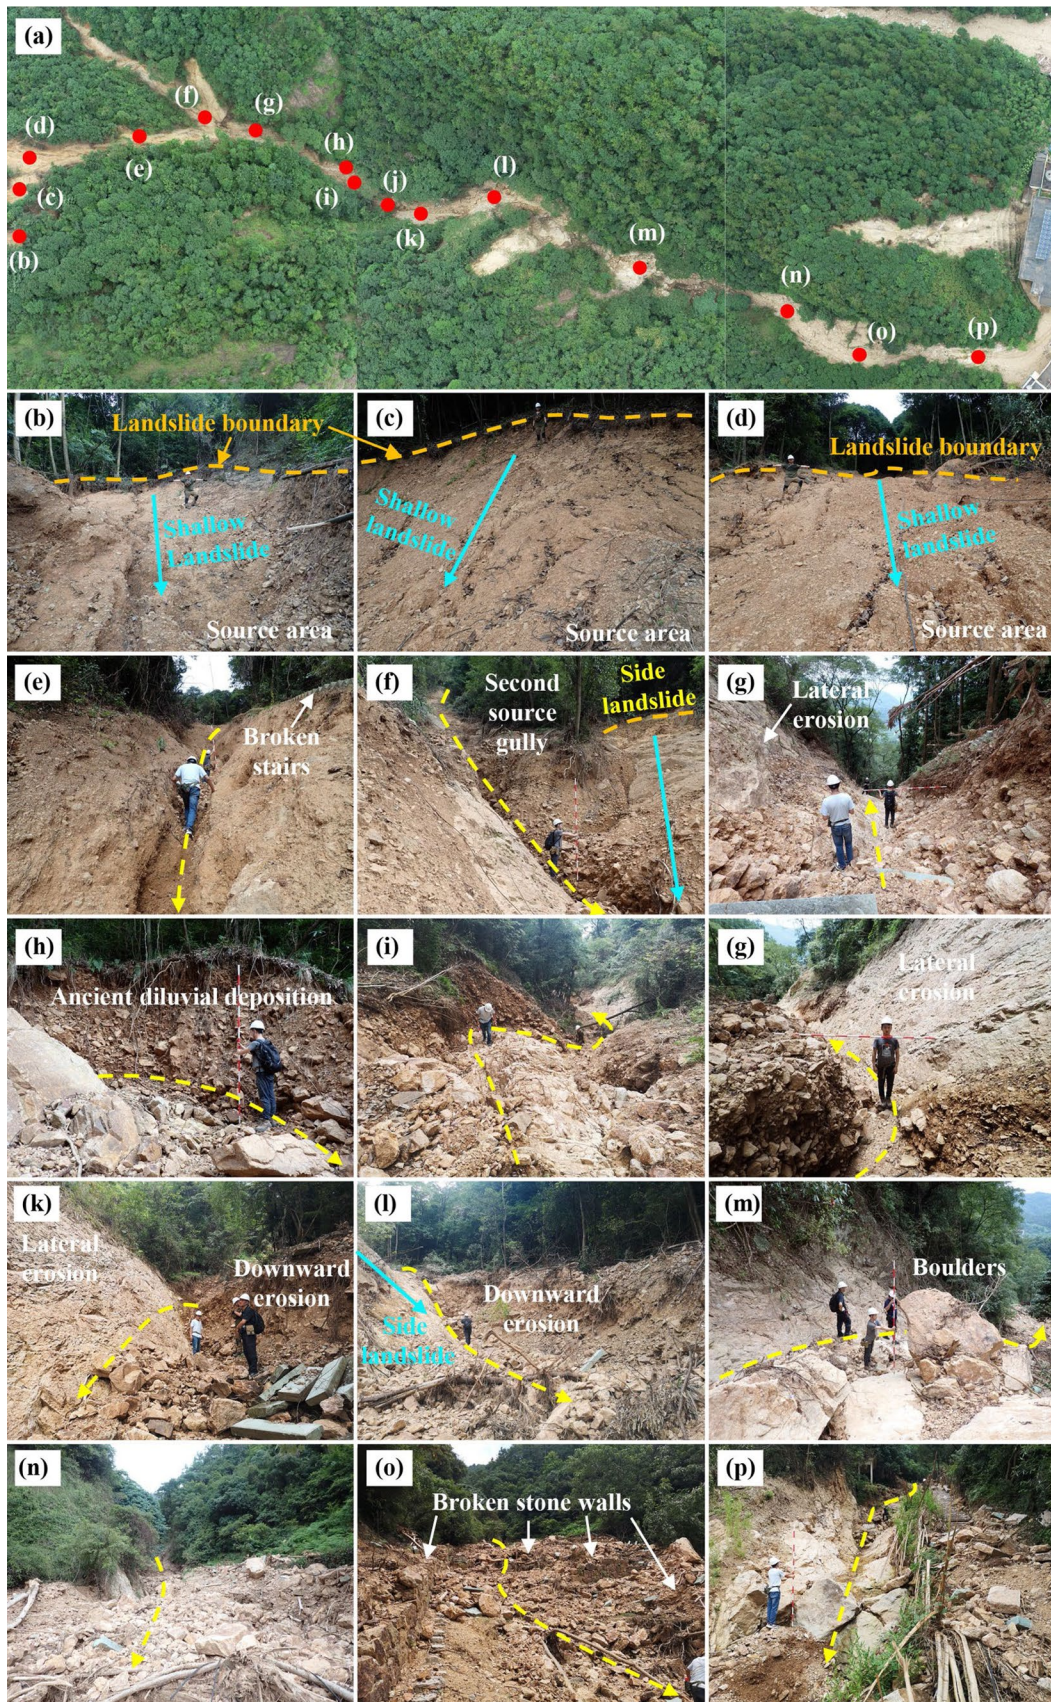
Overall, DF2 had a dip length of 535 m, a dip angle of $S52^\circ E$ and was divided into eight segments by the varied dip direction, except for the small deposition zone. There were two large source areas, three side landslides, six eroded cliffs and a variety of curving paths along the gully. The main source area consisted of three failed shallow landslides, as shown in Figs. 15 and 17b–d. The largest source area had a dip length (L) of 40 m, a width (W) of 15 m and a slope angle of 37° . The other two smaller source areas were estimated to be 20 m/15 m (L/W) and 10 m/10 m (L/W), respectively. They had a similar scarp height of 0.5–1.0 m to that of the largest source area. In terms of the parallel source area, a narrow straight gully towards $S18^\circ E$ had a

length of 70 m, an estimated width of 5 m and a slope angle of 33° . At the merging point of the two source areas (Fig. 17f), there was a small side landslide with a dip length of 22 m, an estimated width of 8 m and a slope angle of 34° . In addition to the above slope failures, two small shallow landslides occurred in the middle of the gully. These were approximately parallel to each other and had similar geometric parameters (see Fig. 15), with a large slope angle of over 40° in particular. Their failure should be attributed to slope cutting caused by the lateral erosion of the debris flow. The failed mass, in turn, blocked the gully and formed a natural dam. Finally, the collapse of the natural dam caused a large and deep area of erosion, as shown in Fig. 17l.

Fig. 17 Photographs describing the DF2 gully from the main source area to the toe. The spliced image (a) illustrates the investigated positions of the detailed features from (b) to (p) along the gully

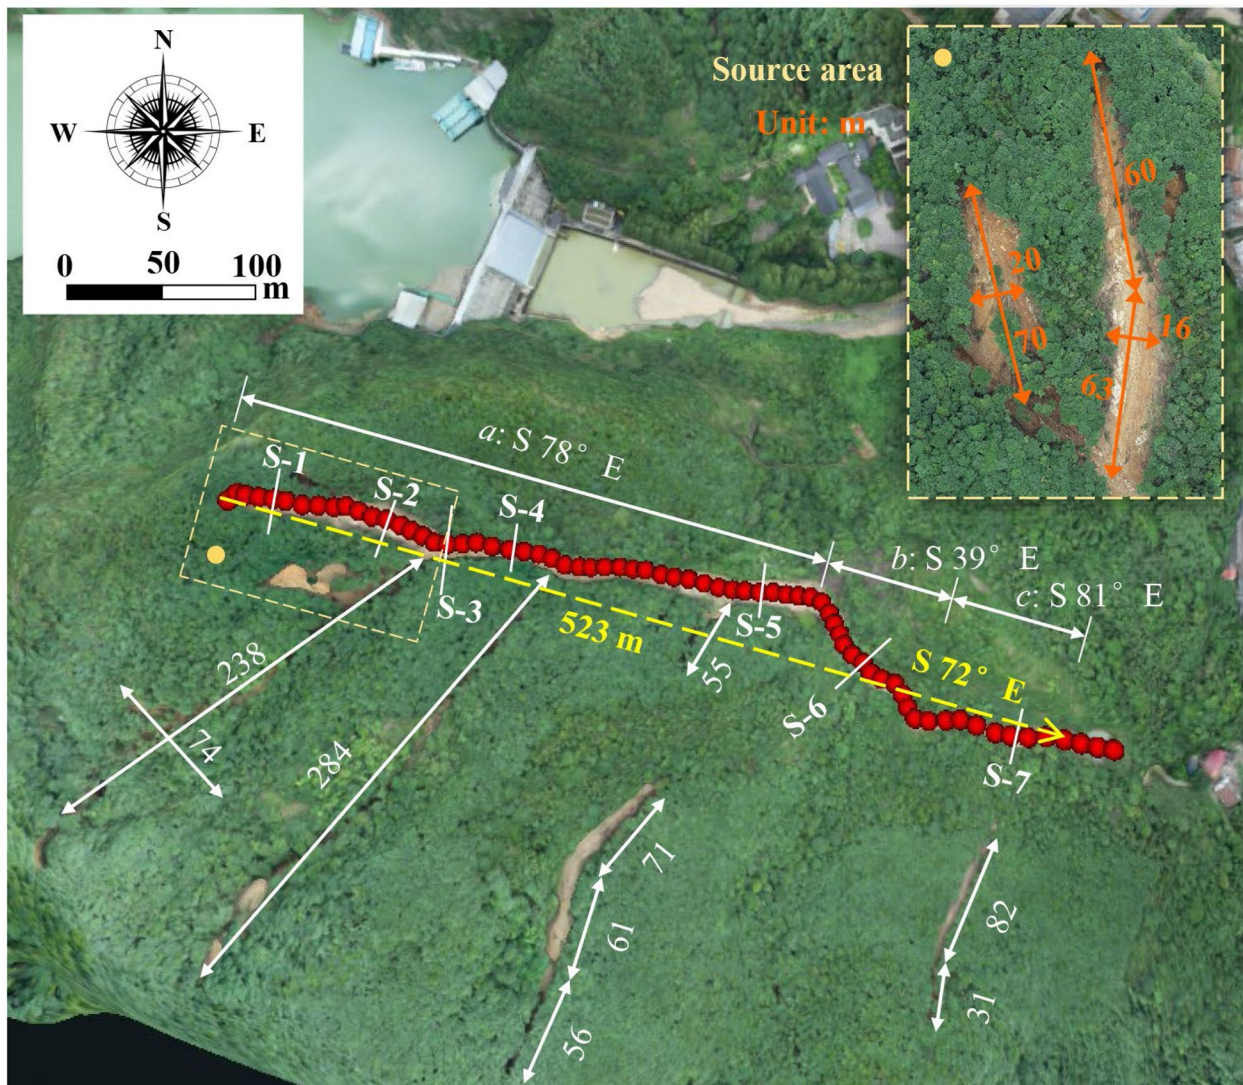
The third gully had different characteristics from the first two, as illustrated in Figs. 18, 19 and 20. The third gully had a dip length of 523 m and a dip direction of S72° E. It had a simple path that was only divided into three segments. Seg-a included the main source area, transition zone and part of the deposition zone, while seg-b and seg-c were fully located in the deposition zone. Two landslides of different sizes occurred in the source area. The larger landslide in the main source area consisted of two segments, with an average dip length of about 60 m. The upper part in the initially failed zone had an estimated width of 10 m and a slope angle of 32° (see Fig. 19), while the lower part had a larger width of 16 m but a gentler slope angle of 25°. The smaller landslide in the parallel source area had a dip length of 70 m and a width of 20 m, according to the SfM modelling. Sliding out from the steeper source area, the debris flow entered a gentle transition zone with a slope that ranged from only 13 to 9°. In the deposition zone, the slope of the gully gradually decreased from 6 to 4° at the end (see Fig. 19).

DF3 had a larger water catchment area (Fig. 9) than DF1 and DF2. According to Fig. 18, two slightly failed gullies merged into the upper part of the transition zone. Although they did not import as

Fig. 18 Topographic properties of DF3 (SfM modelling)

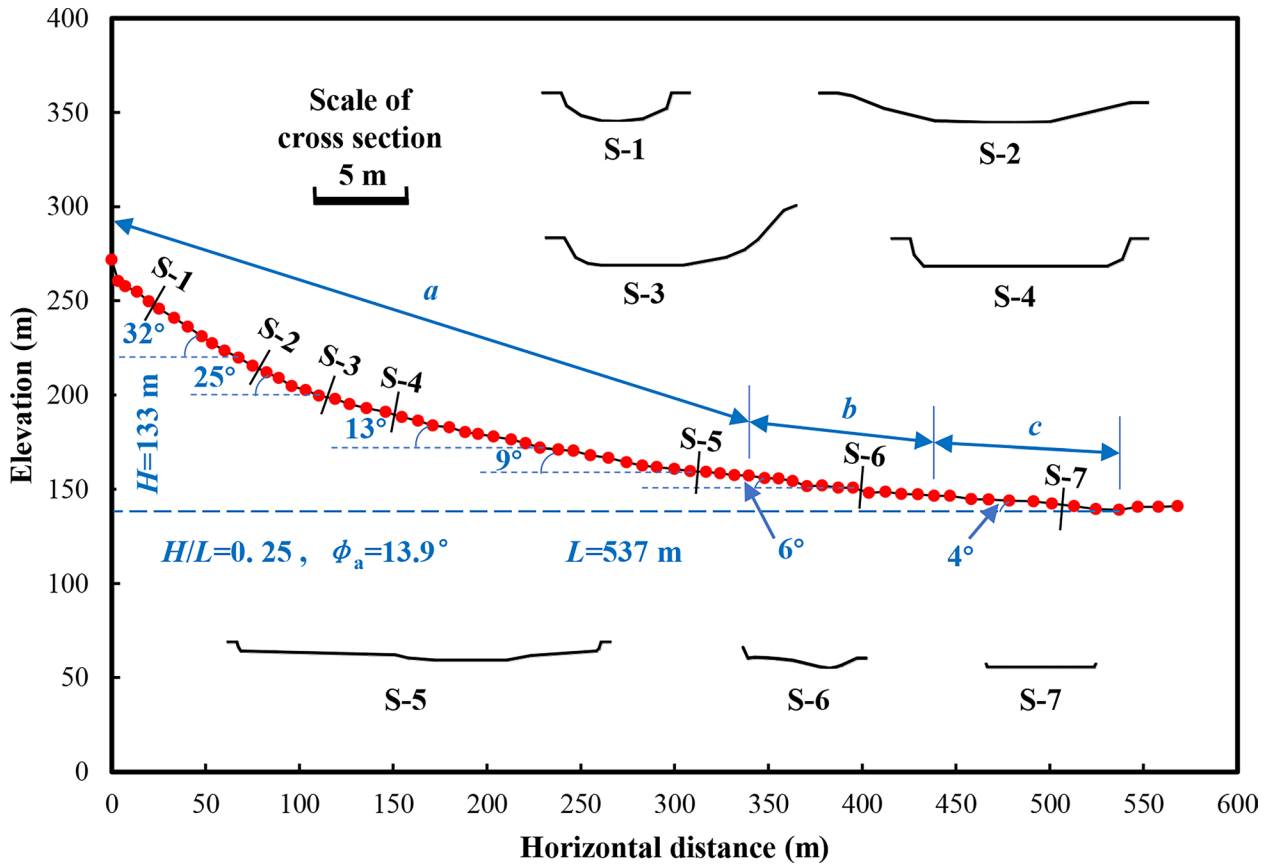
Fig. 19 Longitudinal and cross-sectional profiles of DF3

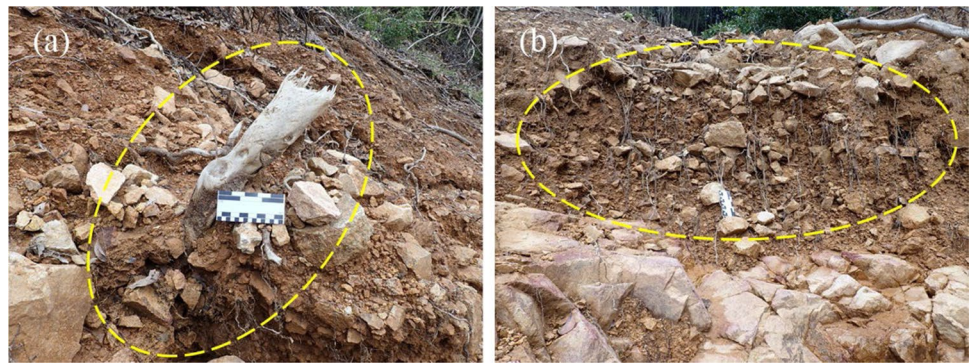
Fig. 21 Root of the plants left in the eluvium of the upper DF3 gully. **a** A single broken root embedded into the gully bed; **b** exposed roots stayed in the table eluvium

The contribution of plants to the stabilisation of slope has been introduced in various studies, as well as in practical projects (Vergani et al. 2017; Löbmann et al. 2020). The field investigation of DF3 found a great number of roots embedded into the eluvial soils, as shown in Fig. 21, which enforced the shear strength of the eluvium. In this case, the anti-erosion capability of the soils was strengthened as expected, which prevented bed erosion and lateral erosion of the debris flows to some extent. The significance of plants with

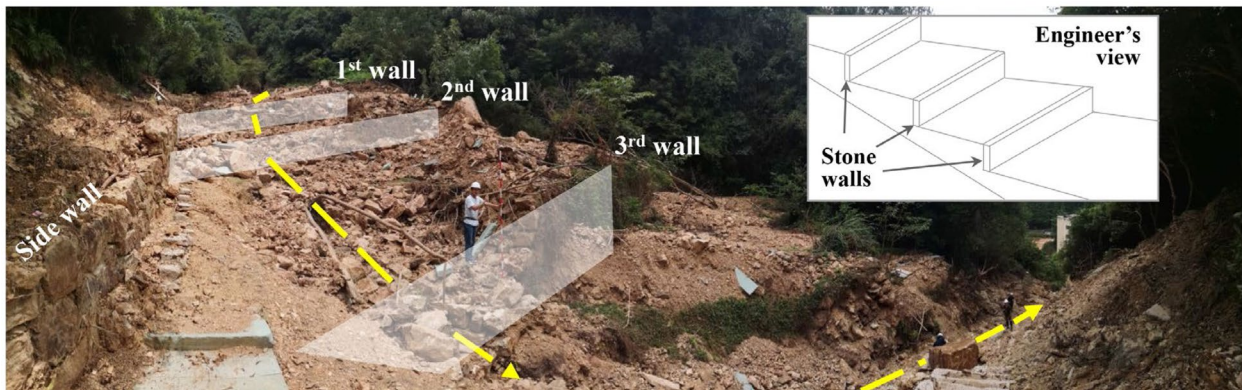
Fig. 22 Debris stone barrier walls behind the hotel

Reasonable and effective countermeasures, based on movement characteristics of the debris flows, are of great importance for the mitigation of geo-disasters. During the field investigations, two preventative structures were found in DF2 and DF3, as illustrated in Figs. 22 and 23, respectively. The first was a composite structure consisting of three barrier walls and two side walls. The walls were made of debris stones without any concrete or rebars. Although this area was damaged in this disastrous event, a large amount of debris mass, especially for the coarser boulders, was

halted here. The multiple walls formed an artificial terrace with a wide, flat platform on top. In this case, the sudden widening of the gully at the flat platform may have sharply reduced the kinetic energy of the debris flow and quickly drained water from the debris mass, causing the debris flow to mostly stop here. In the same way, the second structure, a single earth dam with a drainage channel, also reduced the gradient of the gully at the end of DF3 and effectively prevented debris flow. The long and gentle segment behind the dams provided enough space for the deceleration of the rapid mass movement, which protected the downstream buildings and the lives of the people within them. Effective countermeasures such as these are necessary to mitigate future geo-disasters. Additionally, extreme weather conditions should be taken into account when designing structures for disaster mitigation in the future.

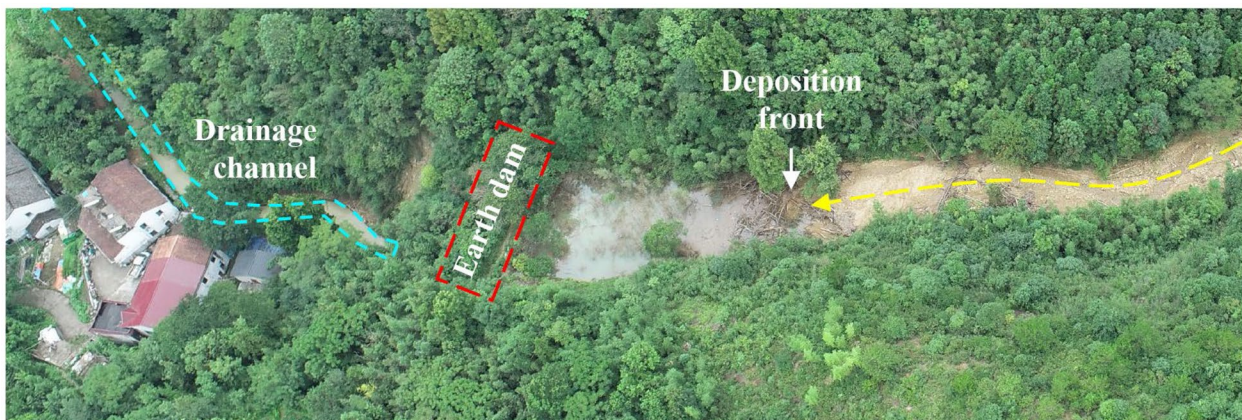
Fig. 23 Constructed earth dam behind the local village
