Landslides (2022) 19:1957–1970
 DOI 10.1007/s10346-022-01904-9
 Received: 14 December 2021
 Accepted: 12 May 2022
 Published online: 26 May 2022
 © Springer-Verlag GmbH Germany,
 part of Springer Nature 2022

Spatial–temporal distribution and failure mechanism of group-occurring landslides in Mibei village, Longchuan County, Guangdong, China

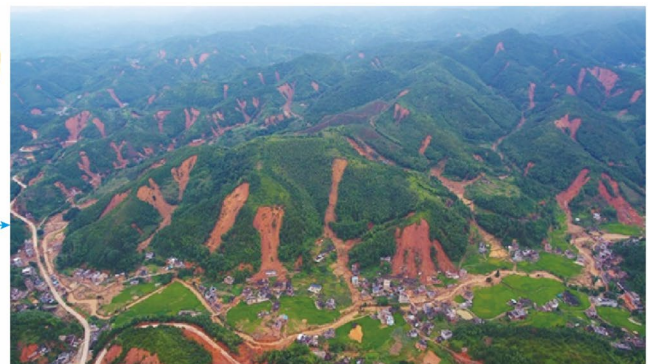
Fig. 1 Unmanned aerial vehicle image after the disaster in Mibei village, Beiling town

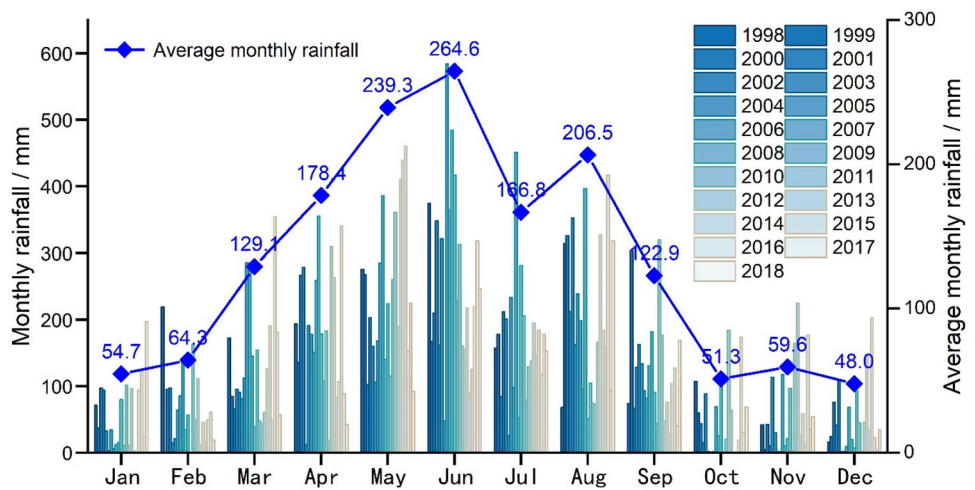
Fig. 3 Monthly rainfall and monthly average rainfall of Longchuan County from 1998 to 2018

north to south. The area with low mountains and hills accounts for more than 90% of the total area. The Meteorological Bureau of Longchuan County statistically analyzed the rainfall data for the whole county and obtained the monthly rainfall and monthly average rainfall of Longchuan County from 1998 to 2018, as shown in Fig. 3. Due to the subtropical monsoon climate, the annual rainfall in the study area exhibits bimodal characteristics. The first rainfall peak typically occurs in June, the monthly average rainfall reaches 264.6 mm, and the second rainfall peak occurs in August, with a monthly average rainfall of 206.5 mm. The above group-occurring landslide disaster event in Longchuan County was attributed to heavy rainfall occurring from June 10 to 13, 2019, which was observed during the first rainfall peak period in the region, generally conforming to the regional climate environment.

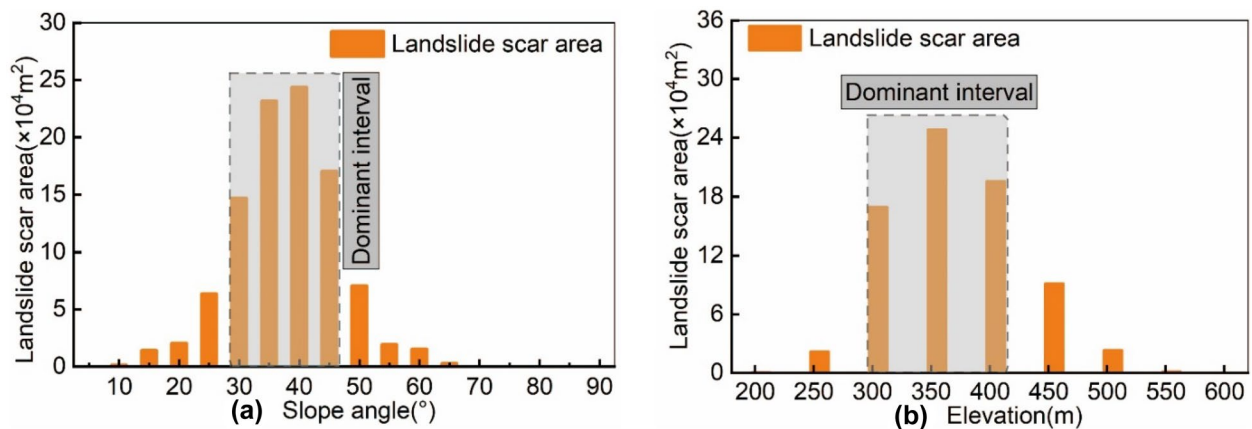
Fig. 6 Relationship between the landslide scar area (LSA), slope angle, and elevation: **a** slope angle; **b** elevation

rainfall infiltration, and the slope potential energy is low. Consequently, it is difficult to reach the potential energy conditions for instability initiation. Therefore, landslides were mainly concentrated in the medium-gradient section in terms of the terrain slope and elevation, which constituted the best comprehensive relationship between the terrain conditions and rainfall, resulting in the most well-developed landslides.

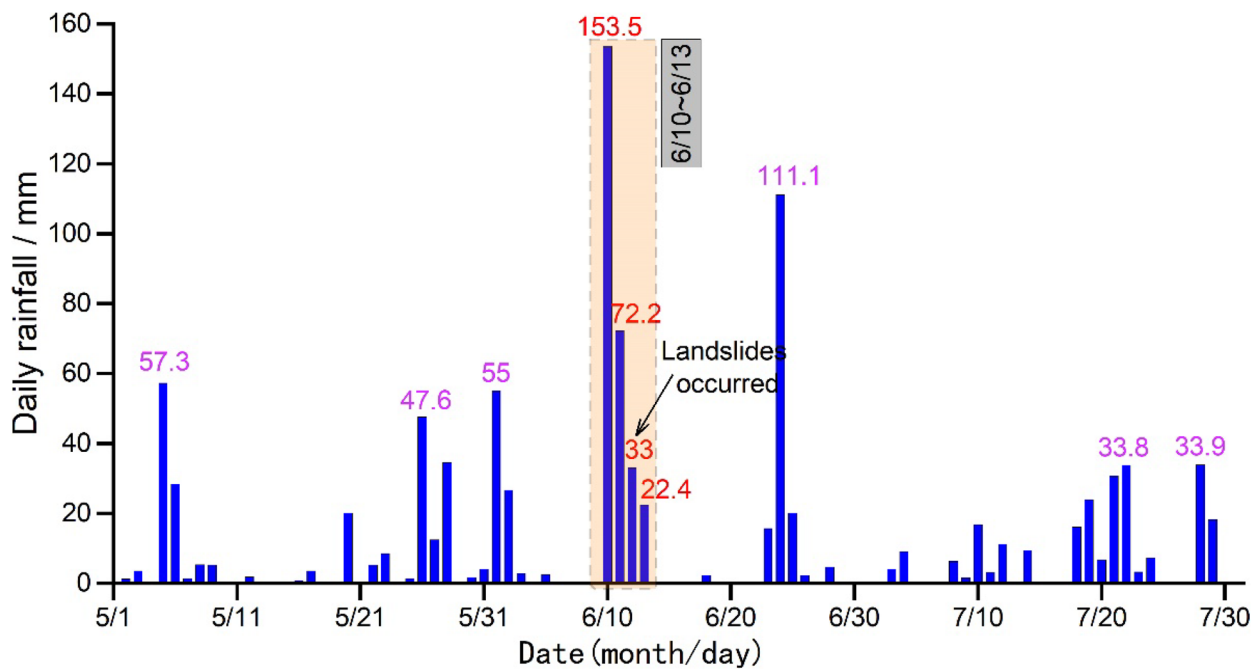
Fig. 7 Daily rainfall distribution in the study area from May to July 2019

as high as 225.7 mm. Therefore, it was preliminarily determined that the group-occurring landslides were mainly caused by continuous heavy rainfall from June 10 to 11.

Through the temporal relationship between the group-occurring landslides and rainfall structure, as shown in Figs. 7 and 8, it could be concluded that extreme heavy rainfall from June 10 to 11 was the key controlling factor of the disaster event, and it was further confirmed that granite residual soil landslides exhibit a major rainfall lag effect. In addition, the single-day rainfall in the study area exceeded 100 mm again on June 24, the rainfall intensity was slightly lower than that on June 10, and no large-scale landslide disaster ensued, which could be largely explained by an unsustainable rainfall structure.

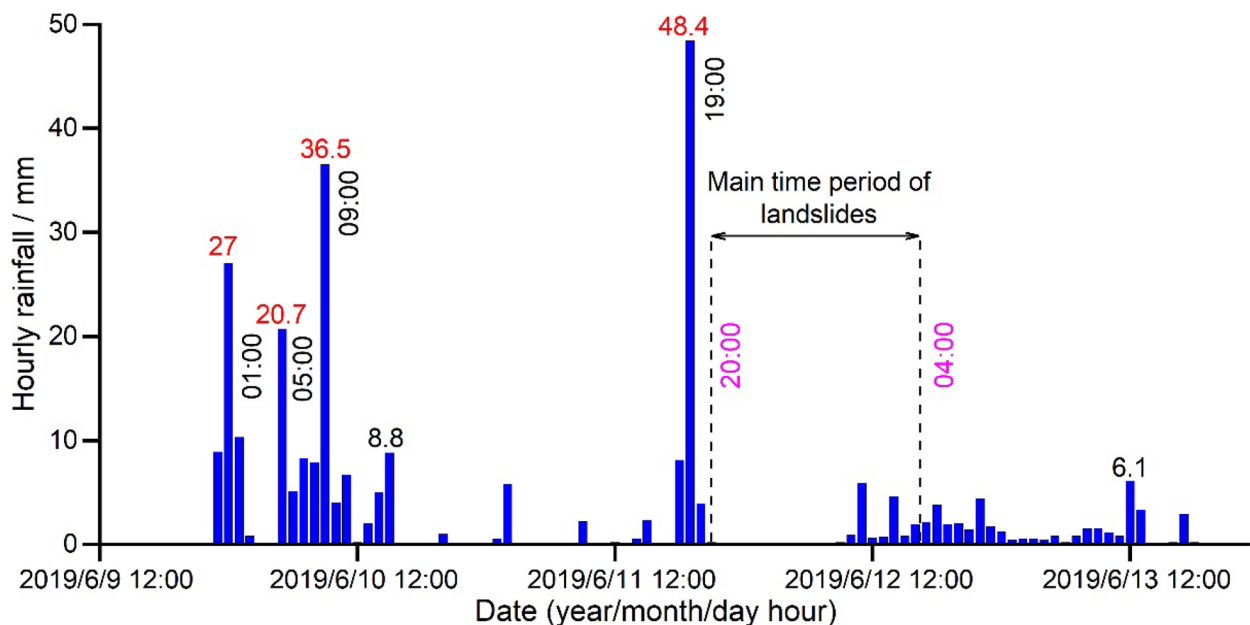
Figure 8 shows the hourly rainfall distribution in the study area from June 9 to 13, 2019, which can further explain the relative temporal relationship between the observed group-occurring landslides and rainfall. From the early morning of June 10 to the end of rainfall at 18:00 on June 13, the hourly rainfall fluctuated

throughout the whole process, and 4 hourly rainfall peaks successively occurred, with peak hourly rainfall amounts of 27, 20.7, 36.5, and 48.4 mm, all of which occurred before the occurrence of group-occurring landslides. A large number of landslides ensued just after the last hourly rainfall peak (20:00 on June 11). During the time interval of concentrated landslide occurrence, weather conditions without rain largely prevailed, and the maximum hourly rainfall was lower than 5.0 mm. However, the previous cumulative rainfall

Fig. 8 Hourly rainfall distribution in the study area from June 9 to 13, 2019

amount reached 225.7 mm. The lag impact of rainfall on the slope seepage field and granite residual soil properties was thus revealed. Consequently, hundreds of landslides occurred within just 8 h.

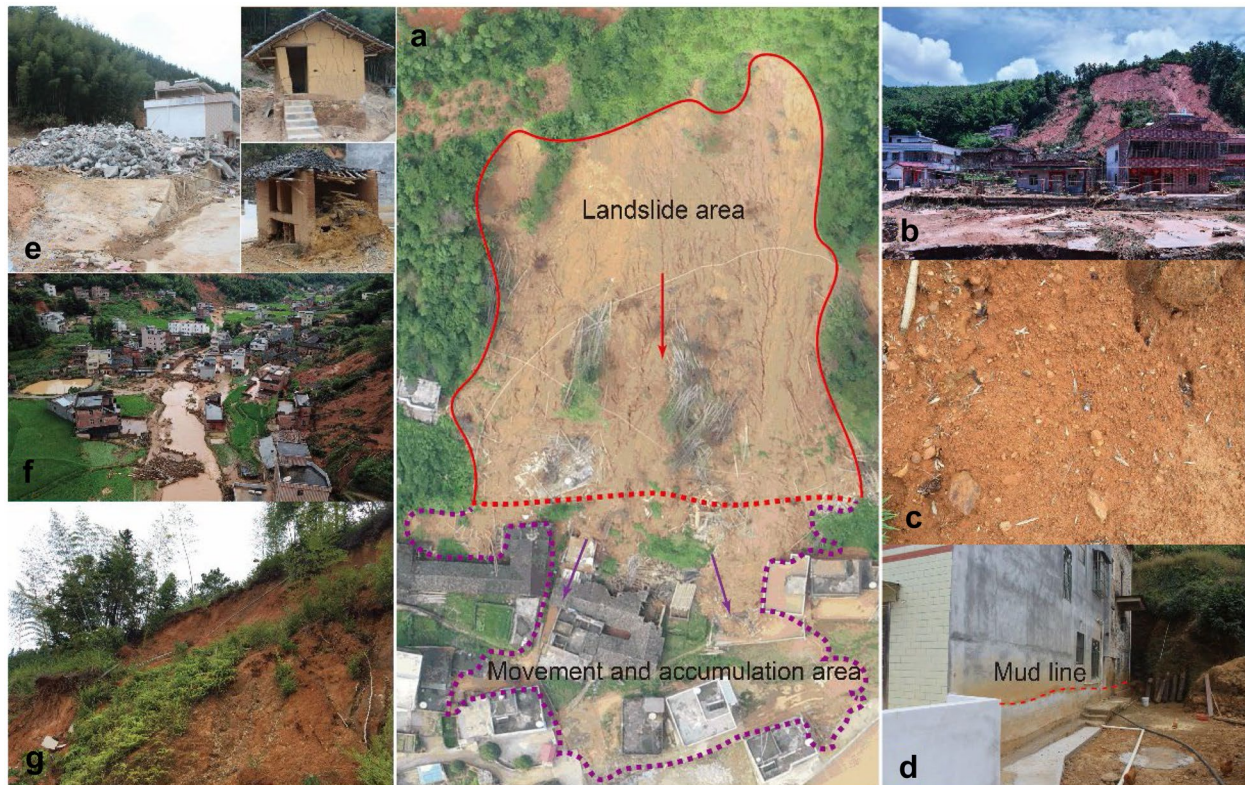
To further analyze the failure characteristics and instability mode of the observed landslide disasters in the area, a representative landslide was selected for analysis. This landslide was located on the back mountain slope of the gathering area at the center of Mibei village, which was conducive to the detailed investigation at the site. The scale of the landslide was relatively large, the boundary was complete, and there were still deformation signs at the trailing edge. In addition, the landslide had a great impact, causing house damage and river siltation. The landslide mass was approximately 103 m long and 92 m wide. The thickness of the landslide mass ranged from approximately 2~5 m, with a total volume of 38,000 m³. The landslide mainly comprised granite residual soil, which was a small landslide (Fig. 9a, b). A sliding surface developed along the granite eluvium and gradually cut

Fig. 9 Failure characteristics and influence results of a typical landslide. **a** Panoramic features of the landslide (UAV image); **b** front features of the landslide; **c** landslide deposits; **d** mud line in the

movement and accumulation area; **e** damaged houses; **f** river siltation characteristics (UAV image); **g** deformation characteristics of the trailing edge

into the fully weathered layer near the front edge. Hence, accumulation mainly entailed silty clay mixed with a small amount of weathered residual breccia and gravel (Fig. 9c). In the high-rainfall environment from June 10 to 11, the slope became increasingly damaged. Due to the high-saturation state of the damaged loose soil, the flow characteristics of the unstable landslide were highly prominent in the movement process. The power provided by the gravitational potential energy endowed the landslide with a certain breaking force, resulting in burial or dislocation and cracking of the houses occurring in the residential area at the slope foot (Fig. 9d, e). Subsequently, continuous rainfall established a surface catchment, which further increased the moisture content in the loose accumulated deposits. These deposits continued to move forward from the gently sloping terrain at the foot of the slope toward the residential area, and soil and water increasingly separated, resulting in the accumulation of landslide materials in front of and behind the affected residential houses. Mud flowed into the Mibei River, which increased the water level of this river, and mud also reached the pavement and cultivated land (Fig. 9f). Traction deformation occurred along the trailing edge of the landslide due to free face conditions, resulting in tension cracks. Staggered deformation and even sliding failure ensued in certain sections under rainfall conditions from June 12 to 13, and trees and bamboo on the slope surface were displaced (Fig. 9g).

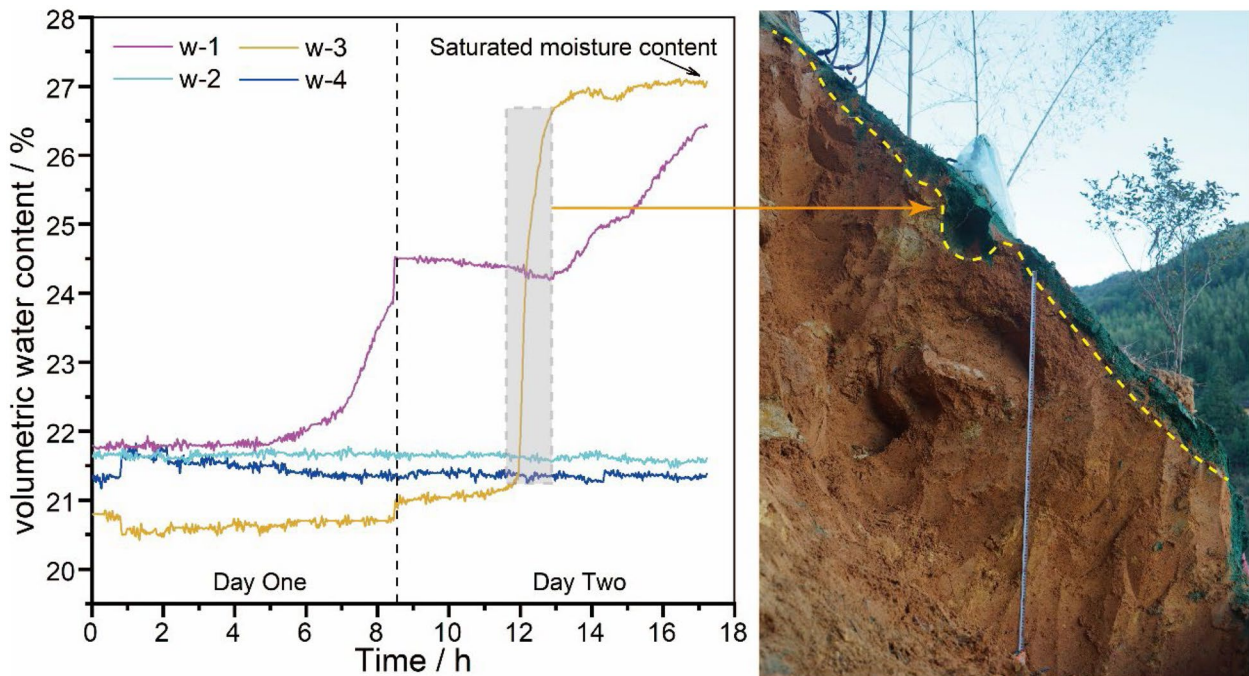
Figure 11 shows the time-history curve of the volumetric moisture content at the different locations under 2-day rainfall conditions. During the first 5 h of the rainfall process on the first day, the volumetric moisture content recorded by the #1 and #3 sensors at a depth of 30 cm did not change significantly. After 5 h of rainfall, the monitoring data recorded by the #1 volumetric moisture content sensor gradually increased and exhibited an accelerated growth

trend. By the end of the rainfall process on the same day, the volumetric moisture content had increased to 24.6%, and the growth trend was nearly vertical. The #3 volumetric moisture content sensor indicated a gradual growth trend as a whole, with limited rapid growth approximately 20 min before the end of the rainfall process on the same day. The rainfall process on the first day was stopped at 18:00, and the rainfall process on the second day was initiated at 08:00. No rainfall was simulated in between, and the process lasted 14 h. After the rainfall process on the second day, sensors #1 and

Fig. 11 Time-history curve of the volumetric water content and characteristics of the seepage section

#3 did not immediately indicate a growth trend of the volumetric moisture content, and the volumetric moisture content recorded by sensor #1 even exhibited a small decrease. This phenomenon was caused by the evaporation and seepage movement of pore water during the rainfall-free period. The rainfall process on the second day compensated for the pore water loss during the rainfall-free period. The data characteristics fully reflected the change trend of the slope volumetric moisture content in the actual rainfall process. After 3.5 h of rainfall on the second day, sensor #3 first increased and indicated a sharp increasing trend. The volumetric moisture content increased from 21.3 to 26.8% over approximately 1 h and then stabilized at approximately 27%. Sensor #1 again indicated continuous growth after 4.5 h of rainfall, and the volumetric moisture content reached 26.3% at the end of the rainfall process on the second day, but a stable value was not reached. Based on the excavation section after the test, it was found that the test physical model remained uneven. There occurred a stone block with a diameter of approximately 20 cm above sensor #3. The stone block was covered by the surrounding residual soil, resulting in slow rainfall infiltration at the early stage. The infiltrated pore water moved around the stone block, thereby increasing the seepage path, resulting in a lag in the reaction of sensor #3 behind that of sensor #1. In the whole rainfall process, the data recorded by sensors #2 and #4 at a depth of 80 cm did not change notably. Artificial rainfall imposed the greatest influence on the soil below the model. This phenomenon was closely related to the rainfall intensity and overburden permeability. This conclusion could also explain why the group-occurring landslides in the study area mostly involved shallow surface failure.

According to the characteristics of the excavation section after the test, as shown in Fig. 11, the local volumetric moisture content exhibited a differential distribution due to the influence of impurities (stone blocks). In regard to the whole model, the migration process and distribution of pore water after rainfall infiltration were regular, revealing shallow characteristics at the top and notable characteristics at the bottom. The pore water seepage depth in the middle and lower parts of the model was relatively large, while the pore water seepage depth in the upper part of the model was relatively small, which was attributable to pore water seepage toward the front under the action of the gravitational potential energy after the model surface had become saturated. An uneven pore water distribution could also cause differences in the deformation and failure characteristics of the model. Under the influence of rainfall, the soil in the middle and lower shallow layers of the model occurred in a saturated state, and the shear strength greatly decreased, resulting in a decline in the stability and gradual failure of the middle and lower parts of the model. Because the influence depth of short-term heavy rainfall was limited and the rainfall intensity was much higher than the soil permeability coefficient, the influence of heavy rainfall was mainly concentrated in the shallow surface zone. Moreover, surface water flow increased at the later rainfall stage, and the erosion effect on the surface of the model was strengthened, thus forming the deformation and failure characteristics depicted in Fig. 12.

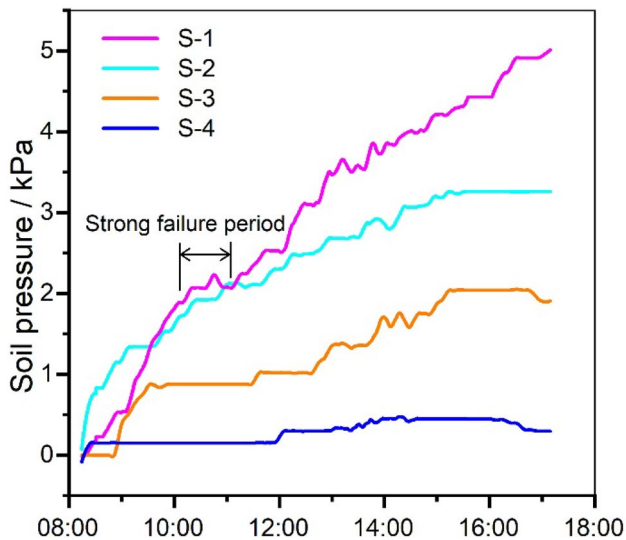
Fig. 13 Time-history curve of the soil pressure on the second day

failure occurred on the surface of the model, and the soil pressure at each position further indicated an obvious development trend (Fig. 13). Since rainfall infiltration mainly affected the middle and lower parts of the model and the gravitational potential energy increased upon soil moisture content enhancement, the growth range of the #1 and #2 soil pressure sensors was the largest and exhibited a continuous growth trend. The soil pressure at sensor #1 finally reached 5.1 kPa, and the soil pressure at sensor #2 remained stable at 3.2 kPa after 7 h of rainfall. Since the rainfall influence depth in the upper part at sensor #3 was relatively limited, the soil pressure at sensor #3 approached 2.0 kPa at the end of the test. Sensor #4 exhibited a large burial depth and a small rainfall infiltration depth in the upper part, and sensor #4 consequently imposed no notable influence of the slight change in soil pressure. The soil pressure response at the different depths and locations reflected the non-uniformity of the impact of rainfall on the model. The higher the rainfall infiltration and the larger the infiltration depth were, the stronger the earth pressure response. In contrast, the soil pressure response was limited or no response was observed. Moreover, sliding failure of the slope surface could reduce the overburden load on the soil pressure gauge. After failure, the volumetric moisture content in the soil in the lower part of the exposed surface was slightly lower than that at the slope surface, and rainfall infiltration easily ensued. Therefore, while the overburden load was reduced, continuous rainfall infiltration compensated for the reduction, which resulted in a gradual growth or stagnation state in the monitoring curve.
