Bioerosion effects of sea-level rise on the Doge's Palace water doors in Venice (Italy)

Abstract

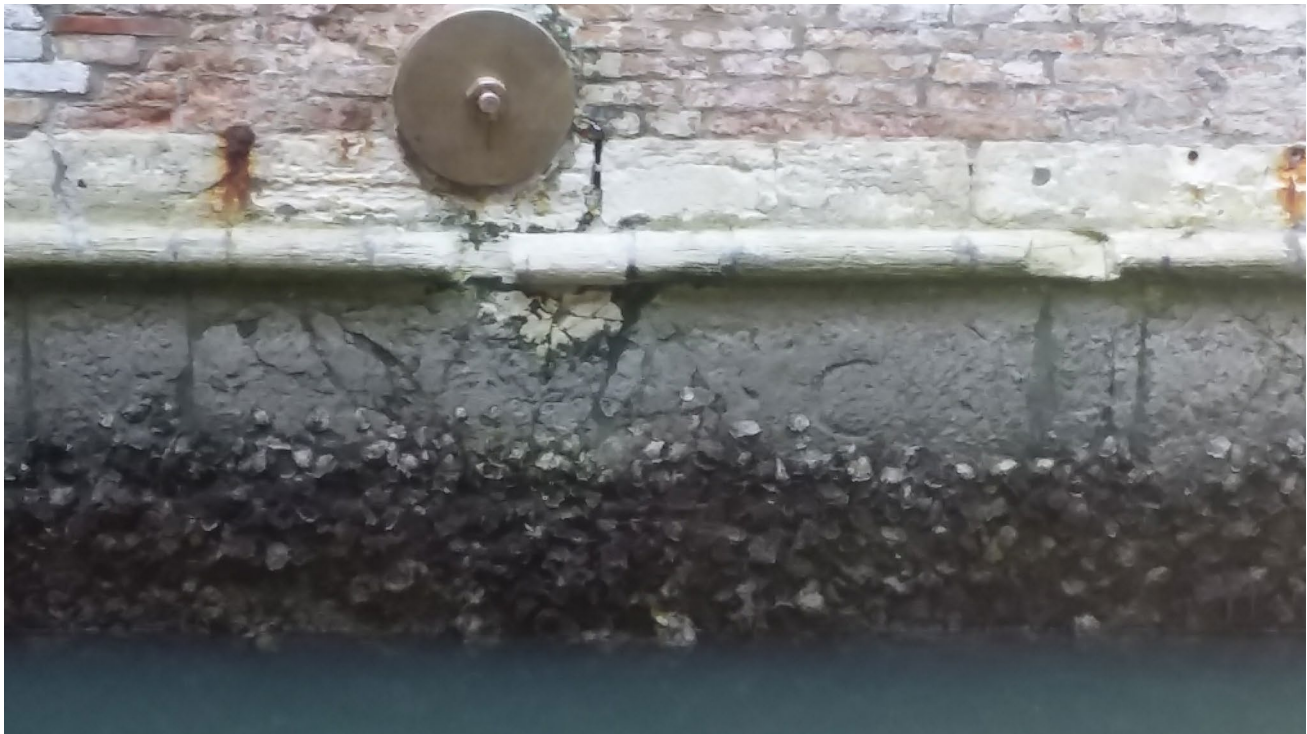
Fig. 1 One of the letters “C” with which the Venetians used to identify the *Comun marin*, i.e., the limit of the dark band of cyanobacteria which marks mean high-water level. The “C”, that was carved just on

top of the CM, is now completely below the current CM, evident just below the stringcourse. The difference gives a measure of the relative sea-level rise (location: *Rio San Severo*)

In the last century, subsidence produced by groundwater extraction in the nearby industrial area has been added to the natural one. As a result, during the 20th century, 12 cm of elevation has been lost due to eustasy, 4 cm to natural subsidence, and 10 cm to groundwater pumping (Trincardi et al. 2016). The ancient Venetians took as a vertical reference the upper edge of the blackish belt that can be observed along the canal banks, which corresponds to the mean high-water level (Fig. 1). This intertidal belt is formed by the growth

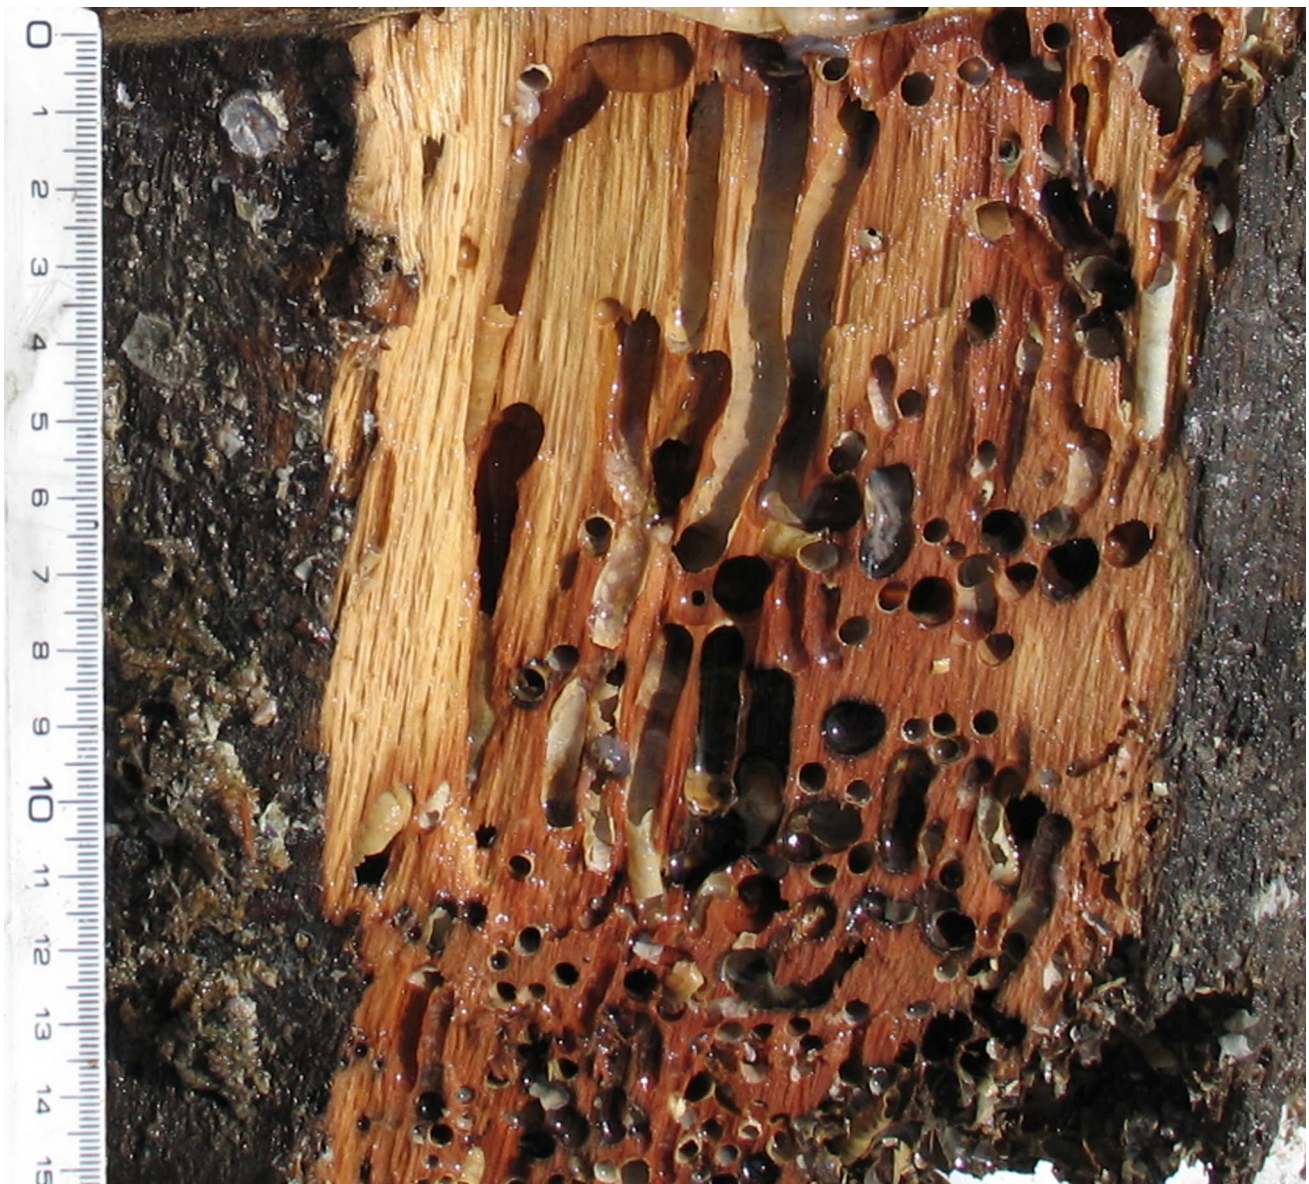
Fig. 2 Section of an Oak pole subjected to shipworm attack. The tunnels follow the grain of the wood upwards and are plastered with a calcareous coating secreted by the molluscs

and peracarid crustaceans such as the Gribbles (Isopoda: Limnoriidae) and the Pincher-tail scud (Amphipoda: Cheuridae). The main species of shipworms inhabiting in the lagoon of Venice are *Lyrodus pedicellatus* (Quatrefages 1849) and *Teredo navalis* Linnaeus 1758. Moreover, the non-indigenous species *Teredo bartschi* Clapp 1923 has been recently recorded. The planktic larvae of shipworms settle on the wood at the stage of pediveliger and start excavating tunnels that develop upward following the grain. The entry holes are generally less than a millimeter and are difficult to spot on the wood surface by the naked eye. Then, the tunnels widen in the subcortical zone up to a centimeter in width, quickly compromising the entire

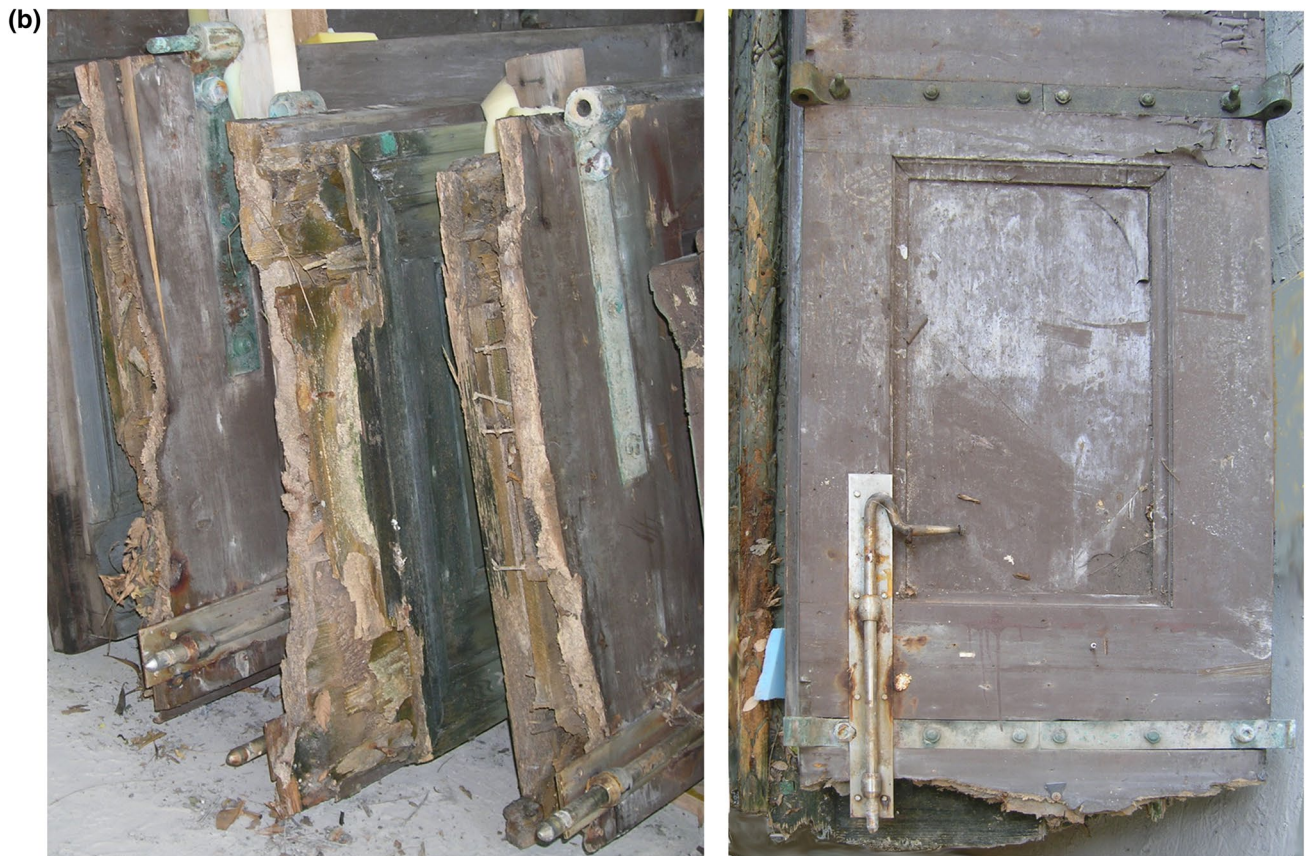
Fig. 6 a Diagram of a pair of water gates; left, the state before restoration, to the right, damage mapping (striped blue=missing parts due to marine woodborers, dotted red=microbiological degradation, yellow=damaged paint), **b** Damage caused by the action of marine woodborers on the water-doors of the *Palazzo Ducale*. The part below the hinge, periodically submerged by the tides, has been completely destroyed

As of 2011, all doors show severe attack by gribbles up to the hinge, whereas the bottom rail was completely missing due to the destructive joint activity of gribbles and shipworms (Fig. 6a, b). The state of the doors urged the Civic Museums Foundation of Venice (Fondazione Musei Civici di

The inspection of the old doors has highlighted a physical limit to the massive attack of the woodborers. This limit is placed about 15 cm from the height of the lower hinge (Fig. 6), approximately at the highest level reached by the woodborers in the test panels.

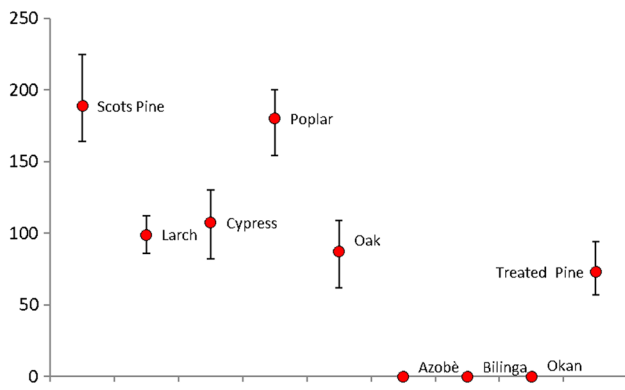
Fig. 8 Average number of shipworms present in the specimens. The vertical bars indicate minima and maxima

In the Scots Pine the density of shipworms was the highest, followed by Poplar with very close values. Larch and Cypress hosted lower but similar numbers of shipworms

followed by the Oak. The Scots Pine treated with boron silicate was a little less attacked than Oak (Table 1, Fig. 8).

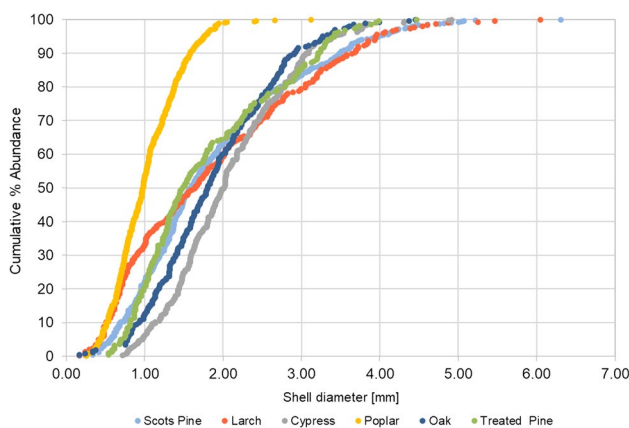
Fig. 9 Shell-size grading curves. The percentage abundances refer to the three replicates pooled

Shipworms were measured from X-ray images of all wood types ($n = 160$ throughout the dimensional range). The diameter of shipworm shells ranges from 0.17 to 6.31 mm. Only a small number of individuals measured more than 5 mm. The shell-size cumulative distributions for each wood species are plotted as grading curves (Fig. 9). The size distribution of the animals was similar in all types of wood except for the Poplar, which housed smaller organisms. In the Larch, the proportion of small-sized shipworms was slightly higher than the one present in the other wood species. The Cypress showed the lowest number of small bivalves.

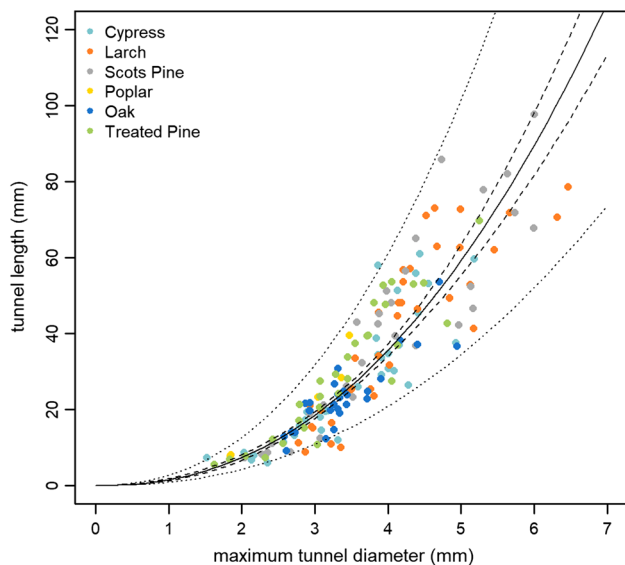
Fig. 10 Relationship between maximum tunnel diameter and tunnel length. Dashed lines indicate 0.95 confidence interval and dotted lines indicate 0.95 prediction interval

No evident relationship between animal density and shell size has been observed. An overall exponential relationship between maximum tunnel diameter and tunnel length was observed ($y = 1.5 x^{2.27}$, $R^2 = 0.84$, Fig. 10). These tunnel dimensions reflect the shell width and length of the living animal.

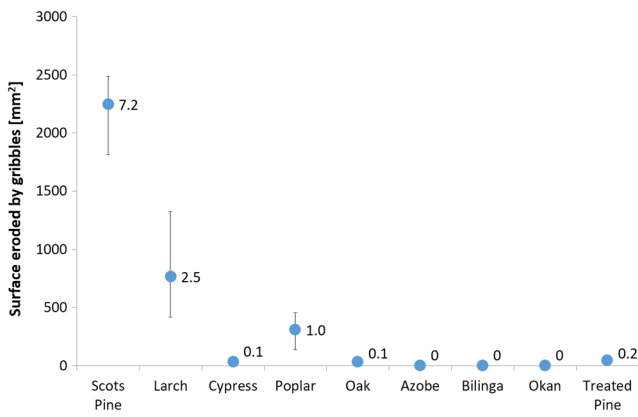
Fig. 11 Woodborers’ bioerosion as detected by image analysis (mean, minima, and maxima). On the left, surface eroded by gribbles. On the right, the shipworm tunnel areas projected on the X-ray film. The

number next to the symbol gives the mean percentage of bioerosion. On the x-axis the wood species

Figures 11 and 12 depict the results reported in Table 1. The largest number of gribble tunnels was recorded on the reference species and on the Larch. On the Poplar, galleries were found only on the narrow lateral sides of the panel oriented towards the building, sheltered from waves and sunlight. Few galleries were found on the Cypress and on the Scots Pine treated with boron silicate.

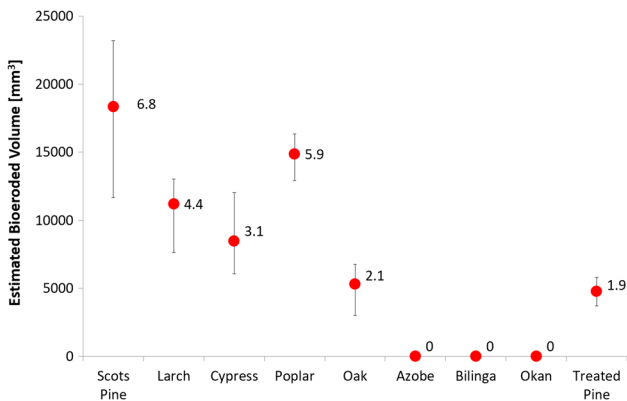
Fig. 12 Estimated bioeroded volume, mean, and extreme values. The number next to the symbol gives the mean percentage of bioerosion

The graph of Fig. 12 shows the shipworms' Estimated Bioeroded Volume depicting the same situation. A linear relationship between the number of shipworms and the bioeroded volume was also detected (Fig. 13).

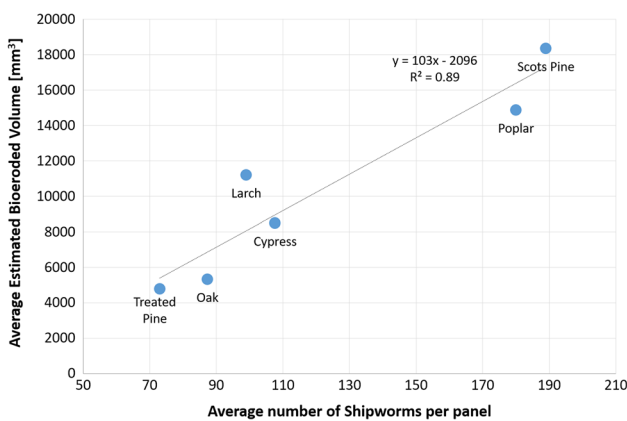
Fig. 13 Relationships between the estimated bioeroded volume and number of shipworms (average of the three test specimens)

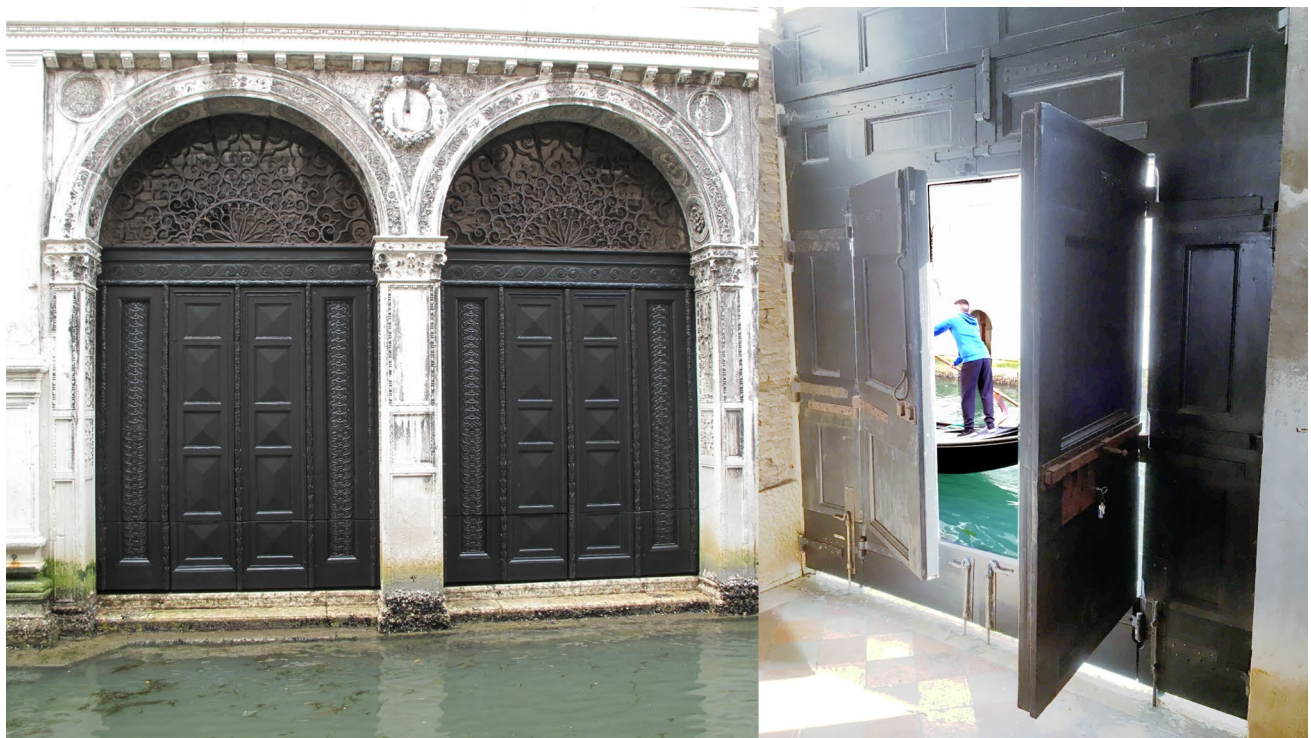
Fig. 15 The water-doors after restoration. The image from the inside shows the separation between the upper and lower parts, facilitating maintenance work

The experimental evidence suggests that the bottom rails of the new doors should be separated from the upper part to avoid the effects of capillarity, at least up to 40 cm above mean sea level. The separation could be made either by interposing a waterproof material or by a cut. The chosen solution was to build the new bottom rails, keeping them physically separate from the rest of the gate by a cut just below the lower hinge. This strategy made possible a higher frequency of maintenance, keeping the cost low. Aesthetically, the line of discontinuity

between the new self-standing bottom rails and the original upper portions was only slightly noticeable from the outside. Doors were finally coated with marine-grade paint (Fig. 15).
