Saving lives in earthquakes: successes and failures in seismic protection since 1960

Robin Spence

Abstract This paper will look at what we have and have not achieved in reducing the risk to human life from earthquakes in the last 50 years. It will review how success has been achieved in a few parts of the world, and consider what needs to be done by the scientific and engineering community globally to assist in the future task of bringing earthquake risks under control. The first part of the talk will re-examine what we know about the casualties from earthquakes in the last 50 years. Almost 80% of about 1 million deaths turn out to have been caused by just ten great earthquakes, together affecting a tiny proportion of the territory at risk from heavy ground shaking. The disparity between richer and poorer countries is also evident, not only in fatality rates, but also in their rates of change. But the existing casualty database turns out to be a very poor basis for observing such differences, not only because of the small number of lethal events, but also because of the very limited data on causes of death, types and causes of injury. These have been examined in detail in only a

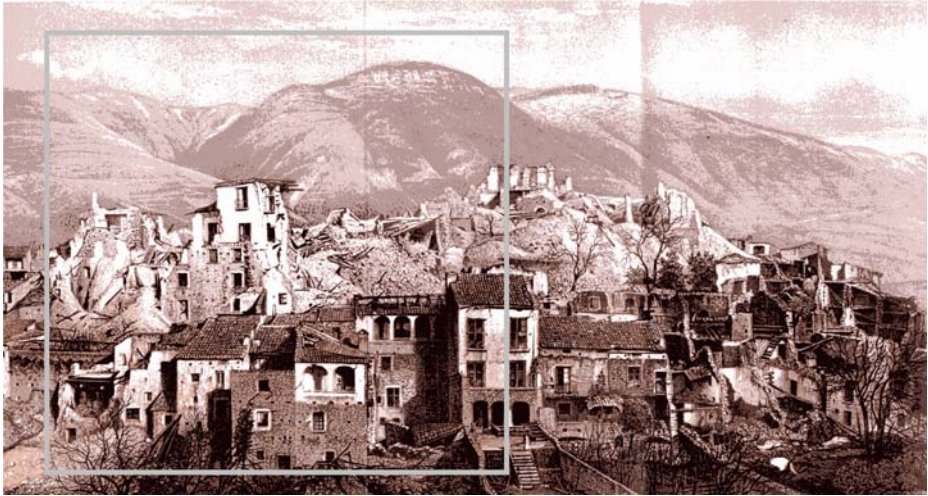
Fig. 1 The damage to Polla, in Irpinia, in the 1857 earthquake (from frontispiece of Mallet 1862)

1862). He was everywhere acutely aware of the tragedy and its causes, even while trying to pioneer an objective science. He concluded with the belief that if “understanding and skill were applied to the future construction of houses and cities in Southern Italy, few if any human lives need ever again be lost in earthquakes, which must recur, in their ‘times and seasons’”. Unhappily, reconstruction, as is so often the case, largely reproduced the form of building that proved so vulnerable in 1857, and when the Irpinia earthquake struck very much the same region in 1980, the patterns of damage were remarkably similar to those Mallet observed in 1857. This can be seen in Figs. 1 and 2, which show the same view of the centre of the village of Polla, first after the 1857 earthquake (from the Frontispiece of Mallet’s book), and then again in 1981, a few months after the Irpinia earthquake, during the author’s visit there. The similarity of building form and building damage is very striking.

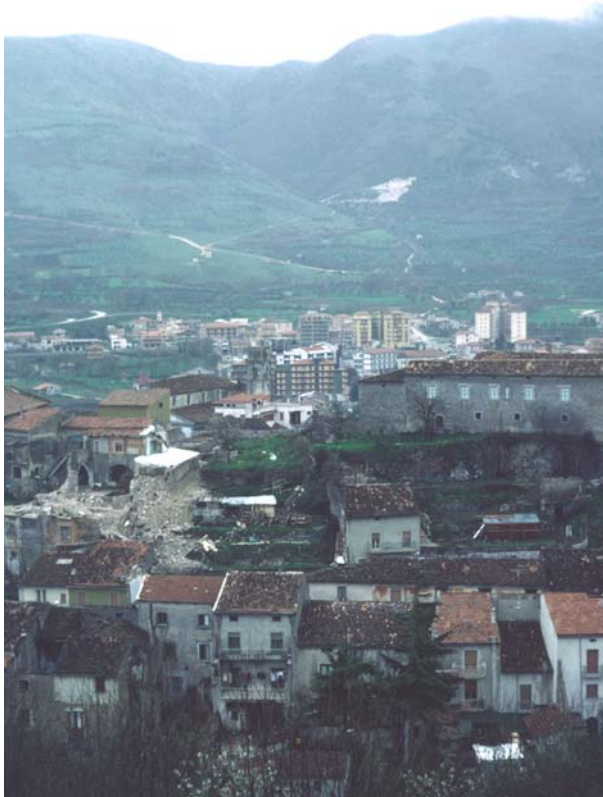
Fig. 2 Polla from the same location as Fig. 1 in 1981 after the Irpinia earthquake. Note similarity of building form and construction (photo by author)

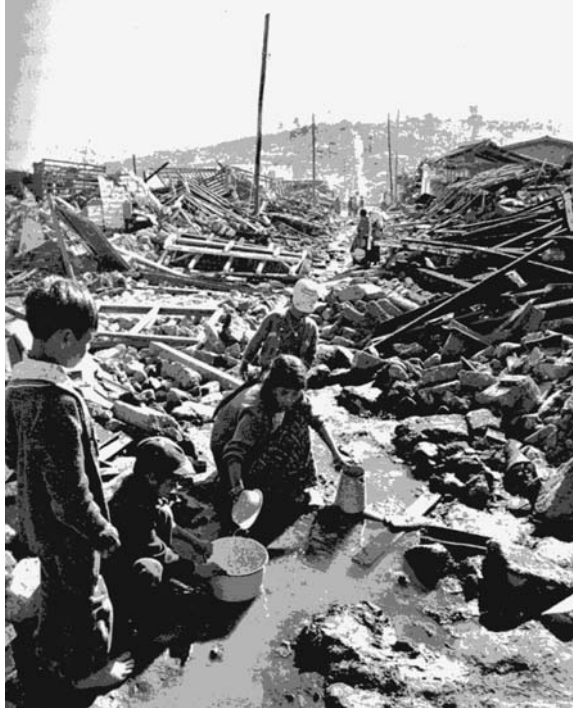
Fig. 12 Failure of adobe houses in the 1976 Guatemala earthquake (source: Cuny 1983)

In the rural areas and small towns most affected by the intense ground shaking, in the Motagua River Valley, houses were generally single-storey, made with walls of adobe (sun-dried earth) blocks, and clay tiled roofs supported by timber rafters (Fig. 12). The walls had very little resistance to ground shaking, and failed, causing the heavy roofs to fall on the sleeping occupants. Although there are no casualty studies available, it can be assumed that most of those who died were crushed under falling masonry and roofs, with some succumbing to asphyxiation. According to Bolt the most common injuries among the survivors were “broken backs and smashed pelvises”.

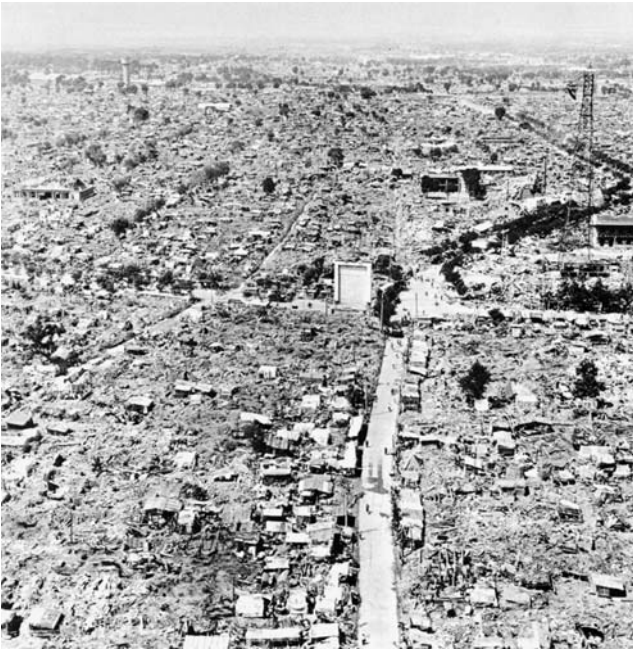
Fig. 15 Aerial view of the totally devastated central part of Tangshan (source: [China Academy of Building Research 1986](#))

The official death toll from the earthquake was 242,000 (149,000 in Tangshan City itself), with a further 164,000 seriously injured, 3,800 disabled and 360,000 with other injuries. It has often been reported (USGS 2006; Housner and Duxin 2002) that the unofficial death toll was in fact much higher, even as high as 650,000. No detailed report on the casualties is available, but the recent RMS report (Grossi et al.) suggests that there are three primary reasons for the extraordinarily high death toll:

- First, the lack of earthquake-resistant design already noted, coupled with general construction deficiencies such as heavy roofs and lack of shear walls, causing many buildings to collapse, but also a lack of preparedness of the infrastructure.
- Second, the time of the earthquake; it took place at 3.42 a.m. local time, when most people would have been in bed, leading to a very high rate of entrapment (perhaps 80%).
- Third, the very high density of the urban population in the worst-affected areas, with buildings occupying up to 70% of the ground surface, and a population density reaching as high as 15,000 per km²—this would have made rescue virtually impossible, offering little hope for those who survived the initial collapse.

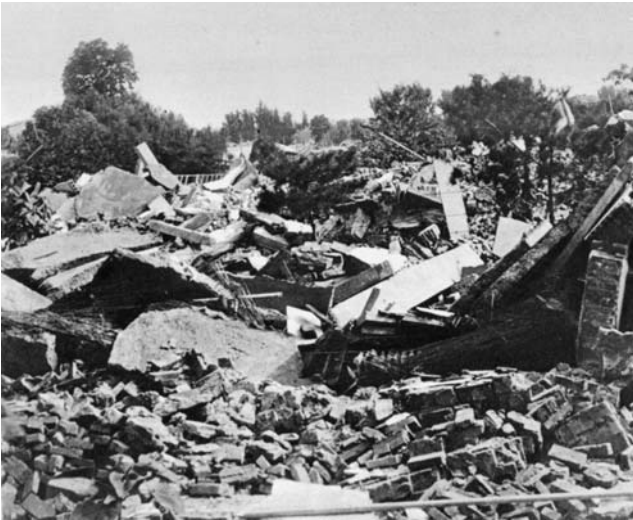
Fig. 16 The huge death toll was mainly due to the total collapse of many brick masonry apartment buildings such as these (source: [China Academy of Building Research 1986](#))

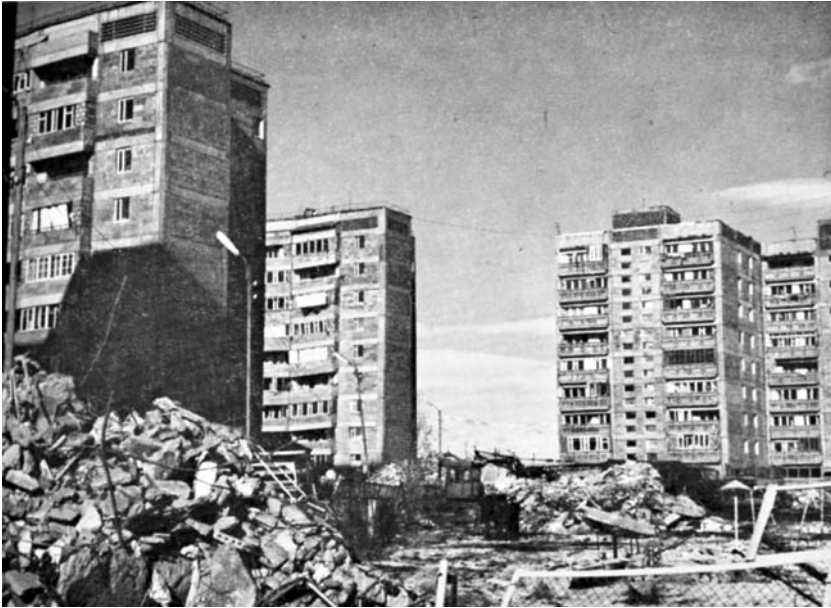
Fig. 19 Spitak earthquake of 7 December 1988. Nine-storey precast concrete frame buildings in Leninakan. The ones standing are severely damaged. Many collapsed completely (source: [Wyllie and Filson 1989](#), Reproduced permission of Earthquake Engineering Research Institute)

87% of the structures collapsed or suffered such heavy damage that they had to be demolished. Even in Leninakan about 30% of the engineered structures suffered heavy damage, and 72 nine-storey precast concrete frame buildings (95% of the total) collapsed (Figs. 19, 20). Many died in these apartment blocks. In contrast, the pre-cast concrete panel buildings performed well, and not one of them collapsed ([Bertero 1989](#)).

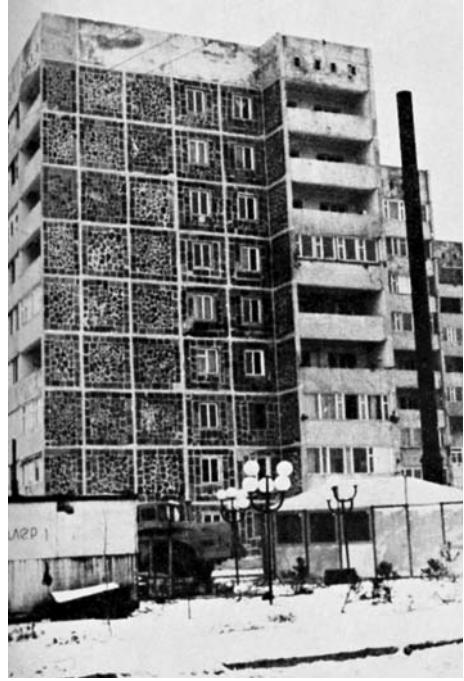
Fig. 20 Large-panel residential building in Leninakan which sustained only minor damage. These buildings generally performed very well, with only minor cracking at panel joints. According to Eisenberg (2006, Personal Communication), not a single building of this type has collapsed in an earthquake (source: [Wyllie and Filson 1989](#), Reproduced by permission of Earthquake Engineering Research Institute)

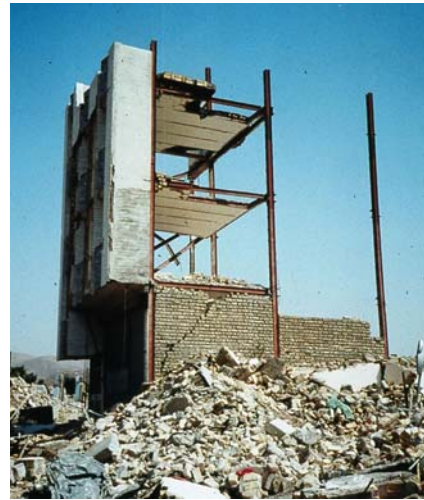
Fig. 23 The Manjil Iran earthquake of 21 June 1990. Failure of infilled steel frame building (source: EEFIT Image Database, Courtesy Earthquake Engineering Field Investigation Team (EEFIT) UK)

ground shaking very few of them were badly damaged in the earthquake (Fig. 22b). Many other forms of construction were found in the area, including multi-storey infilled reinforced concrete frames and infilled light steel frames (Fig. 23). The frames of these buildings tended to survive but their infill walls failed. Landslides and other land instabilities occurred, and added to ground shaking damage in some areas (UNDP 1990).

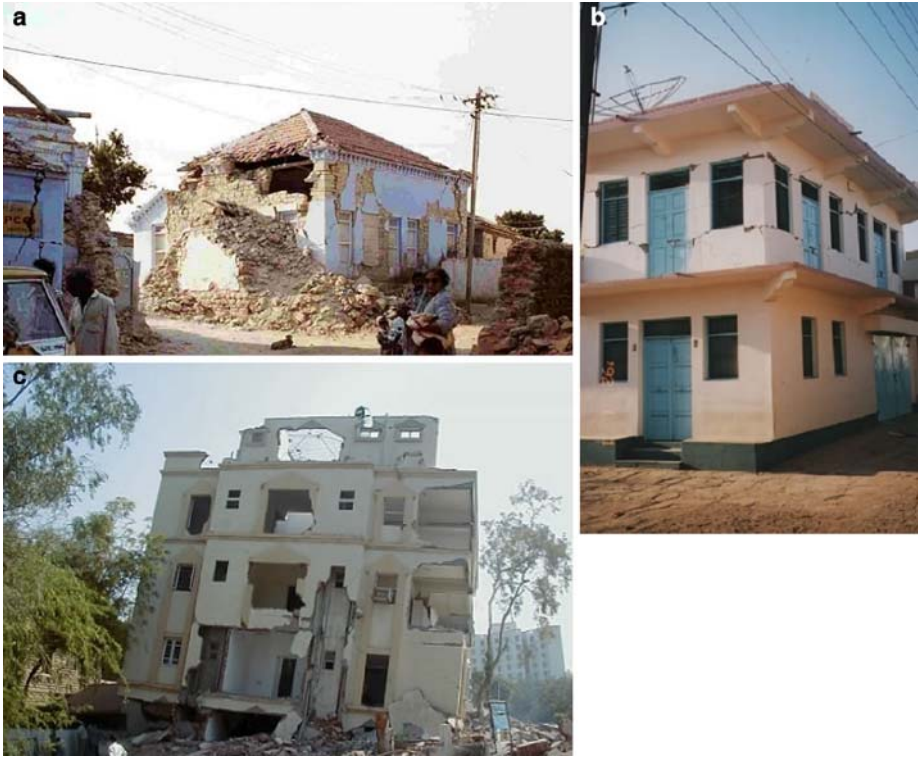
Fig. 29 Masonry and reinforced concrete building types in the Katchchh District (**a, b**) and typical damage patterns. Notice ground floor failure of the reinforced concrete building (**c**) (author's photos)

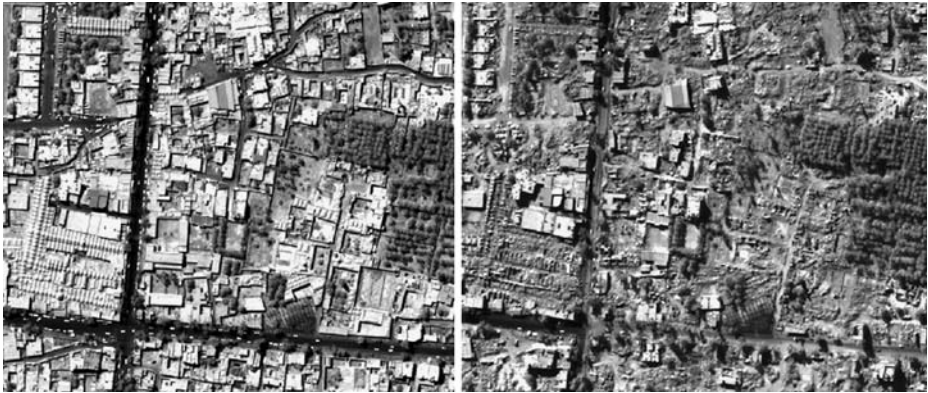
Fig. 31 High-resolution Satellite images of the centre of Bam before and after the earthquake showing the scale of damage (images: Courtesy of Digital Globe)

of $MMI = VIII$. However, a local accelerogram recorded a peak horizontal ground acceleration of $0.8g$, and a peak vertical ground acceleration of $1.0g$ in Bam. This was one of the earliest earthquakes where the extent of the damage was clearly visible in satellite images (Fig. 31).

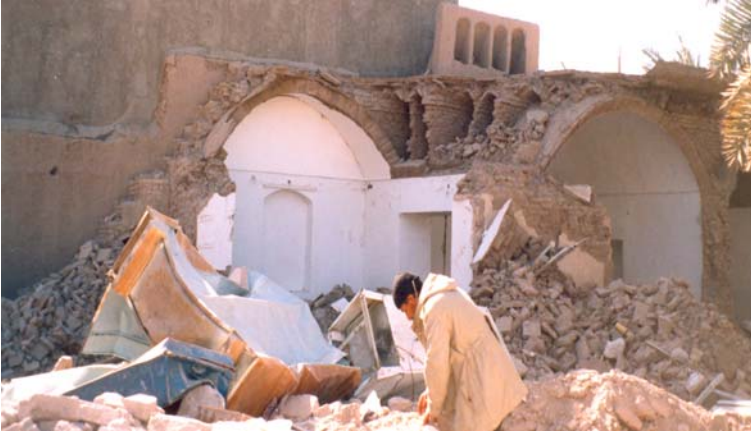
Fig. 32 Bam earthquake: collapse of typical adobe dwelling with vaulted roof (photo courtesy of Jubin Motamed)

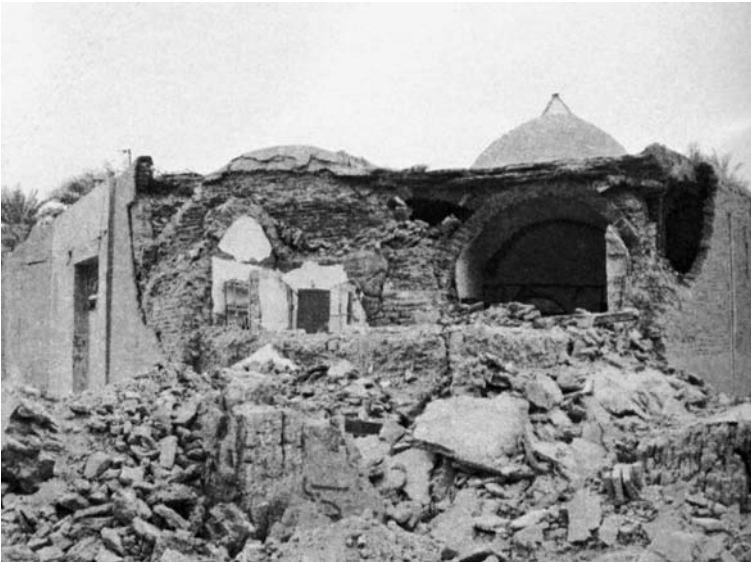
Fig. 33 Failure of adobe structure in Bam earthquake (source: World Housing Encyclopedia, Reproduced by permission of Earthquake Engineering Research Institute)

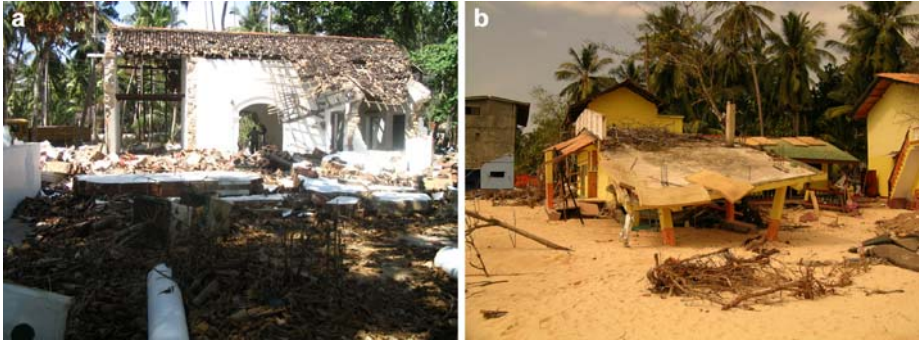
Fig. 37 The 26 December 04 tsunami: typical building damage at Unawatuna, Sri Lanka where the tsunami run-up height was about 5 m in (a) masonry and (b) reinforced concrete structures (Courtesy of the Earthquake Engineering Field Investigation Team EEFIT, UK)

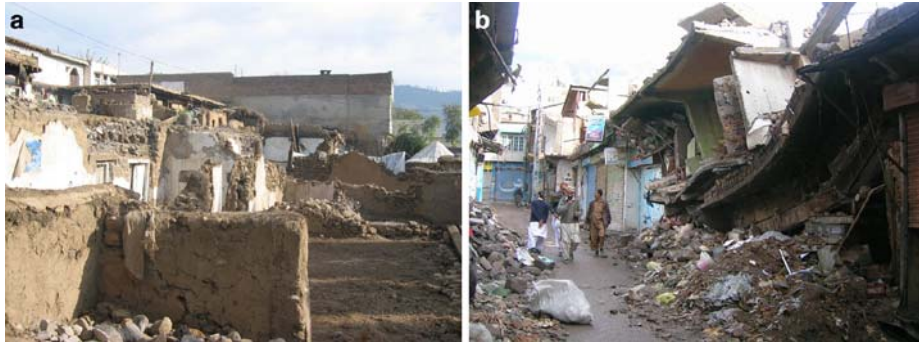
Fig. 39 Traditional masonry construction (a), and damage to reinforced concrete construction (b), Kashmir earthquake (Photos courtesy of Emily So (a) and author (b))

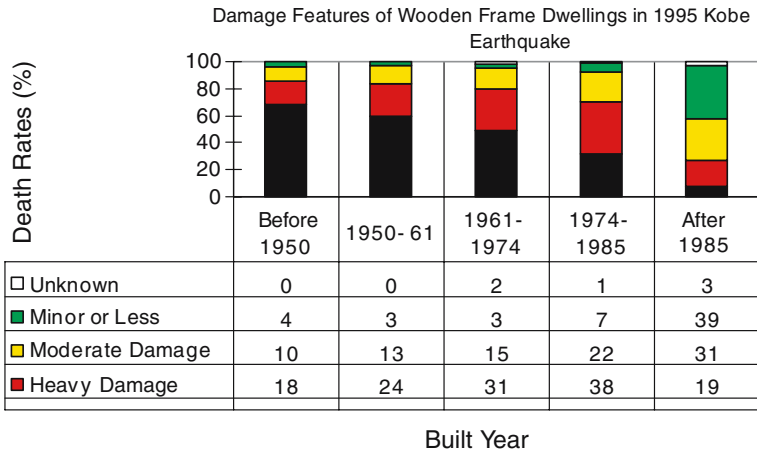
Fig. 42 Comparison of the performance of wooden frame buildings of different ages in the 1995 Kobe earthquake (Source: Y. Ohta, unpublished data)

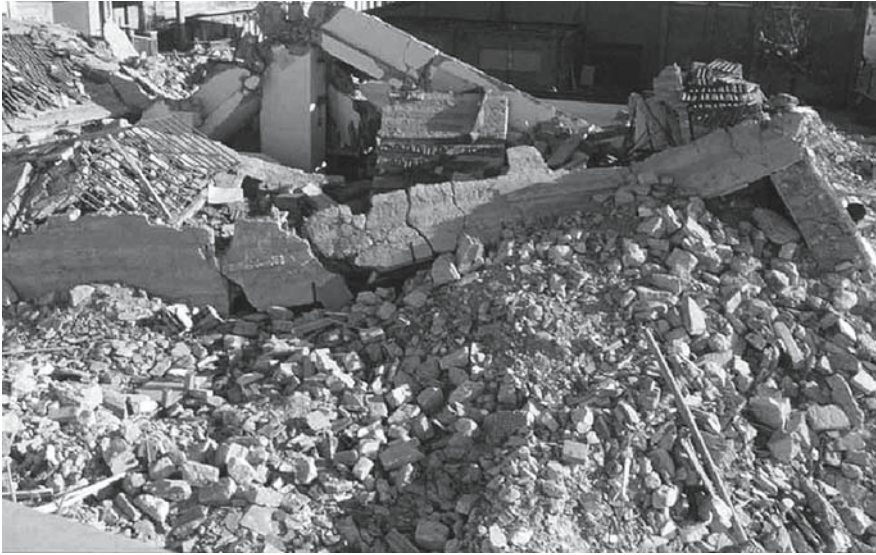
Fig. 43 San Giuliano, October 2002: school collapse which killed 27 children and their teachers (Source: www.oecd.org)

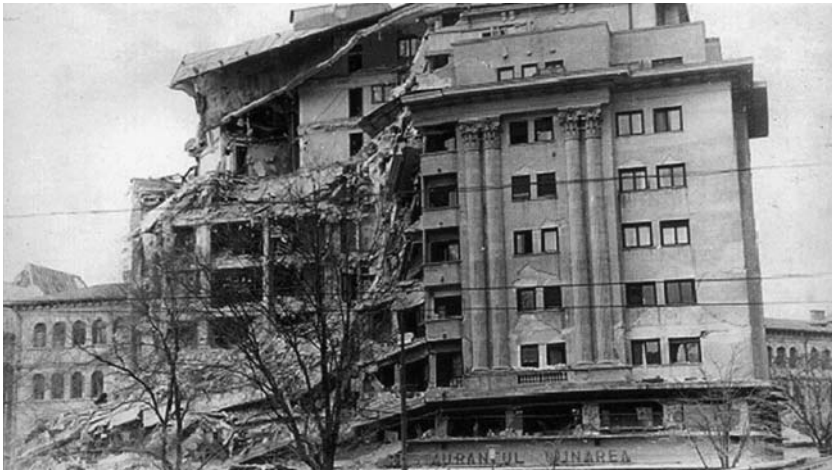
Fig. 44 Bucharest: apartment block damaged by the 1977 earthquake; many such apartment blocks were poorly repaired after the earthquake and upgrading is now in progress (Source: INCERC, Romania)

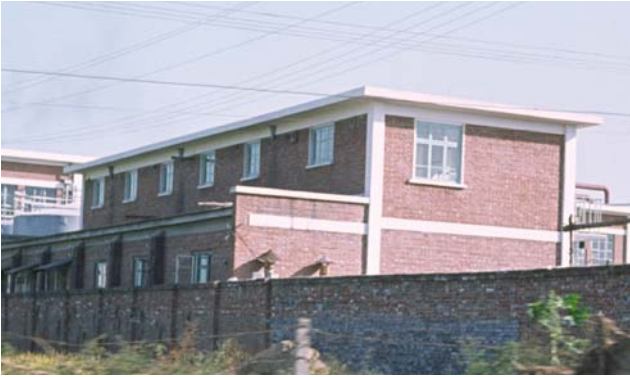
Fig. 45 Student housing in Beijing, 1980, retrofitted with external reinforced concrete frame (Photo by author)

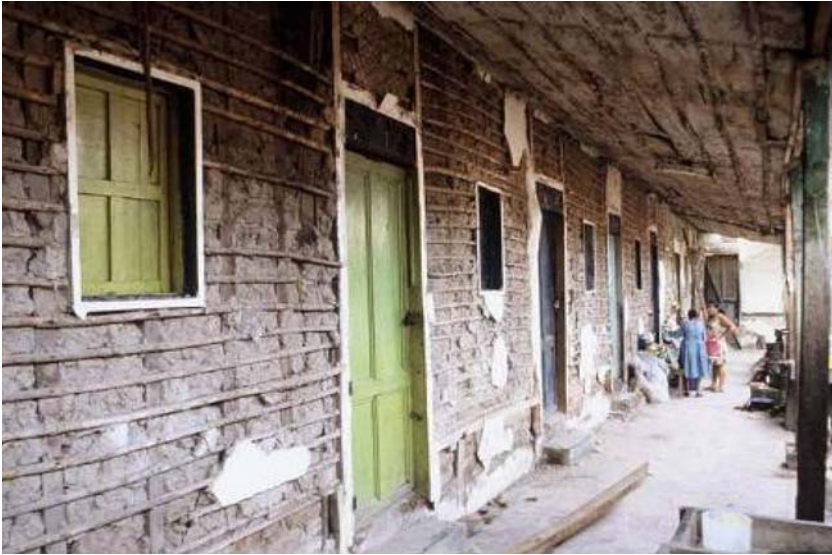
Fig. 46 Bahareque construction in El Salvador, performed relatively well in the 1986 earthquake (Photo courtesy of Randolph Langenbach)

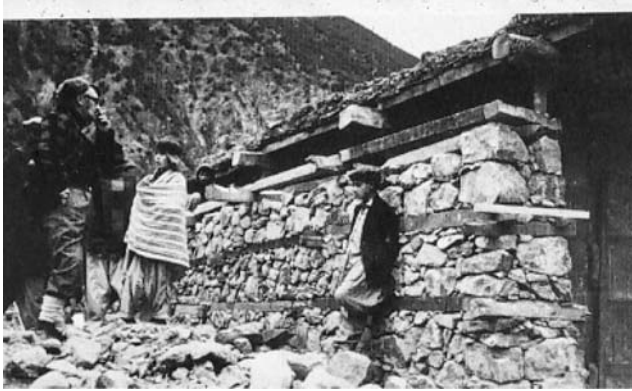
Fig. 50 Traditional dwelling in North West Frontier Province, Pakistan, with timber-laced walls and independently supported roofs. Survivor of the 1974 Pattan earthquake (Source: [Ambraseys et al. 1975](#))

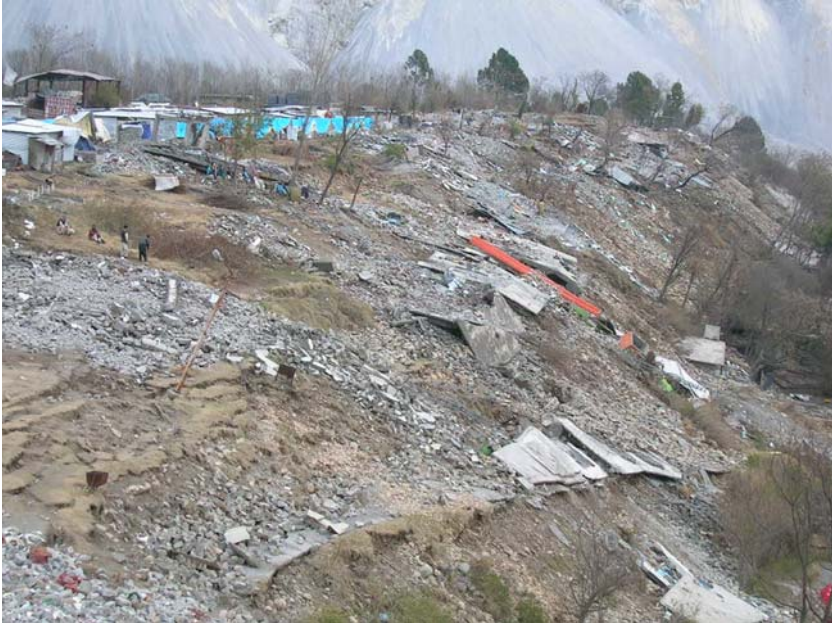
Fig. 51 Kashmir earthquake of 2005. Complete failure of concrete block masonry dwellings, Muzaffarabad (Authors photo)

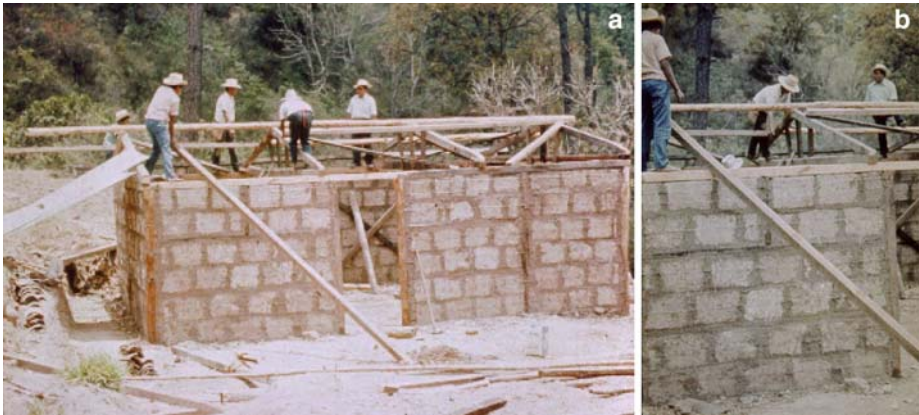
Fig. 59 OXFAM/World Neighbours Rebuilding Programme after the 1976 Guatemala earthquake used a timber frame infilled with locally made concrete blocks (a,b) (Photos from OXFAM Guatemala)

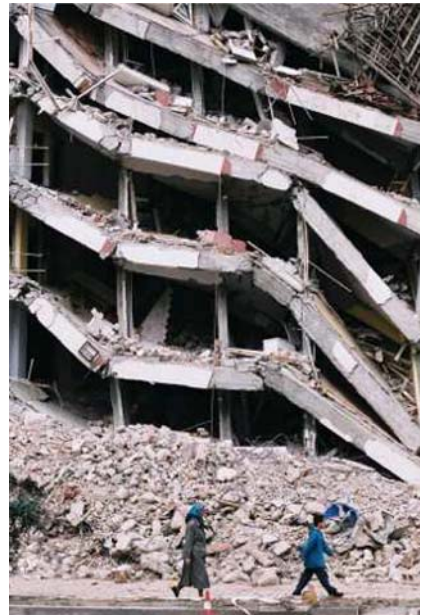
Figs. 60, 61 Collapses of recently constructed reinforced concrete buildings like these in Turkey (1999) (Fig. 60, this page) and India (2001) (Fig. 61, next page) point to a lack of control over the planning design and construction process (Photos: Fig. 60 courtesy of Randolph Langenbach, Fig. 61: author’s photo)

The experience of recent earthquakes, especially those in Turkey and Taiwan (1999) and Gujarat (2001), has demonstrated that even when carefully formulated codes of practice for construction exist, widespread failure of apparently engineered buildings often occurs (Figs. 60, 61). Usually the press and the public attack the builders as the guilty party, with some justification, but in reality the inadequate standard of construction is the result of a more extensive inadequacy of building control involving not just the builders, but government, the building design professions, the property developers and eventual owners, the builders and also the eventual occupants.

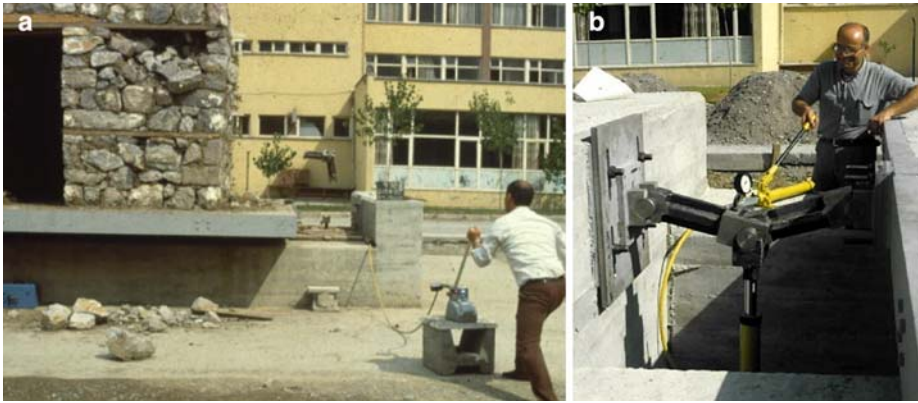
Fig. 63 Low cost impact table designed for full-scale testing of improvements to stone masonry construction (a,b) (Photos by author)
