Assessment and analysis of damage in L'Aquila historic city centre after 6th April 2009

Dina F. D'Ayala · Sara Paganoni

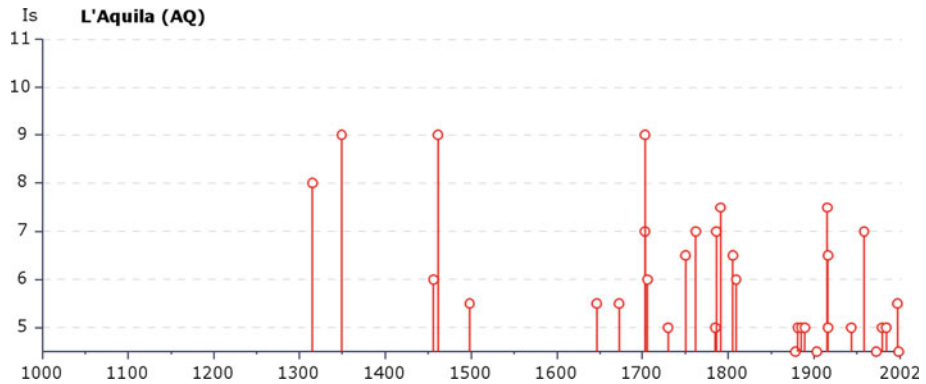
Fig. 1 Historic earthquakes felt in L'Aquila from year 1000 to 2002 (source: INGV Database Macrosismico Italiano-2008, at <http://emidius.mi.ingv.it/DBMI08/>). Is is the Intensity at the site in MCS scale. (Stucchi et al. 2007)

During two on-site visits to L'Aquila and the villages of Paganica and Onna, the authors carried out a detailed post-event survey of the historic centre of L'Aquila focusing on unreinforced masonry (URM) structures. In particular, attention was paid to residential and ordinary buildings, which form the historic fabric of L'Aquila city centre. These have been erected from the thirteenth century onward, with the largest portion being built after the 1703 earthquake, which, together with the 1349 and 1453 events, had a destruction potential comparable to the 2009 event (Fig. 1).

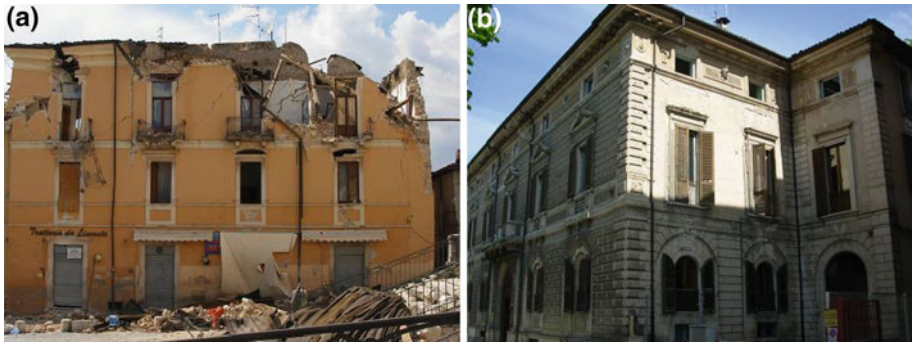
Fig. 2 **a** Apartment building from late nineteenth century and **b** mansion from early 20th century

Within the residential stock two main building typologies can be identified (Fig. 2): common buildings, which nowadays are used as dwellings and small commercial activities, and small to large mansions, which have either residential or administrative functions. Although sometimes substantially different in term of dimensions, the quality of materials

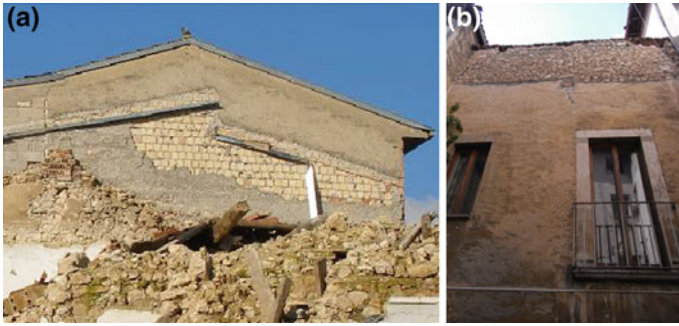
Fig. 3 Example of masonry fabrics with later addition of upper storey and concrete elements

The bearing system is composed by sets of orthogonal walls, the original alignment being frequently compromised as a result of modifications brought to structures throughout the years. Typical alterations to the original structure are the frequent addition of a storey above the original roof level, and the inclusion of mezzanines in those cases where original storey height was more than 4.5 m. The effect of this continuous remodelling of internal spaces, sometimes leading to fusion of two or more buildings into new ones, can also be observed in the masonry fabric: walls, which are from half to a meter thick, feature different quality and typology of units and mortar, in some cases mixed together in the very same wall, sometimes with additions of concrete blocks, steel beams and r.c. slabs replacing original floors (Fig. 3).

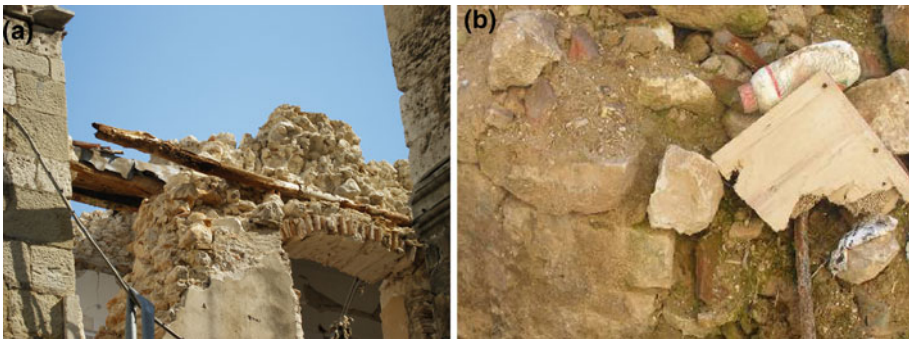
Fig. 4 Typologies of mortar surveyed on site: **a** lime mortar in L'Aquila and **b** mud mortar in Onna

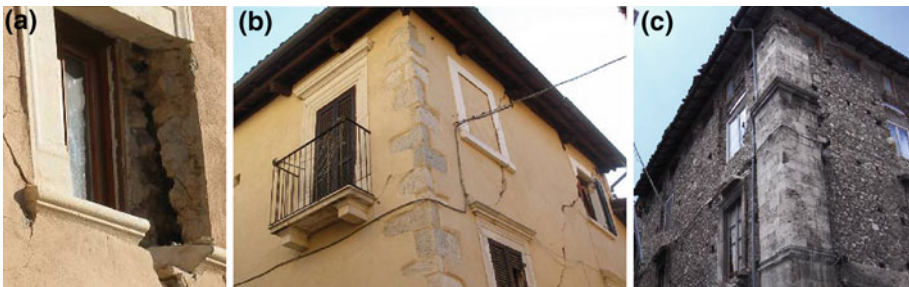
Fig. 5 Examples of **a** 'muratura a sacco' and of **b–c** stone quoins. The photo on the right is of a building of the XIV century in which two storeys have been added under and above the original roof line

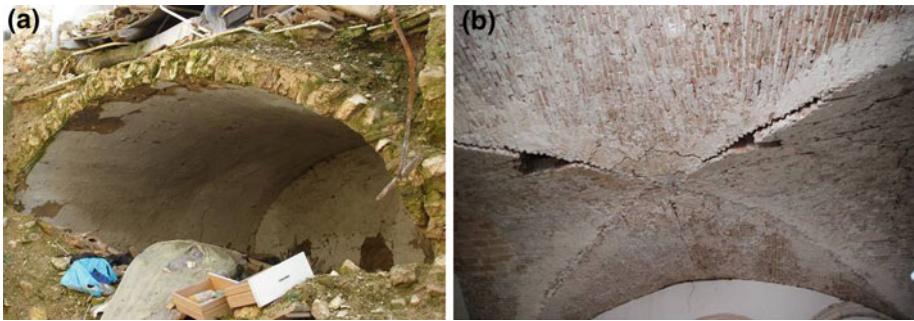
Fig. 6 Typologies of vault: **a** barrel vault built with roughly shaped stone with a thickness of about 0.25 m, and **b** shallow brickwork cross vault, with bricks laid in folio and overall thickness of 0.06 m

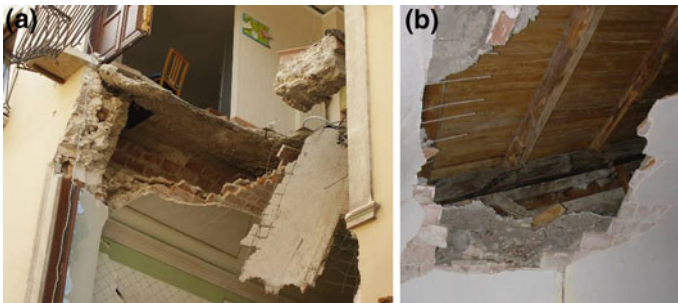
Fig. 7 **a, b** Brickwork in folio vaults introduced after the 1703 earthquake as false ceilings, altered into load bearing elements by the introduction of a wire net reinforced concrete screed in the late twentieth century

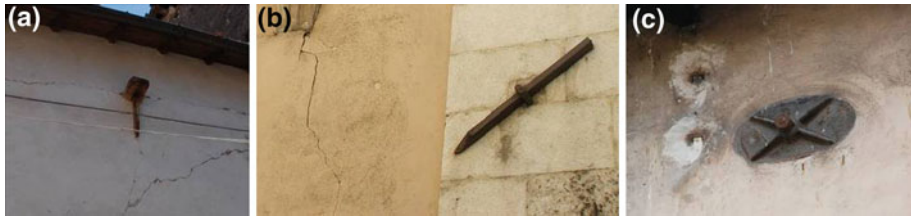
Fig. 8 Traditional reinforcement: **a** timber tie, **b** wrought iron cross tie inserted in a quoin and **c** twentieth century steel tie with end plate

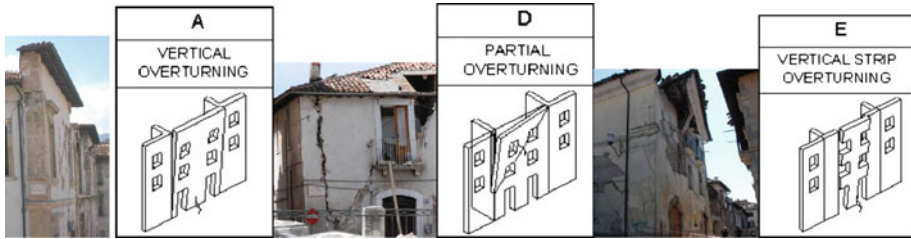
Fig. 9 Out-of-plane mechanisms due to poor connections at corners: damage mechanism A, complete overturning of façade; damage mechanism D, partial overturning along a diagonal, mechanism E, partial overturning of the openings vertical strips

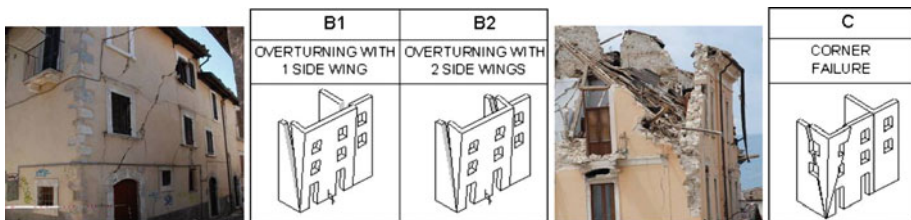
Fig. 10 Effect of good connections at corners: damage mechanism B, overturning with side wing/s (*left*), and damage mechanism C, corner failure (*right*)

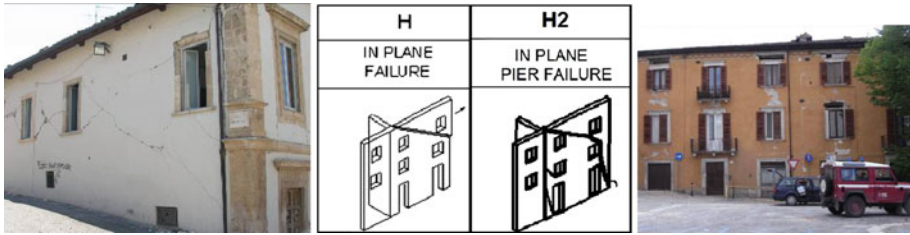
Fig. 11 In-plane damage mechanism in pier, H (left), and combined in piers and spandrels, H2 (right)

When out-of-plane mechanisms of the types described above are prevented by efficient connections among orthogonal walls then in-plane mechanisms, mainly activating the shear capacity of the masonry, are likely to develop. Differently from what usually considered in modern unreinforced masonry, the occurrence of regular diagonal X shaped cracks in the spandrels or in the piers is not the most common case. This is due to various issues: firstly, the irregular distribution and size of opening leads to uneven distribution of stiffness and shear capacity among the piers so that some might be more vulnerable than others; secondly, even when the opening layout is orderly and regular, if the floor structures are not rigid in their plane, as it is the case with timber floors and vaults, the redistribution among piers of the lateral actions will depend on their connections with internal walls and position of the timber beams or groin of the vault.

Furthermore the piers might be failing in a combination of bending and shear, rather than just shear (Casapulla and D’Ayala 2006). For these reasons mechanisms H and H2 depicted in Fig. 11 are calculated by identifying the weakest load path in the façade leading to shear failure, rather than simply using lateral capacity of the piers and assuming a rigid behaviour of the spandrel. Cross-ties, which originally might have been introduced to counteract the thrust generated by vaults, also help to protect the façades from out-of-plane damage in a large number of cases. When the façade is prevented from moving out at the roof level and along the edges, it might behave like a constrained plate, with out-of-plane movement at a lower level. When the mechanism fully develops is identifiable by the bowing out of the walls (Fig. 12). However for the constraints to be effective the ties should be regularly spaced over the façade and correctly anchored and connected through to the orthogonal walls or to the floor structure. When this is not the case, and the unrestrained length of the façade is considerable in respect to its thickness, then mechanism type G is likely to occur.

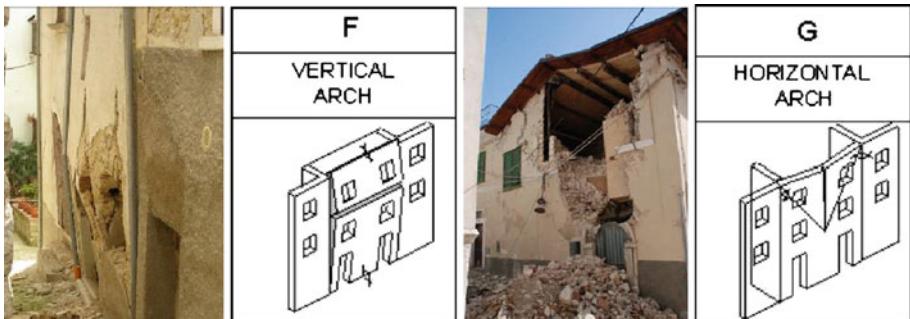
Fig. 12 Damage mechanism F—vertical arch (left) and damage mechanism G—horizontal arch (right)

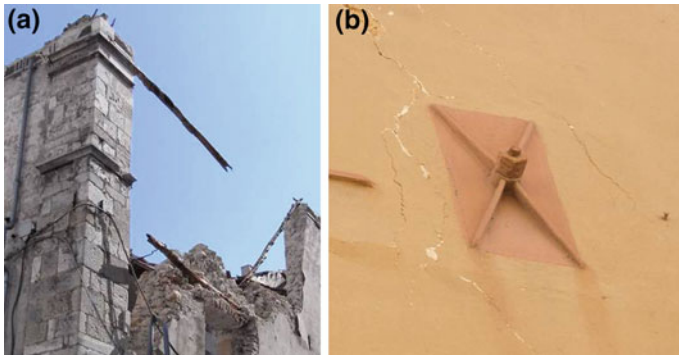
Fig. 13 Examples of failed steel cross-ties: **a** material failure by tension of a timber tie; **b** punching shear failure of the anchor plate through the masonry wall

Examples of poor performance of ties were observed, related to either material deterioration of the anchor (Fig. 13a), mainly in the case of timber, or lack of sufficient integrity and shear capacity in the masonry to withstand the thrust generated at the anchoring plate by the relative movement of the two orthogonal walls (Fig. 13b).

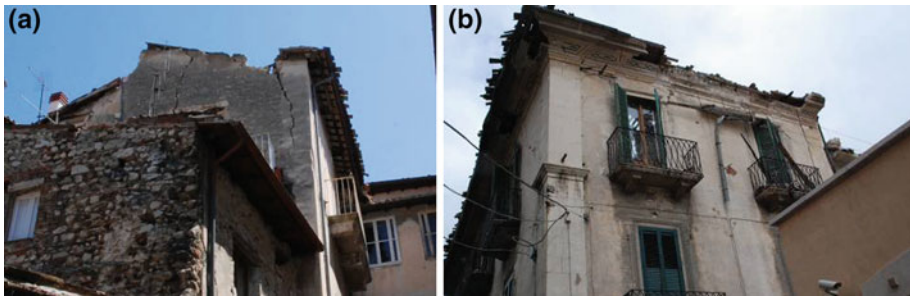
Fig. 14 Collapse of roof structures

The quality of masonry was also a contributing factor for other associated failures observed: indeed the partial or total collapse of floors and roofs recurred frequently, due to the high deformations occurring in the walls, enhanced by the thrusting action of the horizontal structures themselves, which caused the bearings to slip out of their positions (Fig. 14).

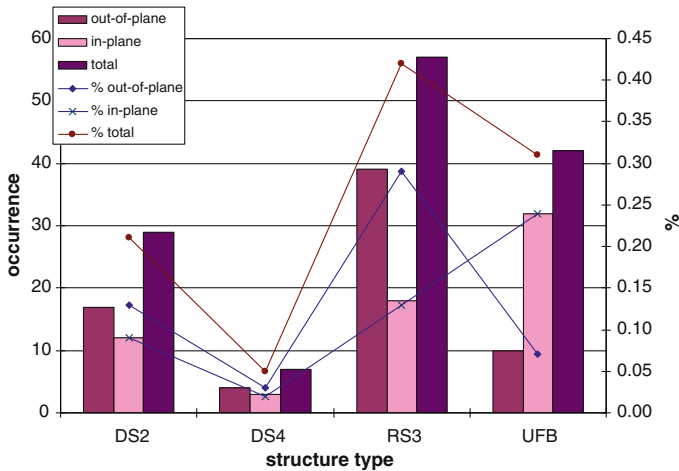
Fig. 16 Distribution of structures types (RS3, DS2, DS4, UFB) and associated in-plane and out-of plane failure mode by façades, within the sample of 90 buildings surveyed with the FaMIVE procedure. For each building typically one or two façades are analysed, depending on access

The chart in Fig. 16 shows the number of façades elevations in each structure type, subdivided into in-plane or out-of-plane failure, on the basis of the analysis’ results. The majority of buildings are either made of poorly dressed stone (RS3, 42% of the sample) or dressed stone with either timber floors (DS2, 21%) or steel joist and tiles (DS4, 5%). A third of the building stock surveyed, of more recent construction, is made of brickwork with timber floors or concrete slabs (UFB, 31%). According to the assessment, the majority of the stone masonry buildings fail in an out-of-plane mechanism, while the brickwork buildings have a majority of in-plane failures. As stated in the general description of damage in Sect. 2, the occurrence of out-of-plane failure is hindered or prevented by presence of quoins or ties, if these are well distributed.

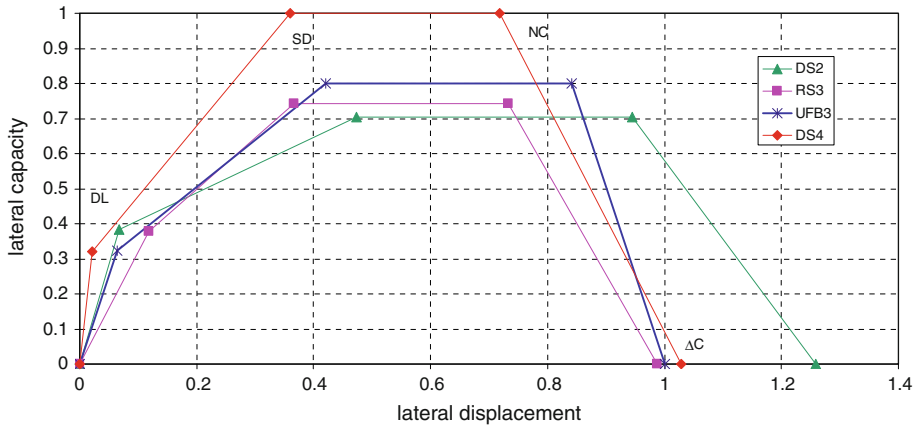
Fig. 17 Normalised and linearised average capacity curves for each of the structure types in L'Aquila city centre

The 3 points identified can be associated to corresponding state of damage as proposed in Fig. 17 where the linearised and normalised curves for each structure type groups are presented. For each curve, DL, *damage limitation*, corresponds to the elastic lateral capacity (D_y, A_y), SD, *significant damage*, corresponds to the peak capacity (D_{sd}, A_u) and NC, *near collapse*, corresponds to incipient or partial collapse (D_u, A_u).

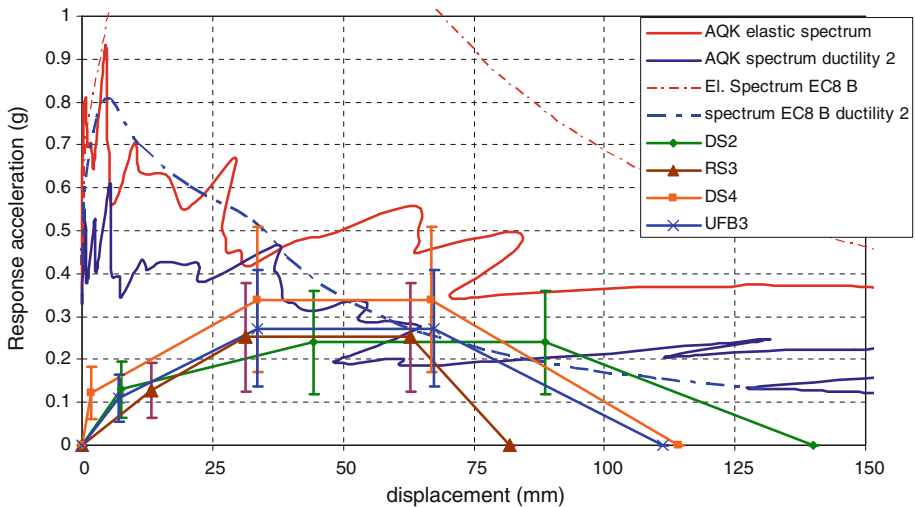
In Fig. 18 the average capacity curves are compared with the EC8 (ENV 2005, Eurocode 8) displacement response spectra (ADRS) having assumed a soil type B and the ADRS obtained from the strong ground motion record closer to the city, AQK (download of the corrected time histories from <http://itaca.mi.ingv.it/ItacaNet/>, last accessed 20/04/2010). For both cases, besides the linear spectra also the non linear spectra obtained for a ductility $\mu = 2$ are shown in Fig. 18, this being the level of ductility calculated from the capacity curves. It should be noted that when compared with the non linear EC8 spectrum the performance point for UFB3, DS2 and DS4 falls in the range between SD and NC, while for RS3 the curve falls short of it (Figs. 18, 20).

Fig. 18 Comparison of capacity curves for each structure type, including uncertainty range, with the EC8 linear response spectrum for soil type B; the nonlinear response spectra obtained from this by using a ductility $\mu = 2$; the response displacement elastic spectrum for record AQK longitudinal component; the corresponding non linear spectra obtained for the same value of ductility. The non linear spectra have been derived using Seismosoft ©

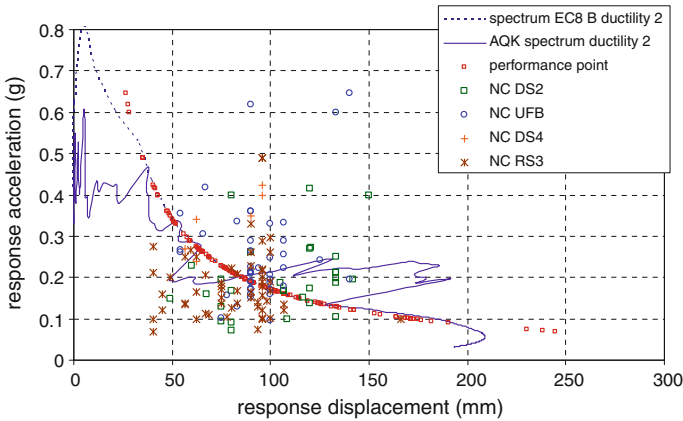
Fig. 20 Correlation between near collapse (NC) point and performance point for the EC8 B response spectrum ($\mu = 2$) for each building by structure type

near collapse point for the acceleration-displacement EC8 response spectrum with ductility $\mu = 2$. These are depicted in Fig. 20 for each building with reference to the structure type. It can be seen that while most of the UFB and DS4 representative *NC* points are to the right of the target performance point, for rubble buildings these mostly lie on the left, predicting collapse. As the number of collapses observed is definitely smaller than that computed the data is further analysed to quantify the error, as shown in Table 3.

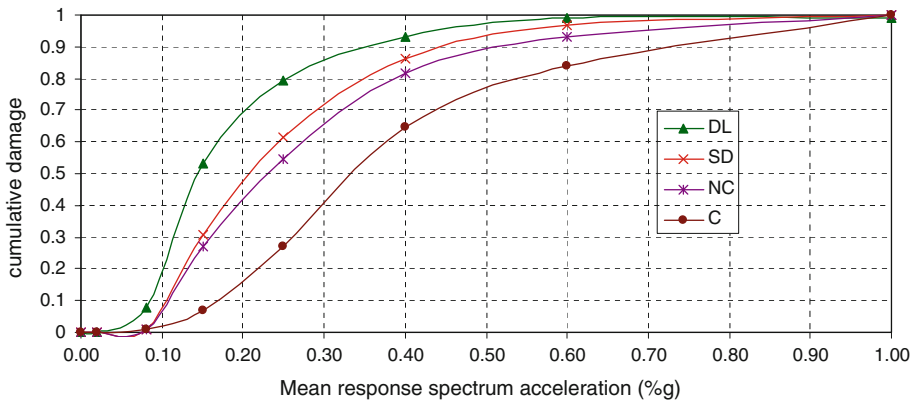
Fig. 21 Fragility curves based on lateral strength capacity for the whole sample

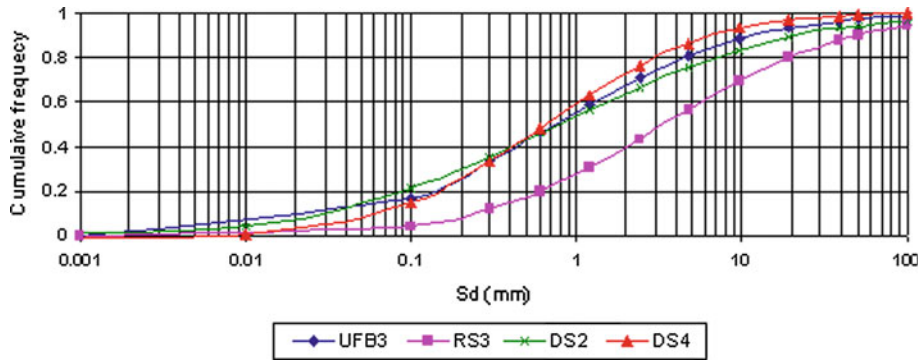
Fig. 22 Fragility curves based on displacement at damage limitation

In order to calculate the fragility functions in terms of displacement, D_y is used to calculate the fragility functions corresponding to damage limitation DL, Δ_u is used for significant damage SD and Δ_c is used for collapse. The curves obtained are shown in Figs. 22, 23, 24 for each structure type.

It can be seen that the greater standard deviation and ductility of the structure type DS2 clearly results in a less steep fragility curve especially at collapse. The poor performance of rubble masonry is also clearly highlighted at collapse. However for the limit state of structural damage the difference between RS3, DS4 and UFB3, is modest.

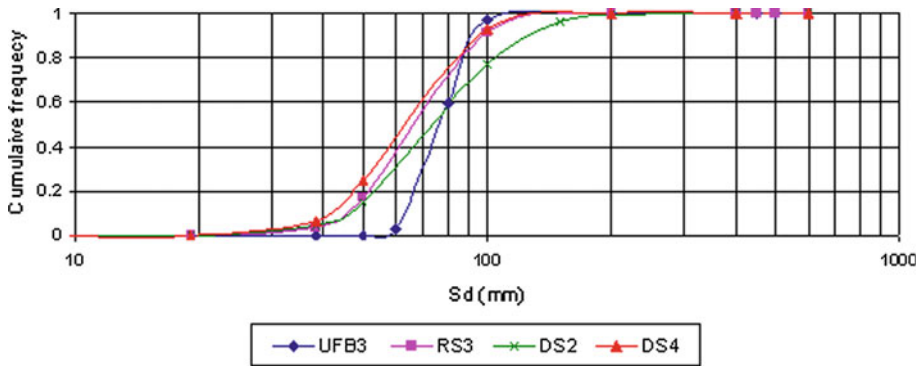
Fig. 23 Fragility curves based on displacement at structural damage

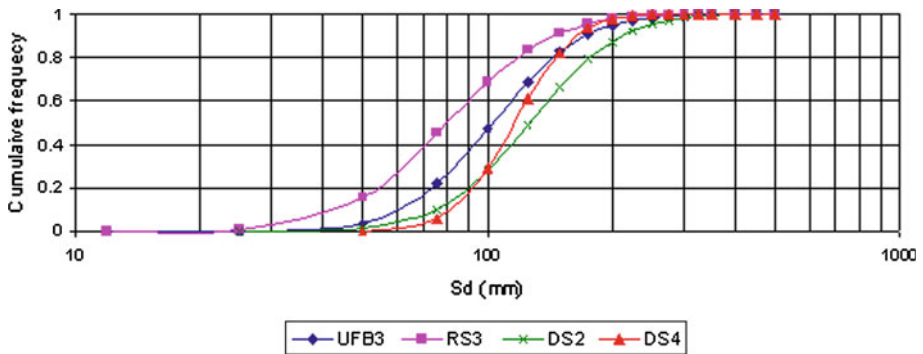
Fig. 24 Fragility curves based on displacement at collapse
