Seismic behavior of three-leaf stone masonry buildings before and after interventions: Shaking table tests on a two-storey masonry model

Abstract The aim of this work is to reach a better understanding of the seismic behaviour of historic three-leaf stone masonry buildings with timber floors, before and after interventions. For this purpose, shaking table tests were performed on a building model (scale 1:2). Initially, the dynamic characteristics of the model were identified. Subsequently, biaxial earthquake tests were performed with the base acceleration increased step-wise until the occurrence of repairable damages. Afterwards, the masonry was strengthened by means of grouting and the diaphragm action of the floors was enhanced. Then, the strengthened model was re-tested. The comparison of the performance of the model under earthquake actions before and after strengthening shows that the selected intervention techniques significantly improved the seismic behaviour of the structure.

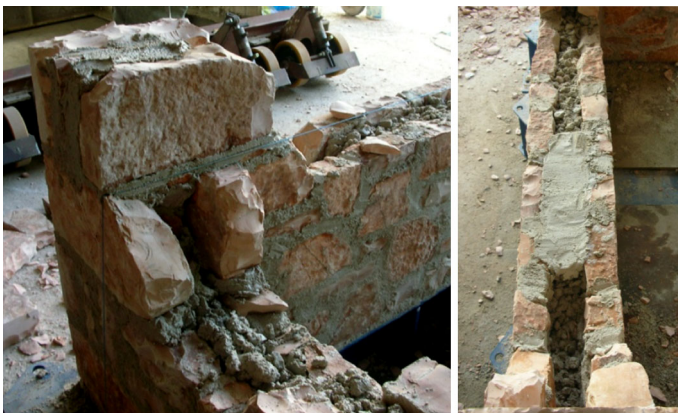
Fig. 2 Construction details of the walls

The walls of PBM were made of three-leaf stone masonry. The three leaves were of approximately equal thickness. At the four corners of the specimen, quoins were placed crosswise throughout the height of the model (see Fig. 2) to provide good connection between longitudinal and transverse walls, as it is the case in real structures. For the construction of the exterior and interior leaves of the walls, limestone units and mortar was used. The mean compressive strength and the density of the limestone are approximately equal to 100 MPa and 2.68 Mg/m^3 respectively. For the mortar, lime putty, pozzolan and an aggregate mix composed of silicate and limestone were used. The mix proportions of the mortar, as well as its main physical and mechanical properties, are given in Table 1. The thickness of both bed and vertical joints was approximately equal to 10 mm. The intermediate part of the walls (see Fig. 2) consists of pieces of stones and mortar in a proportion of 2/1. In order to simulate the characteristics of filling material in real

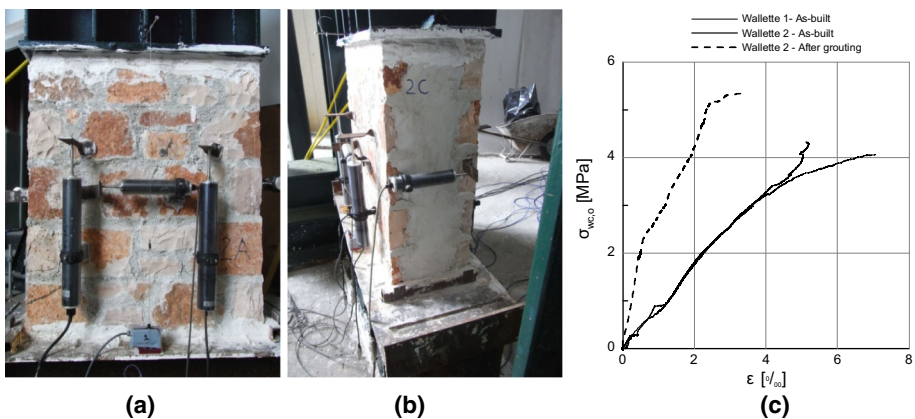
Fig. 3 Wallettes subjected to compression. **a–b** Test setup and instrumentation, **c** compressive stress versus vertical strain curves for wallettes before and after grouting

One specimen was tested up to collapse (Wallette 1). The other wallette was tested until significant damage occurred (Wallette 2). Subsequently, it was grouted with the same hydraulic lime based grout used to the building model. Approximately 6 months after the application of grout, the strengthened wallette was re-tested to failure. In Fig. 3c, the compressive stress versus vertical strain curves are given for Wallette 1 tested as-built and

for Wallette 2 tested as built and after grouting. Table 2 summarizes the mechanical properties of the wallettes before and after grouting. One may observe that both compressive strength and stiffness of masonry were enhanced due to grouting.

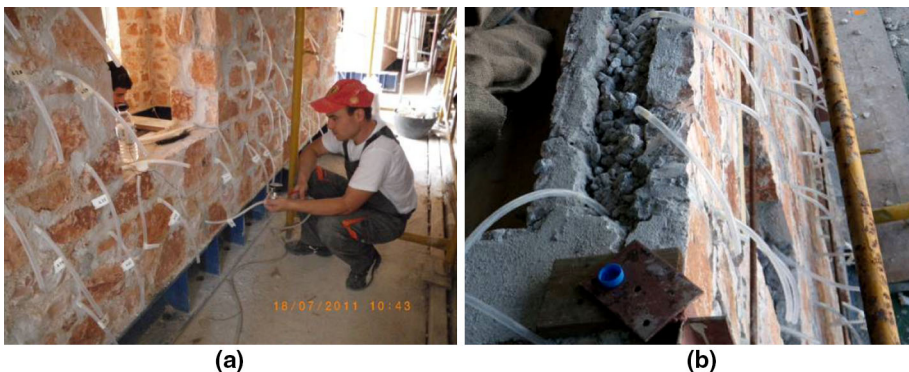
**Fig. 5** a–b Grouting of three-leaf masonry walls

mechanical properties of the grout. The mix to be injected to masonry was prepared using an ultrasound dispersion mixer assisted by a mechanical device of low turbulence. The mix was applied to the masonry following the procedure adopted by the Hellenic Ministry of Culture (Miltiadou-Fezans et al. 2005). Figure 5 shows pictures taken during the application of the grouting technique. In-laboratory and in situ tests (according to Miltiadou and Tassios 2012, 2013a, b) were performed to check and reach the desired properties of the grout in situ. During injection, the consumed quantity of grout was recorded. The total volume of the grout injected in the damaged as-built model was equal to 955 l. This consumption shows that the percentage of voids of the filling material was approximately equal to 32 %. This value is considered to be quite close to the target one (approx. 40 %), as well as to the percentage of voids in real three-leaf masonry.

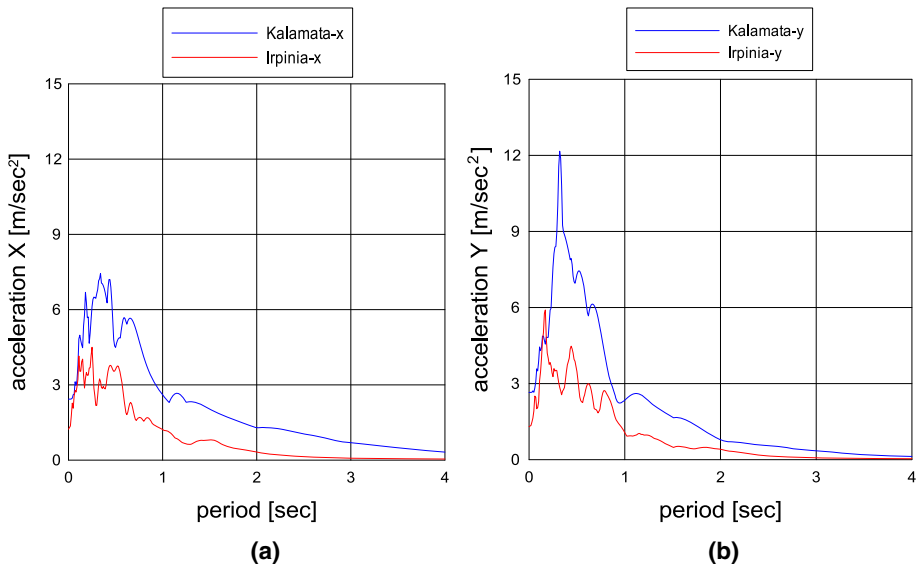
Fig. 11 Kalamata and Irpinia earthquakes. Response spectra for 5 % damping in **a** X direction and **b** Y direction

damages and collapse. Thus, the first part of the Irpinia earthquake signals (November 23, 1980, Calitri record, $M_s = 6.9$, $\max a = 0.13 \text{ g}(X)/0.13 \text{ g}(Y)$) was subsequently imposed to the strengthened model. The time histories of base accelerations for Kalamata and Irpinia signals are given in Fig. 10, whereas Fig. 11 shows the response spectra of the two motions (5 % damping).

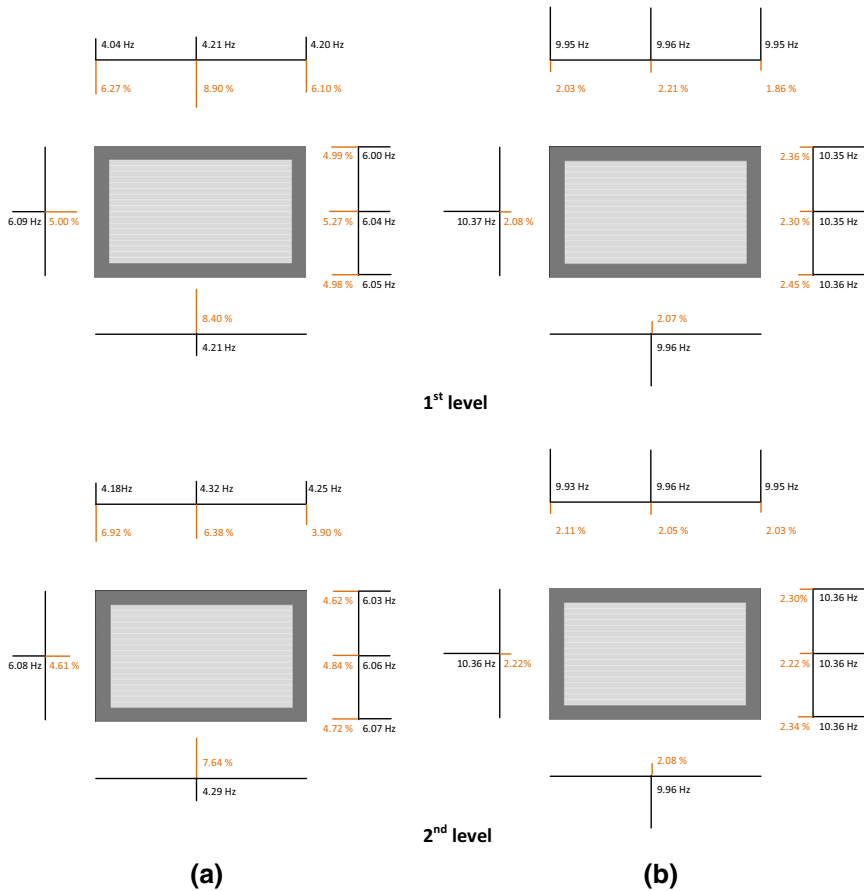
Fig. 12 PBM. Resonance frequencies and damping along X and Y axes. **a** PBM-BS and **b** PBM-AS

the as built model, along both directions. The features discussed in connection with Fig. 12 and Table 6 are also illustrated in Fig. 13, in which the modal shapes (along X and Y directions) of PBM-BS and PBM-AS models are shown.

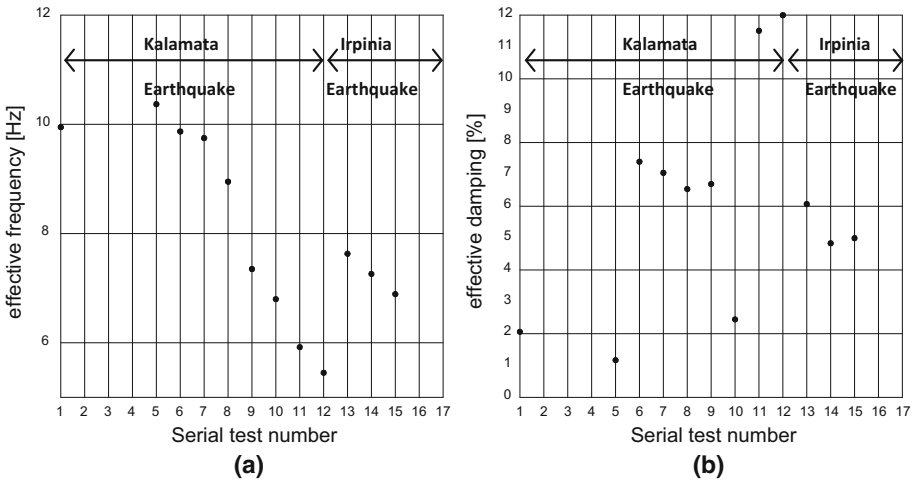
Fig. 15 PBM-AS building. **a** Frequency and **b** damping along Y direction during the sequence of shaking table tests [from Test 2AS (Sine sweep test along Y direction, Table 5) to Test 17AS (Irpinia earthquake: 0.62 g/0.72 g, Table 5)]

Figures 14 and 15 present the variation of the effective frequency and the effective damping of PBM-AS throughout testing (namely, from sine sweep test-1AS to the final test 17AS). By comparing the diagrams along the two directions, one may observe that Kalamata earthquake has affected Y-direction, whereas Irpinia earthquake caused damages in X-direction of the model. Actually, as the imposed base acceleration progressively increased along X direction, the values of frequencies remained constant during Kalamata

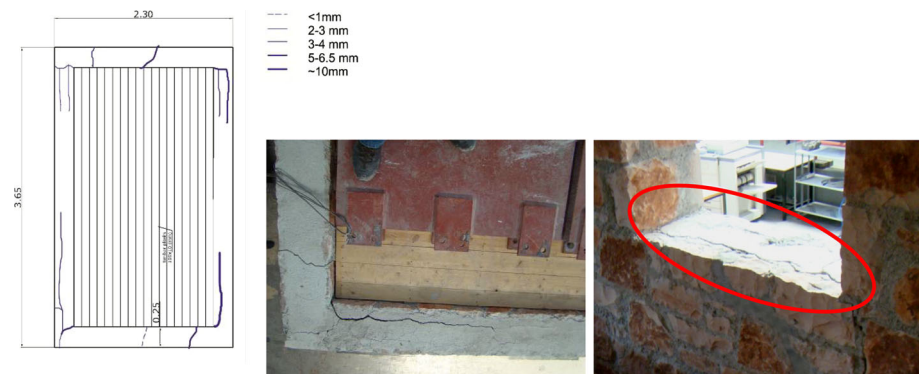
Fig. 18 PBM-As built specimen (BS). Observed damages at the roof level and at the level of openings after Test 8BS (Kalamata earthquake: 0.29 g(X)/0.24 g(Y), Table 4)

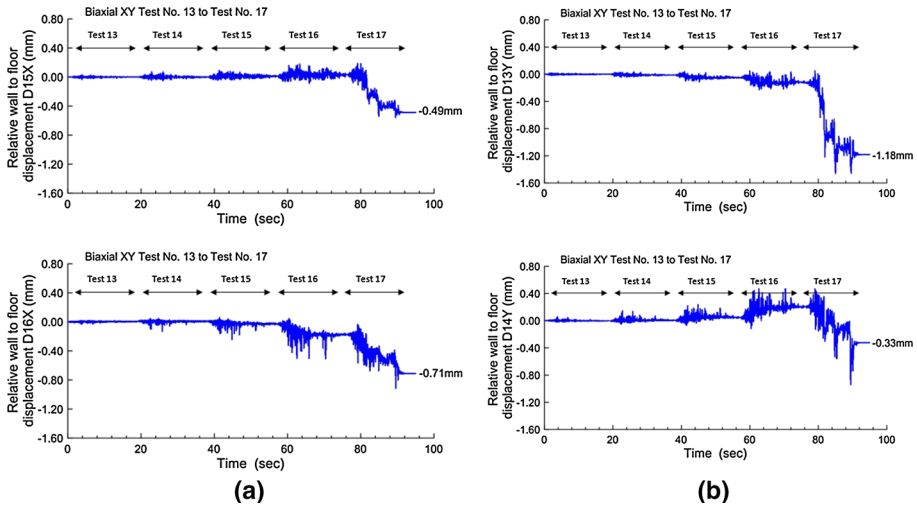
Fig. 24 PBM-AS building. Relative wall to floor displacement along **a** X and **b** Y direction during Tests 13AS (Irpinia earthquake: 0.16 g(X)/0.16 g(Y), Table 5) to Test 17AS (Irpinia earthquake: 0.62 g(X)/0.72 g(Y), Table 5)

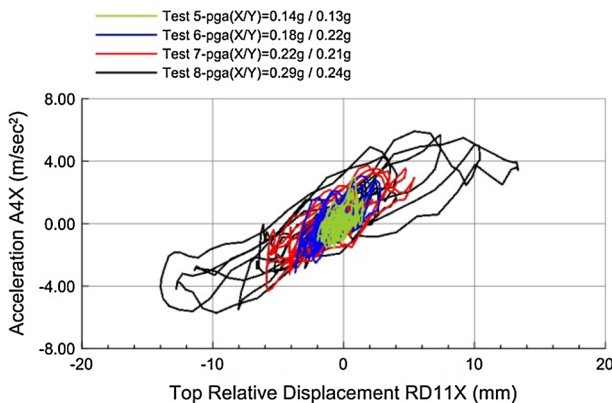
Fig. 25 PBM-As built specimen (BS). Absolute acceleration versus top relative displacement along X direction for Kalamata base motion

Thereby, in Figs. 25 and 26 hysteresis loops are given for longitudinal (X) and transversal (Y) direction respectively [for the Tests 4BS to 8BS (Table 4), i.e. after the occurrence of damage]. One may observe, (a) the significantly smaller stiffness of the system along Y direction, attributed to the out-of-plane behaviour of the long walls, (b) the larger displacements of the model along its weak Y direction and (c) the gradual decrease of the stiffness (along both directions), after the occurrence of damage and under increasing imposed excitations.

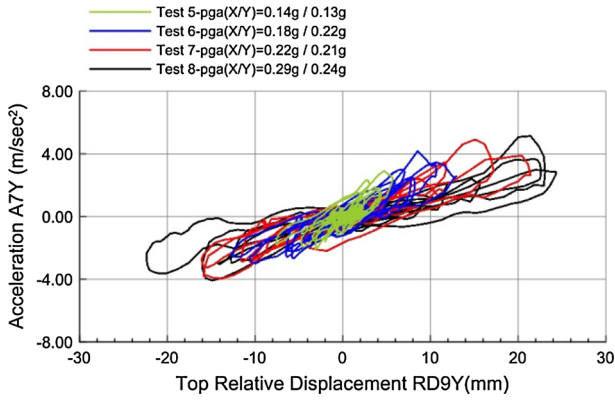
Fig. 26 PBM-As built specimen (BS). Absolute acceleration versus top relative displacement along Y direction for Kalamata base motion

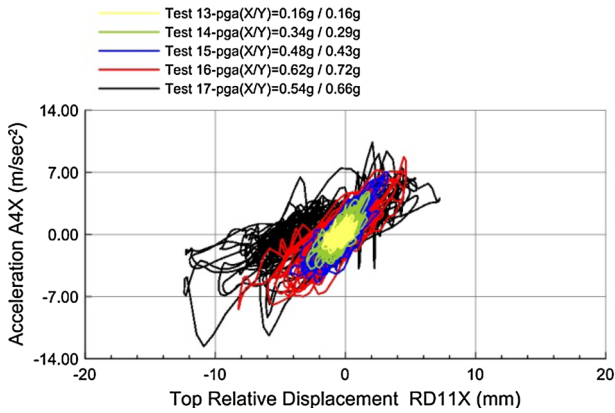
Fig. 27 PBM-Strengthened specimen (AS). Absolute acceleration versus top relative displacement along X direction for Irpinia base motion

Similarly, Figs. 27 and 28 show the hysteresis loops for the strengthened model (for Tests 13AS–17AS, Table 5, i.e. after the occurrence of damages). By comparing the two conditions (before and after strengthening), one may observe that (a) strengthening of the building model has led to significant improvement of its behaviour in terms of maximum sustained acceleration. Furthermore, (b) the stiffness of the strengthened model is significantly higher than that of the as-built model. Thus, the deformations sustained by the
