Seismic performance of three-storey full-scale sub-standard reinforced concrete buildings

Abstract Two three-story full-scale sub-standard reinforced concrete buildings were tested under self-weight and reversed cyclic lateral displacements to examine their behavior during earthquakes. While one of these buildings was a part of an actual existing building (TB1) built in the beginning of 1990's in Istanbul, the other was constructed by the authors as a representative building (TB2) that reflects the most common structural deficiencies of existing building stock in Turkey. Both buildings were constructed with plain bars, low strength concrete and inadequate lateral reinforcement. The differences between these buildings were axial load levels of first story columns, expected location of major structural damages (weak beam–strong column for TB1 and strong beam–weak column for TB2) and connection details of longitudinal bars in columns at the foundation–column interface (continuous for TB1 and lap-spliced with 180° hooks for TB2). Both buildings were pushed and pulled at increasing displacement amplitudes up to near collapse well beyond the life safety performance level. While TB1 was

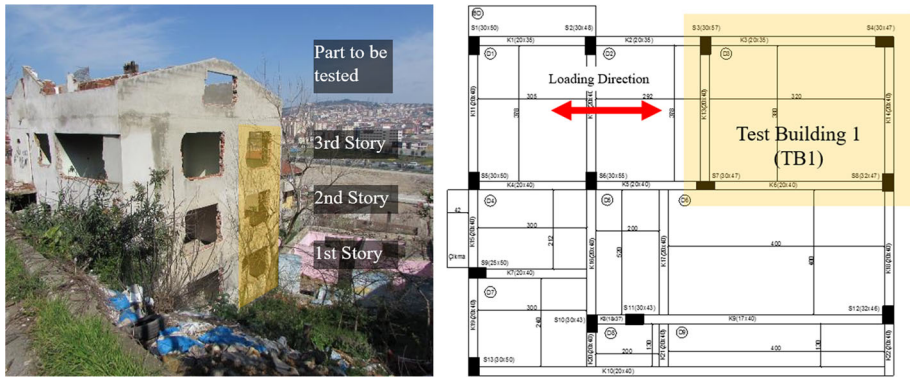
Fig. 1 General view of the test site and plan of the existing building

The experimental phase of the study, which includes reversed cyclic loading tests on two full-scale buildings, was implemented at the Fikirtepe district of Istanbul city. The area is home to hundreds of sub-standard buildings, which lack appropriate engineering design, construction practice, and supervision. Based on the Urban Transformation Law (Law No. 6306 on the Transformation of Areas Under Disaster Risk), that aims to reconstruct or retrofit seismically vulnerable buildings on a mass scale, the area has recently been designated as a high seismic risk area and was abandoned for demolition at the time of testing. Considering a number of factors including the availability of area for construction of the reaction wall and the second test building, availability of the test site during the entire period of the testing project, compatibility of the test building with characteristics of the existing building stock, accessibility to site, access to power and water, and the technical capabilities of the available test equipment; the reinforced concrete building shown in Fig. 1 was selected for execution of the test program. The existing three-story building was standing at the bottom of a steep slope, so that the entrance to the original building was from the third story. In order not to exceed the limitations of the load capacities of the reaction wall, as well as the hydraulic actuators and the load cells used, the existing building was demolished partially so that the remaining part was designated as Test Building 1 (TB1) (as shown in Fig. 1), and the site was arranged for construction of the reaction wall and Test Building 2 (TB2), as shown in Fig. 2a. After partial demolishing of

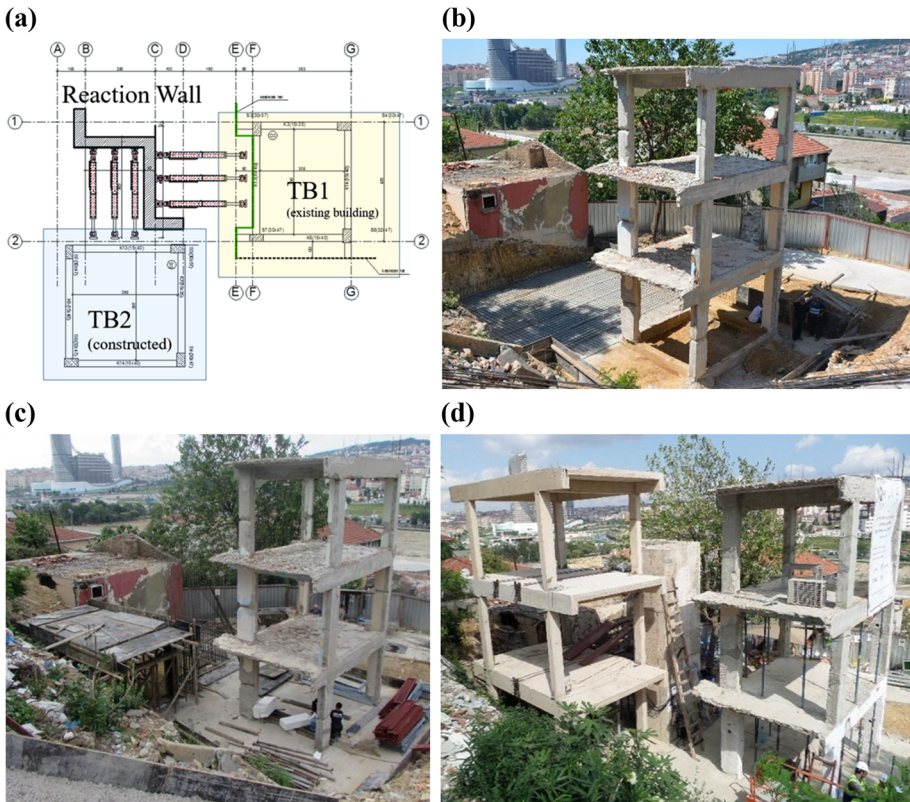
Fig. 2 a Layout of the test site and b–d stages of site preparation

the existing building, the test site was leveled and lean concrete was poured, which was followed by construction of a 0.6 m thick mat foundation (Fig. 2b). The mat foundation not only supported the reaction wall and TB2, but also TB1, which only had unreinforced footings with approximately 0.15 m thickness underneath the columns. In the next step,

construction of the 0.5 m thick reaction wall took place, which was followed by construction of the second test building (Fig. 2c, d). The 7.0 m high reaction wall had an oblique W-shaped cross-section in plan, so that it provided the sufficient stiffness and lateral load capacity for the two buildings to be tested consecutively, only by repositioning of the hydraulic actuators (Fig. 2a).

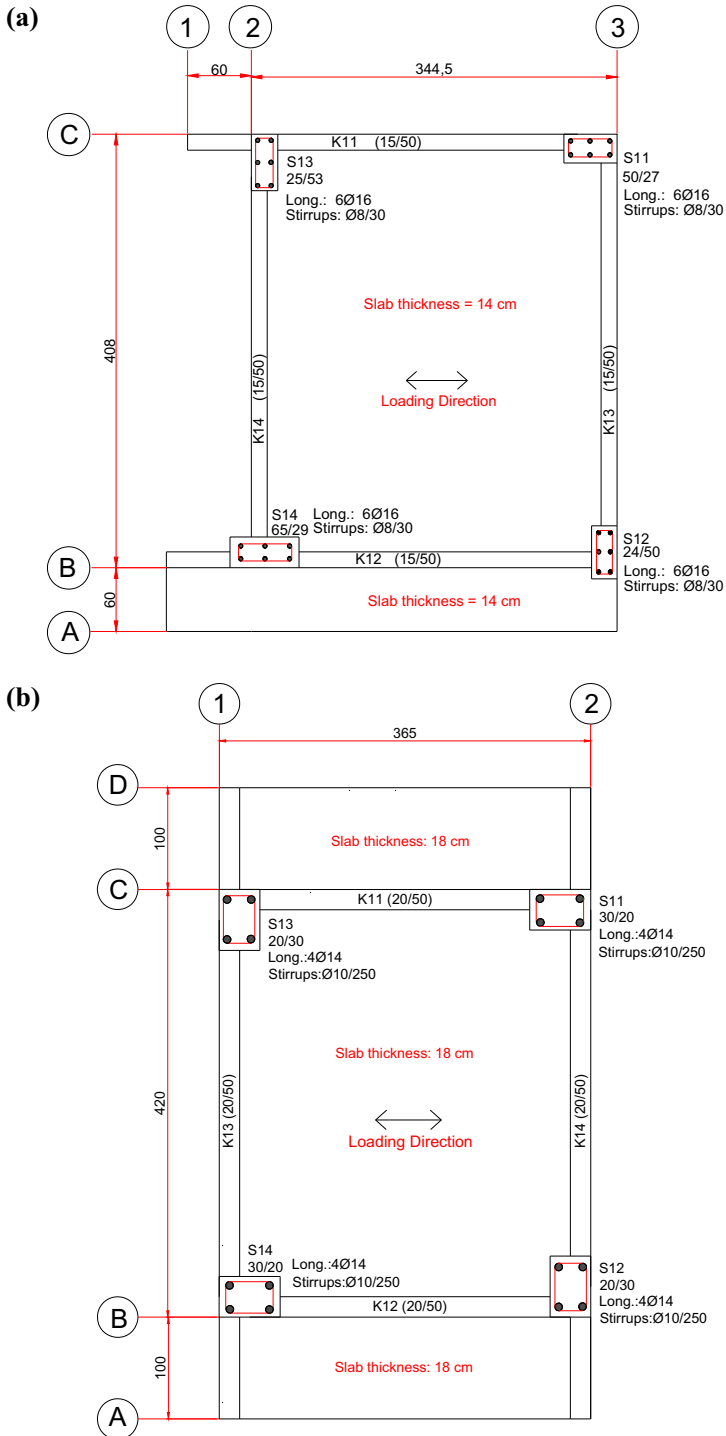
Fig. 3 Plan and reinforcement layouts of **a** TB1 and **b** TB2 at 1st story

During the experimental phase of the study, the two full-scale buildings with reinforced concrete moment resisting frames were tested under reversed cyclic lateral loads. Both three-story buildings incorporated bare frames without infill walls, and had one span in each orthogonal x and y directions. Typical plan views of Test Building 1 (TB1), which was extracted from the existing building, and Test Building 2 (TB2), which was designed and constructed by the authors, can be seen in Fig. 3.

TB1, which was constructed during the first half of 1990s, had 2.7 m story height on all three stories. The plan dimensions measured from exterior surfaces of the beams were approximately 3.5 m by 4.1 m. The beams in x-direction of the building extended for an additional length of 0.6 m from the column surfaces in order to supply adequate anchorage length on the beam longitudinal bars, since the adjacent bay of the building was demolished. Non-structural elements such as hollow clay brick infill walls and plaster covering on beam and column surfaces were removed for preventing potential interference with the structural system. Before and after the partial demolition phase, the building was surveyed for measuring of dimensions and investigation of material characteristics and reinforcement layout. Concrete cores (100 mm × 200 mm cylindrical cores) were sampled from each story and were tested under uniaxial compression, which indicated an average concrete compressive strength of 17 MPa. The general workmanship quality was low, so that the alignment of the reinforcing bars before concrete pouring, formation of the concrete cover around the reinforcement and compaction of concrete was problematic. Reinforcement of the structural members consisted of plain bars, which was typical for the time of construction. Uniaxial tension tests carried out on steel samples obtained from the demolished sections of the building provided average yield strength values of 290 and 370 MPa for the longitudinal and transverse bars, respectively. The beams had 150 mm × 500 mm cross-sectional dimensions, with two 10 mm and one 12 mm diameter longitudinal bars at the top and two 12 mm diameter bars at the bottom of the support cross-sections. Three of the four columns at each of the first and second stories of TB1 had cross-sectional dimensions of 250 mm × 500 mm, whereas the fourth column (S14) had 300 mm × 650 mm cross-section. All columns had six 16 mm bars as longitudinal reinforcement. In the third story of the building, all columns had approximately 250 mm × 400 mm cross-sectional dimensions and incorporated six 16 mm longitudinal bars, except one column that had four 16 mm bars (S31 column). The column longitudinal bars in the first story of the building were continuous down to the foundation, instead of being spliced above the foundation level, probably because the building did not have a proper foundation system. The transverse reinforcement of beams and columns comprised 8 mm diameter stirrups tied at an approximate spacing of 300 mm, with absence of confinement regions at potential plastic hinge locations. As commonly observed in sub-standard buildings, the hooks of the closed stirrups were bent at 90°.

TB2, which was designed and constructed to also represent existing sub-standard buildings in Turkey, had dimensions of 4.20 m \times 3.65 m in plan. The 0.18 m thick slab and beams with 200 mm \times 500 mm cross-sections were elongated as 1 m long overhangs on both sides of the building, for increasing the axial load levels of the columns. Each story of the three-story moment resisting frame structure with 1 \times 1 spans in x and y directions was 3 m high. All columns had cross-sectional dimensions of 200 mm \times 300 mm and were reinforced using four 14 mm longitudinal bars and 10 mm stirrups with 250 mm spacing and 90° hooks. The beams had cross-sectional dimensions of 200 mm \times 500 mm, with five 12 mm diameter longitudinal bars at the top and four 12 mm diameter bars at the bottom of the support cross-sections. The beam transverse reinforcement was identical to columns, and no special confinement regions were provided on either beams or columns. The concrete mix used during the construction of TB2 was designed to intentionally obtain low strength concrete, so that an average compressive strength of 10 MPa was achieved (based on results of tests on 150 mm \times 300 mm cylinders) on the 28th day after pouring. The ready-mixed concrete was produced at a concrete plant and was transported to the test site. The average yield strength of the plain longitudinal and transverse reinforcing bars was obtained from uniaxial tension tests as 350 MPa. Lap splice length for column longitudinal reinforcement was 75 times the diameter of the longitudinal bars (75ϕ) at the first story (above the foundation level), whereas a lap splice length of 50ϕ (above the story level) was used in construction of the second and the third story columns. 180° hooks were formed at the ends of both starter and longitudinal bars in the lap splice regions.

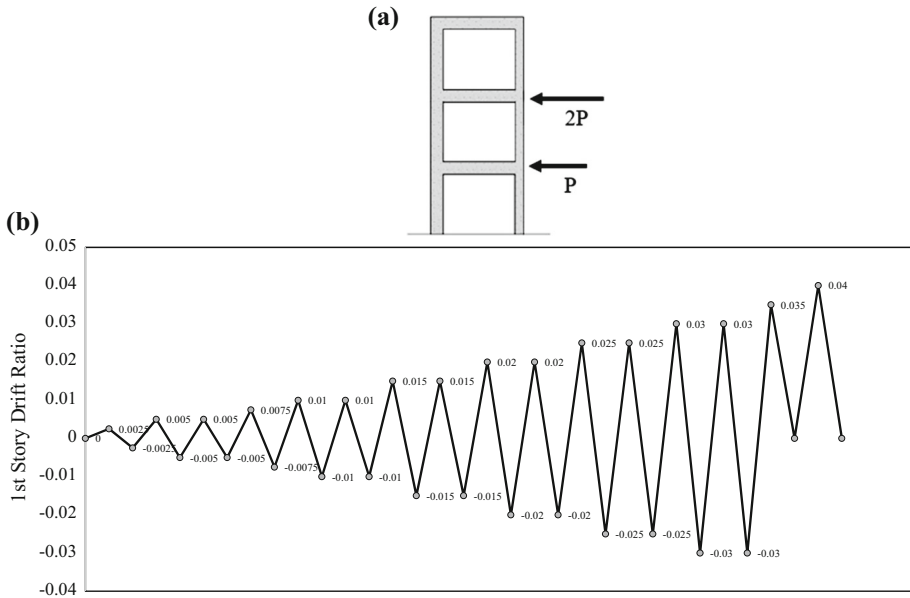
Fig. 4 **a** Loading setup and **b** loading protocol

Both buildings TB1 and TB2 were subjected to quasi-static reversed cyclic lateral loading. For this purpose, three servo-controlled hydraulic actuators with 300 kN load and 800 mm displacement capacities were mounted on the reaction wall and attached to the buildings at first and second story (floor) levels, as shown in Fig. 4. Attachment of the actuators to each floor was accomplished by bolting the plate of the actuator swivel-head to one of two steel plates located at both extremities of the building, which are connected together using post-tensioned threaded steel rods that run above and below the reinforced concrete slab and

pass through holes drilled on beams spanning in the transverse direction of loading. This demountable connection system was chosen since the accompanying dynamic identification tests presented in a companion paper (Goksu et al. 2015) were performed at different damage levels and required removal of the hydraulic actuators from the building. Rather than using one actuator at each story level, two actuators were attached to the second story of the test buildings so that any possible torsional effects could be countered.

The entire loading protocol shown in Fig. 4 was imposed on this building. The test was stopped at a drift ratio of 4.0 %, at which the building lost 40 % of its lateral load capacity. The measured base shear versus first-story drift ratio response is provided in Fig. 13. Since the beams of this building had higher bending moment capacities than the columns, damage was concentrated at the column end regions, and almost no damage (other than minor flexural cracking) was observed on the beams. All columns in the first story of the building failed due to flexural effects and no shear damage occurred despite the 250 mm stirrup spacing (again mainly due to the significant contribution of concrete to shear capacity). The first flexural cracks were observed at the upper and lower end regions of the

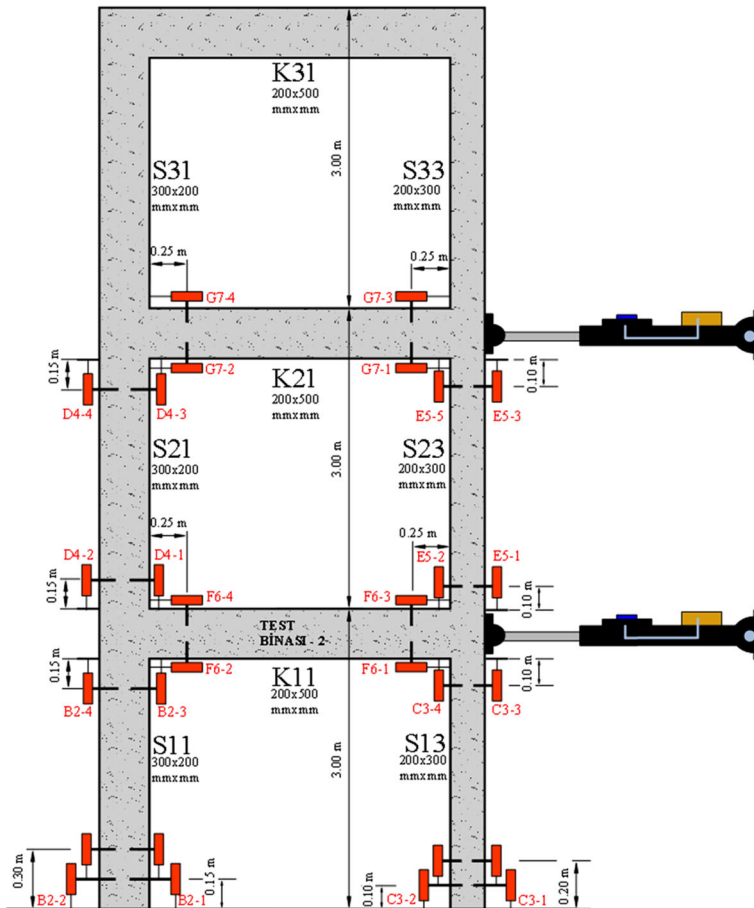
Fig. 5 Instrumentation layout

The measurement system, which collected data from approximately 80 channels, consisted of data loggers, load cells, displacement transducers and strain gauges. General layout of the measurement system can be seen in Fig. 5. The first and second story-level lateral displacements were measured by the internal displacement transducers of the actuators as well as external Linear Variable Differential Transformers (LVDTs) mounted on stiff reference piers constructed using steel profiles. The lateral loads applied on the structure were monitored using the internal load cells on the actuators. Deformations at potential plastic hinging regions of the beams and columns were measured using longitudinal displacement transducers with a measurement (gauge) length of $h/2$, where h is the depth of the beam or column cross-section. Additional displacement sensors were also used at the bottom of the first story columns, where internal forces and deformations were

expected to be higher. These additional transducers spanned a gauge length equal to the depth of the column cross-section. In case of TB2, strain gauges were also bonded on the longitudinal reinforcement of the first-story columns.

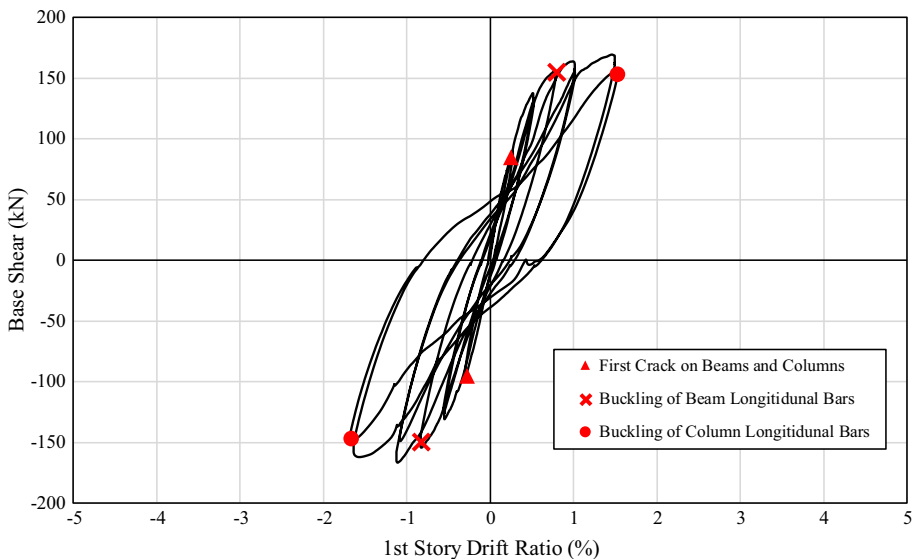
Fig. 6 Base shear—1st story drift ratio response of TB1

The reversed cyclic loading pattern was imposed on the building up to a drift ratio of 1.50 %. Since the damage level attained at this drift ratio was substantial, the test was terminated at this drift level for safety reasons. It should be noted that, in the following results, the load values recorded while pushing the building are referred as positive loads, while the pulling loads are denoted as negative loads. The base shear vs. 1st story drift ratio response of TB1 is provided in Fig. 6. Marks on this figure indicate important stages of the test. Throughout the test, as also predicted during pre-test analyses, no significant shear damage was observed on the building (mainly due to the significant contribution of concrete to shear capacity that was higher than the experienced shear forces) and the overall response was governed by nonlinear flexural behavior at the critical end regions of beams and columns. The damage was first observed at the support regions of the first-story beams parallel to the loading direction (K11 and K12 in Fig. 3). Afterwards, damage started to accumulate at the bottom end regions of the first-story columns S11 and S14 (Fig. 7), which were stiffer and stronger in the loading direction than columns S12 and S13. During the following loading cycles, the level of damage on the beams intensified more rapidly than the columns. Since the thickness of concrete cover on the beams was only about 5 mm, concrete spalling occurred at an early stage at the beam end regions. The bottom longitudinal bars of beam K12 started to buckle during the loading cycles to 0.75 % drift

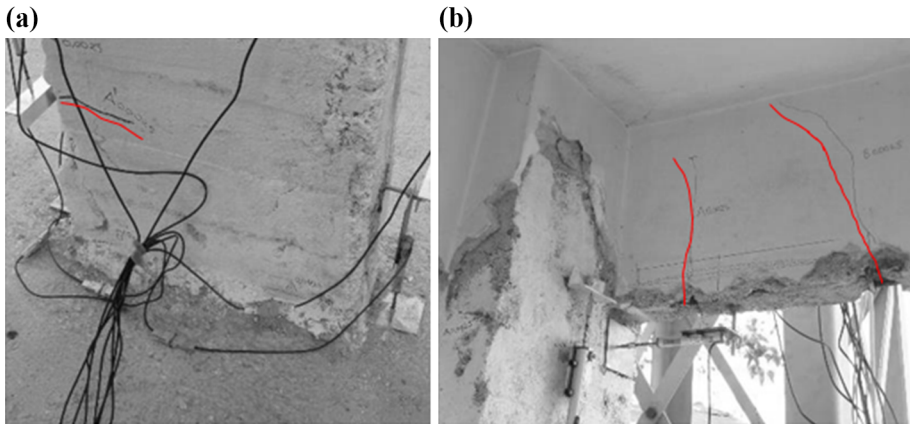
Fig. 7 First cracks observed **a** S14 column and **b** K11 beam at 0.25 % drift ratio

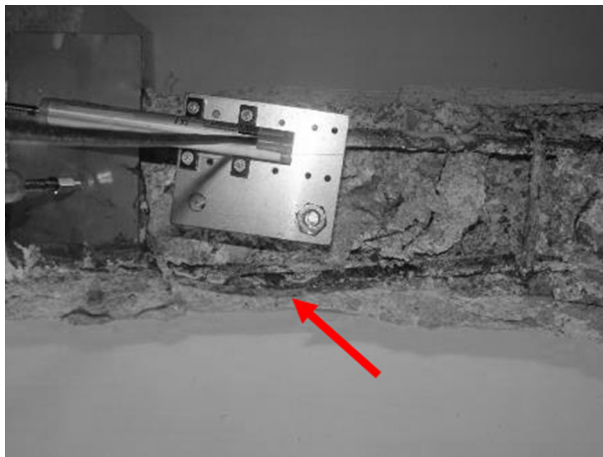
Fig. 8 Buckling of longitudinal bars of beam K12 at 0.75 % drift ratio

(Fig. 8). When a drift ratio of 1.0 % was reached, almost all bottom longitudinal bars at the end regions of the first-story beams, that were parallel to the loading direction, had buckled. Following buckling of beam longitudinal bars, the bottom end regions of the first-story columns started to experience extensive damage. Vertical cracks and cover crushing were observed on column S14 at 1.0 % drift ratio (Fig. 9), and the longitudinal bars of column S14 buckled at 1.5 % drift ratio (Fig. 10). No significant damage was observed on columns S12 and S13 of the first story, which were weaker in the loading direction. As well, no significant damage (apart from flexural cracking) was observed in any of the beams or columns located in the second or third stories of the building. Average longitudinal strains along a length of $0.5h$ at the column base (where h is the depth of the column cross-section) were measured using two transducers installed on the opposite faces of the column in the direction of bending. Similarly, average longitudinal strains along the potential plastic hinging regions of the beams were measured using displacement transducers attached to the top and bottom of the beam end regions. Measurements of these

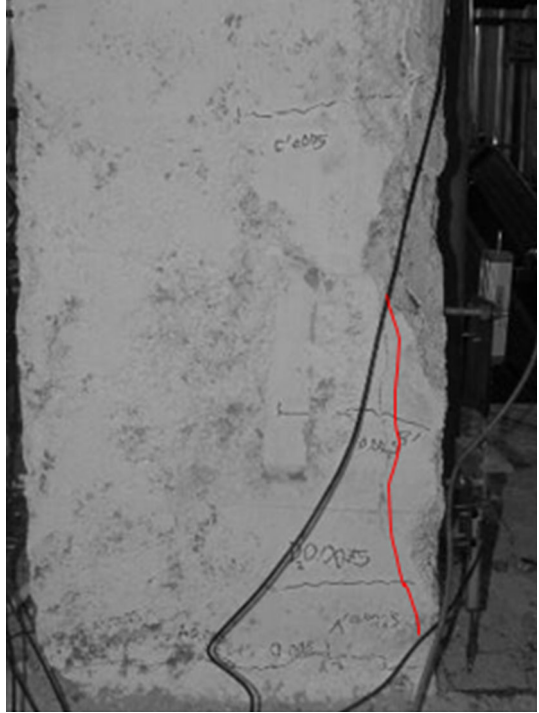
Fig. 9 Vertical crack on column S14 at 1.00 % drift ratio

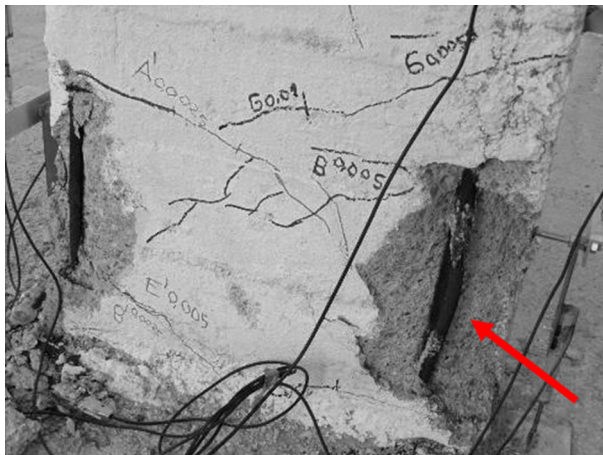
Fig. 10 Buckling of longitudinal bars of column S14 at 1.50 % drift ratio

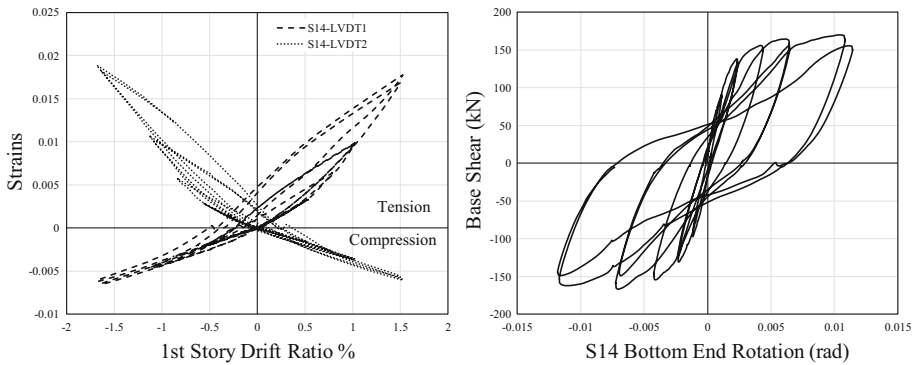
Fig. 11 Strain and end rotation measurements of column S14

transducers were used for calculation of beam and column end rotations. The measured longitudinal strain versus drift ratio and base shear versus end rotation response of severely shear damaged members (S14 and K12) are presented in Figs. 11 and 12. As can be seen in these figures, the maximum average tensile and compressive strain values measured on column S14 are recorded as 0.018 and 0.065, respectively. Additionally, the end rotations created by these longitudinal strains at the bottom of column S14 is 0.012 at a story drift ratio of

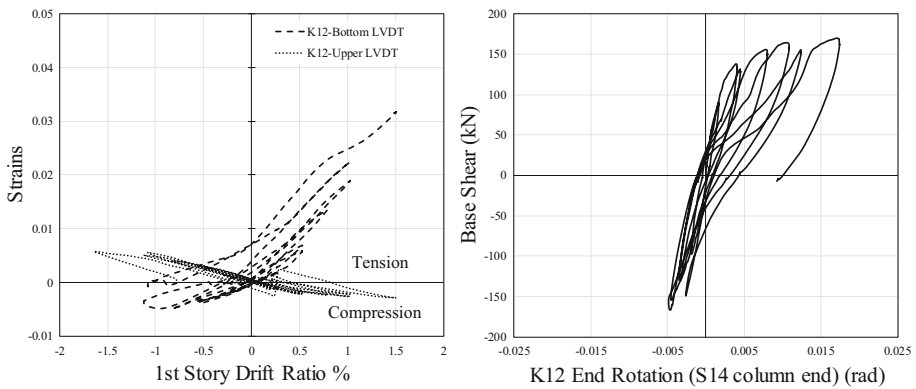
Fig. 12 Strain and end rotation measurements of K12 beam

1.5 %. The maximum tensile strains measured along the uppermost and lowermost longitudinal fibers at the support cross-section of beam K12 are 0.005 and 0.03, respectively. This difference can be attributed to the contribution of the slab to on the bending flexural behavior of the beam in under positive bending moment direction. The maximum compressive strains measured on the beam were approximately 0.004 along both the uppermost and lowermost fibers.

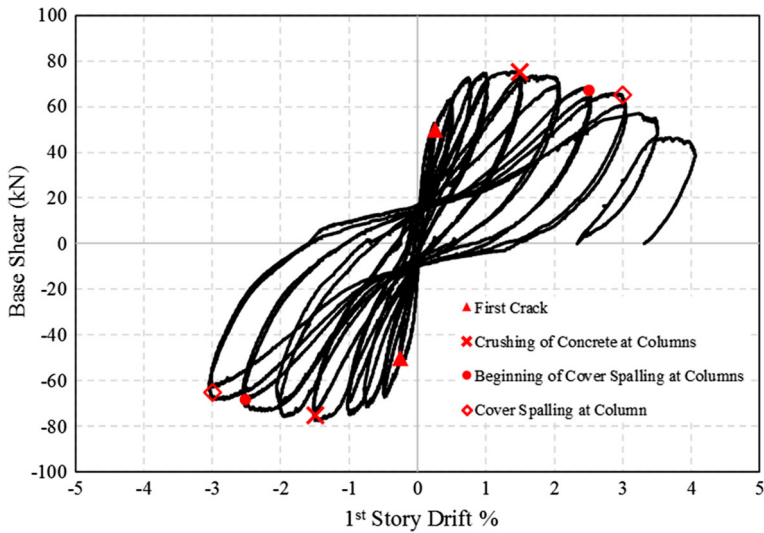
Fig. 13 Base shear—1st story drift ratio response of TB2

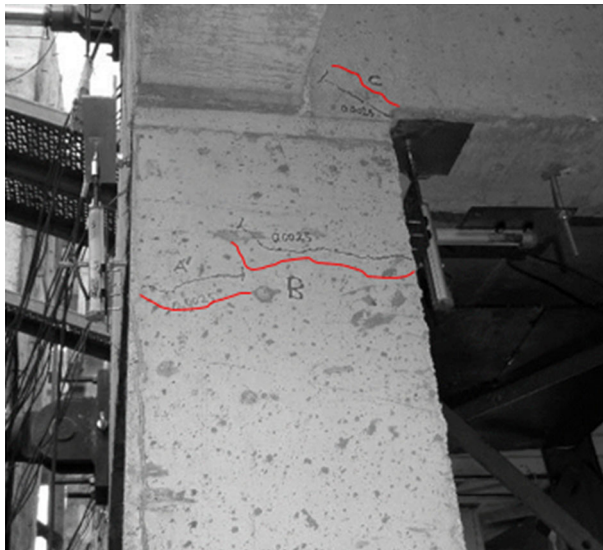
Fig. 14 First cracks observed at 0.25 % drift ratio on column S14

first-story columns at a drift ratio of 0.25 % (Fig. 14). First signs of concrete crushing were observed on column S11, at a drift ratio of about 1.5 % (Fig. 15). Cover spalling was observed on columns S11 and S13 at approximately 2.5 % drift ratio (Fig. 16). Average longitudinal strains measured using the displacement transducers installed along the potential plastic hinging regions of the columns and beams were used for calculation of the member end rotations. Additionally, strain gauges were affixed to the starter bars at the bottom of the first story columns of TB2. The distances between the foundation level and

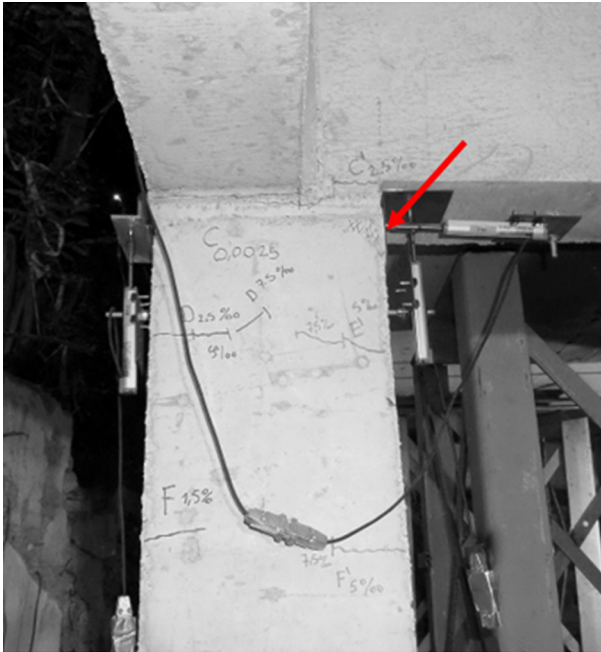
Fig. 15 Cover crushing at 1.50 % drift ratio in column S11

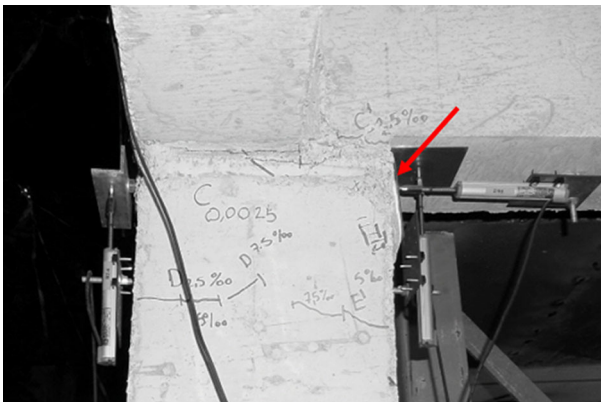
Fig. 16 Cover spalling at 2.50 % drift ratio in column S11

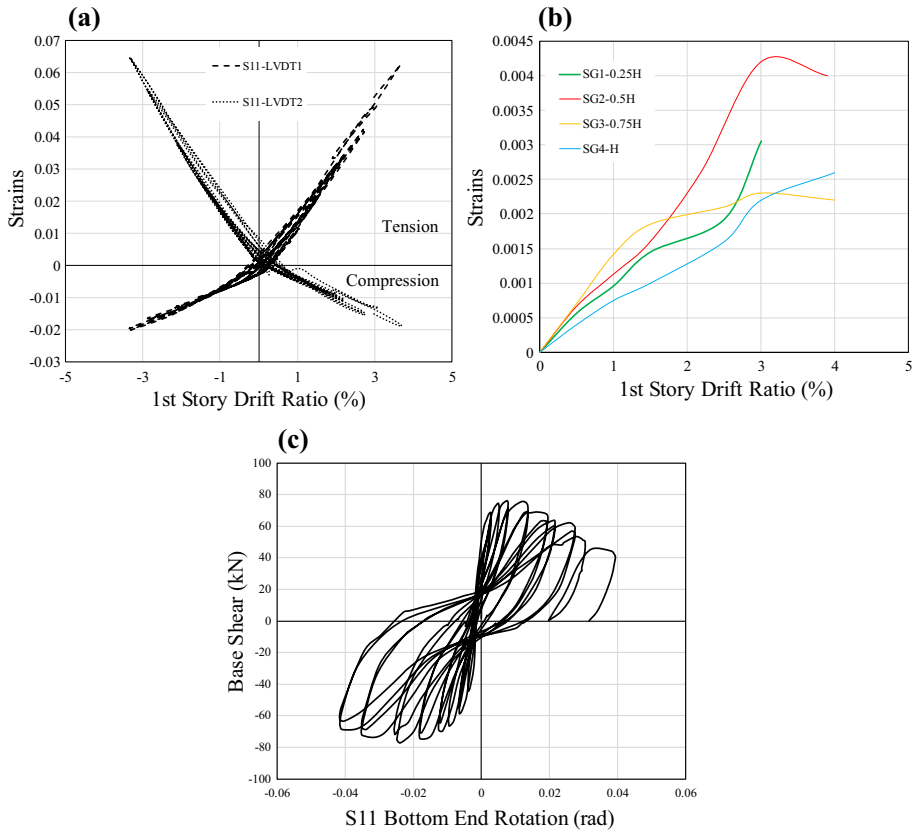
Fig. 17 **a** Average strains measured by LVDTs, **b** local strains measured by strain gauges and **c** end rotation measurements of column S11

the location of these strain gauges were $0.25h$, $0.5h$, $0.75h$, and h (where h is the column depth in the direction of loading). The measured longitudinal strain versus drift ratio and base shear versus end rotation curves for column S11 are presented in Fig. 17a and b. Accordingly, while the maximum average tensile strains recorded by the transducers were approximately 0.065, the maximum strains measured by the strain gauges only reached about 0.0043 (15 times less than transducer measurements). As seen in Fig. 17c, the end rotations calculated using the measurements of the longitudinal transducers on column S11 were approximately 0.04 at first-story drift ratio of 4.00 %.

In the type II anchorage detail used in construction of the columns in TB2, the starter and longitudinal bars at the lap splice incorporate 180° hooks at the ends. As also indicated by Fabbrocino et al. (2004), during seismic actions, these hooks behave like semi-rigid ends with very limited slip, while the straight region of the bar loses its bond to concrete at strain and stress levels much lower than yield. Due to debonding along the straight region, the starter bars deform uniformly along the entire lap-splice length, and under same story displacement (and column end rotation) levels, this phenomenon causes smaller average tensile strains in the reinforcing bars (and therefore smaller average compressive strains in concrete) compared to the continuous type I anchorage condition. When this happens, visual inspection of the damage on the column indicates formation and progressive widening of a single flexural crack at the column–foundation interface, and the column exhibits a rocking-like behavior. This was also observed on the first story columns of building TB2 (with type II anchorage detail). While the damage observed on column S14 of TB1 was distributed along an approximate height of 300 mm from the column base (approximately $0.5h$, where h is the depth of the column cross-section) as shown in Fig. 10, the flexural deformation observed at the base of column S11 in TB2 was localized along the first few centimeters of the column (due to formation of a distinct interface crack), as can be seen in Fig. 19. The strain gauge measurements done for S11 column also gives hint about this behavior. Accordingly, the local tensile strains measured along the longitudinal bar (at 0.25, 0.50, 0.75 and 1.0 H distance from the column bottom) point to close values to each other (i.e. strains vary between 0.0013 and 0.0023 at 2 % drift ratio), as seen in

Fig. 17b. The similar behavior was also seen on cantilever column tests with type II anchorage details conducted by Goksu et al. (2014).

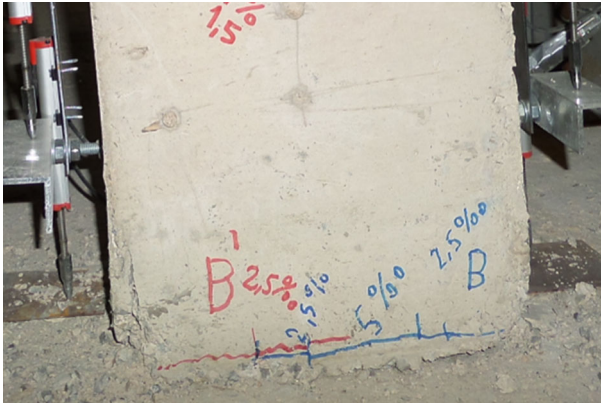
Fig. 19 Distinct single crack observed on column S11

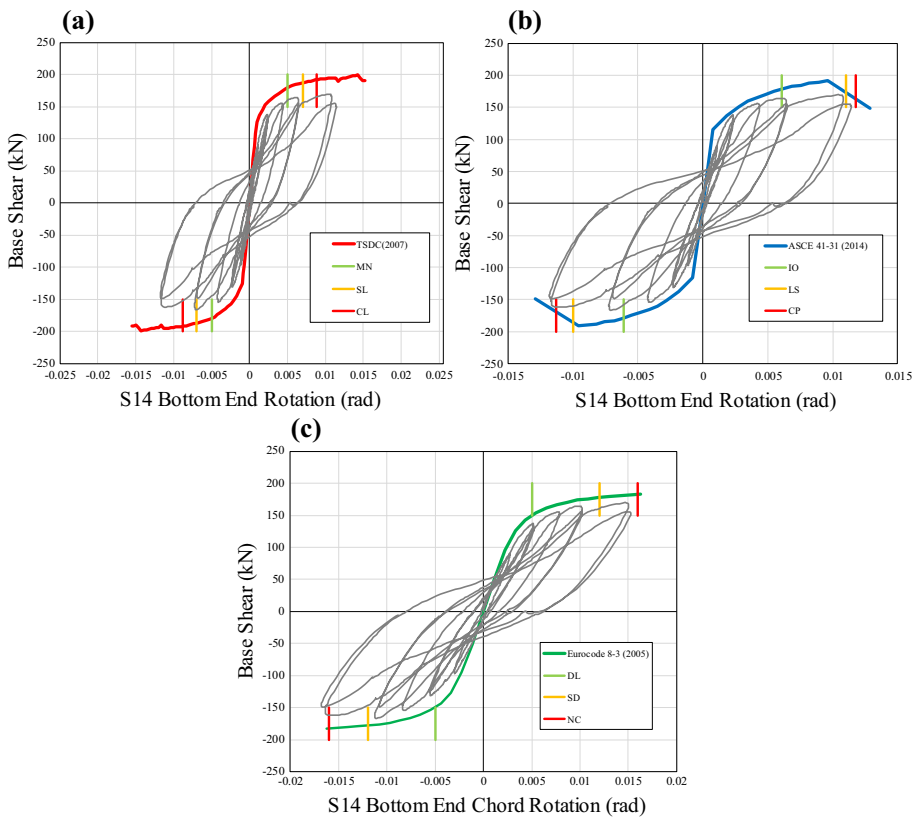
Fig. 20 Comparison of base shear versus end rotation curves for column S14 of TB1 **a** TSDC (2007), **b** ASCE 41 (2014) and **c** Eurocode 8-3 (2005)

compared with the theoretical responses obtained from the two performance assessment procedures in Figs. 20, 21 and 22. The member damage limits defined in the TSDC (2007), ASCE 41-13 (2014) and Eurocode 8-3 (2005) documents are also shown in these figures (the comparison of experimental results of K12 beam with Eurocode 8-3 (2005) are not given since the experimental chord rotation of this member cannot be calculated from available measurements). Furthermore, the damage limits and the observed damage at corresponding rotation levels for column S14 and beam K12 of TB1, as well as column S11 of TB2, are summarized in Tables 2, 3 and 4, respectively. For column S14 of TB1, as can be seen in Fig. 20 and Table 2, although the ASCE 41-13 (2014) and Eurocode 8-3 (2005) defines approximately 20–30 % larger rotation limits compared to the TSDC (2007), all analysis procedures and damage limitations are in overall good correlation with

the test data and observations. The rotation limits that define the member damage states in TSDC (2007) seem to be slightly more conservative than those specified in other documents, when compared with each other and with the experimental observations presented in Table 2. For beam K12 of TB1, all procedures fail to estimate the observed level of damage (Fig. 21; Table 3). The damage observed on this beam during the test progressed much more rapidly than predictions. For beams of TB1, the diameter of the beam longitudinal bars (d) is 12 mm and the spacing of stirrups (s) is approximately 300 mm. Together with the thin concrete cover, the s/d ratio that is in the order of 25 makes the beam longitudinal bars prone to buckling (as also observed during testing of TB1). In predicting the beam damage state, all assessment approaches lack the consideration of beam compression bar buckling, which leads to misprediction of the behavior, ductility, and damage state of the beam.

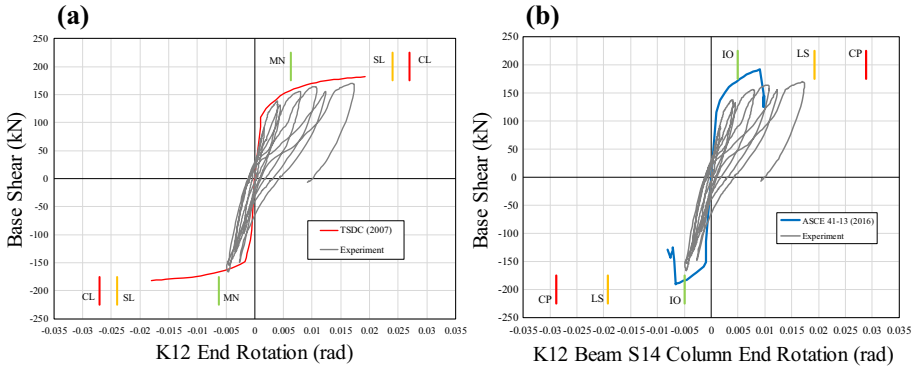
Fig. 21 Comparison of base shear versus end rotation curves for beam K12 of TB1 **a** TSDC (2007) and **b** ASCE 41 (2014)

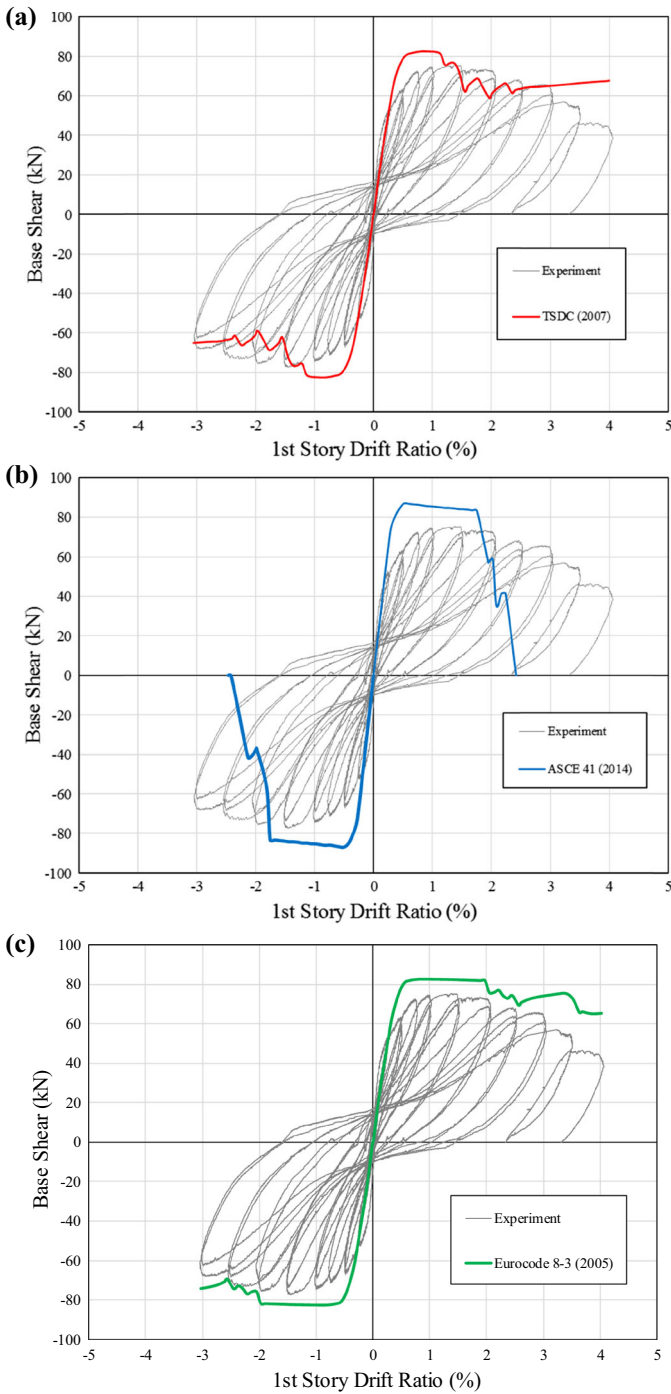
Fig. 24 Comparison of test results and analysis results for TB2 **a** TSDC (2007), **b** ASCE 41 (2014) and **c** Eurocode 8-3 (2005)

The predictions of all seismic performance assessment procedures for the base shear versus first-story lateral drift ratio response of both buildings are compared with the experimentally measured cyclic responses in Figs. 23 and 24. All modeling approaches well-predict the initial stiffness of the buildings, yet overestimate their lateral load capacity by approximately 10–20 %. Except over prediction of lateral strength, the pushover curves predicted for TB1 by the TSDC (2007), ASCE 41-13 (2014) and Eurocode 8-3 (2005) procedures show similar trend up to a drift ratio 1 %. After this point, while the ASCE 41-13 (2014) procedure predicts a sudden decrease in lateral load capacity, the TSDC (2007) and Eurocode 8-3 (2005) pushover curves do not estimate loss in lateral load up to the maximum drift ratio of 1.5 % applied during the test. This difference between the pushover curves is related to the different approaches used for modeling of columns in the performance assessment procedures. While the ASCE 41-13 (2014) backbone curves defined for plastic hinge rotations in columns incorporate a sudden decrease in the moment vs. plastic rotation behavior, the TSDC (2007) and Eurocode 8-3 (2005) did not estimate the strength loss up to larger deformations. In the case of TB2, the consideration of the plastic hinges, which was followed for the TSDC (2007) and Eurocode 8-3 (2005) approach, indicated a better agreement with the test results. Similar to TB1, the ASCE 41-13 (2014) pushover curve for TB2 exhibited a sudden drop in lateral load at a drift ratio of approximately 2 %. The experimentally observed flexural yielding hierarchy at the beam-column connections of both buildings was captured by all assessment procedures (beams of TB1 reached flexural capacity before columns and columns of TB2 reached flexural capacity before beams). However, it should be recalled that none of the performance assessment procedures accurately predicted the experimentally observed damage states of the structural members.
