Analysis of damage mechanisms suffered by Italian fortified buildings hit by earthquakes in the last 40 years

Abstract This paper presents an empirical approach to studying the seismic behaviour of fortified buildings, including castles, fortresses, and citadels. The first step for a focused preventive intervention on this building typology, characterised by the presence of towers, defensive walls and other particular elements, is to identify recurring vulnerabilities. Over 750 castles and 7 seismic events which have hit Italy in recent decades have been considered, including the earthquakes in Central Italy in August and October 2016. For each seismic event, the characteristics of the earthquake have been described by means of shake maps, while the castles in the area have been identified and inserted in a specifically formulated geographic information system. Subsequently, a thorough archival and bibliographical research on the damage suffered by the most significant case histories allowed the comparison of the damage observed in the castles with different characteristics in terms of soil, materials, building typologies and conservation status. A previously proposed table of dam

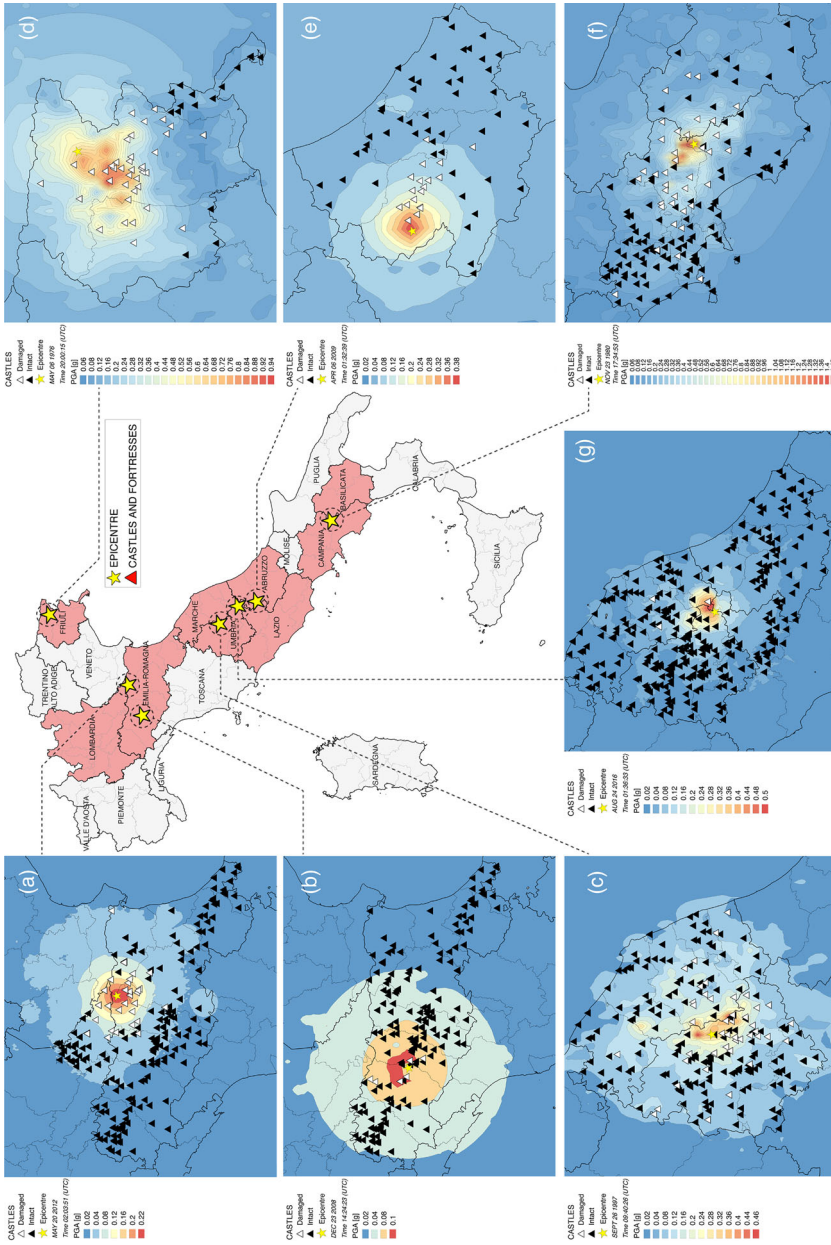
Fig. 1 Castles and fortresses and main shake maps of the most severe earthquakes examined: **a** Emilia 2008, **b** Emilia 2008, **c** Umbria-Marche, **d** Friuli, **e** Abruzzo, **f** Friuli, **g** Central Italy (Umbria, Marche, Lazio, and Abruzzo regions)

Following this procedure, 192 damaged fortresses were detected. In particular, 40 in Friuli, 38 in Irpinia, 45 in Umbria-Marche, 6 in Emilia for the 2008 earthquake, 18 in Abruzzo, 30 in Emilia for the 2012 earthquake, and 15 in Central Italy for the 2016 earthquake. The damaged castles identified are represented with white triangles in Fig. 1.

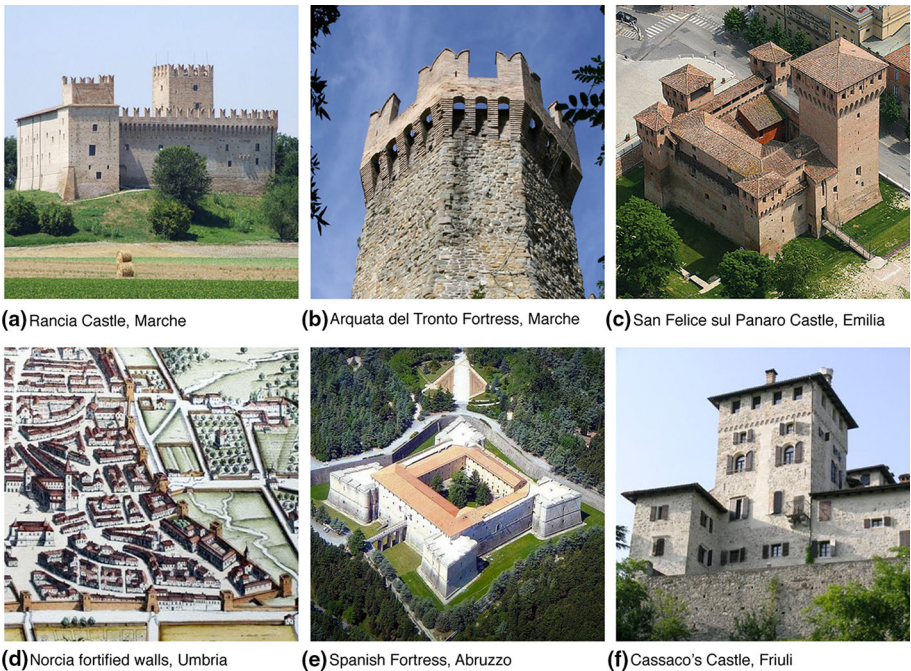
Fig. 2 Typical features of Italian fortified architectures from different historical periods: **a** crenelated parapet with merlons; **b** machicolations; **c** an aerial view of a typical fifteenth century castle; **d** a fortified citadel; **e** a fortress with bastions, introduced to withstand attacks with firearms, from the sixteenth century; **f** a medieval castle transformed into residential palace

In Italy, as in most parts of Europe, the encastellation phenomenon spread during the Middle Ages, mainly as a consequence of the onset of the feudal system. In the Early Middle Ages, the first rudimentary form of defence construction was the so-called motte-and-bailey castle, composed of a small artificial hill with a surrounding palisade in timber and a tower (usually also in timber) inside. In Italy there are traces of this type of fortification mainly in Sicily, dating from the Norman period, but this kind of fortification was also employed in other areas, e.g. on the Po plain in Northern Italy (Settia 1997). Starting from the mountain areas, given the difficulty of digging a ditch or planting a palisade, the wooden elements were soon replaced with stone, with the spread, from the eleventh century, of a large number of stone masonry donjons, sometimes with an external wall. In these donjons the first characteristic features of fortified architectures were introduced and developed: the crenelated parapet with merlons (Fig. 2a), the wooden hoarding (which was

later replaced by permanent masonry machicolation, Fig. 2b), the arrow-slits (Lepage 2002). Starting from the thirteenth century, the architecture of castles became more complex and sophisticated, with the spread of external curtain walls reinforced by wall-towers and corner-towers (Fig. 2c). The interaction between these elements is one of the vulnerabilities inspected and it is also dependent on whether the towers and the defensive walls were built together or at different times. In the same period, many Italian villages and cities built or rebuilt fortified walls, with features similar to the curtain walls and towers of the castles (Lepage, 2002) (Fig. 2d). The last significant evolution of fortified building techniques occurred in the sixteenth century, when the spread of firearms forced a change from a passive form of defence to an active one. The main changes regarded the curtain walls—built with a lower height-to-thickness ratio in order to increase stability against horizontal actions—and bastions (Fig. 2e), added for more complete protection and for the installation of defensive artillery (Duffy 1979). In more recent times, most castles were adapted to residences, with an increase in the number of openings, insertion of roofs over the battlements, sometimes with the transformation of crenels into windows (Fig. 2f), and changes in the inner space organisation.

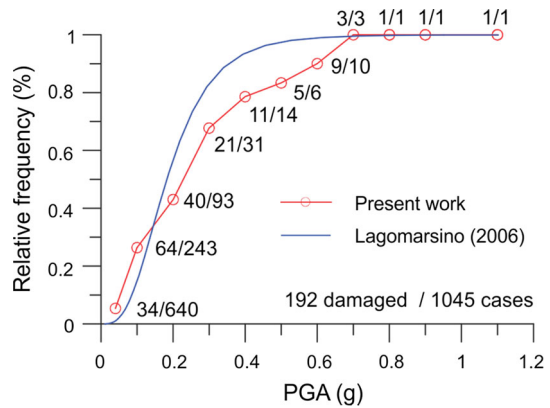
Fig. 4 Relative frequency of damaged fortresses as a function of pga compared with the vulnerability function for castles proposed by Lagomarsino (2006)

The relative frequency of damaged castles subjected to a given value of the maximum pga is represented in Fig. 4. Bins of amplitude 0.1 g were adopted. Labels provide the ratio between the number of damaged and undamaged fortresses for a certain interval of pga . Some fortresses were hit by two or more earthquakes (e.g. Umbria-Marche 1997 and Central Italy 2016), therefore the number of cases considered (1241) is larger than the number of castles. Since damage was not reported for a pga less than 0.04 g, this value was

chosen as a threshold and fortresses subjected to a lower pga were not considered in the analysis for counting the undamaged fortresses, reducing the total number of cases considered from 1241 to 1045. In Fig. 4 the curve is compared to the vulnerability curve for castles proposed in Lagomarsino (2006), choosing a moderate damage level (D2). Since the vulnerability curve was defined as a function of the macroseismic intensity I, it was necessary to transform I to pga by means of the equation proposed in Guagenti and Petrini (1989) specifically for the Italian earthquakes. Results show a good agreement between the two curves, notwithstanding the considerable number of uncertainties, such as: (a) the lack of information about the real damage level; (b) the transformation from I to pga; (c) the different typology of castles (e.g. squat fortresses with bastions display a better seismic behaviour than medieval castles with tall towers).

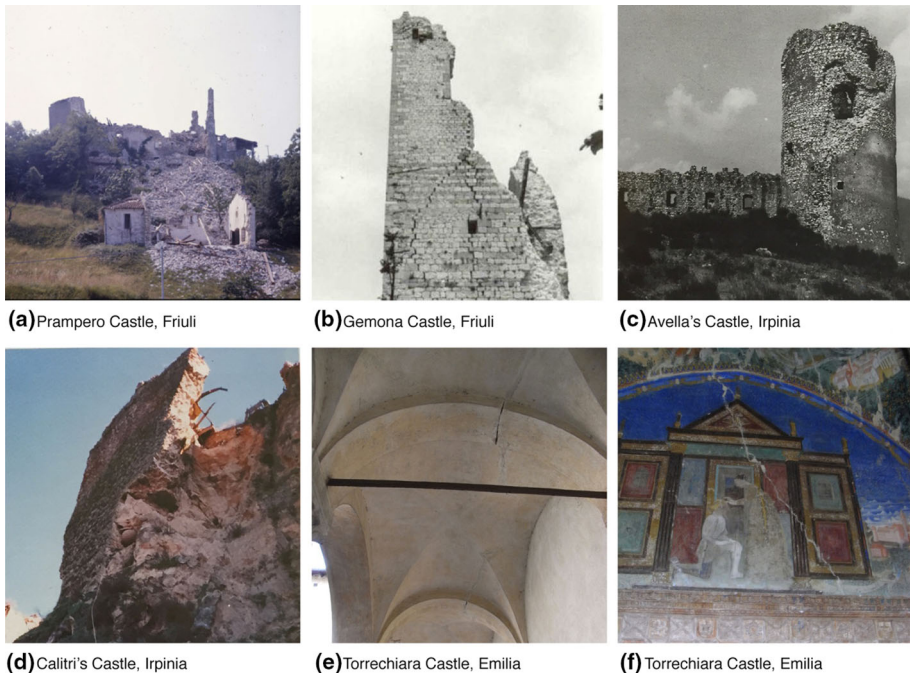
Fig. 6 Typical castles hit by the earthquakes in Friuli (a, b), Irpinia (c, d) and Emilia 2008 (e, f)

Table 3 shows that the Friuli castles are mainly built with stone masonry and often characterised by the presence of merlons (Fig. 6a, b): these vulnerable elements were damaged in nearly all the cases studied, mainly due to overturning (mechanism 4b). Furthermore, it is possible to notice that the buildings which suffered complete collapse due to masonry crumbling (mechanism 1a) were abandoned or in a state of ruin: once again, we have confirmation of the positive effects of maintenance on the preservation of monuments, even from the seismic view point.

The castles of Irpinia (Table 4) were built in stone, rubble masonry and tuff masonry (Fig. 6c, d). It is worth noting that, at the time of the earthquake, these castles were generally unused or in ruins. The poor condition of the masonry, together with high accelerations, explains the severe damage they suffered. The descriptions of damage reported in MiBAC (1994) rarely comment on merlons, battlements, and protruding elements. In addition, the frequent damage to the floors and roofs are described in general terms and it is unclear whether it is caused by rotation of the walls or their deterioration. In the case of ruins, roofs could even have been absent before the earthquake. Some foundation problems (mechanism 8a), usually due to rockfalls, are present, because most of the castles were built on hilltops, as can be seen in Table 4.

The castles in the western part of Emilia, hit by the 2008 earthquake (Table 6), are characterised by massive walls in bricks and cobblestones. Despite their apparent strength, even if subjected to low p_{ga} they all suffered shear damage (mechanism 3b) in the tower walls and consequent damage to the vaults (mechanism 7b) (Fig. 6e, f).

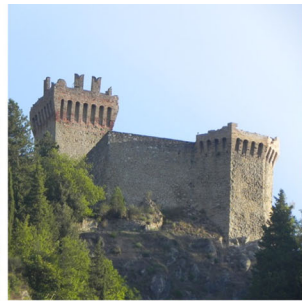
(c) Arquata del Tronto Castle, Central Italy 2016

Fig. 7 Typical castles hit by the earthquakes in Abruzzo (a), Emilia 2012 (b), and Central Italy (c–f)

are built in stone masonry, while in the hills solid clay masonry prevails. The building technique has a correlation with the occurrence of crumbling and delamination of the masonry. Merlons are sometimes present and, in most cases, were damaged. Frequent shear damage on the towers was also reported. This is particularly true for fortified buildings that present a tower built on a massive prismatic base (Fig. 7e). Battlements built with stone slabs did not usually present signs of damage (Fig. 7f). Aftershocks are still occurring, therefore the results reported in Table 9 are provisional.

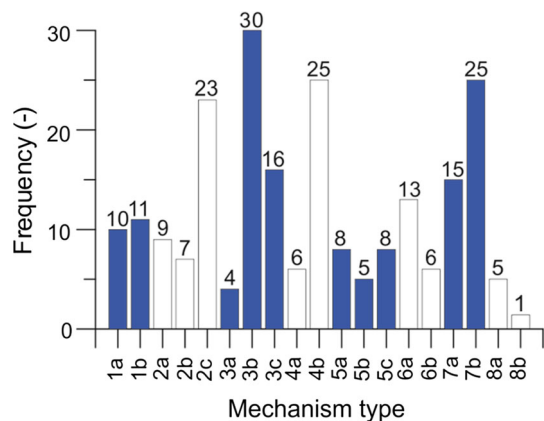
Fig. 8 Frequency of the different damage mechanisms

Considering the eight main damage typologies, it is possible to record the number of recurrences reported in Tables 3, 4, 5, 6, 7, 8 and 9. The bar chart presented in Fig. 8 shows the number of cases for each damage mechanism. It is evident that the most common damage mechanisms affect towers, floors and merlons. In the case of floors, the data are inaccurate because the interiors of the castles hit by the recent earthquakes are still off limits and, consequently, this kind of information is lacking in many cases. Furthermore, most of the photos regard only the exteriors, which is also the case for past events.

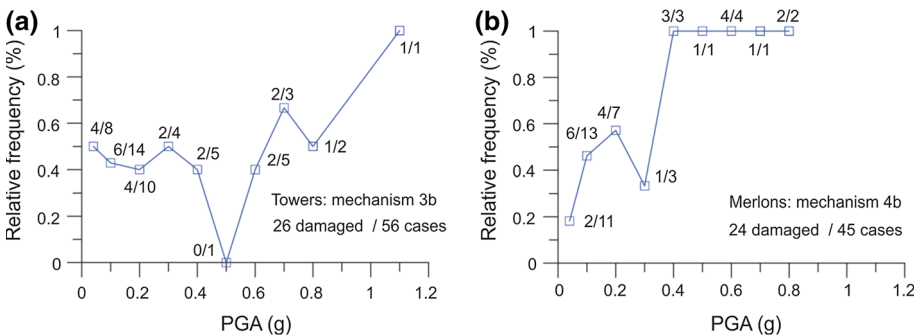
Fig. 10 Relative frequencies of damage as a function of pga: **a** shear cracks in the main body of the tower (mechanism 3b); **b** overturning of the merlons (mechanism 4b)

In Fig. 10 the number of fortresses hit by a specific acceleration, for each level of acceleration, was indicated and the relative frequency of the damage mechanism examined was calculated. As expected, the trend increases quite regularly, although there are some anomalies due to the limited number of cases examined. The presence of damage to towers for very low values of pga can also be explained by the presence of pre-existing cracks.

Introducing a classification of the damage levels for each damage mechanism would make it possible to proceed from the graphs of Fig. 10 to specific vulnerability curves (Simões et al. 2015; Bernardini and Lagomarsino 2008; Jaiswal et al. 2011; D’Ayala 2013; Roca 2012). As the number of cases examined for each damage mechanism grows, the results will become increasingly reliable and meaningful. The results will then be inserted in the GIS and this will allow cross-examination of the damage mechanisms in relation to the seismic action, location, building techniques, materials, etc.
