# Seismic behaviour of timber-laced stone masonry buildings before and after interventions: shaking table tests on a two-storey masonry model

Charalambos Mouzakis<sup>1</sup> · Chrissy-Elpida Adami<sup>2</sup>

**Abstract** The present work focuses on the seismic behaviour of timber-laced masonry buildings with timber floors, before and after the application of intervention techniques. A two-storey building with timber ties (scale 1:2) was subjected to biaxial seismic actions. Prior to the execution of shaking table tests, the dynamic characteristics of the model were identified. The base acceleration was increased step-wise until the occurrence of significant but repairable damages. Afterwards, the masonry was strengthened by means of grouting, whereas the diaphragm action of the top floor of the building was enhanced and the model was re-tested. The tests on the timber reinforced model before strengthening show that the presence of timber ties within the masonry elements contributes to improved seismic behaviour. The performance of the model after strengthening shows that the selected intervention techniques led to a significant improvement of the seismic behaviour of the buildi

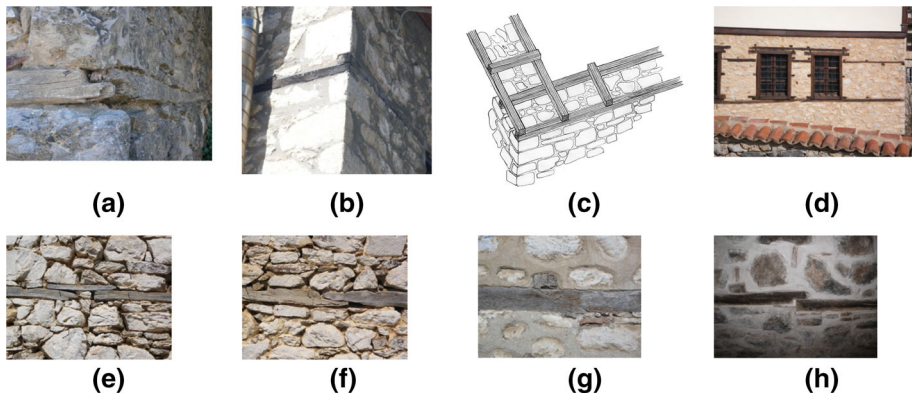
**Fig. 2** a, b Typical connections of longitudinal timber elements at the corner of the building, c sketch of longitudinal and transverse timber elements, d transverse timber elements are visible on the façade of the building, e–h alternative splices of longitudinal timber elements

Detailed survey of structural systems in the earthquake prone area of the Eastern Mediterranean has shown that timber laces (also called ties or reinforcement) have been used in masonry structures, in a variety of forms and arrangements, since 2500 BC (Langenbach 1989, 2002; Palyvou 1999 cited in Vintzileou 2011; Moropoulou et al. 2000; Tsakanika 2006 cited in Vintzileou 2011; Vintzileou 2008; Touliaos 2009 cited in Vintzileou 2011; Tsakanika and Mouzakis 2010; Vintzileou 2011). In numerous historic centers (more than 70 in Greece alone), constructed during the eighteenth and nineteenth centuries, timber laced masonry systems were identified and surveyed (Fig. 1). In those systems, longitudinal timber elements are placed along the perimeter of buildings at several levels (e.g. top of the foundation, floors and roof levels, around the openings, etc.). The longitudinal timber elements are connected at the corners of the buildings (Fig. 2a, b), whereas splicing is provided when the plan dimensions of the building are longer than the timber elements (Fig. 2e–h). In the most frequent case, where a pair of longitudinal timber elements are placed parallel to the faces of masonry walls, transverse timber connection of the longitudinal elements is provided at intervals (Fig. 2c, d).

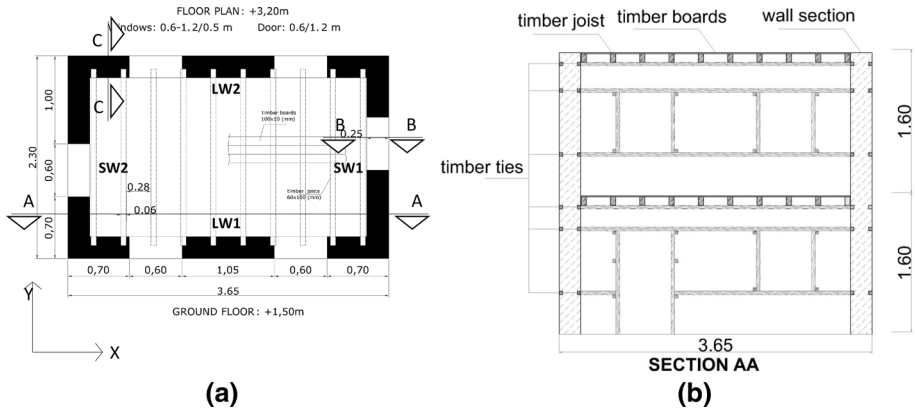
**Fig. 3** a Typical plan and b section of TLMBM

A two storey Timber-Laced Masonry Building Model (TLMBM) with regular in-plan geometry was constructed at a reduced scale of 1:2 (Fig. 3). The model was subjected to seismic excitations at the Laboratory for Earthquake Engineering/NTUA before and after interventions. Initially, the specimen was excited with sine sweep signals and its dynamic characteristics were determined. Seismic excitations were then applied (with gradually

The geometry of TLMBM is identical to that of the plain masonry specimen described in Vintzileou et al. (2015): The plan dimensions of the floor of TLMBM are  $3.65 \times 2.30$  (m<sup>2</sup>) (Fig. 3a), whereas the height of each floor is 1.60 m. The thickness of the walls is equal to 0.25 m. With the exception of a door at the ground storey, instead of a window at the first storey (Fig. 3b), the two storeys were identical. It should be noted that the geometry of the building models was dictated by several criteria, such as (a) typical characteristics of real buildings (number of storeys, almost symmetrical arrangement of openings, typical distance between consecutive bearing walls, dimensions of openings etc.) and (b) the limitations of the shaking table (in terms of maximum load, height, acceleration and displacements).

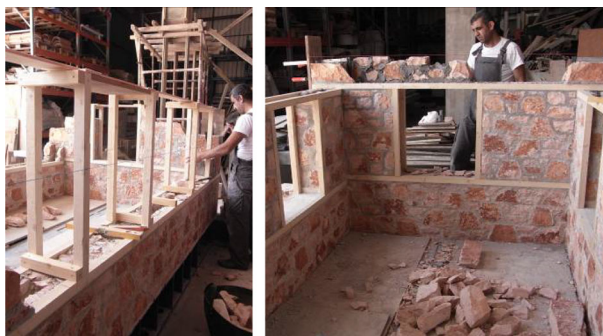
**Fig. 5** Timber ties and timber frames around openings

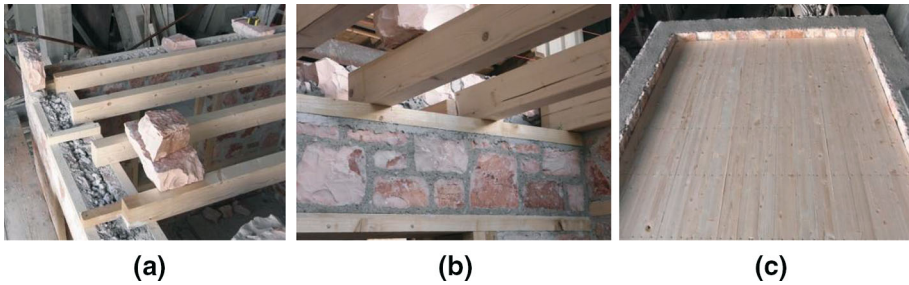
**Fig. 6** Structural details of the wooden floor

Figure 6 shows the typical floor construction of the TLMBM: Timber joists ( $60 \times 100$  mm<sup>2</sup>) were placed every 340 mm (Fig. 6a). The floors were resting on the masonry through the timber ties placed at the floor levels (Fig. 6a, b). As shown in Figs. 3, 4 and 6, timber joists were arranged parallel to the short walls, there was no connection between the timber floor and the short walls of the model. A timber pavement was provided, made of  $100 \times 10$  mm<sup>2</sup> boards. Each board was connected to every joist using two nails (Fig. 6c). Class C22 wood (according to EN 338) was used. Based on their geometry, the floors are classified as flexible (ASCE (2007) 41-06).

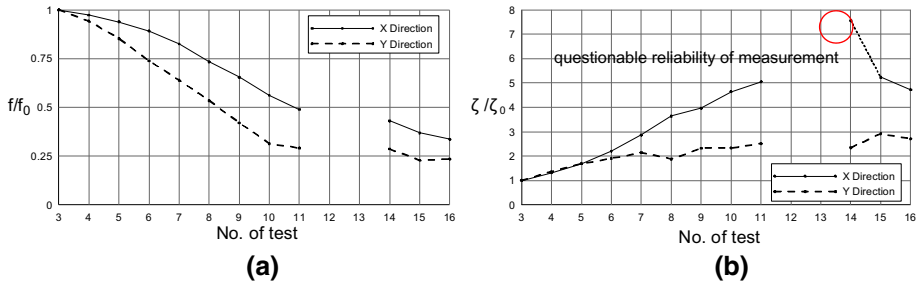
**Fig. 12** TLMBM-BS building. Values of **a** frequency and **b** damping along X and Y directions during the sequence of shaking table tests (from Test 3BS to Test 16AS, Table 1), normalised to the respective values recorded during Test3BS. Values of frequency and damping ratio measured during sine sweep tests (i.e. Tests 12BS and 13BS) are not presented

The variation of the equivalent elastic frequency and the equivalent damping of TLMBM-BS and TLMBM-AS throughout testing is presented in Figs. 12 and 13, respectively. These values are normalised to the values of frequency and damping ratio

obtained during Test 3BS and Test 3AS, respectively. Regarding the as-built model, it seems that the Kalamata earthquake has affected its behaviour along both directions. Furthermore, although the model presented visible damages during Test 10BS, a significant reduction of frequency (followed by an increase of the corresponding damping ratio) occurred much earlier (after Test 5BS, Table 1). This behaviour may be attributed to (invisible from the exterior) damage within the thickness of the three leaf walls. As expected, the grouted building model TLMBM-AS1, was mainly affected in its Y-direction by the Kalamata earthquake. Although the homogenization of masonry has reduced the vulnerability of the resulting monolithic walls to out-of-plane actions, the flexibility of the floor diaphragms is still affecting the out-of-plane behaviour (especially) of the (long) walls. Part of this vulnerability seems to persist (though for higher imposed maximum accelerations), after the stiffening of the top floor (Tests 16AS-24AS, Fig. 13a). The abrupt change of both frequency and damping during the last phase of testing is in accordance with the observed damage that became extensive during Test 29AS.

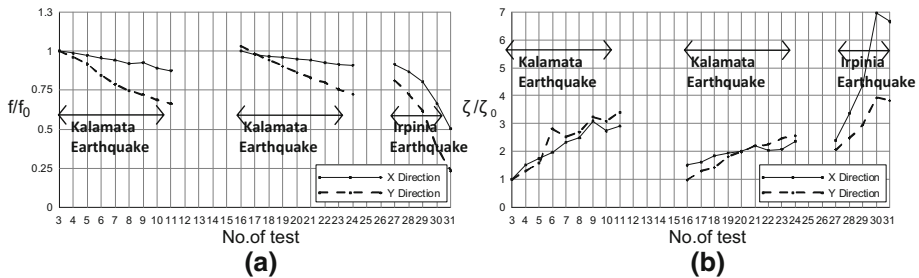
**Fig. 13** TLMBM-AS building. Values of **a** frequency and **b** damping along X and Y directions during the sequence of shaking table tests (from Test 3AS to Test 31AS, Table 2), normalised to the respective values recorded during Test3AS. Values of frequency and damping ratio measured during sine sweep tests (i.e. Tests 12AS to 15AS and Tests 25AS to 26AS) are not presented

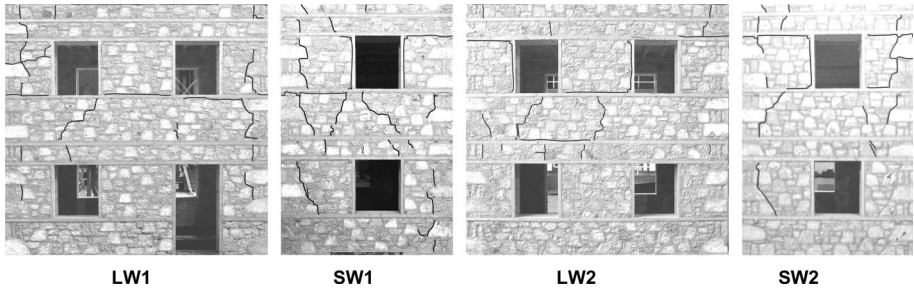
**Fig. 14** TLMBM-BS. Observed damage after Test 11BS [Kalamata earthquake: 0.38 g(X)/0.34 g(Y), Table 1]

After each test, the model was carefully inspected and the observed damage was reported on drawings. Figures 14, 15 and 16 show the crack pattern of the model before and after

repair and strengthening. The damages shown in Figs. 14 and 15 refer to TLMBM-BS and were surveyed after the completion of Test 11BS [Kalamata earthquake: 0.45 g(X)/0.35 g(Y)] and Test 16BS [Kalamata earthquake: 0.42 g(X)/0.37 g(Y)] respectively, whereas those presented in Fig. 16 were surveyed after the completion of Test 31AS [Irpina earthquake: 0.77 g(X)/1.03 g(Y)] for the strengthened model.

At the as-built state (TLMBM-BS), the formation of visible damages started during Test 10BS [Kalamata earthquake: 0.34 g(X)/0.34 g(Y), Table 1]. Vertical cracks and some minor shear cracks formed in the long walls after the completion of Test 11BS [Kalamata

earthquake: 0.38 g(X)/0.34 g(Y), Table 1]. The width of the vertical cracks at the top was of the order of 1.0–2.5 mm, decreasing towards the base of the building. At the ground floor level only hairline cracks were visible. Although the diaphragm action of the floors was insufficient, the presence of the timber ties seems to have prevented the opening of shear cracks in the corners of doors and windows. Such cracks were limited to the short walls, having a width of the order of 1 mm. Some shear cracks also formed in the long walls. Moreover, a separation of the leaves of the three-leaf masonry was apparent (see Fig. 17a, b) after 11BS [Kalamata earthquake: 0.38 g(X)/0.34 g(Y), Table 1]. This detachment was limited to the upper part of the structure and was more pronounced along the long (from 2 to 6 mm) than along the short walls (up to 1–2 mm) of the specimen. The detachment of the leaves of masonry was visible also at the vertical sides of the windows of the upper level. It should be reminded here, that there were no header stones connecting the outer leaves of masonry. During the first test series (up to Test 11BS), it was observed that (a) cracks were of limited opening at the vicinity of timber ties (e.g. Fig. 14, observe the discontinuity of cracks at the vicinity of timber ties) and (b) separation between timber ties and masonry had occurred (Fig. 18a, observe the horizontal cracks between timber elements and masonry), mainly at the upper floor.

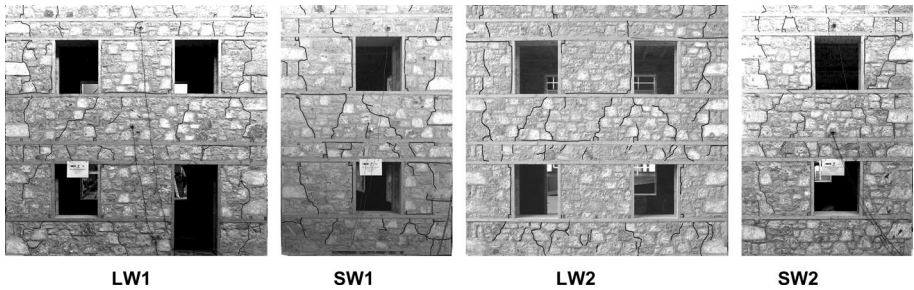
**Fig. 15** TLMBM-BS. Observed damage after Test 16BS [Kalamata earthquake: 0.42 g(X)/0.37 g(Y), Table 1]

formed and the detachment of the leaves became more severe (Fig. 17c). Finally, Figs. 15 and 19 show similar crack pattern in the exterior and the interior faces of masonry. This is attributed to the beneficial effect of timber ties (longitudinal and transverse elements) that contribute to a more uniform distribution of vertical loads to the walls.

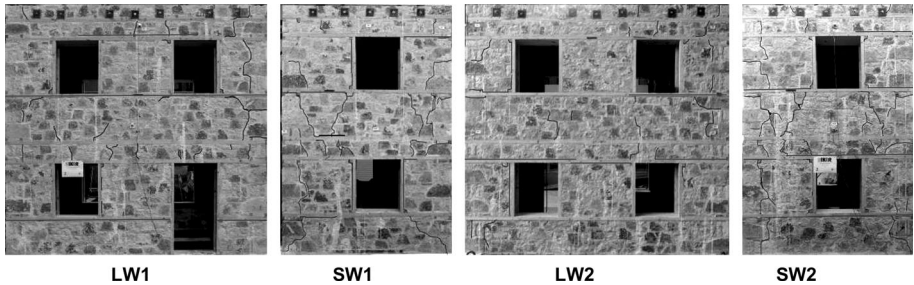
**Fig. 16** TLMBM-AS2. Observed damage after Test 31AS [Irpina earthquake: 0.77 g(X)/1.03 g(Y), Table 2]

The strengthened model exhibited a significantly improved behaviour, in the sense that damage occurred at significantly higher maximum acceleration values than for the as-built model. Specifically, (a) TLMBM-AS1 and TLMBM-AS2 were free of visible damage after the completion of Tests 11AS and 24AS, respectively (Table 2), (b) no separation between the leaves of masonry was observed, even after the application of the strongest motion [Test 30AS, Irpinia earthquake: 0.66 g(X)/1.11 g(Y), Table 2], and (c) due to the enhanced box-action of the building, its vulnerability to out-of-plane bending was significantly reduced as vertical cracks close to the corners appeared only at an advanced stage of testing.

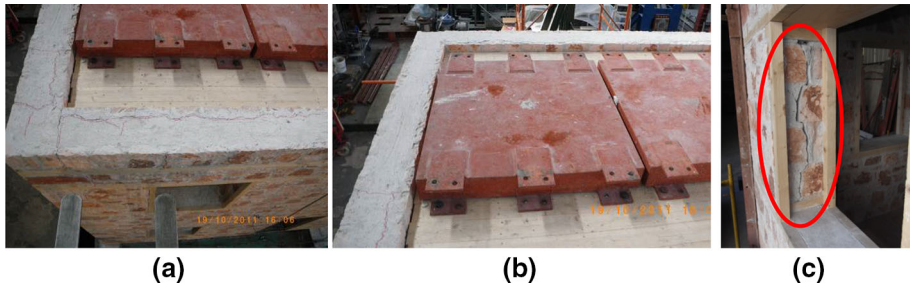
**Fig. 17** TLBMB-BS. Observed damage **a**, **b** at the roof level, **c** at the level of openings after Test 16BS [Kalamata earthquake: 0.42 g(X)/0.37 g(Y), Table 1]

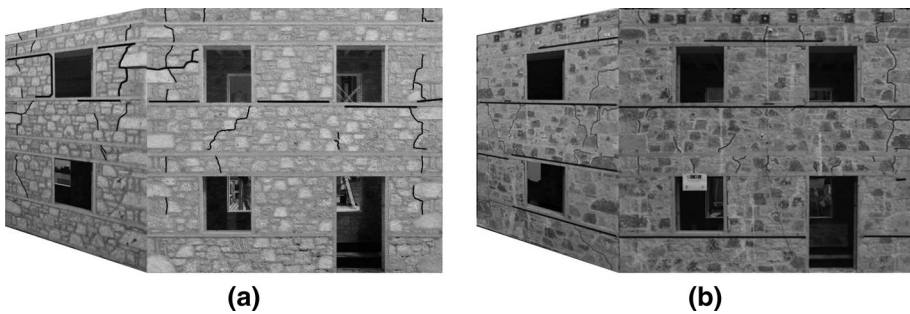
**Fig. 18** **a** TLBMB-BS specimen: rigid bodies formed during Test 11BS [Kalamata earthquake: 0.38 g(X)/0.34 g(Y), Table 1]. **b** TLBMB-AS specimen: rigid bodies formed during Test 31AS [Irpinia earthquake: 0.77 g(X)/1.03 g(Y), Table 2]

Moreover, the improved bond between masonry leaves (due to grouting) together with the enhancement of the diaphragm action of the top floor and its connection with the perimeter walls modified the behaviour of the building. As the seismic input increased to 300% of the Irpinia earthquake [Test 29AS, Irpinia earthquake: 0.47 g(X)/0.72 g(Y), Table 2], minor vertical cracks occurred at the corners of the building, whereas at the ground floor level, the timber ties detached from the masonry at the base of the windows. As the seismic excitation increased further, a combination of rocking of the upper floor and sliding mechanisms at the level of timber-ties was observed. At that point, significant separation occurred at the splices of the longitudinal timber elements, mainly in the short walls. With the repetition of the same seismic input [Test 31AS, Irpinia earthquake: 0.77 g(X)/1.03 g(Y), Table 2], cracking was generalised. Horizontal cracks opened at the levels of timber ties and, thus, rocking proved to be the predominant failure mechanism for TLMBM-AS (see Fig. 18b).

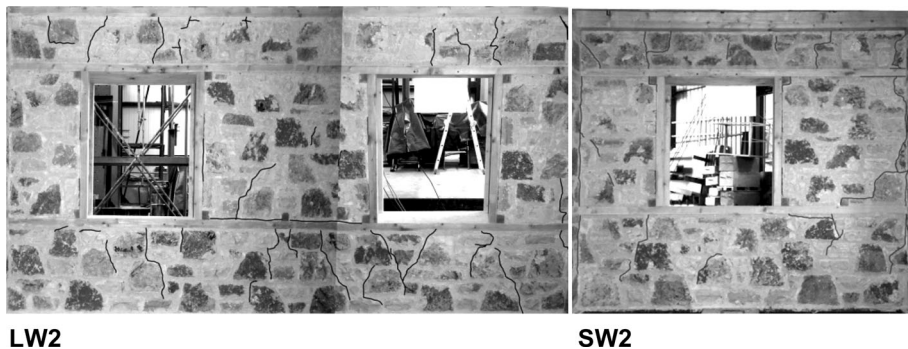
**Fig. 19** TLMBM-BS. Observed damage in the walls LW2 and SW2 at the ground floor of the interior of the model after Test 16BS [Kalamata earthquake: 0.42 g(X)/0.37 g(Y), Table 1]

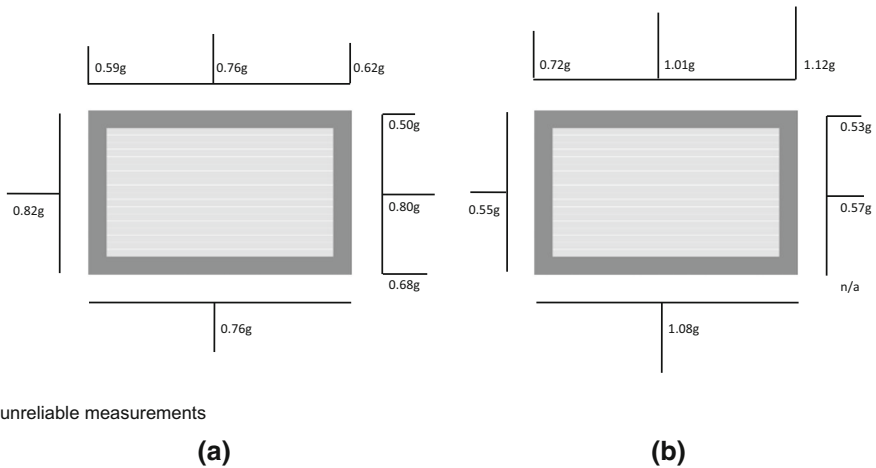
**Fig. 20** Maximum recorded accelerations **a** TLMBM-BS and **b** TLMBM-AS2

Figure 20 shows the values of the maximum accelerations recorded at the top floor in X and Y directions, for both TLMBM-BS and TLMBM-AS2. The accelerations shown in Fig. 20 were recorded during the excitations that caused damage to the model, namely Test 10BS [Kalamata earthquake: 0.34 g(X)/0.34 g(Y), Table 1] for TLMBM-BS and Test 29AS [Irpinia earthquake: 0.47 g(X)/0.72 g(Y), Table 2] for TLMBM-AS2.

For TLMBM-BS, the recorded accelerations at mid-length of both the long and short walls of the top floor are practically equal, due to the effect of interconnected timber ties. However, the accelerations measured close to the corners of the as-built model are smaller (of the order of 0.50–0.60 g) than those recorded at mid-length of the walls. This is attributed to the interconnection of walls (using large dimension stones-Fig. 7b).

In the case of the TLMBM-AS2 model, as shown in Fig. 20b, some of the accelerometers did not provide reliable measurements. However, the available measurements show similar values of acceleration at mid-length of the walls and close to the corners of the model. This is attributed to both homogenisation of masonry and stiffening of the top floor.

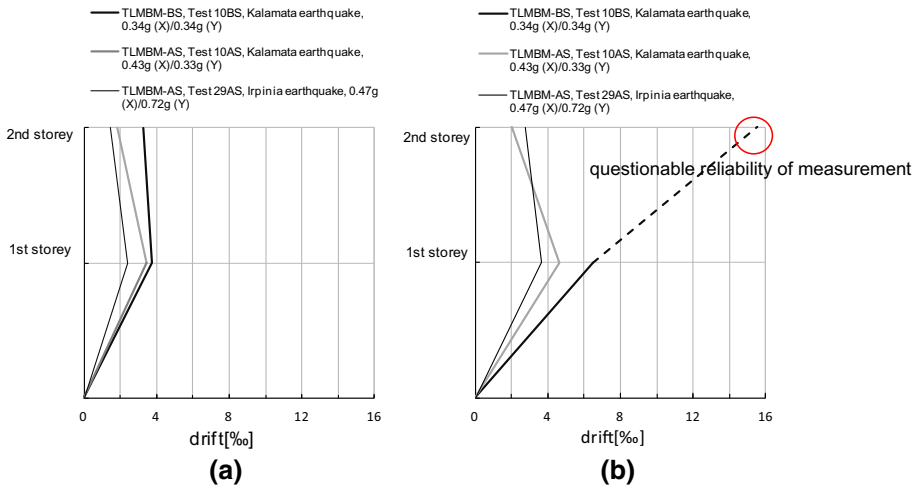
**Fig. 21** Interstorey drift values [%] along **a** X direction (along the long walls) and **b** Y direction (along the short walls) recorded for the as-built and strengthened models during Tests 10BS and 29AS

Interstorey drift values,  $\delta$ , for both storeys of the building model were measured for Tests 10BS and 29AS (Fig. 21). Furthermore, drift values are measured for the TLMBM-AS1 specimen for the motion that corresponds to the initialisation of cracking for the TLMBM-BS specimen (Table 2: Test 10AS). The drift values reported on Fig. 21 were recorded by displacement transducers D11, D12 (X-direction) and D9, D10 (Y-direction).

The results presented in Fig. 21 allow for the following observations to be made: In TLMBM-BS, the interstorey drifts measured at mid-length of the long walls are higher than those measured at mid-length of the short walls, due to the vulnerability of the long walls to out-of-plane bending. It should be noted that the large value of interstorey drift (15.5%, Fig. 21b) is not reliable, as it is due to local damage at the location of a measuring device. Furthermore, drift values measured before and after repair and strengthening prove the efficiency of the interventions in reducing the drifts of the building model for the same

seismic input. This is more pronounced in Y-direction, i.e. perpendicular to the long walls, more vulnerable to out-of-plane actions and, expectedly, more favoured by the interventions (for example at the first level of the model: reduction varying from 8 to 54% and from 39 to 78% along X and Y direction respectively).

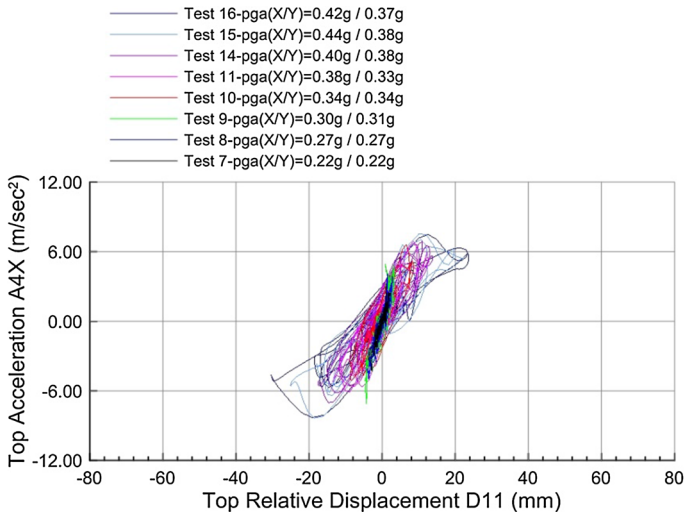
**Fig. 22** TLMBM-BS. Absolute acceleration versus top relative displacement along X direction for Kalamata base motion

The comparison of Figs. 22 and 23 shows the significantly smaller stiffness of the building model along the Y direction, as well as the larger displacements along its weak Y

The hysteresis loops of Figs. 22, 23, 24 and 25 demonstrate the positive effect of the applied interventions, in terms of maximum sustained acceleration, as well as in terms of deformations sustained by the building model.

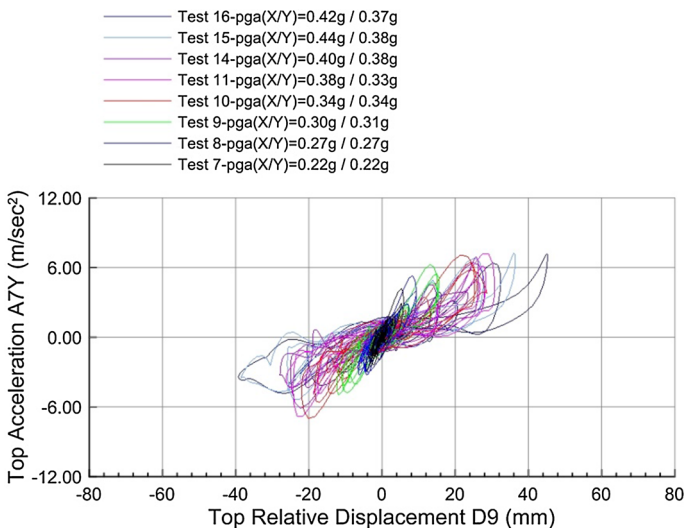
**Fig. 23** TLMBM-BS. Absolute acceleration versus top relative displacement along Y direction for Kalamata base motion

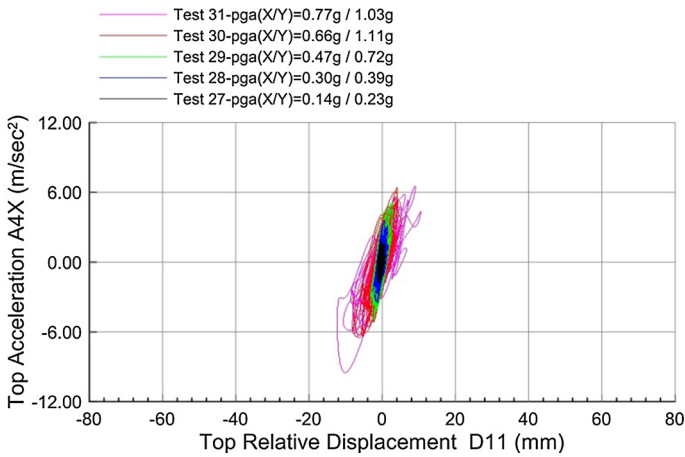
**Fig. 24** TLMBM-AS2. Absolute acceleration versus top relative displacement along X direction for Irpinia base motion

Comparing Figs. 24 and 25, it is evident that the behaviour of the model after strengthening is very similar in both directions. This is not true for the last two tests, where the rocking-sliding mechanism appeared.

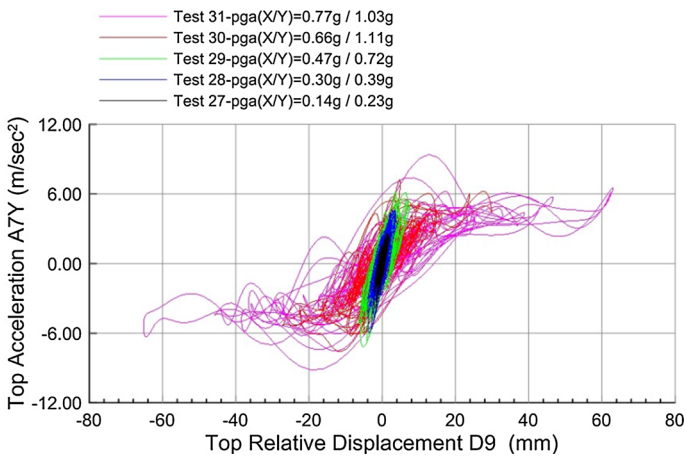
**Fig. 25** TLMBM-AS2. Absolute acceleration versus top relative displacement along Y direction for Irpinia base motion

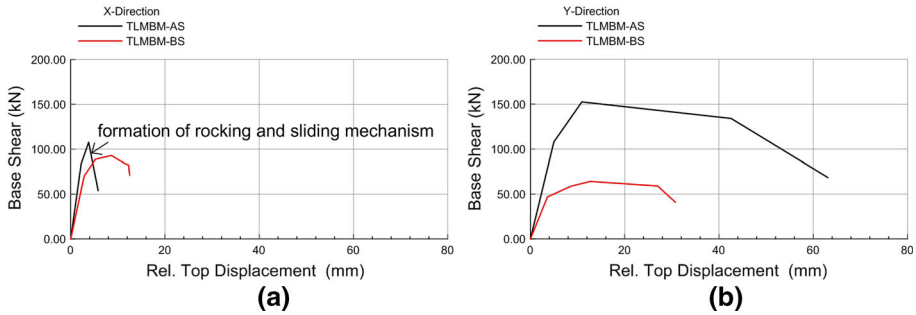
**Fig. 26** TLMBM: Capacity curves before and after strengthening in **a** X-direction and **b** Y-direction

Capacity curves of the tested models were derived as envelopes of the hysteretic loops. The base force was calculated as the sum of inertia forces (the product of the effective mass and the corresponding acceleration) at each floor level. The signals recorded by the displacement transducers at the mid-length of the top floor were used as relative displacement values in X and Y direction. The capacity curves for TLMBM before and after strengthening are presented in Fig. 26, while some key test results are summarised in Table 4.

The comparison of the capacity curves before and after intervention, as well as the data of Table 4 show that the elastic stiffness of the strengthened building model was significantly increased (by more than 50%) in both X and Y directions. An increase in the force-response was also recorded (by 15 and 130% along X and Y direction respectively). This increase in base shear was much higher perpendicularly to the long walls and it is attributed to the beneficial effect of both grouting and enhancing the diaphragm action of the top floor. After strengthening, the behaviour perpendicular to the short walls remains practically elastic for the entire series of seismic tests. During the last seismic test, corresponding to large acceleration values, appearance of the rocking-sliding mechanism led to a pronounced reduction of base shear. It should be noted that an equally high force-response degradation was recorded during the last seismic test perpendicularly to the long walls, as well. However, in this case, an increase of the ductility of the order of 60% was recorded after strengthening. Finally, the building model, after strengthening, was able to undergo high acceleration values with extensive damage, but without collapse.
