# Dowel connections securing roof-diaphragms to perimeter walls in historic masonry buildings and in-field testing for capacity assessment

**Abstract** In the seismic retrofit of existing masonry constructions, global interventions are often needed to inhibit the onset of local mechanisms and to engage the whole building box-like structural behaviour. Such interventions are represented by perimeter ties and roof and floor diaphragms. This paper considers the roof diaphragm strengthening solution and investigates the use of stud connections securing the roof thin-folded shell to the perimeter walls. Stud connections serve the dual purpose of collecting and transferring the out-of-plane inertia forces of the masonry walls to the roof diaphragm, as well as transferring the diaphragm reaction forces to the shear walls. Specific detailing of the stud connection and the adoption of an improved lime-mortar overlay on the top of the masonry walls are proposed to improve the connection strength; without such improvements, the connection capacity would be jeopardised by the reduced shear resistance of the masonry wall due to the absence of significant vertical confining action at the roof l

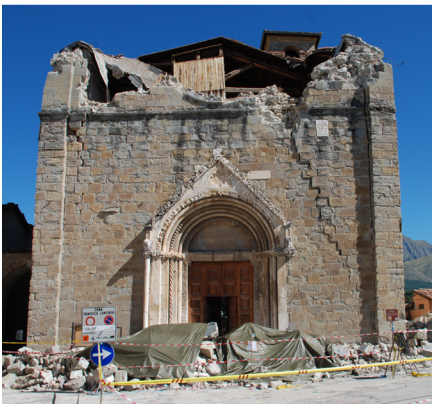
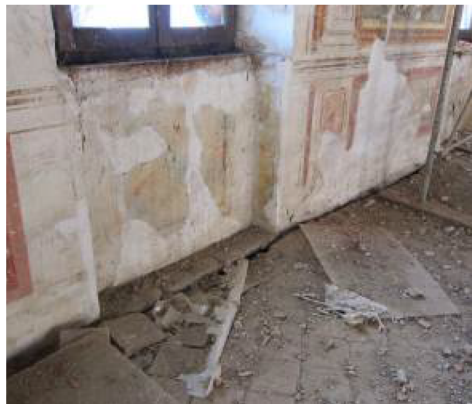
**Fig. 1** Typical failure mechanism involving the overturning of the perimeter walls: **a** overturning of the façade and lateral walls in S. Agostino Church (as it was after the first shock of August 2016); **b** detachment of a perimeter wall in Villa Galvagnina hit by the Emilia earthquake in 2012

The remarkable damage surveyed on historical buildings in the aftermath of recent earthquakes is mainly due to either the poor quality of the masonry walls, or to a lack of conceptual design with respect to horizontal actions, or both. When the quality of the masonry is poor, or when the masonry walls are arranged as two- or three-leaf walls devoid of any interlocking of the leaves, the building may crumble in the event of an earthquake, without the onset of the typical local failure mechanisms involving macro-elements of the buildings. On the other hand, when the quality of the masonry is not an issue, the seismic vulnerability of existing buildings is often caused by the absence of a seismic-resistant structural system or by its poor conceptual design, resulting in the inability of the structure to retain the perimeter walls under out-of-plane seismic loads (Turnšek et al. 1978; D’Ayala and Speranza 2002; Giuriani and Marini 2008a). In the latter case, despite the good quality of the masonry, damage can be so severe as to lead to the total or partial collapse of the building. Wooden floors, vaults and existing timber roofs are unable to inhibit the out-of-plane wall detachment and, in the worst scenario, the wall overturning (Fig. 1). Considering churches, additional damage and collapse of the vaults could be triggered by the rocking motion of the diaphragm arches (Lagomarsino et al. 2004; Giuriani et al. 2009; Ferrario et al. 2009, Fig. 2). Examples of all these typical failures have been repeatedly observed after the recent earthquakes in Central Italy (2016), as for instance in the church of Sant’Agostino in Amatrice, where the major damage was caused by the onset of the overturning of the façade and the lateral walls (Fig. 1a), or in Sant’Emidio church, housing the civic museum in Amatrice, where severe rocking of the nave arches was observed (Fig. 2c).

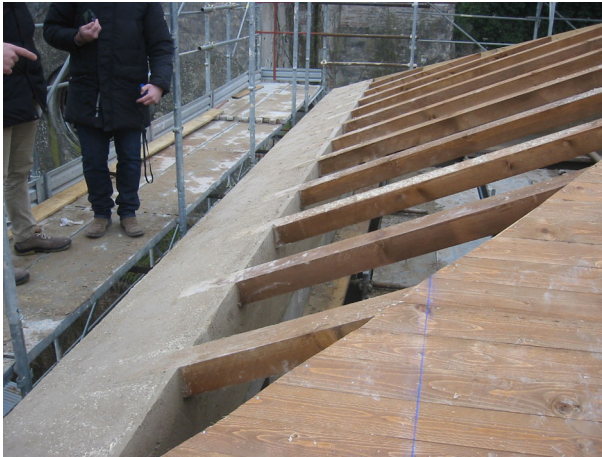
**Fig. 8** View of the thick lime mortar layer, pre-consolidating the top portion of the peripheral walls

In this paper, pre-consolidation of the top of the masonry walls to increase the capacity of the connection is proposed. Pre-consolidation can be obtained by rearranging the top courses of the masonry by repositioning or replacing any loose stones and bricks and by using good quality mortars, and by introducing a thin structural lime mortar layer on top of the masonry walls (Figs. 7a, 8). Indeed, when the thickness of the mortar layer is greater than the effective length of the dowel (Gelfi et al. 2002), the connection can be assumed as a dowel completely embedded into a homogeneous material and the maximum capacity of the dowel is exploited, as explained in the next section. In this scenario, the improved lime mortar overlay allows the shear loads to be spread as tangential stresses along the interface

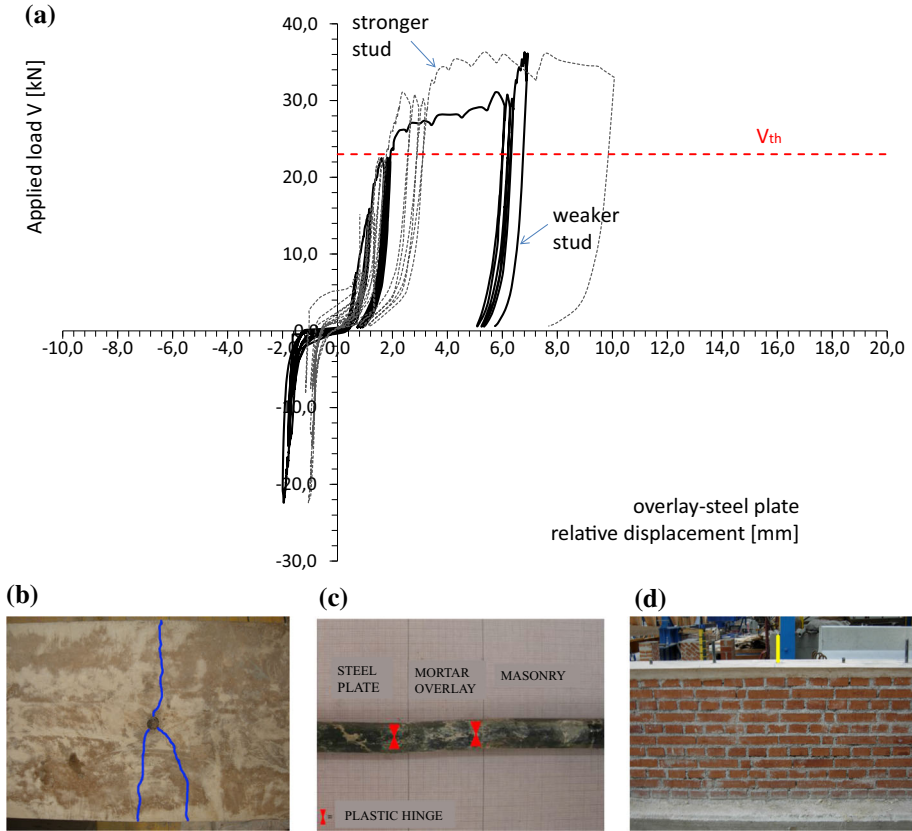
**Fig. 11** Specimen A featuring a high strength mortar overlay: **a** typical load–displacement curve obtained from laboratory cyclic tests for the weaker (a) and stronger (a′) stud connection (see the “Appendix”). The connection yielded at a shear load of 38 kN. **b** At failure, cracks developed radially from the stud to the mortar overlay edges and **c** collapse was reached with two plastic hinges developing in the stud shank in the portion embedded in the steel plate and in the mortar overlay. **d** No crack pattern developed in the masonry

In the experimental test, load cycles equal to multiple of  $\pm 7.5$  kN were applied to the connections up to failure. Figure 11 shows the typical load–displacement curve obtained from the tests on the stud connections for the first pairs of studs in Specimen A (Fig. 10b). The initial low stiffness branch of the curves is associated with the recovery of the clearances between the stud and the vertical connecting pipes fixed to the plates of the LTF. In the case of tight fitting connections or in the case of welding of the stud to the steel pipe such low stiffness of the curve segment would have been removed. All tested connections exhibited a ductile failure, with the development of two plastic hinges in the stud shank: one plastic hinge in the portion embedded in the mortar overlay and one developing along the portion driven into the steel pipes. It is worth noting that the sole stud connection at the edge of the wall (position 1' in Fig. 10b) showed a different failure mechanism,

Besides the small initial clearance recovery, pinching of the curve is also induced by the incremental damage of the mortar layer due to repeated load reversal. Collapse occurred with thinner cracks opening radially around the stud head in the mortar overlay (Fig. 11b), and the envisioned two plastic hinge mechanism of the connector (Fig. 11c). Results obtained from the four tests carried out on Specimen A are summarised in the “Appendix”. For the tested connections, the average yielding displacement and load are equal to  $s_{y,av} = 1.67$  mm and  $V_{y,av} = 29.5$  kN, respectively. The average capacity is  $V_{max,av} = 34.7$  kN. The average shear load at 1 mm slip after clearance recovery is  $V_{1,av} = 28.8$  kN.

By comparing Figs. 11a, 12a and 13a, it can be observed that the stud connections tested on Specimen A, featuring a high-performing mortar overlay, remarkably outperformed the stud connections of both Specimen B and C. Pinching of the curve is still observed in Fig. 11a but its amplitude is almost halved with respect to the tested connections of Specimens C. The same observation applies to the reduction of the net cyclic stiffness, which confirms a reduction in the incremental damage of the mortar layer for increasing load reversal with respect to Specimens C.

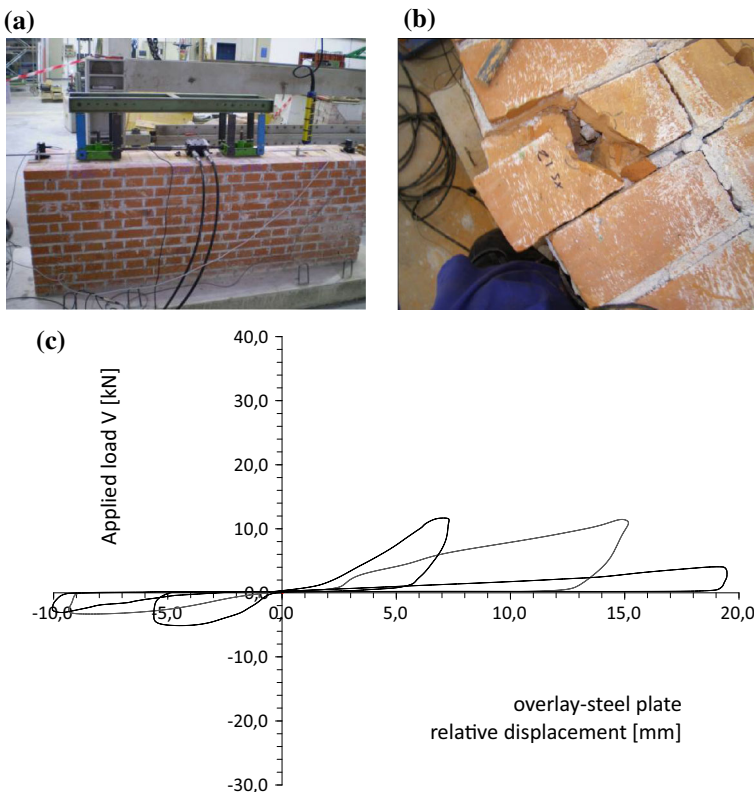
**Fig. 12** Specimen B. Details of the specimen **a** before and **b** after the laboratory tests. **c** Envelope load–displacement curves obtained in three different cyclic tests; studs with 20 mm diameter and 400 mm embedment length collapsed for shear loads ranging between of 5 ÷ 10 kN with sliding shear failure of the upper layers of bricks

The typical load–displacement curve obtained from the tests on the stud connections in Specimen B, lacking the lime mortar overlay, is plotted in Fig. 12c. As expected, no remarkable shear capacity is observed if no strengthening of the top of the masonry wall is considered. The curve shows a very low connection capacity which is usually associated with the early failure of the connection due to either: (a) overcoming sliding shear resistance along the masonry bed joints, caused by the reduced friction resistance in the absence of vertical loads; (b) crushing of the bricks induced by the high stress concentration; or

(c) diagonal shear failure of the corner portion of the masonry wall. Average connection capacity is approximately equal to 4.5 kN, and is related to a relative displacement between the steel plate and the overlay of about 3 mm. Collapse is brittle, with crushing of the upper layer of bricks (Fig. 11b), which are unable to withstand the high stresses transferred by the stud connection.

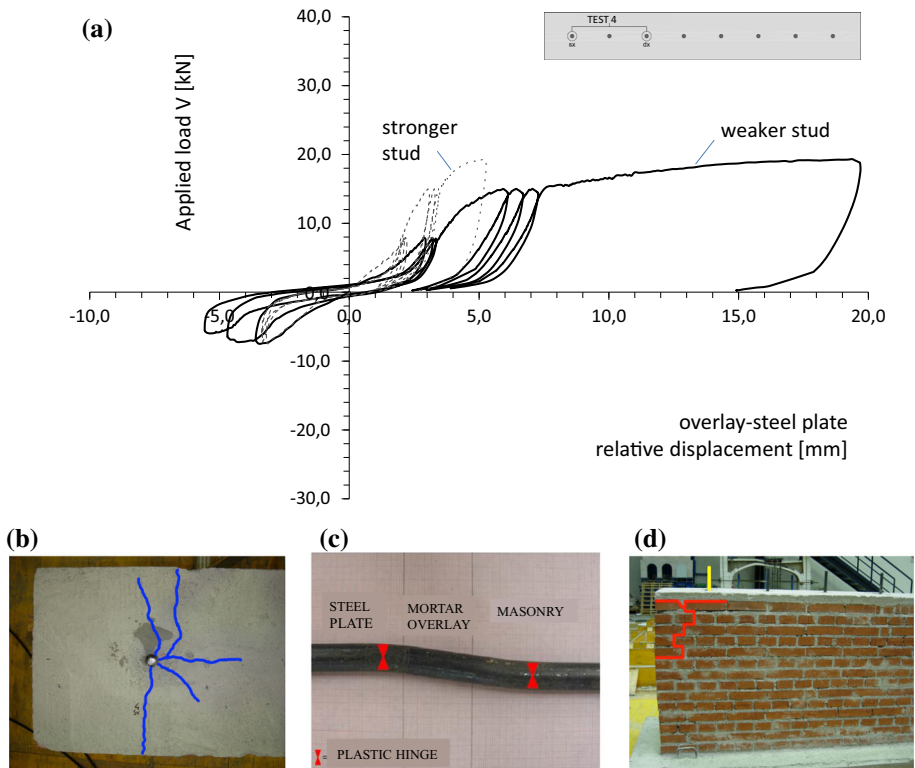
**Fig. 13** Specimen C with low strength mortar overlay: **a** typical load–displacement curve obtained in laboratory cyclic tests (Specimen C, Test 4, see the “Appendix”). The stud connection yielded at a shear load of 15 kN. **b** At failure, cracks developed radially from the stud to the mortar overlay edges and **c** collapse was reached with two plastic hinges developing in the stud shank in the portion embedded in the steel plate and in the masonry. **d** Sliding shear failure of the upper brick layers at the masonry wall corner

Figure 13 shows a typical load–displacement curve obtained from the tests on the stud connections in Specimen C. The initial gap of the curve follows the slackness recovery, whereas the remarkable pinching of the curve is increased by the progressive plasticisation of the mortar overlay. The substantial reduction of the net cyclic stiffness for different cycles at equal load provides evidence of the incremental damage of the mortar layer due to increasing load reversal. Results obtained in the 4 tests carried out on Specimen C are summarised in the “Appendix”.

For the weaker connection, the average shear load at 1 mm net of relative slip is equal to  $V_{l,av} = 8.6$  kN, whereas the yielding displacement and load are equal to  $d_{y,av} = 3.2$  mm and  $V_{y,av} = 16.8$  kN, respectively. The average capacity is  $V_{max,av} = 17.9$  kN. The connection illustrated in Fig. 13 shows an example of ductile failure, with cracks spreading radially across the mortar overlay and two plastic hinges in the stud, one within the steel plate and one within the masonry; the development of plastic hinges in the stud was followed by the masonry failing in sliding shear.

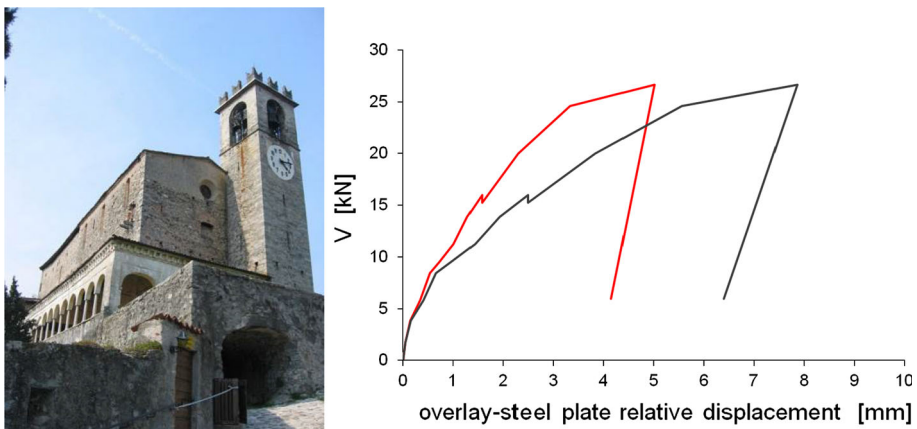
**Fig. 15** Example of in situ tests. Madonna della Rocca, Sabbio Chiese, Italy

As an example, Fig. 15 shows the results obtained from the shear tests carried out on the connections securing the roof shell structure to the masonry walls in the “Madonna della Rocca” Church, a sanctuary located in Sabbio Chiese (Brescia, Italy) which was significantly damaged by the Salò earthquake in 2004. The top of the masonry walls are made of rubble stone masonry of good quality. The quality of the masonry was judged based on the procedure proposed by Borri et al. (2015). The top of the perimeter masonry walls is strengthened with a high-performance premixed lime mortar overlay of 50 mm. The mechanical properties of the premixed improved lime mortar are the same as those used in Specimen A. 20 mm S355 studs were driven into 400 mm depth holes, vertically drilled in the masonry wall with a core drill. The stud heads were spot-welded to the steel plates of the testing apparatus.

The load–displacement curves of monotonic shear tests are shown in Fig. 15b. Thanks to the spot-welding of the stud heads no initial gap in the curve is observed. For the weaker connection, the shear load at 1 mm relative slip is equal to  $V_1 = 10$  kN, whereas the yielding displacement and load are equal to  $d_y \cong 5.6$  mm and  $V_y \cong 24$  kN, respectively. Collapse occurred with thinner cracks opening radially around the stud head in the mortar overlay, and following the onset of the envisioned 2 plastic-hinge mechanism of the connector.

The experimental yielding strength compares well with the theoretical prediction obtained from Eq. 1, which yields  $V_{th} = 23.5$  kN (with  $d = 20$  mm,  $\chi = 2$ ,  $a = 27$  mm,  $f_{mh} = 44$  MPa,  $f_y = 355$  MPa yielding an effective length of about:  $l_{ef} = 27$  mm = 1.33 d). The spacing of the connection was selected to provide a capacity equal to twice the design load in order to obtain an over-resistant system.

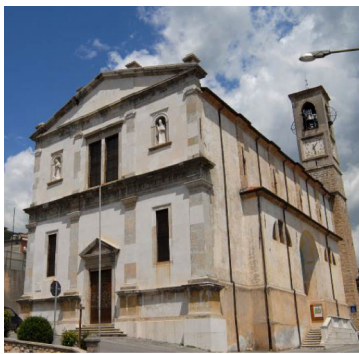
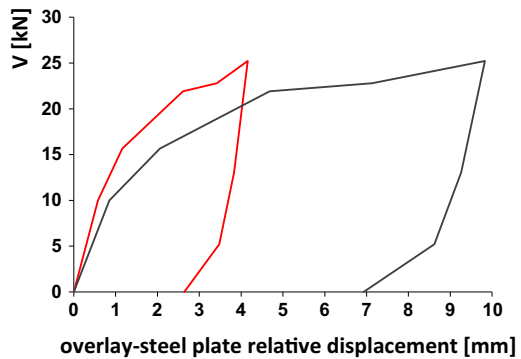
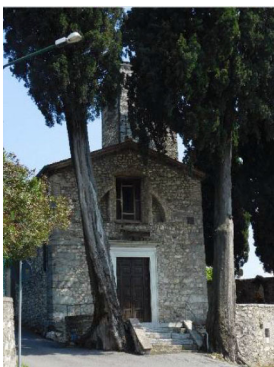
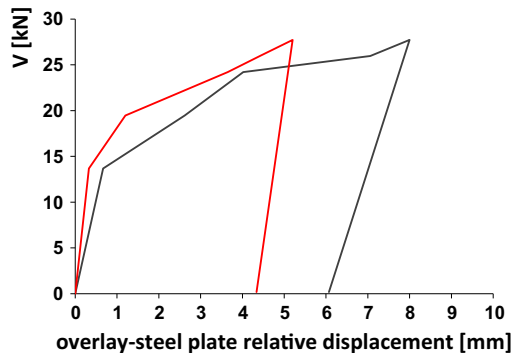
**Fig. 16** In-situ tests results obtained in two Churches in northern Italy. **a** S. Maria Assunta, Bione, Italy. **b** SS. Trinità, Roè Volciano, Italy

Other examples of in situ test results carried out on two churches located in northern Italy are shown in Fig. 16. Both churches are made of rubble stone masonry of good quality (Borri et al. 2015). The materials used for the thin lime mortar overlay and for the roof shell structure are the same as those adopted in the Madonna della Rocca Church. The experimental yielding strength  $V_y$  compares well with its theoretical prediction in these cases as well, confirming the reliability of the theoretical model.

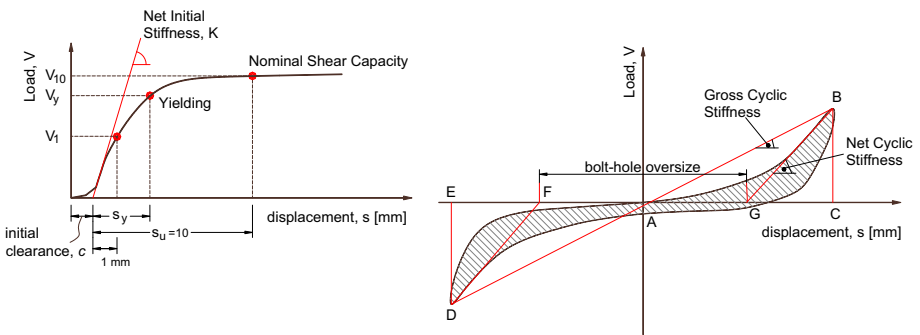
**Fig. 17** Main properties of the envelope curve and properties of the single load cycle
