Preliminary data and field observations of the 21st August 2017 Ischia earthquake

On 21st August 2017, an earthquake (M_L 3.6; M_W 3.9; M_d 4.0) struck the municipality of Casamicciola Terme on the island of Ischia, Italy. It was a peculiar earthquake: low magnitude, very superficial (focus depth of about 1.7 km), centered in a high population density area. Despite the island was historically struck by destructive earthquakes during the last centuries, buildings vulnerability in the area was high. Many masonry buildings (main structural typology in Casamicciola Terme and on the island) collapsed or were severely damaged, occasionally exposing the original, dating back to end of nineteenth century, wooden frame that is one of the first examples of code designed anti-seismic structures in Italy. In this study, preliminary data and field observations of the 21st August 2017 Ischia earthquake are given. First, data from the permanent seismic network are used to assess seismic input characteristics and compare them to the known seismic hazard. Building vulnerability is then analyzed via the results of field observations carried out soon after the seismic event, thus providing significa

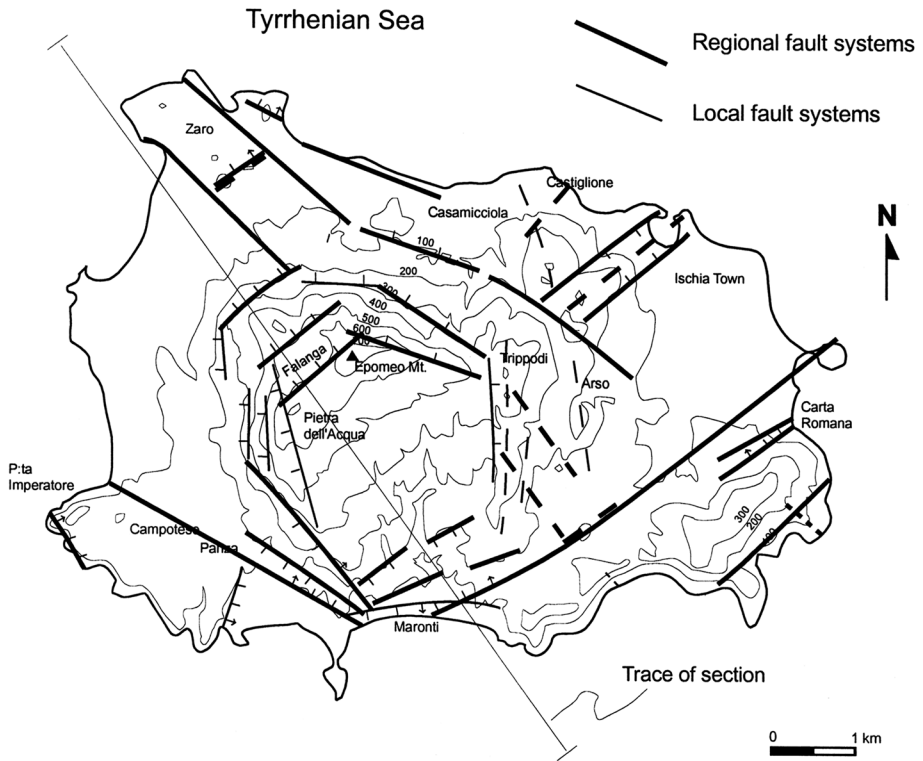
Fig. 4 Location of the main faults of Ischia island (arrows display dipping; hatches on the downthrown side; dashed lines = volcano – tectonic alignments). After Acocella and Funicicello (1999)

The final earthquake assessment was consistent with the island historical seismicity. The structural features of the island are quite complex because deformation patterns in volcanic areas are the result of stresses applied at regional and local scales. The former induces fractures which may constitute preferred pathways for the rise of magma while the latter is induced by the emplacement of magma or by gravity (Acocella and Funicello 1999). This produces a large number of fault systems as shown in Fig. 4. In particular, the NE-SW and

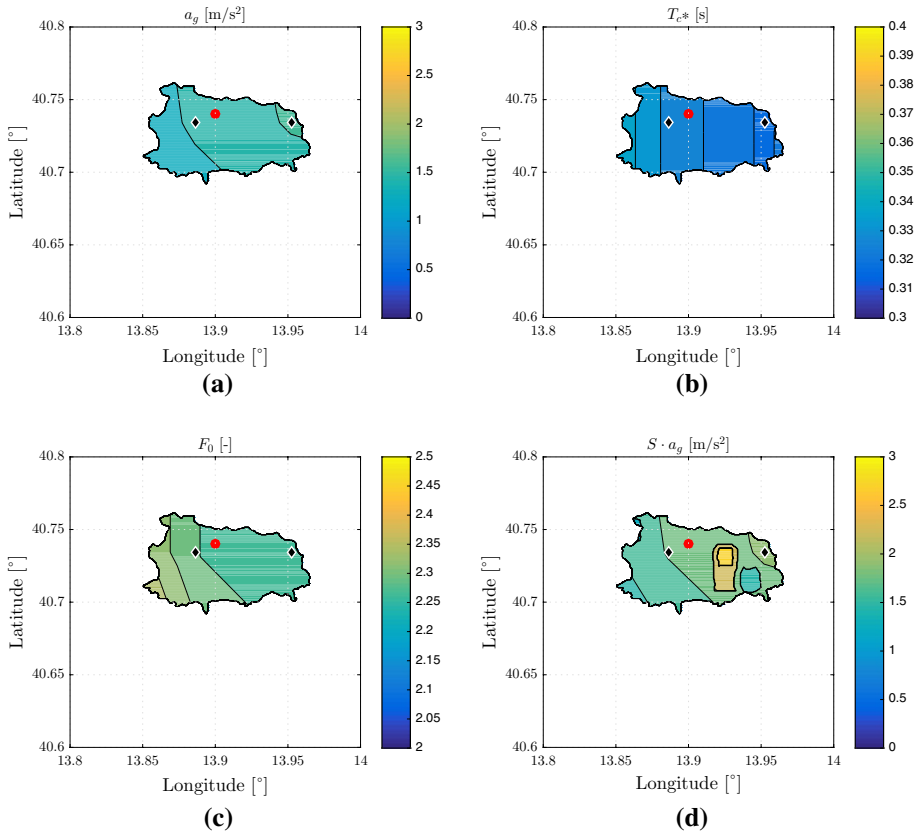
Fig. 7 a_g (a), T_C^* (b), F_0 (c), $S \cdot a_g$ (d) with 10% probability of exceedance in 50 years (return period 475 years) according to Italian Building Code (NTC; MIT 2008) for the Ischia island. The red dot indicates the epicenter of the seismic event of the 21st August 2017. The black squares indicate the location of the nodes coming from the Italian Building Code (NTC; MIT 2008)

a return period equal to 475 years. In particular, it is visible that the maximum horizontal ground acceleration considering the soil effect is around 2 m/s^2 with peaks up to 3 m/s^2 where amplifications due to the soil are predicted. However, the seismic ground classification reported in Fig. 6 may be inaccurate at this small scale and is intended as the best available proxy to the real one.

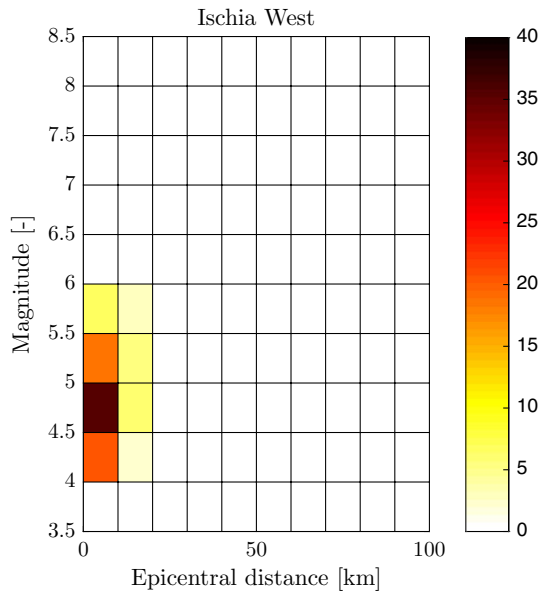
Fig. 8 Disaggregation of the peak ground acceleration, a_g , with return period 475 years for Ischia West (LAT: 40.7343, LON: 13.8862, ID: 33639). Data from <http://esse1-gis.mi.ingv.it> (INGV-DPC 2006)

The 475 years return period disaggregation of the peak ground acceleration for Ischia West (Lat: 40.7343, Lon: 13.8862, ID: 33639) is shown in Fig. 8. For the same local soil conditions, the intensity of the ground shaking at the site mainly depends on the magnitude, M , and source-to-site distance, R , of the causative event (Bazzurro and Allin Cornell 1999). The disaggregation was performed according to the procedure reported in Spallarossa and Barani (2007). The disaggregation of the peak ground acceleration is available only at grid points (shown in Fig. 7); in Fig. 8, it is only reported the closest grid point to the epicenter. However, it is noteworthy that negligible differences were found between the east and west parts of Ischia, with differences lower than 1%. Seismic hazard in Ischia is mainly dependent on local and low energy events, with a magnitude in the range 4–5.5, and epicentral distance smaller than 10 km. This is compatible with the 2017 Ischia earthquake.

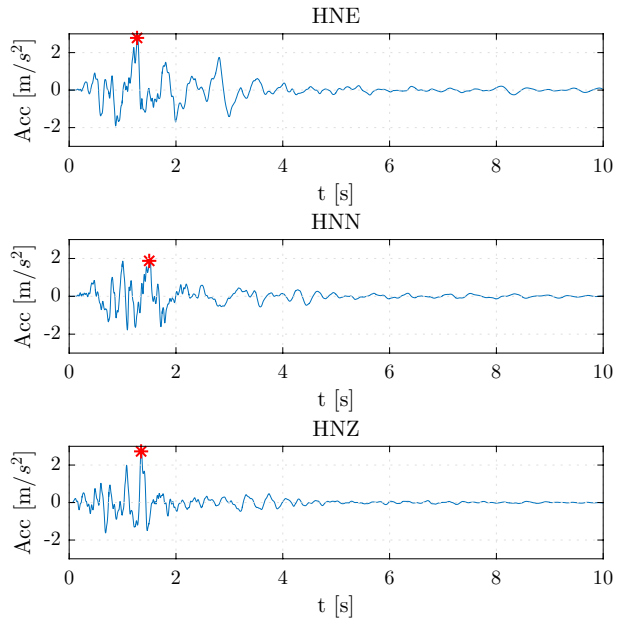
Fig. 9 Acceleration time histories for the three components (HNE: East component; HNN: North component; HNZ: Vertical component) for the Ischia-Osservatorio Casamicciola seismic station (Code: IOCA) for the 21st August 2017 earthquake. The red asterisks indicate the absolute maximum. (Data provided by INGV-Osservatorio Vesuviano)

The acceleration time histories and the 5% damped elastic response spectra are shown in Fig. 9 while Table 3 reports some features of the strong motion. Arias intensity (I_A) is a duration related intensity measure that represents the total earthquake input energy per unit weight for a set of undamped elastic oscillators with frequencies uniformly distributed from zero to infinity (Arias 1970). It is the area under the square of ground acceleration, $a(t)$, and it can be an indicator of potential destructiveness in ground motions:

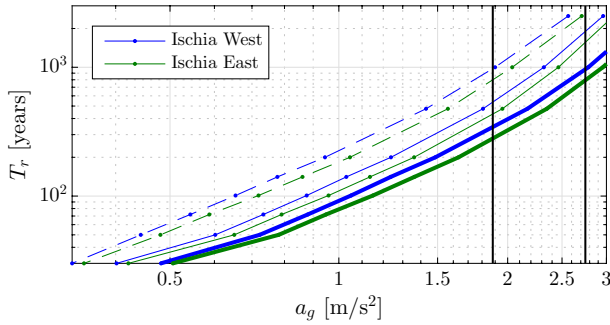
Fig. 11 Hazard curves in terms of a_g for Ischia Island according to the Italian Building Code (NTC; MIT 2008). The colored dashed lines are the hazard curve on soil type A and neglecting the topographic effects. The colored thin solid lines are the hazard curve on soil type B and neglecting the topographic effects. The colored thick solid lines are the hazard curve on soil type B and considering topographic effects (i.e., topographic amplification factor equal to 1.2). The vertical black solid lines are the maximum values of PGA recorded by the Ischia-Osservatorio Casamicciola seismic station (Code: IOCA) for the two directions (HNE and HNN) for the 21st August 2017 earthquake

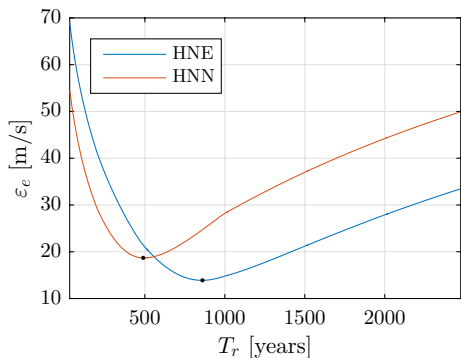
Fig. 12 Variation of ε_e (Eq. 5) for different T_r for the East component (HNE) and North component (HNN). The two black dots on the curves are the minimum of the function $\varepsilon_e(T_r)$

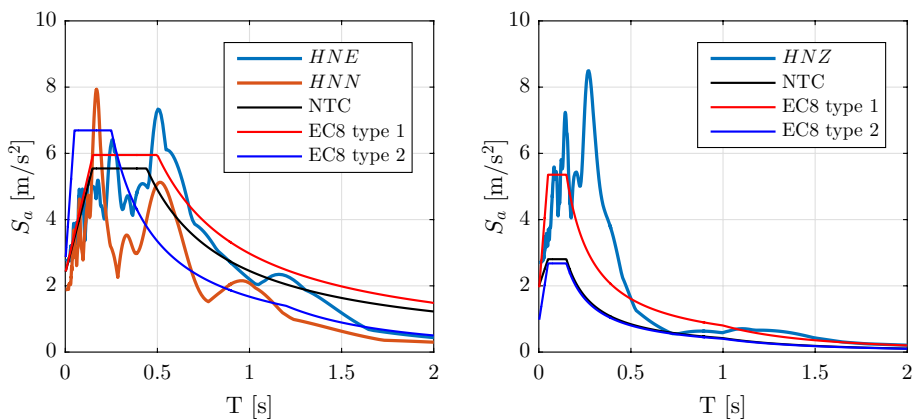
Fig. 13 Comparison of the measured elastic response spectra (HNE: East component; HNN: North component; HNZ: Vertical component) and design elastic response spectra of the Italian Building Code (NTC; MIT 2008) and Eurocode 8 (CEN 2004) type 1 and 2 evaluated with return period 860 years for damping equal to 5%, soil class B for the horizontal (left) and vertical (right) components of the event of the 21st August 2017 earthquake at Ischia

Figure 13 shows a comparison of the measured and design elastic response spectra according to the Italian Building Code (NTC; MIT 2008) and Eurocode 8 (CEN 2004) type 1 and 2, with 5% damping, 860 years return period, soil class B (i.e., the same soil class as the IOCA instrument). In particular, Eurocode 8 (CEN 2004) considers two different types of spectral shapes (type 1 and type 2) for varying seismicity conditions. In this regard, provisions of Eurocode 8 (CEN 2004) state: “If the earthquakes that contribute most to the seismic hazard defined for the site for the purpose of probabilistic hazard assessment has a surface wave magnitude, M_s , not greater than 5.5, it is recommended that the Type 2 spectrum is adopted”. In this case, being the analyzed earthquake characterized by a low magnitude, type 2 should be adopted.

Looking at Fig. 13, it can be seen that the Italian Building Code (NTC; MIT 2008) and Eurocode 8 (CEN 2004) type 1 vertical spectra strongly underestimate the vertical effects. This is probably due to near-field effects (Grimaz and Malisan 2014) that are not considered by the uniform hazard spectrum (e.g., Demartino et al. 2018). On the other hand, as expected, Eurocode 8 (CEN 2004) type 2 spectrum gives a better estimate of the measured response spectrum.

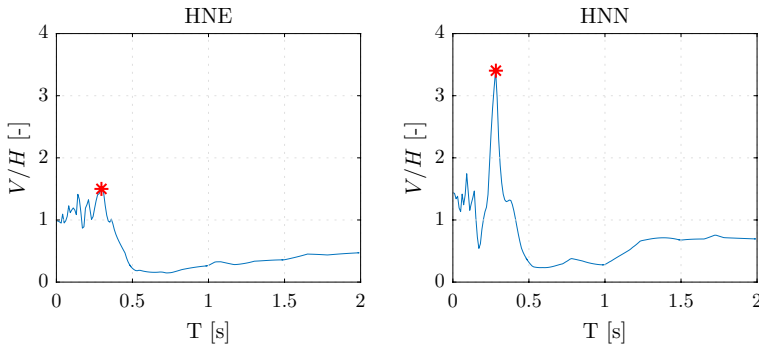
Fig. 14 V/H PGA ratio in terms of spectral components for the two horizontal components (HNE: East component; HNN: North component) for the Ischia-Osservatorio Casamicciola (code: IOCA) for the 21st August 2017 earthquake. The red asterisks indicate the absolute maximum

Figure 14 shows the ratio between elastic response spectra (damping 5%) in the vertical and horizontal directions (i.e., HNE and HNN), namely V/H ratio. The largest value is 3.4,

at a fundamental period equal to 0.28 s in the north direction. At zero period (i.e., PGA), the ratio is within 0.98 (east) and 1.44 (north). Literature V/H PGA ratios (e.g., Collier and Elnashai 2001; Bozorgnia and Campbell 2016) indicate values above 1 within a 5 km radius of earthquake source, higher than $2/3$ within 25 km; they further show dependence on earthquake magnitude. The V/H PGA ratios of the Ischia earthquake appear to confirm these findings (the IOCA seismic station was 600 m away from the epicenter).

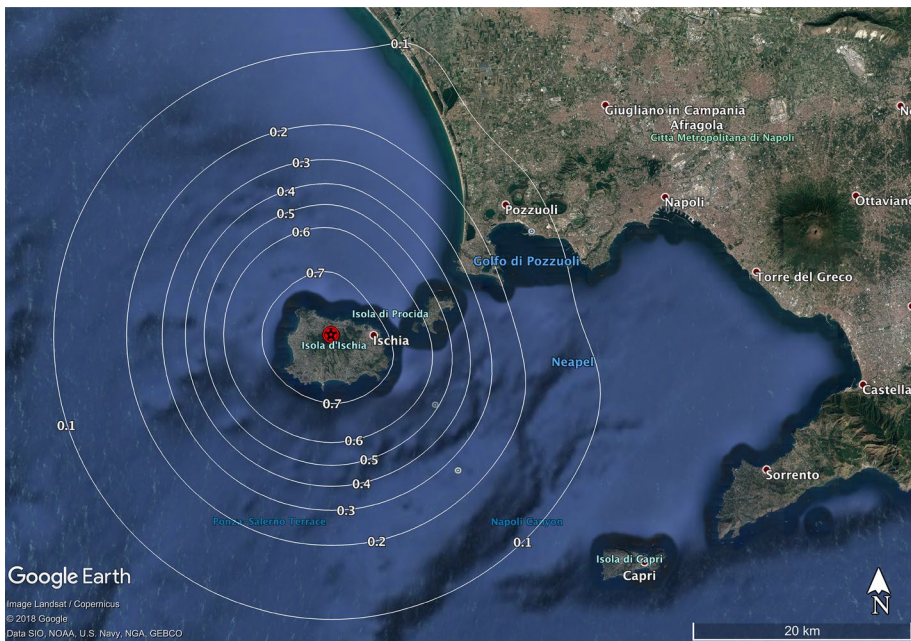
Fig. 15 ShakeMap for the 21st August 2017 Ischia earthquake. Event location and magnitude from INGV seismic center, peak ground motion data from INGV (red star). Intensities expressed in terms of PGA [m/s^2]. The blue triangle indicates the seismic station of Pozzuoli (code: CPIS). (From Google Earth)

Figure 15 shows the ShakeMap for August 21, 2017, Ischia earthquake in terms of PGA (Michelini et al. 2008). Almost the whole island experienced horizontal PGA values larger than 0.9 m/s^2 . This particular shakemap, however, is pretty non-informative. Results are biased, as the almost circular iso-accelerations curves show, because only two seismic stations were near the epicenter: (1) Ischia-Osservatorio Casamicciola (code: IOCA) and (2) Pozzuoli (code: CPIS, around 20 km from the epicenter).

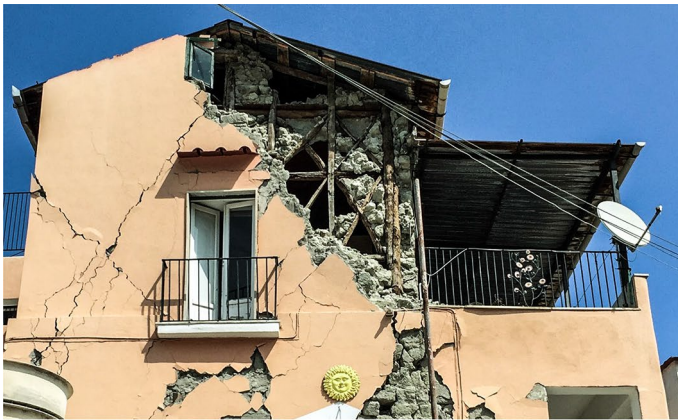
(a)

Generally speaking, this structural typology showed better seismic performances with respect to more recent masonry structures realized with poorly construction practice. Figure 20a showed a typical example of complete damage (i.e., separation between infill and frame) of a “*Casa baraccata alla Beneventana*” construction (two storeys) located in piazza Maio near the epicenter (see Fig. 3b). The damage was mainly localized at

Fig. 20 Complete damage of “*Casa baraccata alla Beneventana*” constructions: **a** piazza Maio (Lat: 40.7425–Lon: 13.9013); **b** viale Paradisiello (Lat: 40.7451–Lon: 13.909)

the corner of the building unit just below the roof system made of light corrugated roof panels supported by timber beams. It can be clearly observed the beneficial effect of the timber frame that continued to support the roof system also when the upper part of the masonry was totally damaged. Similar observations can be done for the case reported in Fig. 20b although it can be clearly seen that the original structure was modified with the addition of reinforced concrete parts such as the balcony, the third floor and the presence of new openings.

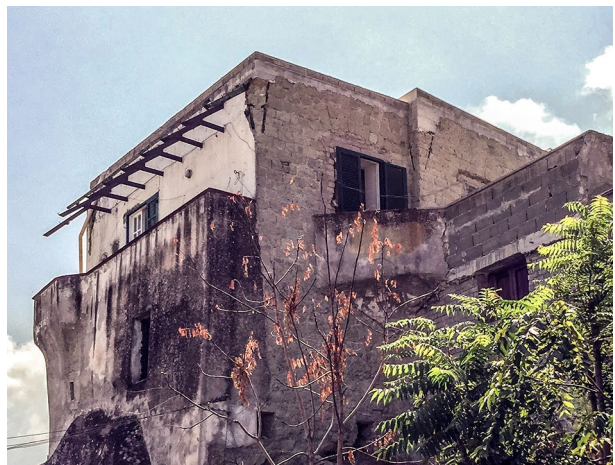
Fig. 21 Undamaged leaf tuff masonry construction with iron tie rods-via provinciale Lacco Fango (Lat: 40.7462–Lon: 13.8899)

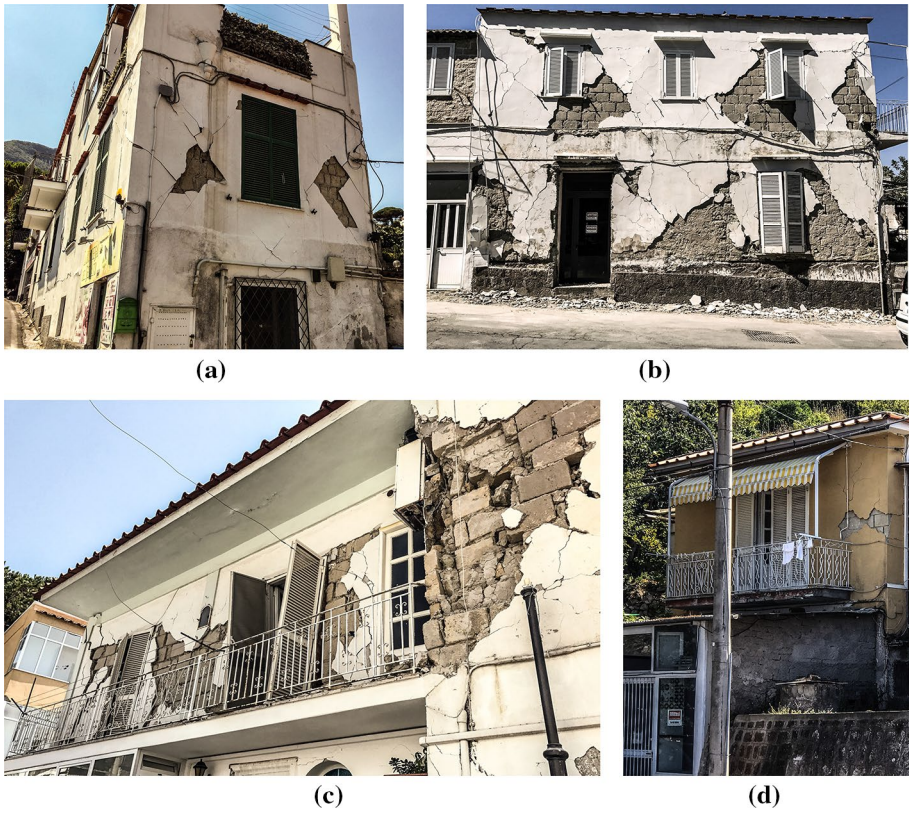
Fig. 22 In-plane storey shear mechanism of leaf tuff masonry constructions: **a** via Principessa Margherita (Lat: 40.7452–Lon: 13.9068); **b** near piazza Maio (Lat: 40.7423–Lon: 13.902); **c** near piazza Maio (Lat: 40.7436–Lon: 13.8976); **d** via Montecito (Lat: 40.7412–Lon: 13.8968)

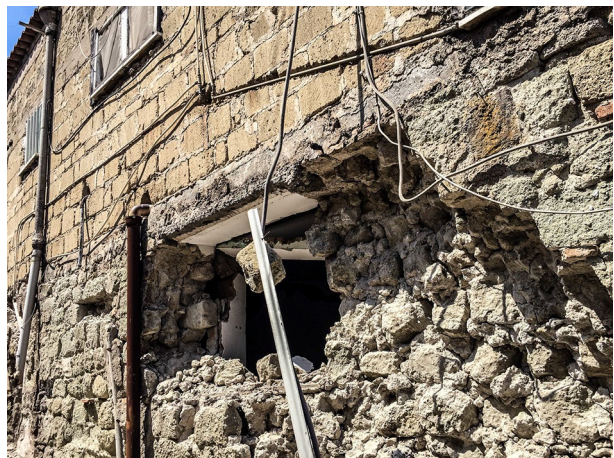
Fig. 23 Failure of the outer wythe of wall: via Epomeo (Lat: 40.742–Lon: 13.9006)

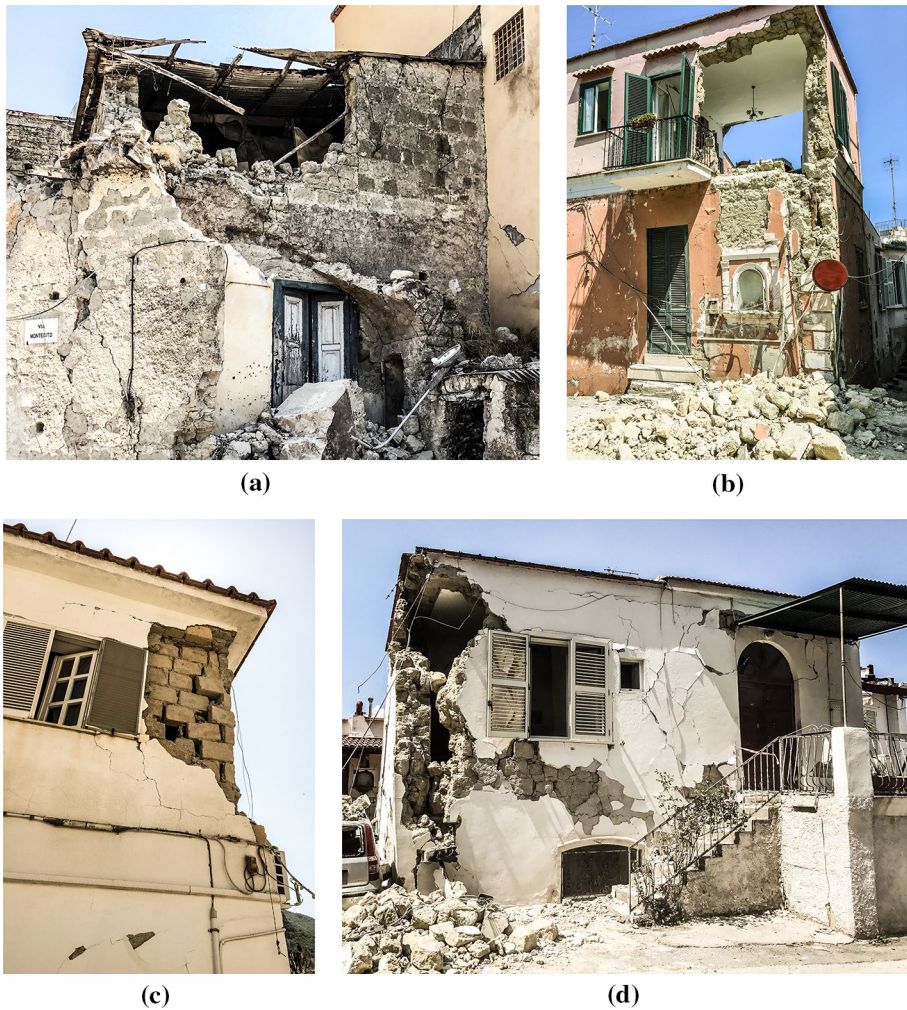
Fig. 24 Damage at building corners: **a** via Montecito (Lat: 40.742–Lon: 13.8995); **b** viale Ottringolo (Lat: 40.7428–Lon: 13.9023); **c** via D’Aloisio (Lat: 40.7434–Lon: 13.8976); **d** via Montecito (Lat: 40.7419–Lon: 13.8995)

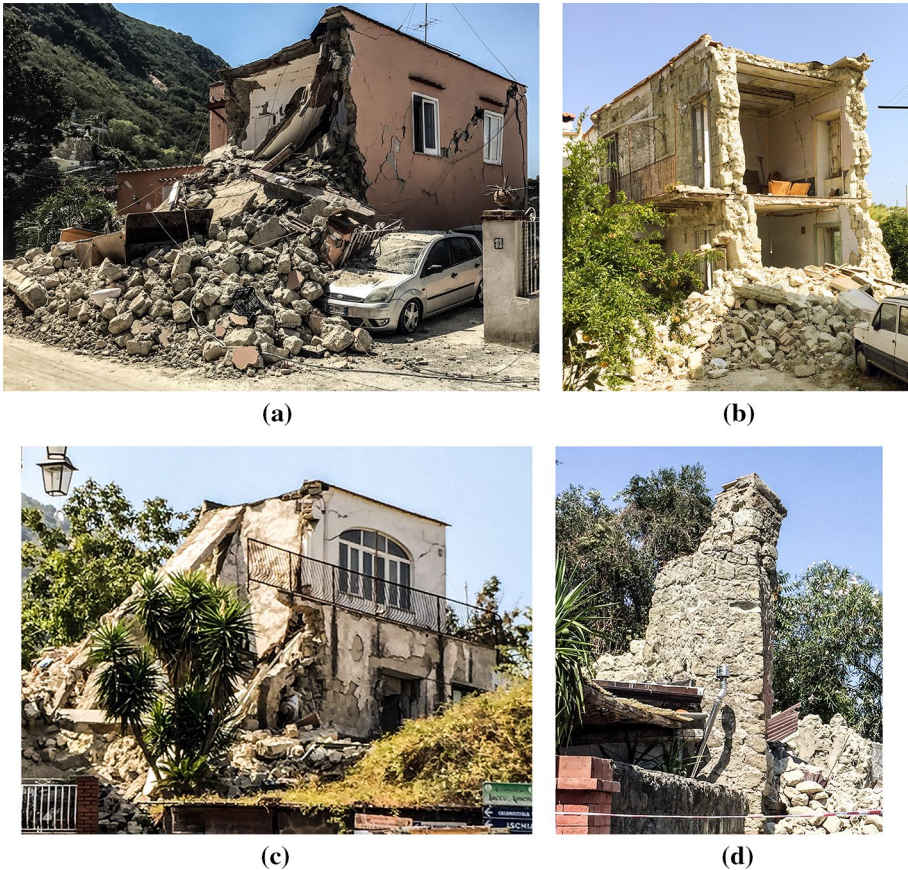
Figure 25 reports the case of the collapse of leaf tuff masonry construction or a portion of construction. In particular, Fig. 25a depicts the collapse of a portion of a two-storey building that was characterized by an irregular L shaped footprint leading to torsional effects. In the part that remained standing, the typical in-plane storey shear mechanism is well visible. The collapse was probably induced by the poor quality of masonry and

Fig. 25 Collapse of leaf tuff masonry construction: **a** via Montecito (Lat: 40.7419–Lon: 13.8995); **b** via Montecito (Lat: 40.7425–Lon: 13.8893); **c** via Borbonica (Lat: 40.7435–Lon: 13.8882); **d** piazza Maio (Lat: 40.7425–Lon: 13.9011)

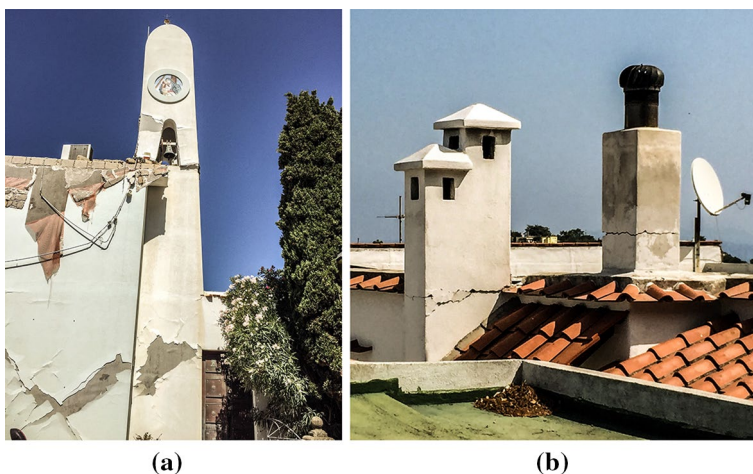
Fig. 26 Damage of: **a** the bell tower of the “*Chiesa di santa Maria dei Suffragi*” via provinciale Lacco Fango (Lat: 40.7458–Lon: 13.8903); **b** masonry chimney pot-via Montecito (Lat: 40.7413–Lon: 13.8964)

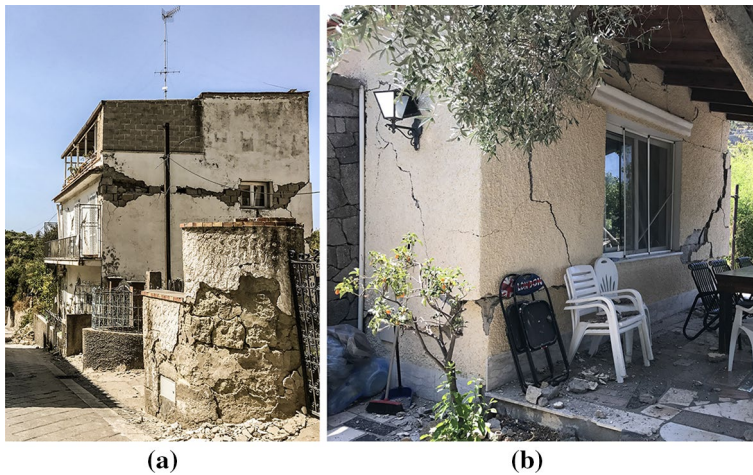
A common type of construction in Ischia Island is the hollow cement bricks technology, sometimes called *Cellublok*. Concrete hollow blocks are usually made from cast concrete (e.g. Portland cement and aggregates, usually sand and fine gravel, for high-density blocks). The typical *Cellublok* construction is formed by a concrete foundation and

Fig. 27 Damage of a Cellublok constructions: **a** three storeys building-via D'Aloisio (Lat: 40.7434–Lon: 13.8978); **b** single storey building near via Montecito (Lat: 40.7415–Lon: 13.8947)

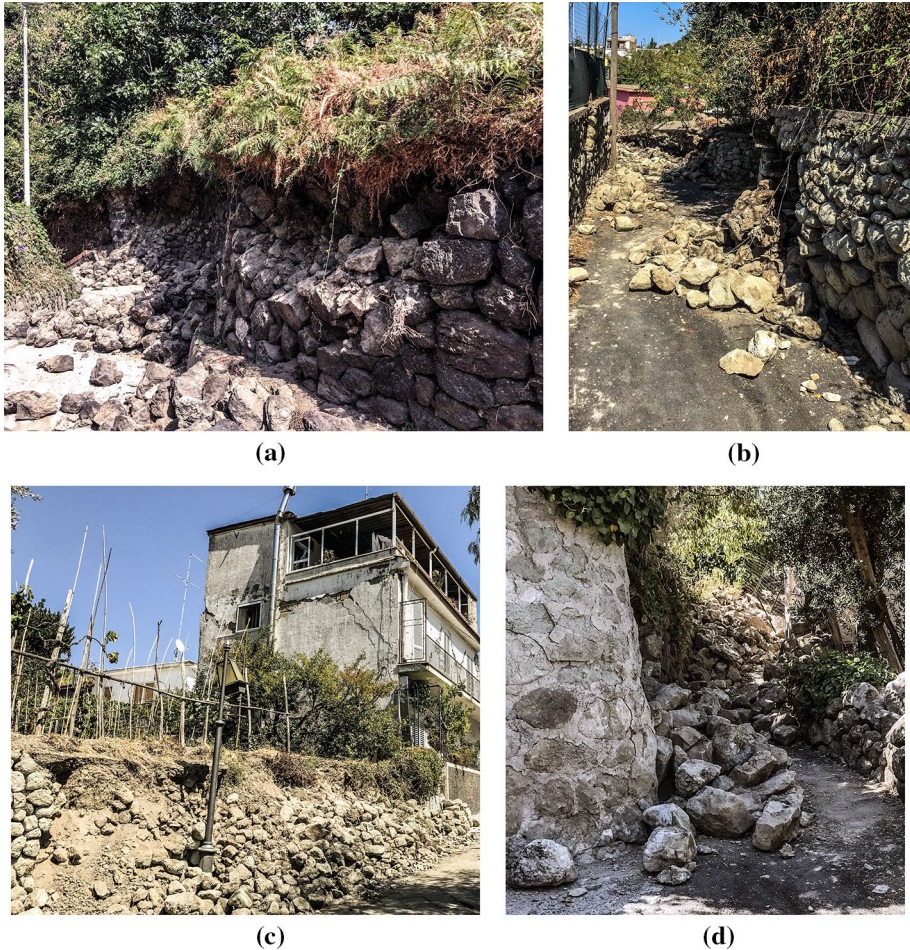
During the survey, collapse phenomena of dry stone masonry cantilever retaining walls were observed in the investigated area. This structural typology made of stones without any mortar to bind them together is quite diffused on Ischia Island for retaining walls. Built by skilled masons, dry stone walls rely on careful selection and positioning of stones for their integrity. Figure 28 shows four different examples of collapses of dry stone masonry walls used for retaining walls. Due to the absence of mortar, the collapse (i.e., partial wall overturning) occurred in the out-of-plane direction due to the low moment capacity of the wall generated by the negligible tensile strength. In all the observed collapses, the masonry was found disrupted after the collapse. In many cases, the debris leads to the blockage of some street sections (Fig. 28) creating problems for the emergency services and disaster recovery responses. On the other hand, reinforced concrete retaining walls exhibited a good seismic response without damage observed.

Fig. 28 Collapse phenomena of dry stone masonry retaining walls: **a** via Paradisiello (Lat: 40.7465–Lon: 13.908); **b** near via D’Aloisio (Lat: 40.7428–Lon: 13.8956); **c** near corso Garibaldi (Lat: 40.7435–Lon: 13.8974); **d** via Iasolino (Lat: 40.7417–Lon: 13.8949)
