Out-of-plane seismic retrofitting of masonry walls with Textile Reinforced Mortar composites

Stefano De Santis¹ · Gerardo De Canio² · Gianmarco de Felice¹ · Pietro Meriggi¹ · Ivan Roselli²

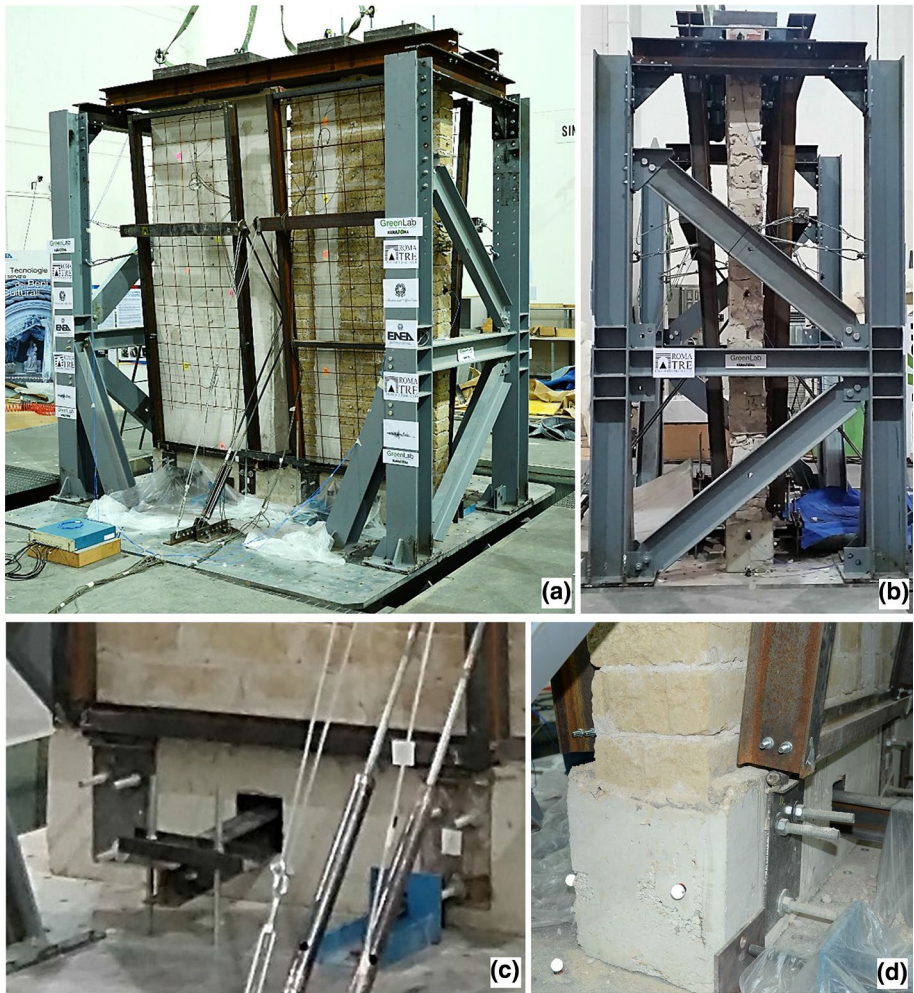
Fig. 1 Perspectival (a) and lateral (b) views of the experimental setup for shake table tests, with details of the anchoring system to the shake table (c) and of the retaining hinged steel frames (d)

On top of each wall, a 1530 mm × 270 mm × 250 mm reinforced brickwork top beam ($\gamma = 18$ kN/m³) was built with four layers of clay bricks and an M15 class (according to EN 998-2:2016) lime-based mortar. The top beams were reinforced with a steel textile (the same used for the SRG reinforcement, see §4.2.1), installed in the bed joints during construction, which provided tensile and bending strength. Each top beam was connected to the underlying masonry wall with three 600 mm long steel connectors, 0.5 m spaced, inserted in drilled holes and then injected with a lime-based grout. In order to avoid

overturning and induce out-of-plane vertical bending under seismic base motion, the horizontal displacement of the top beams were constrained. Their upward displacement and their rotation, instead, were free, in order to reproduce the constrain conditions experienced by a perimeter wall at the last storey of a masonry building. It has to be noted that this is an approximation since the seismic action at the base and at the top are not expected to be identical due to the dynamic amplification over the height (Tondelli et al. 2016). To apply such constrain condition, two steel frames were placed on the shake table near the masonry walls and connected to each other on top by two IPE200 I girders (Fig. 1b). The in-plane stiffness of the frames and the bending stiffness of the girders were sufficiently high to limit the relative displacement between the bottom and the top of the wall specimens. Eight rubber hollow cylinders, having 160 mm external diameter and 20 mm thickness, were fixed to the I girders and put in contrast with the top beams, two on the front side and two on the

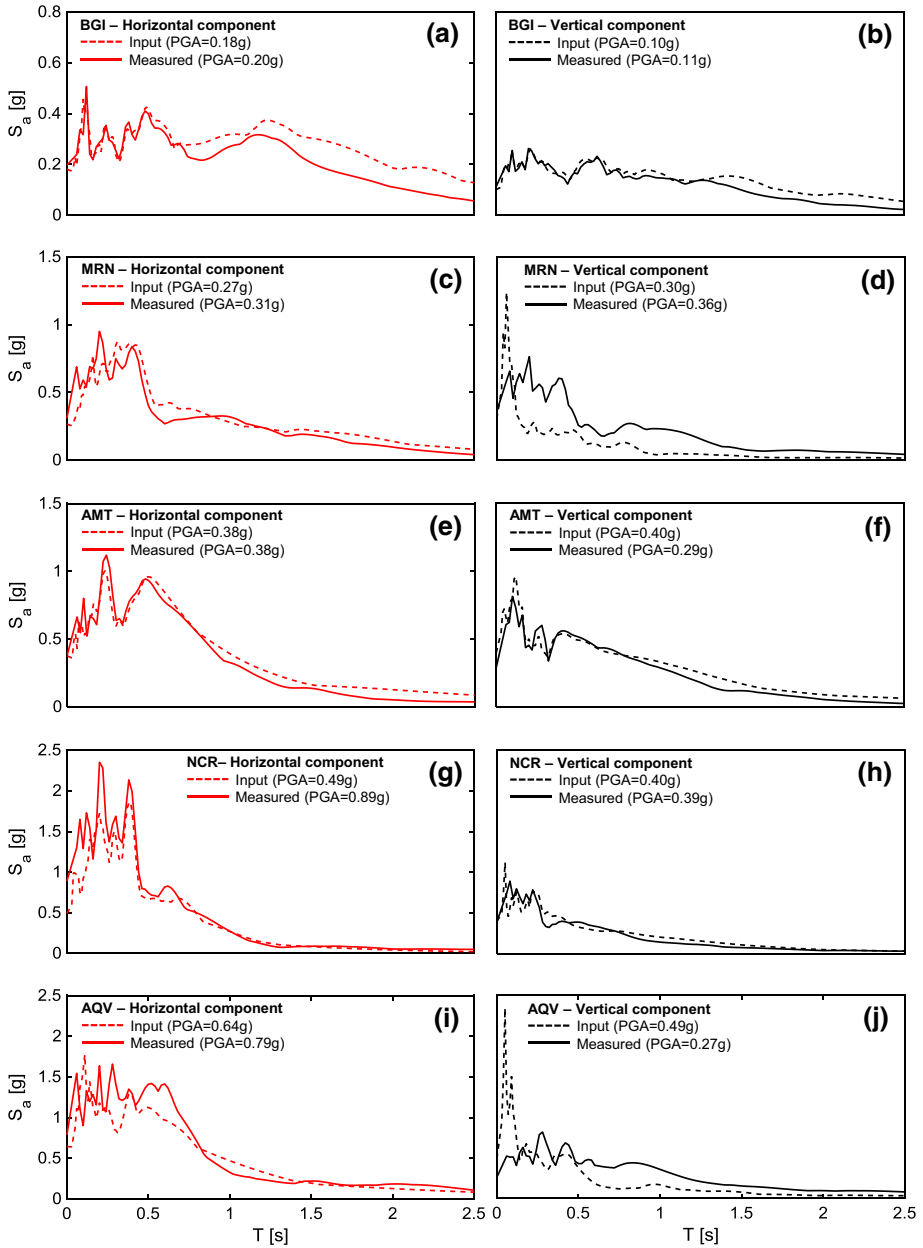
Fig. 3 Pseudo-acceleration response spectra of the signals imposed to the shake table and of those recorded on the reinforced concrete foundation during the tests with SF=1 on the reinforced specimens. Note that PGA denotes the maximum absolute acceleration

The pseudo-acceleration response spectra of the input accelerograms are shown in Fig. 3, together with those of the accelerations recorded on the foundation during the tests performed with SF = 1.0 on the retrofitted specimens. The comparison proves the effective control of the shake table system, the amplitude of the recorded spectra being lower than the target ones only at high periods (above 1.5 s), which have minor structural interest. A less precise matching is also seen for the vertical components of MRN and AQV signals (Fig. 3d, j), as the shake table was not able to reach the highest peaks. Finally, tests under PGA = 0.05 g white noise (applied both horizontally and vertically), labelled as WN hereinafter, were carried out before the beginning of the tests, after each input sequence with the same SF and at the end, and were used for dynamic identification analyses.

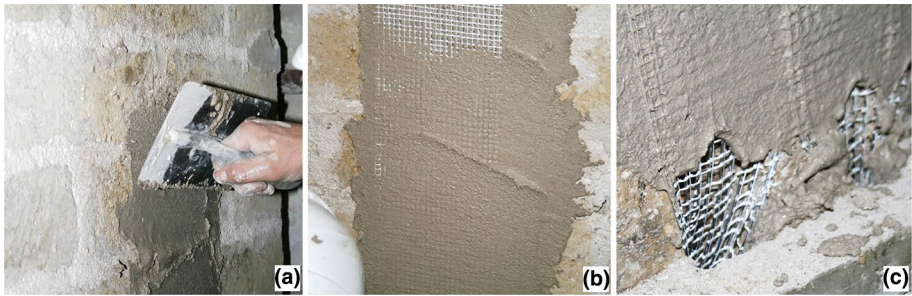
Fig. 6 Retrofitting of the tuff wall with SRG: laying of the first mortar layer (a), installation of the steel textile (b) and steel connectors inserted in the reinforced concrete foundation (c)

First, the tuff substrate was consolidated with potassium silicate and the crushed bed joints were repointed with lime-based grout. Then, the first 5 mm thick layer of matrix was laid down by hand (Fig. 6a) and the steel textile was installed taking care of letting the mortar passing through the voids between the cords (Fig. 6b). Finally, the second layer of mortar was laid down. The total thickness of the SRG strip was about 10 mm. Each strip was connected to the foundation with a 150 mm long steel connector, made by rolling the textile, inserted in a hole having 30 mm diameter, 250 mm length and about 20° inclination angle with the vertical (Fig. 6c). The hole was injected with a lime-based grout, whose mechanical properties are similar to those of the mortar matrix, but it is more fluid to make it suitable for injections. Technical information provided by the supplier reports a pull-out strength of the connector of 1 kN/cm, which, in this case, yields to 25 kN, corresponding to about 60% of the tensile strength of the 150 mm wide strip, whereas it is 15% higher than

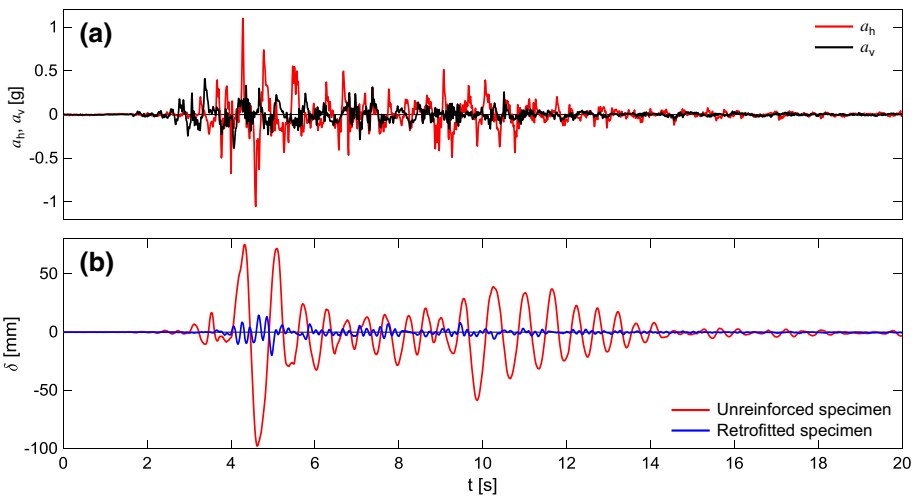
Fig. 7 Acceleration recorded on the foundation and out-of-plane horizontal displacement (measured by 3DVision on the marker at $z=2.46$ m) on the tuff wall (before and after retrofiting) under AQV signal with SF=1.25

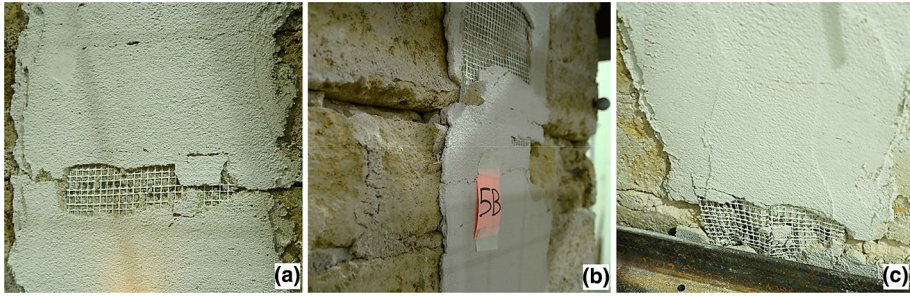
Fig. 8 Damage pattern of the reinforced tuff wall at the end of the shake table test session: cracking of the mortar matrix (a), crushing of the tuff units (b) and connector in the foundation (c)

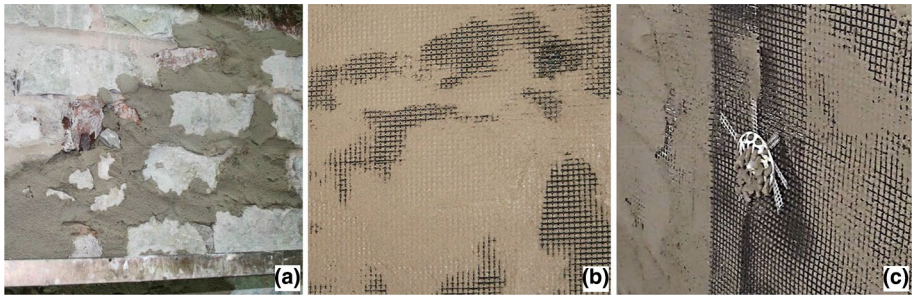
Fig. 13 Retrofitting of the stone wall with BTRM: repointing of the crushed joints (a), installation of the basalt mesh (b) and grout injection of the transversal steel connectors (c)

First, the wall was repaired by repointing the crushed joints with lime-based grout and replacing the stones that had fallen down (Fig. 13a). The masonry was wet with water and the first layer of matrix was laid down. Then, the fabric was installed (Fig. 13b) and the top layer of mortar was laid down. The overall thickness of the TRM overlay was about 10 mm, even if the unevenness of the substrate entailed local variability. The connectors (Fig. 13c) were made by rolling the UHTSS textile used for SRG and a plastic wedge, inserted in crossing holes drilled in the masonry before the installation of the basalt mesh and injected with lime-based grout at the end of the retrofitting works. Grout injections filled the voids, providing an additional improvement of the mechanical properties of the

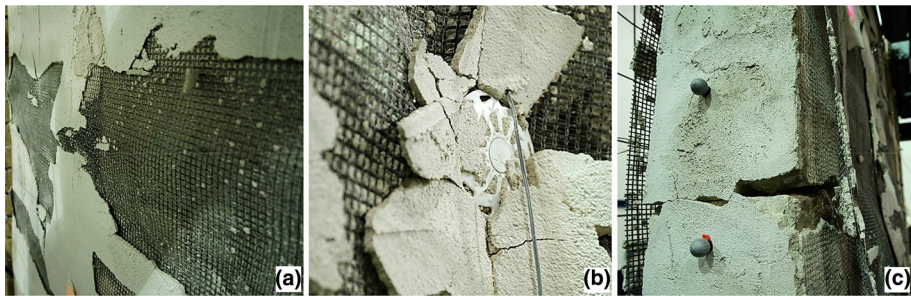
Fig. 15 Damage pattern of the reinforced stone wall at the end of the shake table test session: BTRM detachment (a), detail of the connector (b), local rupture of the basalt wires at the edges of crushed stones (c)

The basalt mesh detached locally from the substrate during the set of tests with SF=1.0, approximately at the same height where the hinge developed in the test session on the unreinforced wall (Fig. 14a). Damage progressively developed (Fig. 14b) and, at failure, a large surface of the reinforcement debonded from the masonry substrate (Figs. 14c, 15a). Such detachment appeared caused by a combination of shear stresses and buckling of the TRM overlay. The steel connectors (Fig. 15b), however, remained effective (they did not show signs of pull-out) and, in addition to preventing leaf separation, contributed to the load transfer mechanism from the wall to the basalt fabric. Indeed, even if this latter was partially detached from the substrate, the presence of the connectors made it still effective similarly to an unbonded tendon between connectors. Finally, signs of tensile rupture of the basalt wires were detected only locally near the edges of the stones (Fig. 15c).

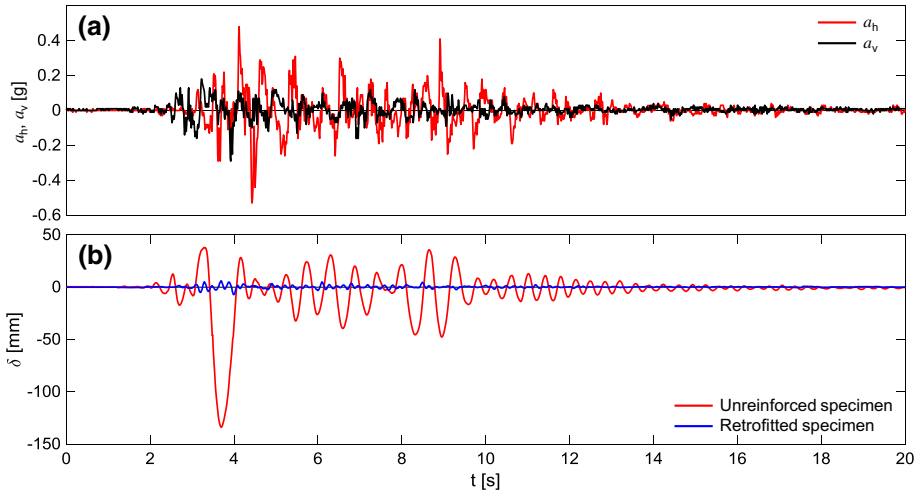
Fig. 16 Acceleration recorded on the foundation and out-of-plane horizontal displacement (measured by 3DVision on the marker at $z=2.61$ m) on the stone wall (before and after retrofiting) under AQV signal with SF=0.75

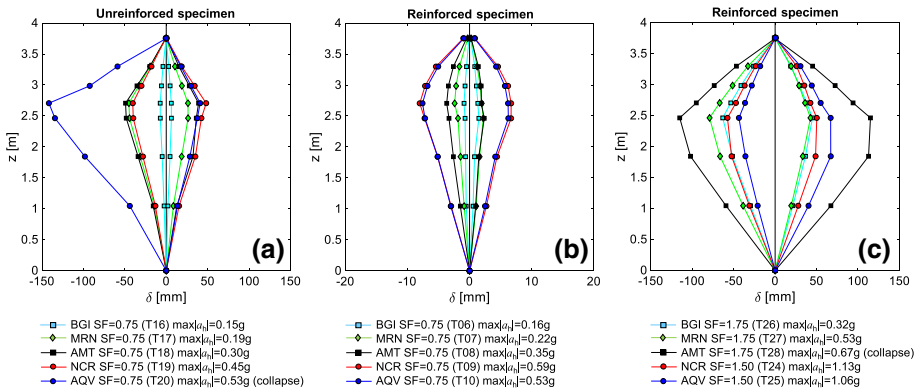
Fig. 17 Deflection profiles of the stone wall before (a) and after (b, c) BTRM retrofiting

The deflection profiles of the stone wall, before and after retrofitting, are shown in Fig. 17. As in the case of the tuff wall, there is a marker on the foundation ($z=0$), one on the top beam ($z=3.75$ m), and six on the wall, at $z=1.04$ m, $z=1.84$ m, $z=2.36$ m, $z=2.61$ m, $z=2.98$ m

and $z=3.30$ m. The closest marker to the hinge developed after T05 in the first test session was at $z=2.61$ m and the deflection profiles are built for each test in the time instants when this marker attained δ_{max} and δ_{min} , respectively. As for the tuff wall, also in this case the response of the unreinforced wall was mainly governed by the presence of the hinge (Fig. 17a), whereas the BTRM overlay entails both a reduction (for the same input, Fig. 17b) and a redistribution (also at collapse, Fig. 17c) of the deflections along the height of the wall.

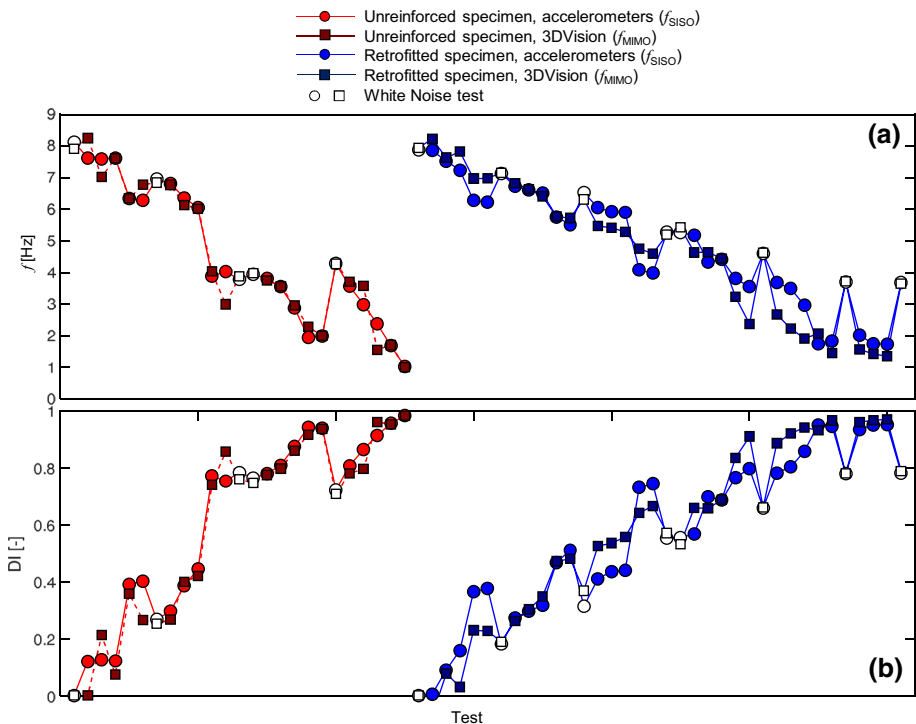
Fig. 18 Fundamental frequency (a) and damage index (b) of the stone wall

of tests with $SF=0.50$ (see WN03 and WN04 in Table 4). At collapse, both the experimental modal analysis approaches (SISO and MIMO) provided a frequency of 1.0 Hz. The repair works and the installation of the BTRM reinforcement balanced the effect of the damage accumulated in the former test series and restored the initial frequency of the undamaged specimen ($f=7.8$ Hz, Table 5). As observed in the tuff wall, also in this case the composite overlay entailed a slower accumulation of damage, since the same reduction of stiffness (f decreased to 1.3–1.4 Hz) was obtained as the effect of more tests under higher intensity of seismic input (Fig. 18a). Finally, the increase of the damage index (DI), plotted in Fig. 18b, clearly shows both the slower accumulation of damage ensured by the BTRM and the absence of the sudden damage increases visible on the unreinforced wall.
