# Assessment and mitigation of seismic risk at the urban scale: an application to the historic city center of Leiria, Portugal

**Keywords** Risk management · Seismic vulnerability assessment · Historic centers · Masonry buildings · Retrofitting strategies

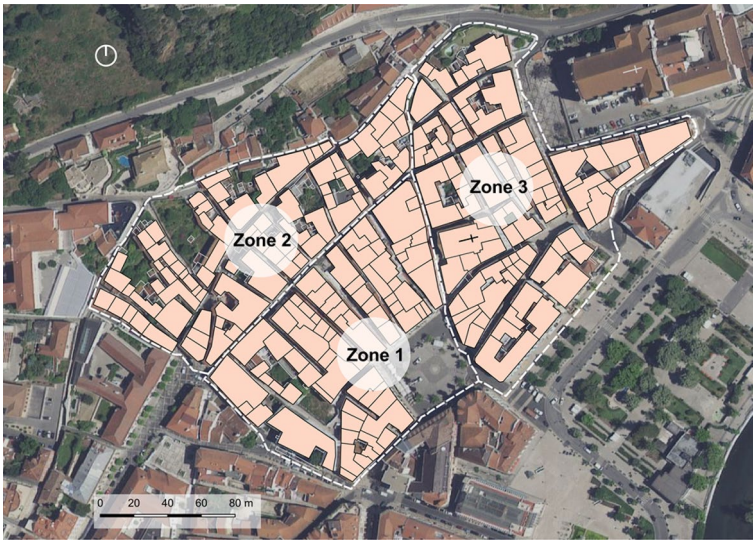
**Fig. 1** Case study zones, adapted from Anglade et al. (2020)

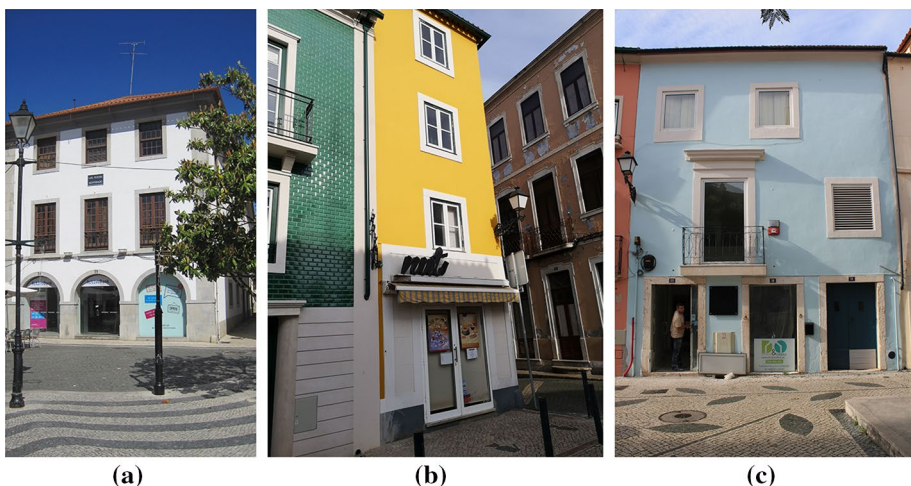
**Fig. 2** Regular big openings facing of a building facing the cathedral's square (a), a minor square (b) and irregular size and layout openings of a secondary street (c)

The study area is composed of a fairly homogeneous building stock with common features that were easily identifiable during fieldwork. The buildings are generally part of an aggregate, and they tend to be of 3–4 stories and regular in both plan configuration and height. The façade layout characterization is also notable, as it has a great influence on the shear resistance and in-plane response of the façade walls. The façade openings were found to be of notable size and fairly regular in layout for façades facing the main streets and squares, see Fig. 2a, b, while in secondary streets they present a less regular configuration and are smaller in size, Fig. 2c. In some cases, sources of irregularity both in plan and elevation were introduced by later interventions carried out on the buildings, such as additions, super elevations, creation of larger openings at the ground floors, floor slab replacements, etc.

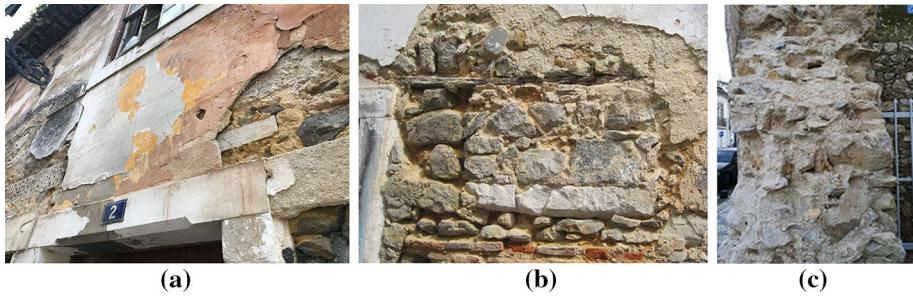
**Fig. 3** Rubble stone masonry with other material units: sub-horizontal arrangement (a, b) and cross section (c) of some masonry walls in Leiria

External inspections were used to evaluate the quality of masonry because deterioration of the external renders allowed for direct observation of the material underneath. The external walls of the buildings are mainly composed of stone masonry, usually limestone units of different sizes sometimes mixed with units of other materials, e.g. clay bricks, marlstones, etc. The units' arrangement has sub-horizontal mortar joints, but the alignment of the vertical joints does not indicate a good quality masonry (Borri et al. 2015). In addition, there is large variability in the size and shape of the units, Fig. 3. The walls' thicknesses range from 0.4 m to 1.0 m with an average of 0.7 m and are a three-leaf arrangement with weak inner filling and lack of connections. The mechanical properties of the masonry were identified according to the “*Masonry of roughhewed stones*” category defined in the Italian Codes (Circolare 21 gennaio 2019 n. 7 C.S.LL.PP 2019) and confirmed by flat jack tests performed by Pinheiro et al. (2017).

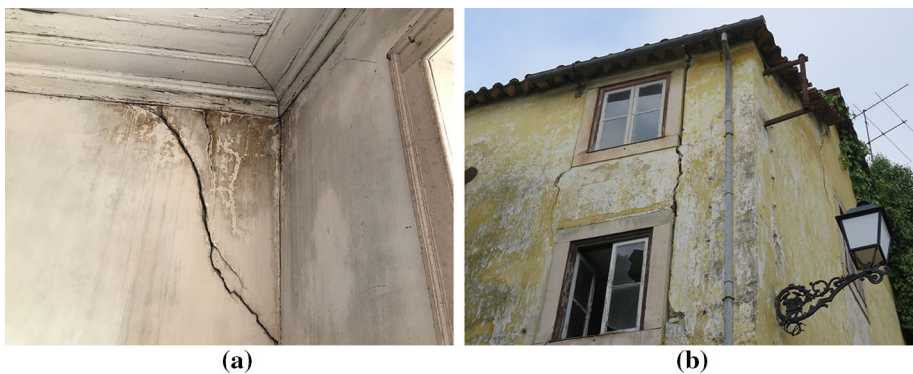
**Fig. 4** Bad quality connections between orthogonal walls evidenced by diagonal cracks on internal walls (a) and by detachment cracks on the corners (b)

Good wall-to-wall connection was often evidenced by the presence of large stones in the façade corners, Fig. 4a. Thus, when this feature was detected, good quality of the

wall-to-wall connection was assumed for the building. If this was not observed, a bad quality connection and improper interlocking was assumed. This assumption was supported by observations of large vertical and diagonal cracks, an indication of a poor connection between the internal and external walls that allows for independent behavior and rotation of the façade walls, Fig. 4b, c.

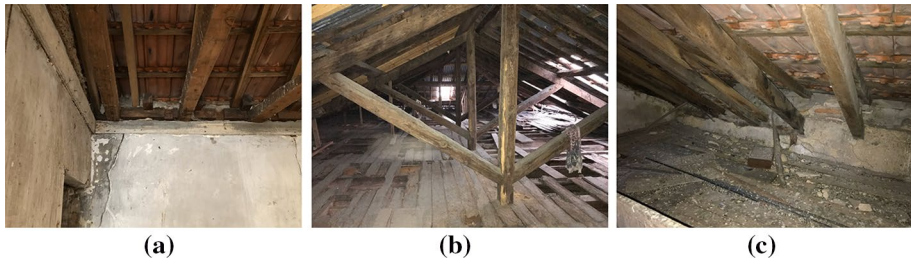
**Fig. 5** Example of a two-order timber floor with connection to the perimeter wall (a), timber king post truss of a roof (b), mixed masonry-timber perimeter ribbon of the roof (c)

Three floor types were observed in the study area: concrete slabs, metallic structures, and timber floors. The first two typologies were observed in just a few cases in buildings that were recently restored, while the third type was found in the majority of buildings. The timber floors are composed of pine beams directly supported by the bearing wall or by a primary order of timber beams, Fig. 5a. No tie rods or metallic elements were observed to improve connections between the floor and walls. Thus, a conservative assumption was made when information about the floor was not available: the presence of a flexible timber floor with weak connections to the walls and no presence of tie rods was assumed.

Few roofing systems were accessible during the fieldwork. However, all of the roofs inspected consisted of timber truss elements. In some cases, half trusses were observed, but in most cases king post trusses or simple trusses were used, Fig. 5b. Additionally, in all the inspected roofs, the truss structure was connected to the walls through a dormant beam extending all along the perimeter with load distribution and tying function, Fig. 5c. This

beam is a mixed masonry-timber element that indicates that the roof weight and thrust are properly distributed to the perimeter walls and a good connection between walls and roof is assured. It was assumed that inaccessible roofs are similar to the ones inspected. These assumptions, namely the non-impulsive nature of the roof and the presence of a perimeter ribbon, might lead to an underestimation of the vulnerability of the buildings to the roofing system interaction. However, the assumptions made are supported by observations made in the field inspections and by the knowledge of the traditional construction techniques of the area. For these reasons the assumptions made are considered sufficiently cautious.

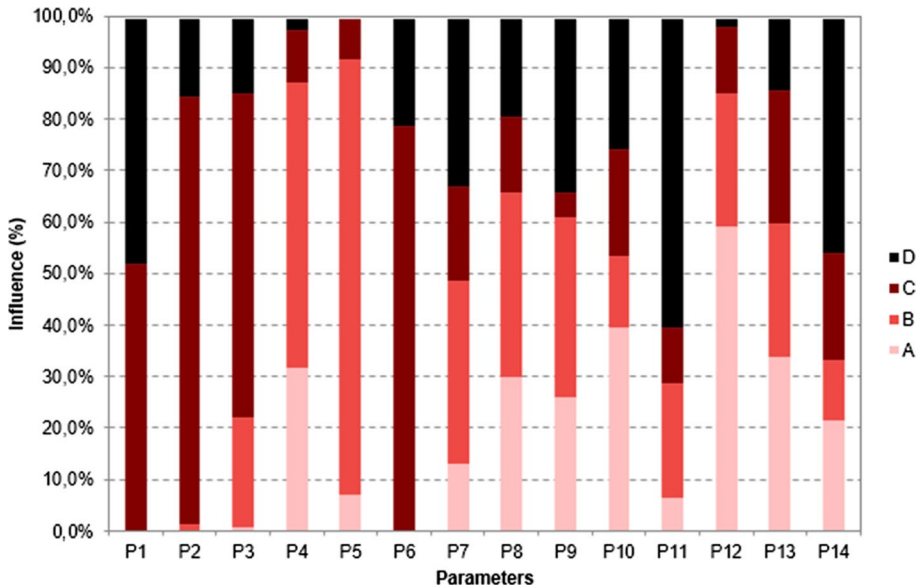
Fig. 7 Vulnerability class distribution of each parameter

The compilation of the database and analysis of the parameters yields the parameter class distribution shown in Fig. 7. Of these, P1, P2, P7, and P12 were found to be the most influential and given a weight of 1.5 or greater (Table 2). Parameters P3, P11, and P13 are also notable with weights of 1.0; P1, P2, P3, P11, P12, and P13 are the target of the retrofitting strategies presented in Sect. 6. The position of a building within its aggregate (P7) is fixed and thus unaffected by retrofitting.

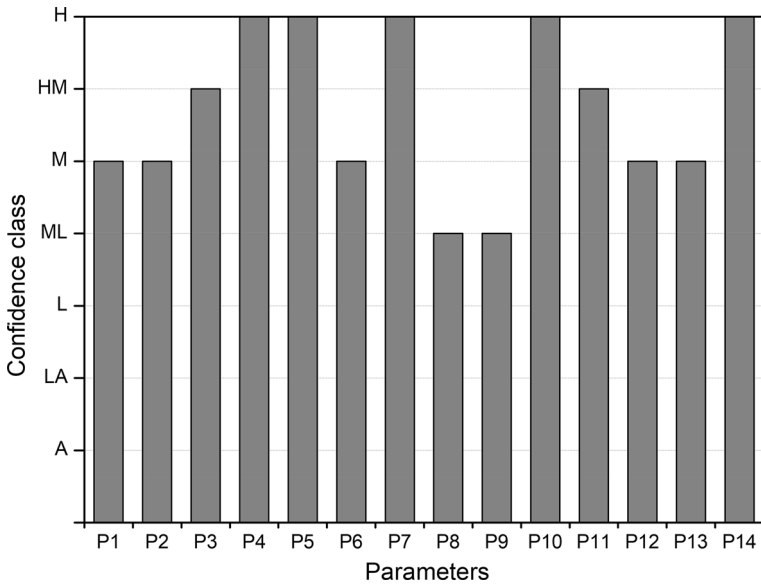
Fig. 8 Bar chart distribution of the average confidence class for each parameter

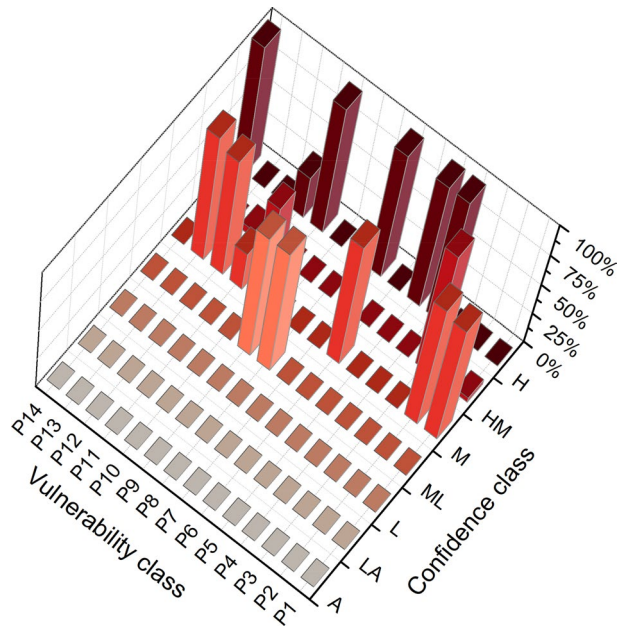
Fig. 9 Matrix distribution of the confidence class for each parameter

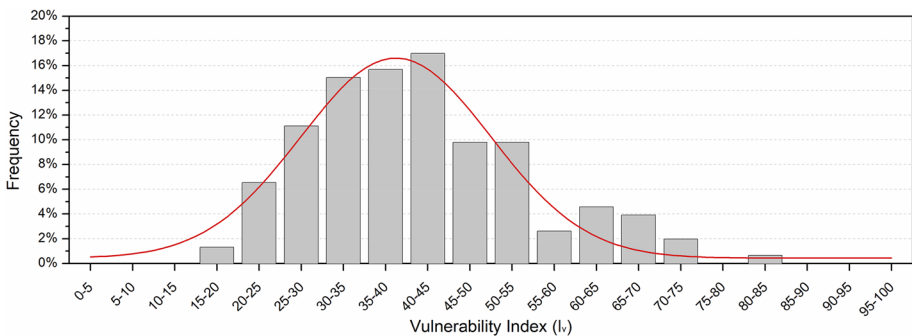
**Fig. 10** Vulnerability Index distribution of the building stock: histogram and best-fit normal distribution curve

$\sigma_{I_v}$ , is 12.93. The Kolmogorov–Smirnov normality test (Massey 1951) confirmed that at the 0.05 significance level, the data was significantly drawn from a normally distributed population with a  $p$  value of 0.148. Figure 10 shows the histogram and the best-fit normal distribution curve resulting from the assessment. The buildings’ conservation status ranges from good condition to ruin, and a good distribution of the  $I_v$  values can be observed in the plots in Fig. 11a. This distribution was mapped in GIS software to show the spatial relationship of the vulnerability index values in the study area (Fig. 11).

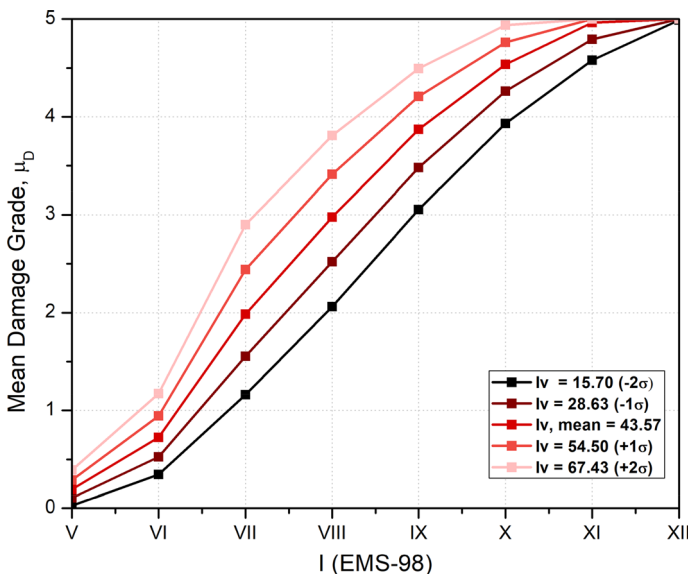
Fig. 12 Mean damage grade curves for characteristic values of the vulnerability index

Vulnerability curves are plotted in Fig. 12 that show the expected mean damage grade for events with a range of macroseismic intensities given the mean value of the vulnerability index ( $I_{v,mean}$ ) and upper and lower bound ranges ( $I_{v,mean} \pm 1\sigma_{I_v}$ ,  $I_{v,mean} \pm 2\sigma_{I_v}$ ) found for Leiria.

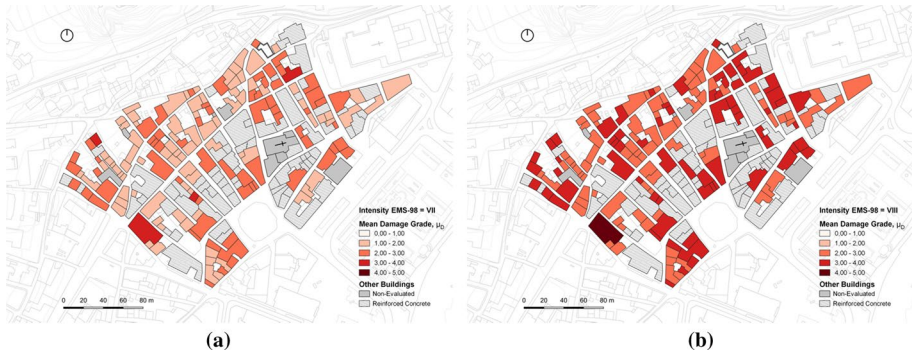
Fig. 13 Mean damage grade maps for a seismic event of Intensity  $I_{EMS-98} = VII$  (a) and  $I_{EMS-98} = VIII$  (b)

While the vulnerability curve is able to show the mean damage grade for the average ( $I_{v,mean}$ ) building found in Leiria’s city center, by using the GIS tool the mean damage grades for every building can be visualized in their actual location on the map. Figure 13 shows the distribution of the mean damage grades across the study area given macroseismic intensities of VII and VIII.

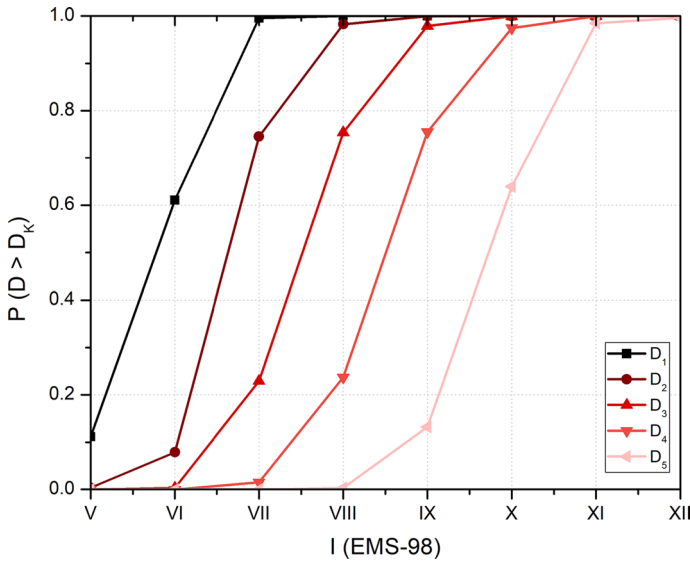
Fig. 14 Fragility curve depicting the probability of reaching or exceeding discrete damage grades  $D_1$ – $D_5$

Figure 14 shows the fragility curves plotted as continuous probability functions for the mean vulnerability index value ( $I_{v,mean} = 41.57$ ).

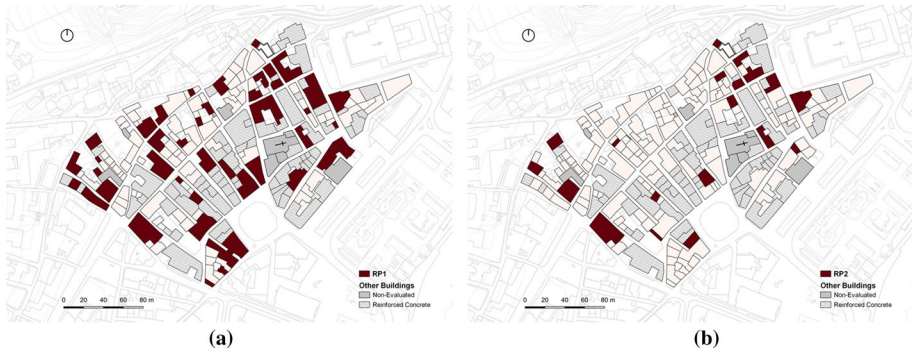
**Fig. 16** Location of the building intervened with the RP1 (a) and the RP2 (b)

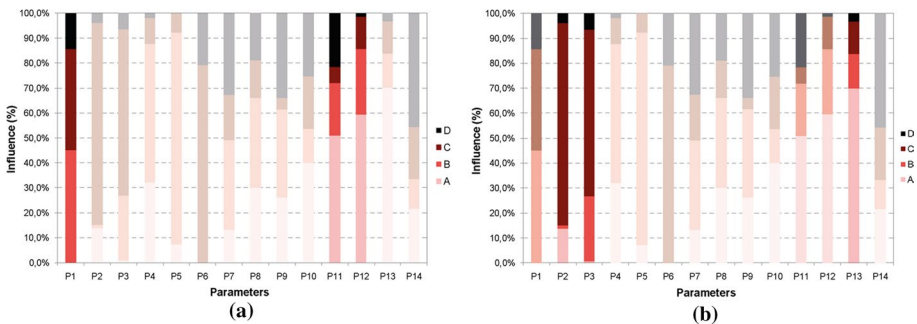
**Fig. 17** Vulnerability class distribution after the application of RP1 to the selected 69 buildings (a) and of the RP2 to the selected 21 buildings (b)

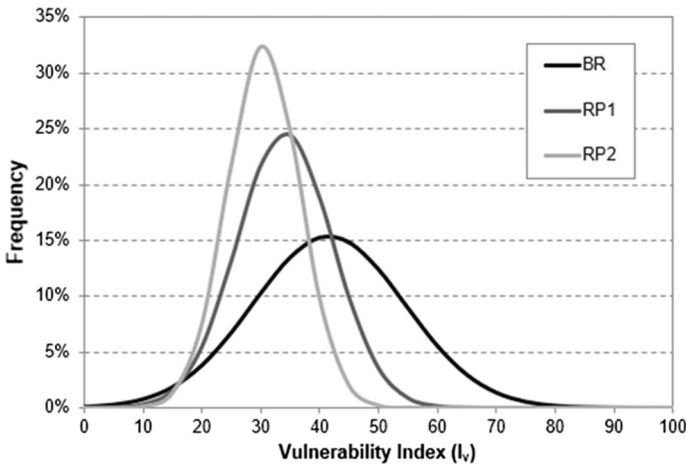
**Fig. 18** Best-fit normal distribution curve of  $I_v$  before and after retrofitting

values as a result of the reduction in the mean vulnerability index  $\sigma$  and standard deviation values, Table 5.

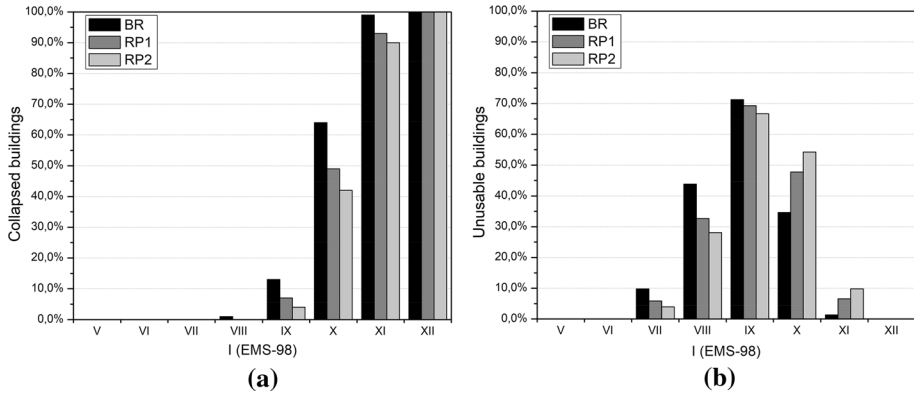
**Fig. 21** Probability of collapsed buildings (a) and unusable buildings (b) for the different building conditions analyzed

event with intensity greater than IX, more buildings are unusable in the strengthened scenarios and fewer collapse.

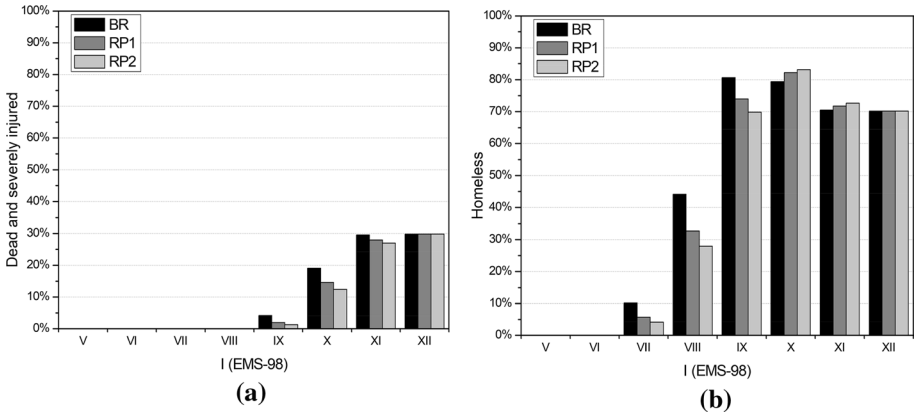
**Fig. 23** Probability of dead or severely injured (a) and homeless (b) people

a probability of having casualties (Fig. 23a) occurs only above intensity IX. However, if the maximum intensities (from IX to XII) are considered, a decreasing trend can be seen after applying the RP1 and RP2 up to intensity XI. After that the probability remains constant (30% for intensity XII) due to the destructiveness of the seismic event. The maximum variation can be observed for intensity X where the probability drops from 19% (BR) to 15% (RP1) and 12% (RP2). In terms of probability of homelessness, in Fig. 23b, a decreasing trend can be seen up to seismic intensity IX due to a decrease in the number of collapsed buildings for the retrofitted scenarios. Then this trend reverses because there are more non-collapsed buildings after the retrofitting interventions. These outputs can be used for emergency planning by authorities and civil protection since they provide an estimation of the number of people that will need to be temporarily relocated.

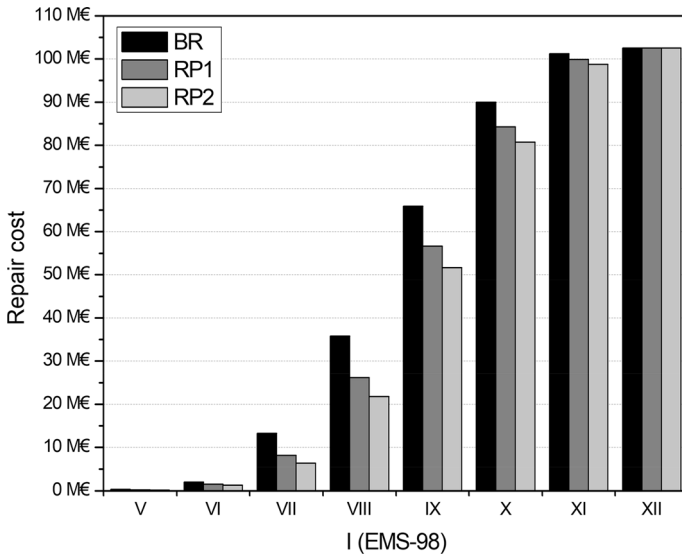
**Fig. 24** Evaluation of the reparation costs for the different conditions analyzed

The application of the retrofitting strategy decreases the estimated economic losses for low intensity earthquakes ( $I_{EMS-98} = VII$ ) from 13.27 to 8.15 M€ for RP1 (reduction about 39%) and to 6.36 M€ for RP2 (reduction about 52%), see Fig. 24. For higher intensities the repair costs of the retrofitted scenarios are equivalent to the initial repair costs of the BR situation, because these are unlikely situations, and total destruction is expected.

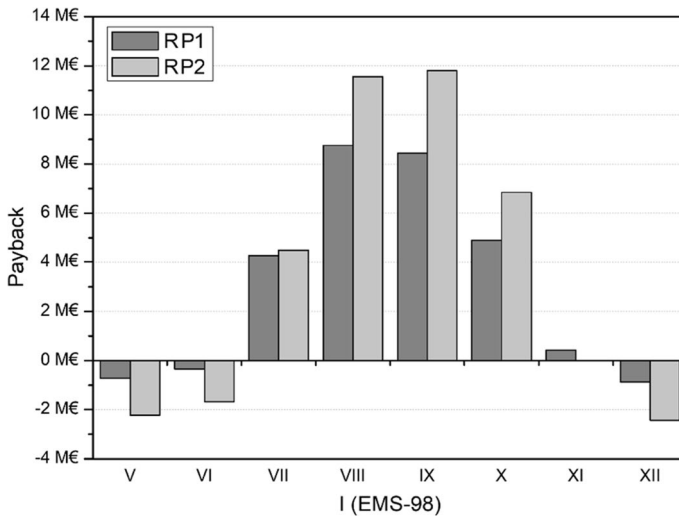
**Fig. 25** Evaluation of the payback amounts for the retrofitting packages applied

Considering the repair costs and the total cost of each retrofitting package, the seismic intensity range for which the application of the indicated retrofitting strategies is effective can be identified, Fig. 25.

For low intensity earthquakes (V and VI), the initial retrofitting cost is not justified. The effectiveness range of the two intervention types are between intensities VII and X for RP1 with a payback maximum at intensity VIII of 8.75 M€ (ten times the initial investment), and for RP2 with a payback maximum at intensity IX of 11.81 € (5 times the initial investment). Beyond seismic intensity IX, the retrofitting applications start losing their effectiveness because the building stock, including the unreinforced buildings, start to suffer severe damage and collapse.
