Case study for a performance based rapid seismic assessment methodology (PERA2019) based on actual earthquake damages

Abstract

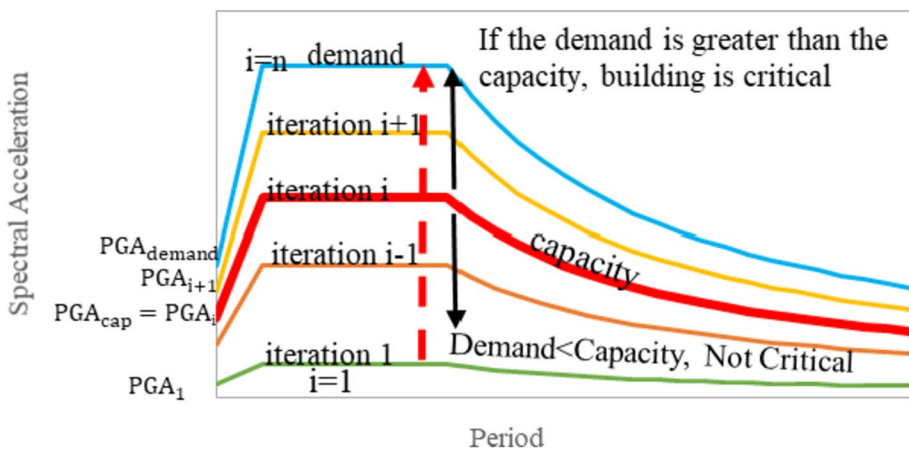
Fig. 1 Typical elastic acceleration spectra scaled at various levels for iterations

The seismic capacity is determined by an incremental approach repeating the simplified structural analyses and assessment procedures at each increment of seismic demand beginning from very small seismic actions until the seismic capacity of the building is reached (Fig. 1). The incremental analysis begins with the first step, which is corresponding to 1% of the acceleration demand spectrum. If the building is not determined critical (this process is explained below), the spectral acceleration values of the spectrum are increased by 1% (such as 2%, 3%...) until the step that the building is determined critical which is the iteration step $i + 1$. Then, step i is determined as the last step for which the building is not critical, and the PGA value of the spectrum applied at iteration i is defined as the PGA capacity of the building. Seismic Safety Ratio (SSR), determined through this incremental procedure is the ratio of PGA capacity to PGA demand (Eq. 1). For example, the SSR value of 50% means that the PGA capacity of the considered building is 50% of the PGA demand. If the building satisfies the PGA demand, the SSR value of that building is equal to or greater than 100%.

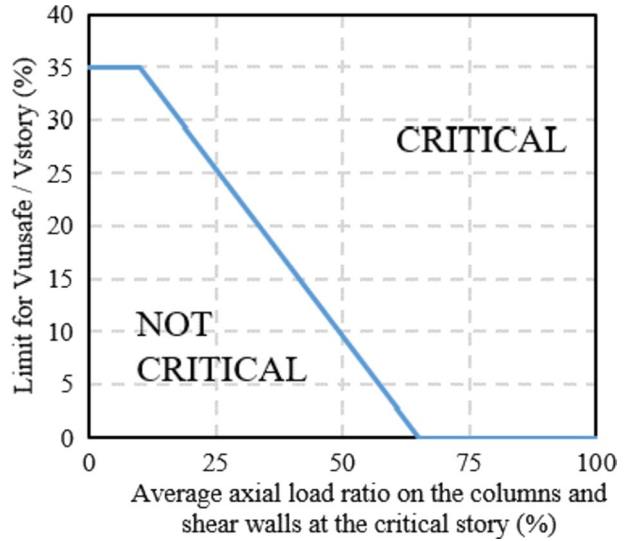
Fig. 2 The total allowed shear force ratio of columns exceeding their demand/capacity ratio limits. The ratio is dependent on the average axial load ratio at the critical story (V_{unsafe} : The total shear force that is carried by risky elements, V_{story} : The total shear force of the story)

Figure 2 illustrates the computation of the global performance of the structural system. If the average axial load ratio is less than 10% at the critical story, the total shear force of the risky columns and shear walls (V_{unsafe}) are allowed up to 35% of the story shear force (V_{story}), while none of the columns and shear walls is allowed to exceed their demand/capacity ratio limits for the buildings that have average axial load ratio greater than 65%. For the cases where the average axial stress is between 10 and 65% at the critical story, interpolation should be made in order to calculate the allowed story shear limit. The normalised average axial load ratio is computed by Eq. (2).

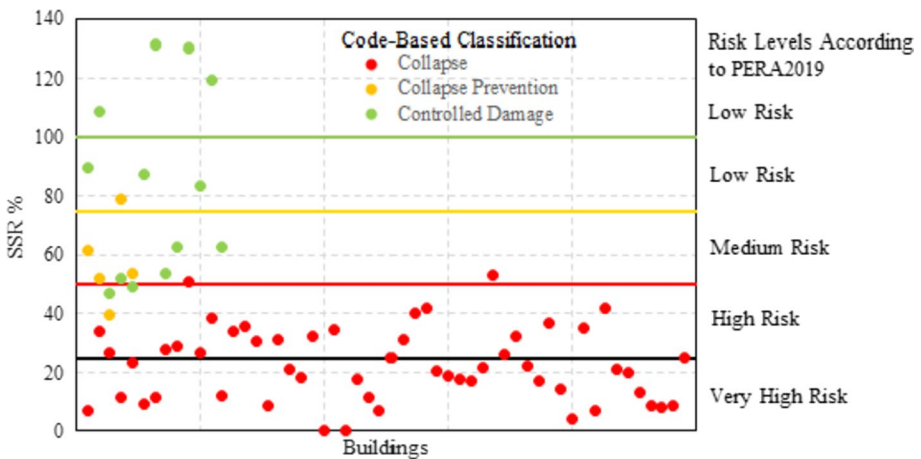
Fig. 4 Comparison of detailed assessment results with estimations of PERA2019: score scatter with risk limits (adopted from Aydogdu et al. 2023a). The horizontal axis illustrates the buildings in a random order

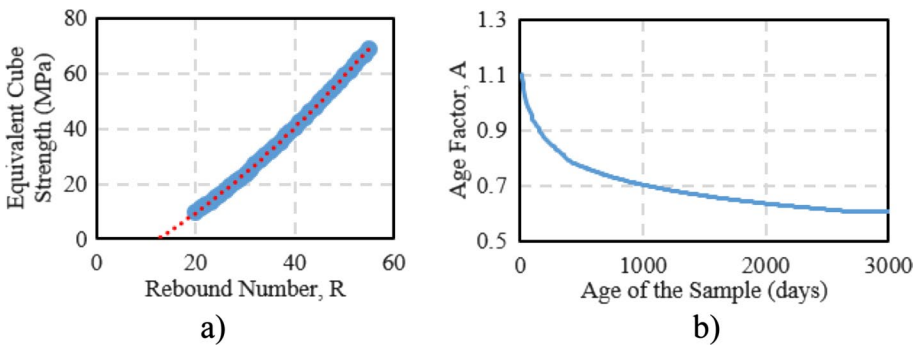
Fig. 8 **a** The conversion factor for the rebound number of the concrete hammer to equivalent cube strength, **b** age factor for concrete to take into account carbonation

also provided by the producer of the test hammer, is used (Fig. 8b). The cylindrical equivalent of the cubic compressive strength is determined through Eq. (4). To calculate the in-situ compressive strength of the concrete for the structures, Eq. (5) is used as suggested by Turkish Building Earthquake Code (2018).

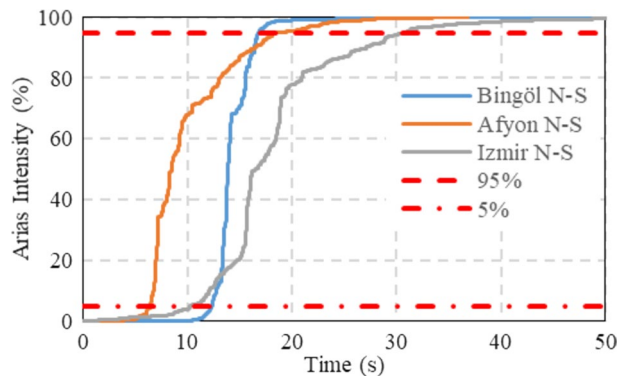
Fig. 9 Arias intensity curves computed for N-S records of all investigated earthquakes

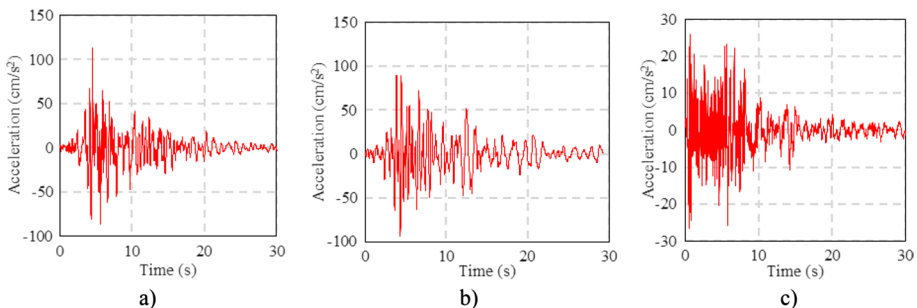
Fig. 10 Acceleration-time histories for the Afyon earthquake: **a** N-S record, **b** E-W record, **c** Vertical record (TADAS database, AFAD 2020). V_{s30} parameter of the site, of which the recorder is located, is 226 m/s

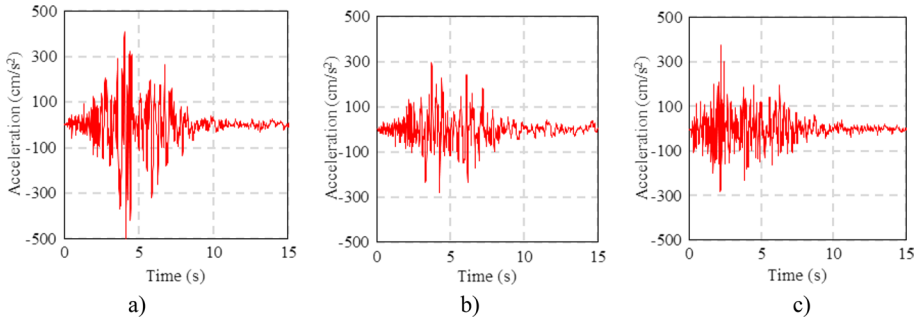
Fig. 13 Acceleration-time histories for the Bingöl earthquake: **a** N-S record, **b** E-W record, **c** Vertical record (TADAS database, AFAD 2020). V_{s30} parameter of the site, of which the recorder is located, is 529 m/s

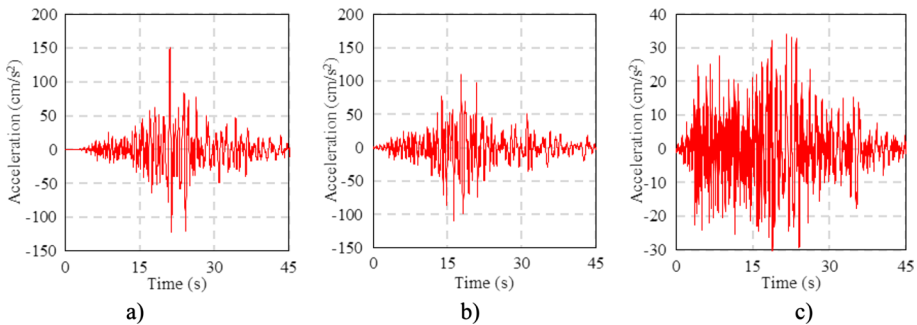
Fig. 16 Acceleration-time histories for the Izmir earthquake: **a** N-S record, **b** E-W record, **c** Vertical record (TADAS database, AFAD 2020). V_{s30} parameter of the site, of which the recorder is located, is 131 m/s

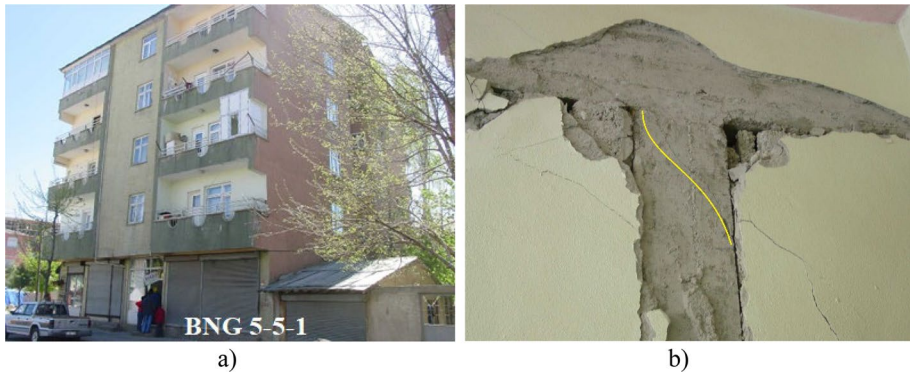
Fig. 19 a The BNG-5-5-1 building (lightly damaged), b Type A shear crack (METU 2003)

A lightly damaged building is given in Fig. 19. The building contains a column with a Type A shear crack and is identified as slightly damaged since it does not have any higher damage type elements. A building that experienced Afyon Earthquake (2002), which was under construction during the earthquake, is shown in Fig. 20a. The building contains a Type B flexural crack (Fig. 20b). However, owing to the Type D damages illustrated in Fig. 20c, the building is categorized as heavily damaged.

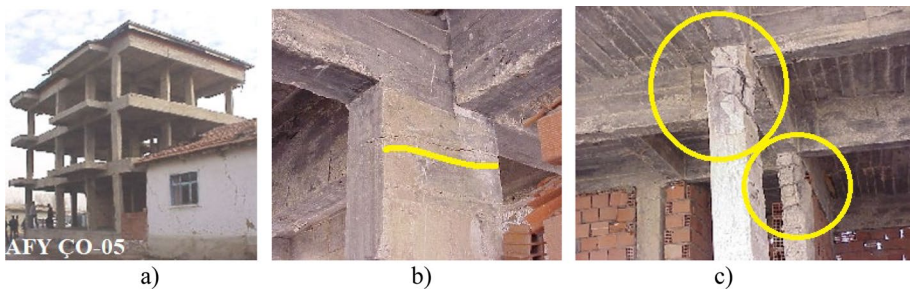
Fig. 20 a The AFY-ÇO-05 building (heavily damaged), b Type B flexural crack, c Type D flexural and shear damages (METU 2003)

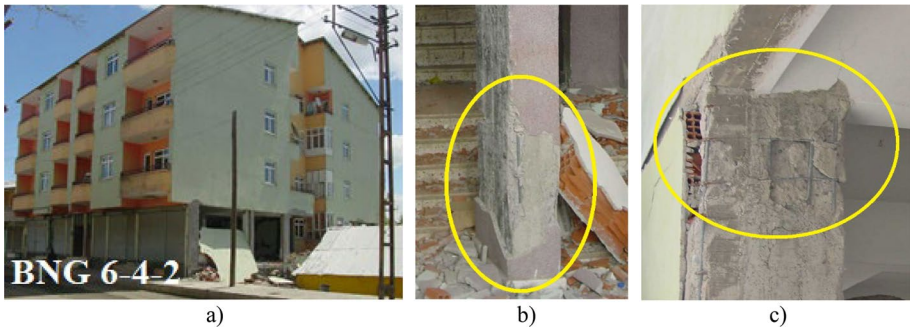
Fig. 21 a The BNG-6-4-2 building (heavily damaged), b Type C damage: Spalling of Concrete Cover, c Type C damage: Spalling of Concrete Cover (METU 2003)

At least two columns of the building shown in Fig. 21a experienced Type C damage. In Fig. 21b, c, two examples of spalling of concrete cover are given. The building also has elements with Type D damage. Thus, the damage state of the BNG-6–4-2 building is decided as heavy damage. Figure 22a shows another building that experienced Bingöl Earthquake (2003) and was subjected to heavy damage. Vertical reinforced concrete members of the

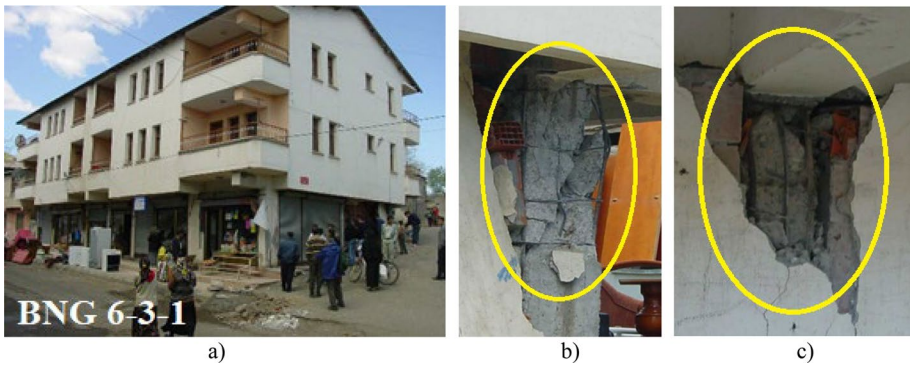
Fig. 22 a The BNG-6-3-1 building (heavily damaged), b Type D shear crack, reinforcement buckling, crushing of concrete core and rupture of transverse reinforcement, c Type D flexural damage with crushing of concrete core and buckling of longitudinal bars (METU 2003)

building exhibited Type D shear crack, reinforcement buckling, crushing of concrete core and rupture of transverse reinforcement (Fig. 22b, c).

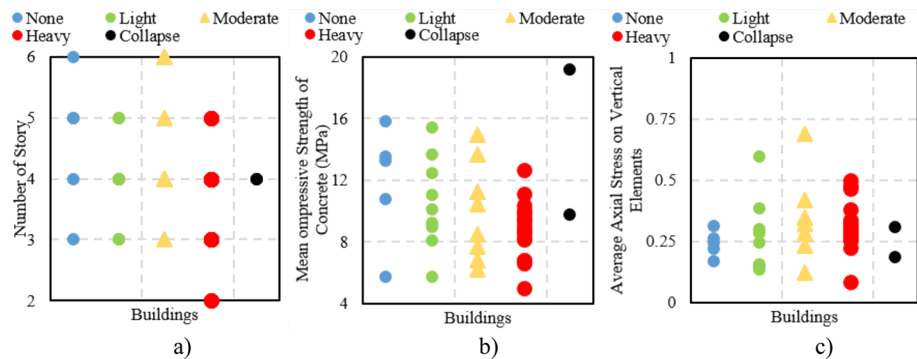
Fig. 23 The trends between the observed damage levels and various important structural parameters of the buildings: **a** Number of stories, **b** compressive strength of the existing concrete, **c** average axial stress on vertical members. The horizontal axis illustrates different damage state groups

of stories can be at different levels. Hence, it would not be realistic to perform a building scale seismic evaluation based only on their number of stories. The compressive strength of the existing concrete is a critical parameter for the seismic performance of RC buildings. The relationship between observed damage levels and the compressive strength of the existing concrete does not exhibit a good trend. The building in which the highest compressive strength of the existing concrete is measured has collapsed, and the building with the lowest compressive strength of the existing concrete has not experienced any seismic damage.

Also, the comparison of the average axial load on columns at the critical story resulting from gravity loads and the observed damage states of the buildings shows a large scatter. Thus, estimating the seismic safety of individual buildings using simplified procedures without considering all crucial structural parameters may lead to grave misclassifications.

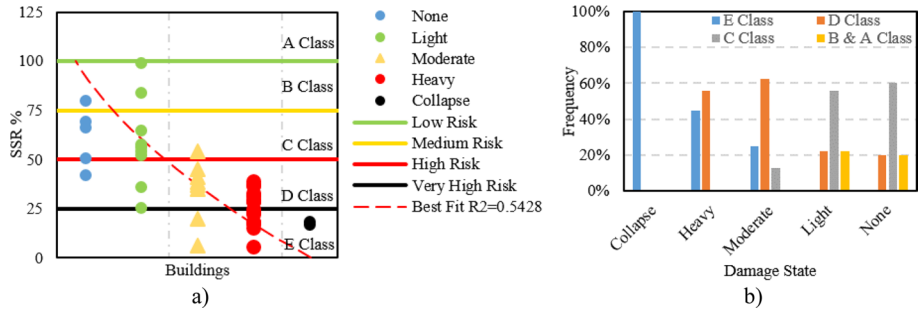
Fig. 24 a Distribution of SSR values of the investigated buildings computed through PERA2019 for each damage level groups, b histogram of risk class distributions for each damage level groups

Figure 24a demonstrates the harmony of the observed damage levels with SSR values and risk classes of the buildings computed through the implementation of the PERA2019 methodology. On contrary to the inadequate consistency of individual structural parameters investigated above compared to structural damages, the SSR values obtained for the examined buildings exhibit good conformity with observed damages and tend to decrease as the damage state increases. Figure 24b illustrates the risk class ratios of the buildings for each damage state group. Seismic risk classes of the buildings also show a promising consistency with the observed damages too.

The proposed methodology satisfactorily labels all collapsed buildings as E class, which corresponds to a very high seismic risk. The buildings severely damaged are also classified as either E or D class. Moreover, the SSR region above 40% does not contain any heavily damaged or collapsed buildings, which is a good safety indicator because a buffer zone of SSR values between 40 and 50% does not include any heavily damaged or collapsed buildings, while this range of SSR is still in D Class. Distinguishing the buildings with good seismic performance from the ones with poor seismic performance is another critical aspect of seismic assessment methods. The results of this study show that PERA2019 is able to determine almost 80% of the buildings without seismic damage or lightly damaged ones as C, B or A class, while none of them is categorized as E class or very high risk.
