# Investigating the seismic vulnerability of traditional ancient Tibetan buildings via structural subscaling experiments

**Keywords** Traditional ancient Tibetan structure · Three-leaf stone wall · Seismic vulnerability · Shaking table test · Quasistatic test

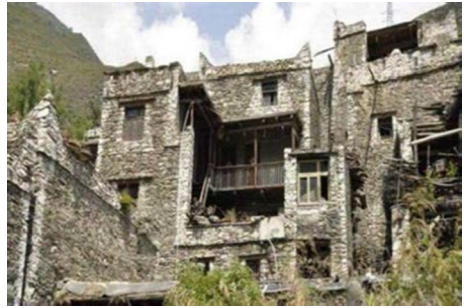
**Fig. 1** Traditional ancient Tibetan stone masonry structure

a three-leaf wall constructed with two leaf walls, and the space between the two leaf walls is filled with inferior materials (stones and/or bricks and mortar) (Silva et al. 2014, 2016). Currently, there is very limited quantitative information that can help to determine the vulnerability of TATBs. Therefore, it is necessary to study this type of architecture.

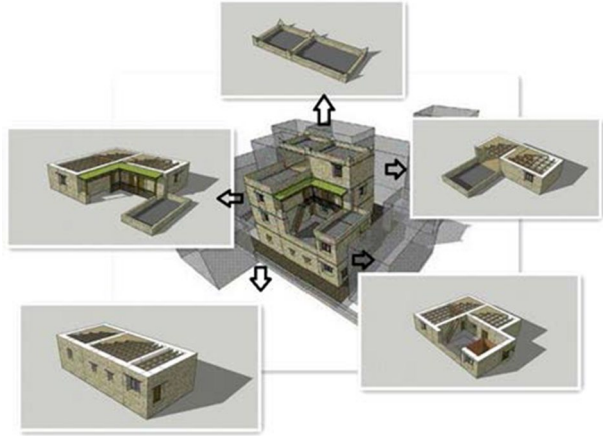
**Fig. 3** Typical TATB

TATBs represent valuable cultural heritage sites. Some typical representative buildings, such as the Potala Palace, Jokhang Temple, and Norbulingka Summer Palace, have been inscribed on the World Heritage List (2023). A field visit to Mudui Village, Ganbao Tibetan Township, Li County, Aba Tibetan and Qiang Autonomous Prefecture, Sichuan Province, was conducted to investigate the basic information of the TATB. Considering security, the window areas are relatively small. Most houses have 2 to 4 floors. The bottom floors are often used as a livestock enclosure. The top floors are mostly only half of the area of the partial buildings and are used for halls. The main building is made of stone and yellow mud. Wood is used for reinforcement and beams. The overall shape of the building is slightly upward (Fig. 3). The main load-bearing structure of the TATB is a trilobite wall. The TATBs are generally three-story with three-leaf stone walls (Fig. 4) with wide bottom widths and narrow upper widths. The thickness of the walls of the bottom floor is 600 mm. The thickness of the walls of the second floor is 500 mm. The thickness of the walls of the

third floor is 400 mm. The thickness of the walls of the roof parapet is 300 mm. The total height of the building is 9.34 m. The total weight of the building is approximately 479.3 tons. Wooden beams lap on top of the masonry walls, thereby transferring the upper loads.

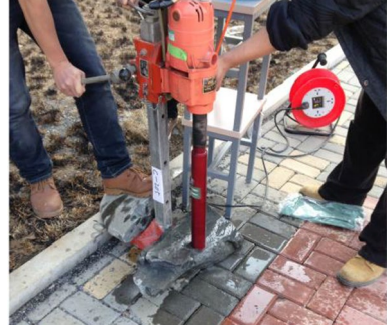
**Fig. 5** Specimen design

The stone used in TATBs is bluestone. The stone was drilled by a rhinestone for mechanical property testing (Fig. 5) (GB/T2542-2012, 2012). The stone specimen is shown in Fig. 6. Six specimens of stone were tested to determine their mechanical characteristics. The test was carried out under displacement-controlled loading. The mechanical characteristics of

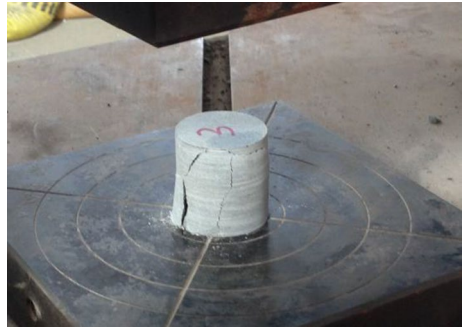
**Fig. 7** Crack distribution of the specimen

the stone are listed in Table 1 according to the relevant standard, with COV values given in parentheses. The stones selected for this study are similar to those found in the stone masonry structures of the region. The failure mode of the stone specimen was brittle failure (Fig. 7). The load displacement curve shows that the elastic stage was jagged (Fig. 8), which was caused by uneven density distribution and voids inside the stone.

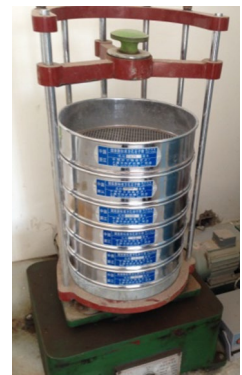
**Fig. 9** Shaking sieve

Mud is usually sifted before use in the standard construction procedure of mud mortar. However, workers usually omit this procedure to improve efficiency (Liang et al. 2023a, 2023b). Yellow soil is used as the main material in mud. Gradation analysis (GB 5009–2011 2011) (Figs. 9, 10) and mortar compressive strength tests (JGJ/T98-2010, 2010) were performed.

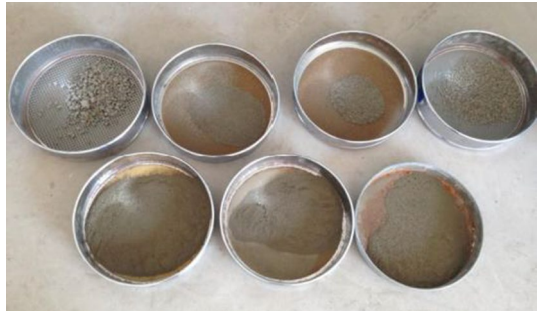
**Fig. 10** Yellow mud sieve allowance

The soil grains in the yellow mud are mainly composed of sand. The sand grains are mainly medium sand grains and fine sand grains, which are mixed with some very fine sand grains, silt grains and breccia grains. The uniformity coefficient is  $C_u = \frac{d_{60}}{d_{10}} > 5$  ( $d_{60}$  is the defined particle size and  $d_{10}$  is the effective particle size). The yellow mud has good gradation (Table 2). The curvature coefficient is  $C_c = \frac{d_{30}^2}{d_{10} \cdot d_{60}}$  ( $d_{30}$  is the median

particle size). The lack of particles is mainly due to the presence of coarse sand particles in a range of 0.5–2 mm. Sand with large particle sizes has good permeability and is nonsticky. Yellow mud mortar mainly needs sand with relatively low permeability and is viscous when wet. According to the yellow mud gradation analysis test, the yellow mud basically met the test requirements.

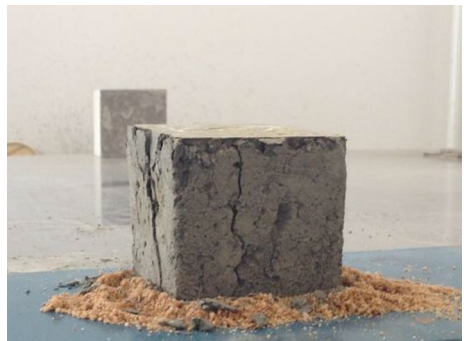
**Fig. 11** The crack distribution of mud mortar

The water content of the specimen was 23%. The specimens were cured for 30 days under outdoor conditions. The failure mode of the mud specimen was vertical layered peeling (Fig. 11). The density distribution inside the yellow mud was uniform, and the curve of the linear stage of the load displacement curve was relatively smooth (Fig. 12). The compressive strength of the cube of yellow mud mortar was 0.408 MPa. The

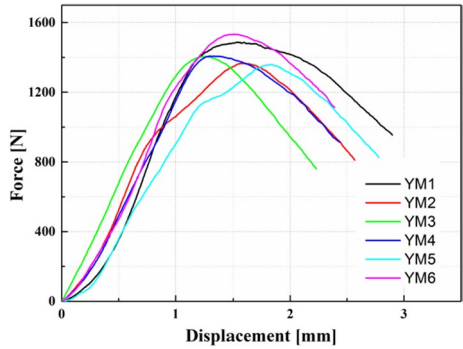
**Fig. 12** The load–displacement curve of mud mortar

standard deviation was 0.013. The coefficient of variation was 0.044. The arithmetic average of 1.3 times the measured value was used as the average value of the compressive strength of the specimen (JGJ/T70-2009, 2009).

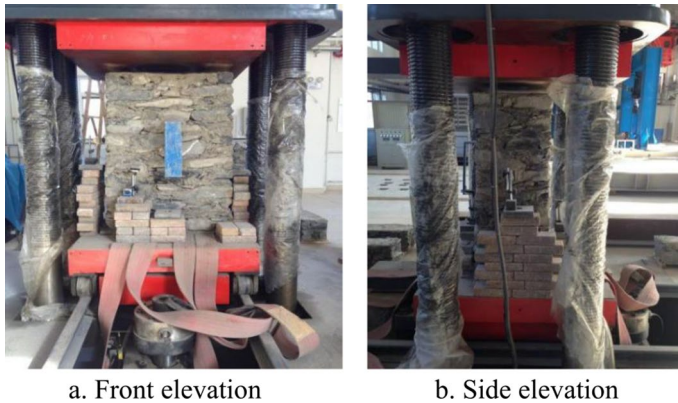
**Fig. 14** Layout of test setup

The compression test of stone masonry walls was carried out on a YAW-10000 J compression machine in the Structural Engineering Laboratory of Dalian Minzu University (Fig. 14). The compressive test of stone masonry was carried out according to the standard

“Basic Mechanical Properties Test Method for Masonry” (GB/T50129–2011 2011). Displacement control was used to complete the loading process by step loading (loading control chart). Each step of the load was increased to 10% of the calculation failure load. In each step, the samples were evenly loaded within 1.0–1.5 min (Fig. 15). Each step was loaded evenly and continuously for a defined period of time, keeping the loading rate constant.

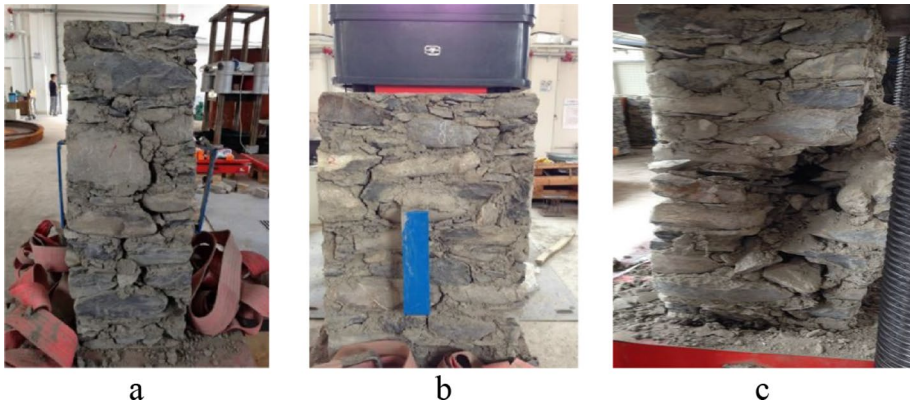
**Fig. 16** Typical damage distribution

The damage to the TATB walls showed irregular longitudinal penetrating cracks on the lateral sides (Fig. 16a) in the compression test. Multiple vertical cracks along the vertical mortar joints appeared on the front side (Fig. 16b). A large number of stones dropped off from the bottom of the wall (Fig. 16c). According to the load–displacement curve of the wall, the crushing process of the wall was divided into an elastic stage and a failure stage. Due to the uneven distribution of the mass and stiffness of the stone masonry wall, the load–displacement curve shows a sawtooth shape (Fig. 17). After the compressive strength of the stone masonry walls reached the elastic extreme, the wall maintained a period of ductility.

The damage to the TATB wall in the compression test showed irregular penetrating cracks in the longitudinal sides of the wall. A large area of stone fell off at the bottom of the side of the wall. The uneven distribution of the mass and stiffness of the stone masonry wall resulted in a jagged load–displacement curve. The wall maintained a period of ductility after the compressive strength of the TATB wall reached the elastic extreme. The TATB walls were sheared with diagonal penetrating cracks in the quasistatic test, accompanied by a large number of vertical and transverse cracks. As the displacement increased, the rate of degradation of the stiffness of the wall gradually decreased. The specimen stiffness reached a minimum value when the specimen was subjected to ultimate loads.

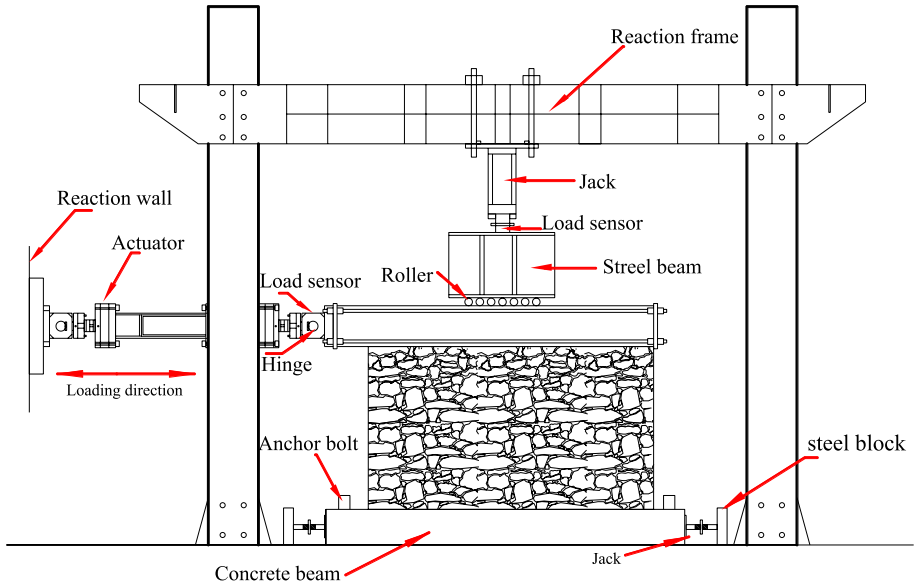
Fig. 18 Schematic view of the equipment

The specimens were cured for 6 months under natural ventilation. Then, the wall was moved to the test equation (Fig. 18). To better observe the cracks in the specimen, the side of the specimen was painted with burnt lime. The concrete beam under the wall was fixed to the solid ground by anchor bolts. The axial load was applied by a jack with a maximum load capacity of 2000 kN, which was transmitted to the wall by a steel beam. There were 5 rolling bars at the bottom of the steel beam that could be moved with the wall to avoid possible eccentricity caused by axial loads. The cyclic load was applied by a 1000 kN jack fixed to the reaction wall and transmitted to the wall by a steel beam.

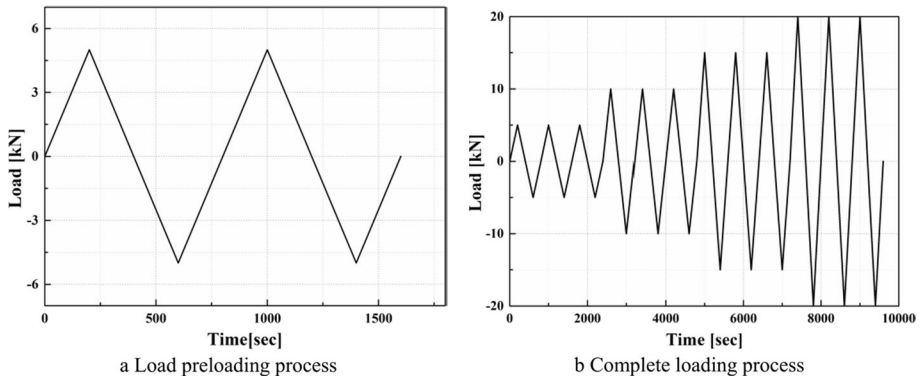
**Fig. 20** Lateral cyclic loading schedule

The shear cyclic load was applied in increments of 5 kN at each stage (Fig. 20b) after ensuring proper operation of the sensor. Because the stone was soft and prone to brittle failure, the loading rate was kept stable at 0.025 kN/s. Three cycles were repeated at each step with the same loading to observe the degradation in the stiffness and strength. The loading mode with displacement as the control value was adopted before the wall yielded. The transverse cyclic force was increased by 16 kN per step after wall cracking.

Two cycles were repeated at each step with the same loading. The test ended when the lateral load dropped to 85% of the lateral peak load.

The axial load was applied to the top surface center of the beam by a vertical actuator, which remained constant during loading (JGJ/T 101-2015, 2015). The wall was preloaded laterally before the test. The preload value was 30% of the expected cracking load of the wall (Fig. 20a). The expected cracking load was calculated by Eq. 2 (GB

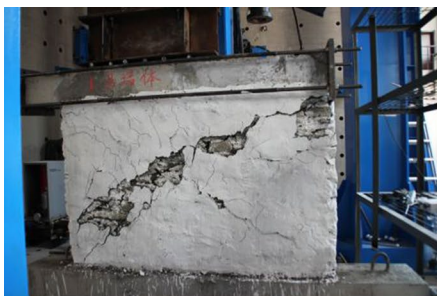
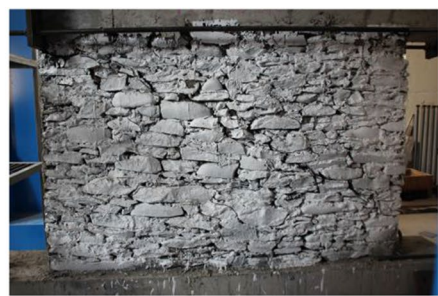
**Fig. 21** Typical damage observations

The specimen was in the elastic phase of the wall during the preloading and the first and second loading phases. The first crack appeared in the lower right of the wall when the wall was loaded to 10 kN. Cracks gradually appeared on the wall, leading to the failure of the upper horizontal constraint with increasing horizontal load.

The plaster on the wall gradually fell off. Three millimeter-long cracks appeared on the wall. The cracks extended  $45^\circ$  to both sides of the wall. The mud joints of the wall gradually loosened (Fig. 21b). The wall entered the yield stage and gradually lost its bearing capacity. A large number of oblique cracks (Fig. 21a) and vertical cracks appeared on the wall when the load reached 22 kN. The wall plaster fell off in large quantities. A transverse crack appeared when the load reached 26 kN, which was formed under a horizontal shear load, and a small number of the vertical cracks were compression cracks. The widest crack was located in the middle of the wall with a width of 5 mm.

(a) Oblique cracks

(b) The joints of the wall gradually loosened

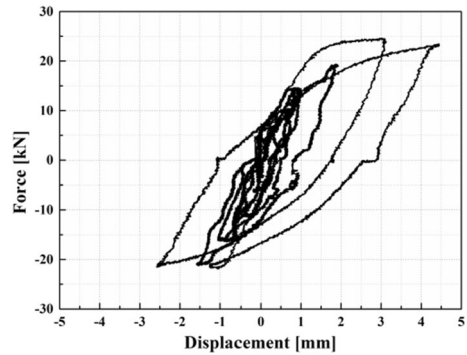
**Fig. 22** Hysteresis loop for wall specimen

The hysteresis curve (Fig. 22) was spindle-shaped. The hysteresis curve area increased with the load level, and the hysteresis curve maintained a certain fullness, indicating an

increase in the energy dissipation of the specimen. The number of cracks increased. The cracks gradually widened and expanded. Due to the sliding of the mud joints, X-shaped cracks appeared in the specimens with further increases in the transverse load. The hysteretic deformation gradually changed from a spindle shape to a bow shape.

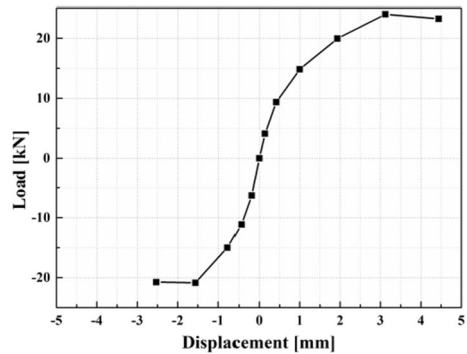
**Fig. 23** Skeleton curve

According to the slope trend of the skeleton curve (Fig. 23), the damage to the specimen can be divided into three stages: the elastic stage, the hardening stage, and the destruction stage. The loads and displacements of these three stages were 11.2 kN and 0.48 mm, 26.5 kN and 3.23 mm and 23.2 kN and 4.48 mm, respectively. The specimen stiffness continued to decrease with increasing displacement (Fig. 24). In the elastic phase, the rate of degradation of the wall stiffness was significant. After entering the plastic phase, the decay rate of the specimen stiffness also decreased gradually. When the specimen was subjected to the ultimate load, the specimen stiffness reached the minimum value, 5.52 kN/mm, in the steady state. The ultimate bearing capacity and initial stiffness of the specimen were 26.5 and 32.3 kN/mm, respectively, which were lower than the limits of the local earthquake code (GB 50011–2010, 2010).

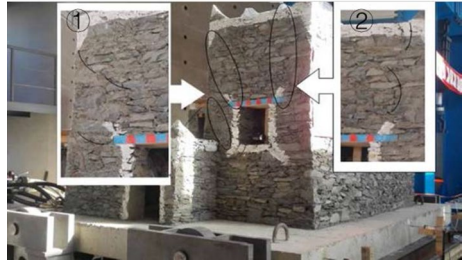
**Fig. 28** Distribution of wall cracks between axis B–C

The oblique shear cracks appeared at the vertical and horizontal corners of the wall when the peak acceleration of ground motion was 1.042  $\text{m/s}^2$ . The cracks developed obliquely along the walls at the end of the beam top of the door and window. Some cracks extended

to the junction of the longitudinal and transverse walls. A horizontal crack appeared at the windows on the second floor when the peak acceleration of ground motion was  $1.598 \text{ m/s}^2$ . The original crack extended upward across the entire wall. Oblique cracks along the cracks appeared at the corners of the wall with doors and windows in the B and C axes. When the peak acceleration of ground motion was  $2.881 \text{ m/s}^2$ , the crack expansion caused the roof to separate from the wall. The wall was extensively damaged. The stones were delaminated and fell from the walls, which led to wall collapse at the corner. The cracking of the specimens was mainly concentrated in the corners of the third floor and the window positions of the second floor (Fig. 28).

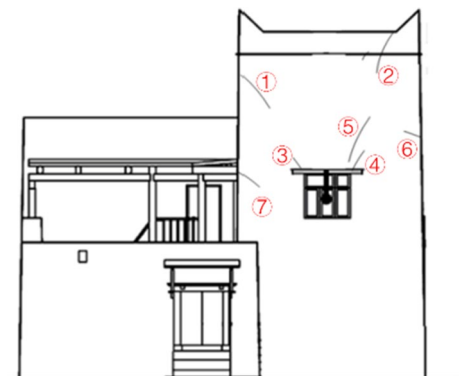
**Fig. 29** Schematic diagram of the crack distribution

Due to the large, concentrated stress at the windows and doors of the specimen and the gradual decrease in the wall thickness of the specimen, the bearing capacity and stiffness changed suddenly at the four corners of the window on the second floor, leading to oblique cracks on the wall. These diagonal cracks first arose at the corners of the top floor, followed by the upper corners of the windows, and then extended toward the transverse walls. The sequence in which the diagonal cracks were generated is shown in Fig. 29. In addition, the weak tensile strength of the longitudinal and horizontal walls and the weak strength of the mud were also reasons for wall cracking. The damage state of the specimen was similar to the seismic damage state of the stone masonry structure in the introduction section.

The flat elevation geometric irregularity of the TATB was particularly evident on the 2nd and 3rd floors. A change in the stiffness and bearing capacity resulted in a “V” shear slant crack. The irregularity of the plane and façade led to asymmetric torsion of the TATB. The asymmetric torsion resulted in a difference of approximately 10% between the peak acceleration and the peak displacement on the same floor. The presence of the torsional effect seriously affected the seismic performance of the structure.

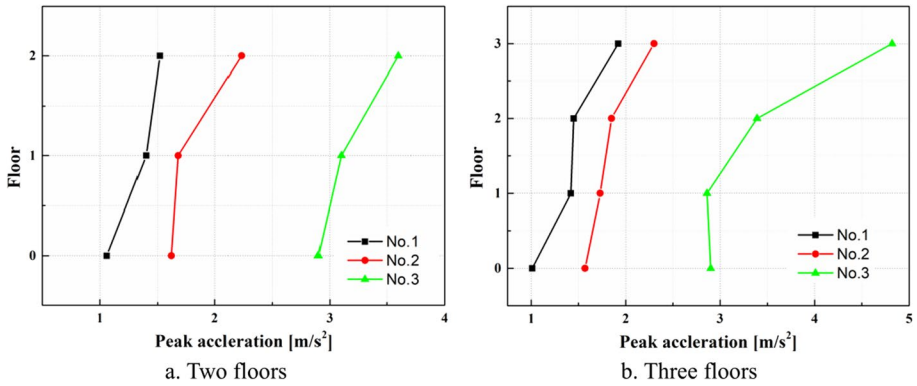
Fig. 30 Acceleration response of the TATB

For the irregular façade characteristics of the TATB, the structural response accelerations of floors 2 and 3 under different seismic excitations are discussed. Based on the

acceleration time histories at each measurement point, the peak accelerations of the specimens can be derived at peak displacement waves of 8.34, 12.18 and 15.89 mm. The peak accelerations at the second and third floors are shown in Table 7. The variation in the peak along the height direction is shown in Fig. 30. The corresponding acceleration amplification factors are shown in Fig. 31. The acceleration of the superstructure increased as the peak surface displacement increased. Moreover, the peak acceleration of the same floor differed by approximately 10%, which was mainly caused by the torsional effect of structural asymmetry. Figures 30 and 31 show that along the height of the building, the floor acceleration increased gradually, especially in Case No. 3. The increase in acceleration was more pronounced on the third floor, which was due to the change in mass and stiffness of the building along the vertical direction.
