Injury to Endoscopic Personnel from Tripping over Exposed Cords, Wires, and Tubing in the Endoscopy Suite: A Preventable Cause of Potentially Severe Workplace Injury

Mitchell S. Cappell

Aim To describe a novel, previously unappreciated workplace hazard to endoscopic personnel: Exposed wires in the endoscopy unit.

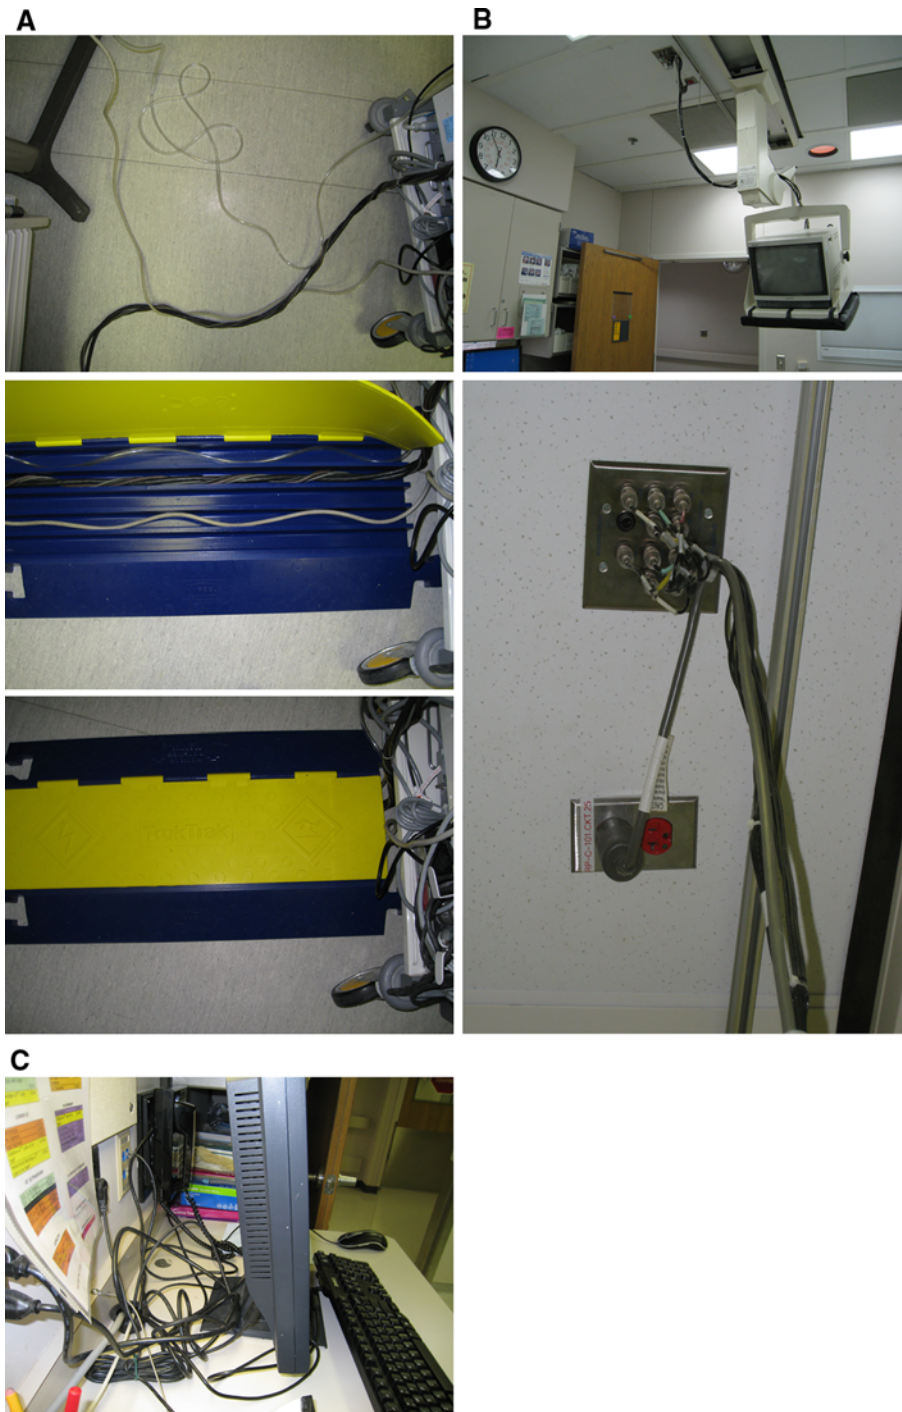
Fig. 1 Remediation measures for exposed cords, wires, and tubing to reduce slip and fall hazards in the endoscopy suite, as illustrated in an endoscopy room equipped with fluoroscopy for endoscopic retrograde cholangiopancreatography. **a** Covering exposed wires on the floor using a nonslip mat. **a1** Before remediation, five cords run above the floor and represent a fall hazard; these include three cables for the transmission of colors to the endoscopic video monitor, one cable to a power strip on the endoscopy cart (to supply electricity to the endoscopic video processor, light source, water pump, coagulation/cautery unit, etc.), and one soft plastic tubing from the wall vacuum to an endoscopic port for endoscopic suction. Soft plastic tubing forms loops above the ground, which present a particular hazard for falls. The soft plastic tubing is used for the wall suction and for the supplemental oxygen. Note the wheels at the bottom of the endoscopy cart on the *right* of the photographs **a1–a3**. **a2** During remediation, the four cables and the one plastic tubing which ran above the floor in **a1** are placed in the grooves of an opened nonslip mat. **a3** After remediation: Closing the top door of the nonslip mat conceals the five previously exposed cords or tubing within the mat to eliminate the fall hazard. **b1** Outlets from ceiling. Photograph shows outlets placed on the ceiling rather than the walls for wires leading to endoscopic equipment placed >2 m above the floor (e.g., illustrated mounted endoscopic video monitor). This arrangement avoids running these wires directly on the floor and reduces the fall hazard. **b2** Bundling of wires. Close-up photograph of the outlet area in **b1** shows bundling of ten wires arising individually from outlets in the ceiling to form a single thick cable to reduce the number of independent wires coursing through the room. Note the additional plug arising from the nearby electrical outlet that powers the endoscopic video monitor. **c** Accessory nonendoscopic equipment placed on countertop near wall. Side-view photograph taken behind the computer in the endoscopy room shows numerous wires embedded within the wall and running just a few inches on the countertop to the computer, computer monitor, internet access, keyboard, and telephone. This arrangement avoids running wires to this equipment on the floor

The three injuries occurred during the performance of 110,000 endoscopies during a 5-year period at one hospital. Hospital review revealed a mean of 35.3 ± 7.5 cords, wires, and tubing per endoscopy room during procedures ($n = 10$ rooms).¹ Before remediation most of these wires were exposed above the floor. As remediation measures, wires arising from the wall plugged into electrical units <2 m above the floor, such as the endoscopy cart, were switched from being completely exposed above the floor to being completely covered by a heavy metal nonslip mat (Fig. 1a); wires plugged into electrical units high (>2 m) above the floor, such as mounted endoscopy monitors, were switched from coming from wall outlets to dropping from ceiling outlets to reduce the number of wires above the floor (Fig. 1b1); individual wires were combined into cables to reduce the number of independent wires (Fig. 1b2); wires for accessory nonendoscopic equipment (e.g., computers, telephones) were embedded in the wall with the nonendoscopic equipment placed on a counter near the wall (Fig. 1c). Exposed tubing for supplemental oxygenation or endoscopic suction was covered by a heavy metal nonslip mat such as that used for exposed wires on the floor (Fig. 1a). These remediation measures virtually eliminated exposed wires and tubing.

¹ Cords, wires, and tubing: (1) in all ten rooms included those for the main endoscopic television monitor, endoscopy cart, endoscope water pump, supplemental oxygen, wall vacuum, intravenous line, blood pressure cuff, electrocardiographic leads, and pulse oximetry; (2) in eight rooms for the auxiliary endoscopic television monitor; (3) in one (ERCP) room for the portable X-ray machine, fluoroscopy display monitor, electrically powered ERCP stretcher, and anesthesia gas machine. In all ten rooms, an additional 11.3 ± 1.1 wires were easily embedded in the wall and are not included in the above total. These wires were for telephone jacks, computer, computer monitor, keyboard, mouse, and X-ray view box (Fig. 1c).
