Geotechnical assessment of road failure and slope monitoring along Nsukka-Adoru-Idah highway, Southeastern Nigeria

Abstract The quality of highway pavement is greatly influenced by the subgrade materials, the general geology of the area, and the materials used for construction. Investigation into the 75-km Nsukka-Adoru-Idah highway revealed that the pavement was underlain by three lithological units—Imo, Nsukka, and Ajali formations. The geotechnical evaluation carried out in the study includes the particle size distribution, Atterberg limit, specific gravity, compaction tests, and California bearing ratio (CBR). The base course has clay/silt (7–14%), fine sand (1–4%), medium sand (6–13%), and coarse sand (65–86%), while the subgrade presented clay/silt (74–82%), fine sand (6–9%), medium sand (10–17%), and coarse sand (1–3%). The average specific gravity results for the studied base course and subgrades are 2.58 and 2.52. Liquid limit (LL) result ranges from 27 to 60%, while plastic limit (PL) ranges between 17 and 24%, and plasticity index (PI) ranges from 5 to 39%. The maximum dry density (MDD) result ranges from 1.70 to 2.10 mg/m³, while the optimum moisture content (OMC) for t

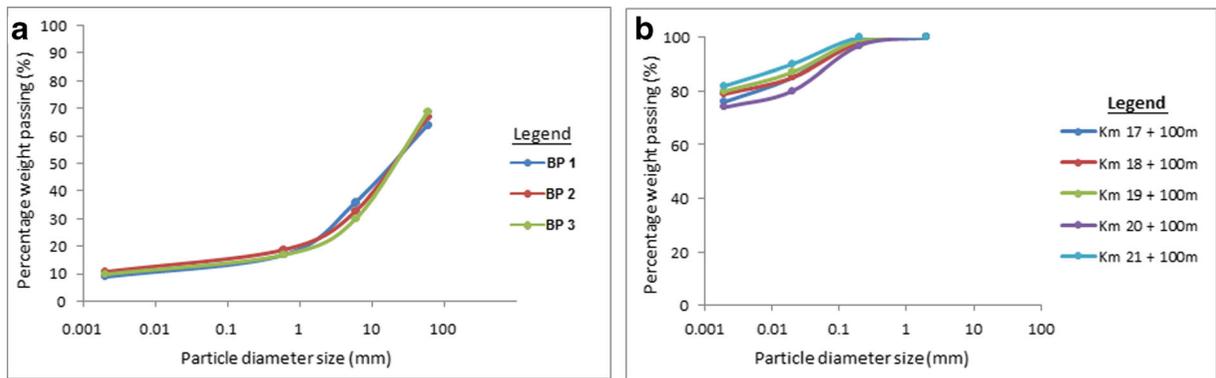
Fig. 4 Borrow pits and subgrade particle size curves

The analysis indicated that sand is the predominant soil particle size in the borrow pits. The particle size curve is situated to the right of the particle distribution chart (Fig. 4a). And according to Arora (2008), if the particle size distribution curve is situated to the right, it indicates a coarse-grained soil. Thus, the base course is well drained and non-plastic, suggesting a good engineering material. The setting of the particle size curve of the subgrade to the left of the particle distribution chart (Fig. 4b) hints a likely poor fine grain subgrade due to plasticity and low permeability.

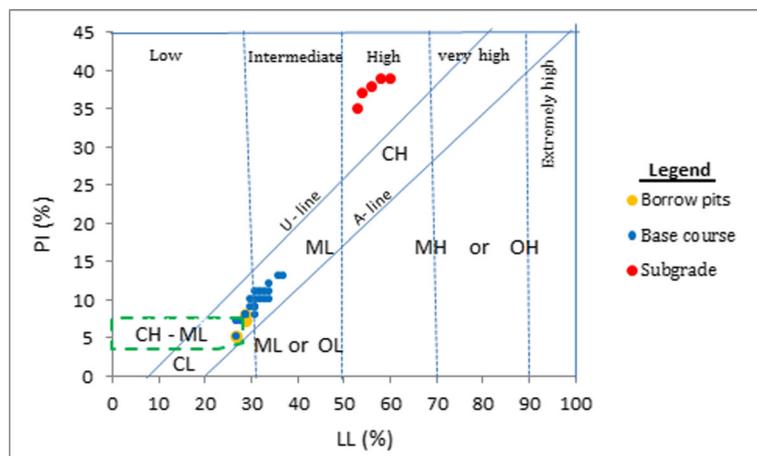
Fig. 5 Samples' plasticity chart

According to the Unified Soil Classification System (USCS), the base course can be classified as SM-SC (silty/clayey sand), with 5–12% passing sieve no. 200 and PI > 7. The subgrade can be classified to be CH (high plastic clay), with LL > 50% and PI > 30% (Bell 2007; Arora 2008). Following the American Association of State Highway and Transport Official (AASHTO) classification, the base course can either be graded as A-2-4, with less than 35% passing sieve

no. 200 and LL and PI less than 40 and 10%, respectively, or as A-2-6, with less than 35% passing sieve no. 200, LL < 40%, and PI > 11%. In general, the base course can be classified as excellent to good construction materials. However, the subgrade within the failed pavements (around Adoru and Okuje) can be grouped as A-7-6, with more than 36% passing sieve no. 200, LL > 41%, PL < 30%, and PI > 11% (Table 4). Thus, the subgrade can be grouped as poor to fair construction material. Nonetheless, the subgrade can be improved with the application of the base course, which conducts water away from the pavement due to apparently high porosity, permeability, and hydraulic conductivity.

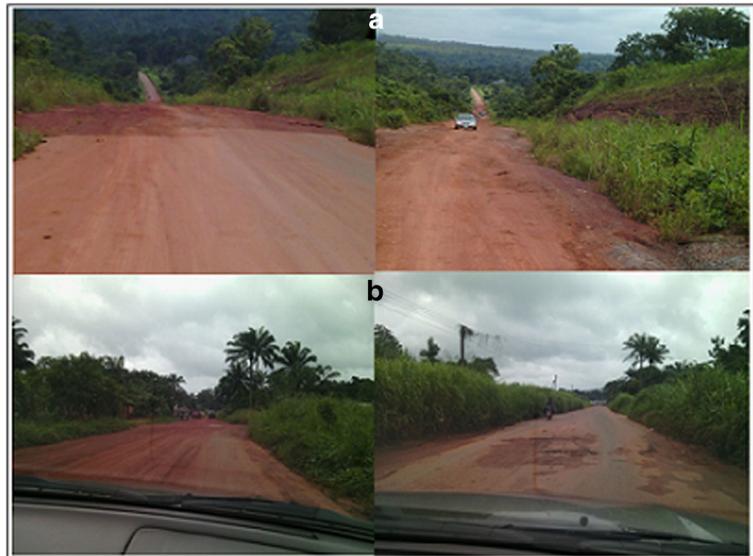
Fig. 6 Bad spots (washouts and portholes) along the highway alignment

continuous severe pavement failure at Okpuje, Okutu, Adoru, and Igabada towns as shown in Fig. 6.

the life span of the pavement. If preventive measures are not done in the near future, pavement washouts and pot-holes (Fig. 6) and landslides can develop on the road which might lead to total failure of the highway pavement.

and soaked test results reached the recommended limit for base course. This situation suggested very likely that the tested samples are fairly suitable as base course, though it can be improved upon. Despite the fact that the highway under investigation shows good base course quality for construction, the CBR, LL, and PI values of the subgrade suggested that potholes which are prevalent in some parts of the road alignment around Ukuje, Okutu, Adoru, and Igabada cannot be ruled out along the highway pavement because of the underlying shale, which has the tendency to slide over another when involved with water, especially on sloppy ground as shown in Fig. 6a (Arora 2008; Singh 2008; Aghamelu et al. 2011).

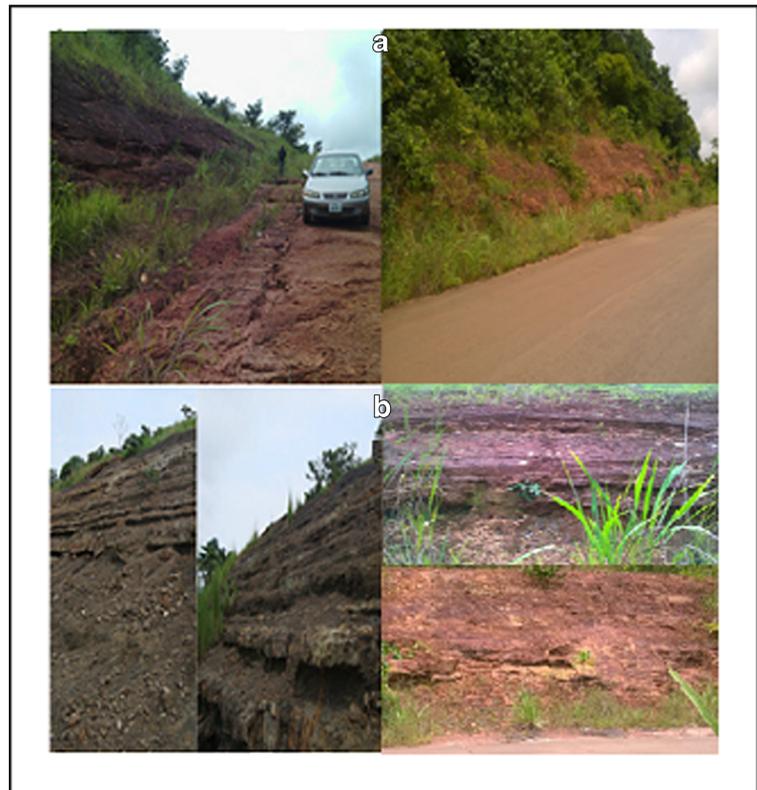
Fig. 7 High shaley road cuts with possibility of sliding

bed on one or both sides that remains after local topography is minimized by cutting an elongated depression through higher ground during road construction (Fig. 7). These road cuts could pose a threat to the highway pavement if the slopes are unstable.

The difficulty of water removal from slope might be the reason for the use of the benching method in the stabilization (in terms of lowering the slope angle and slope length, and possible slip surface) of some of the road cut slopes along the highway alignment (Fig. 7).

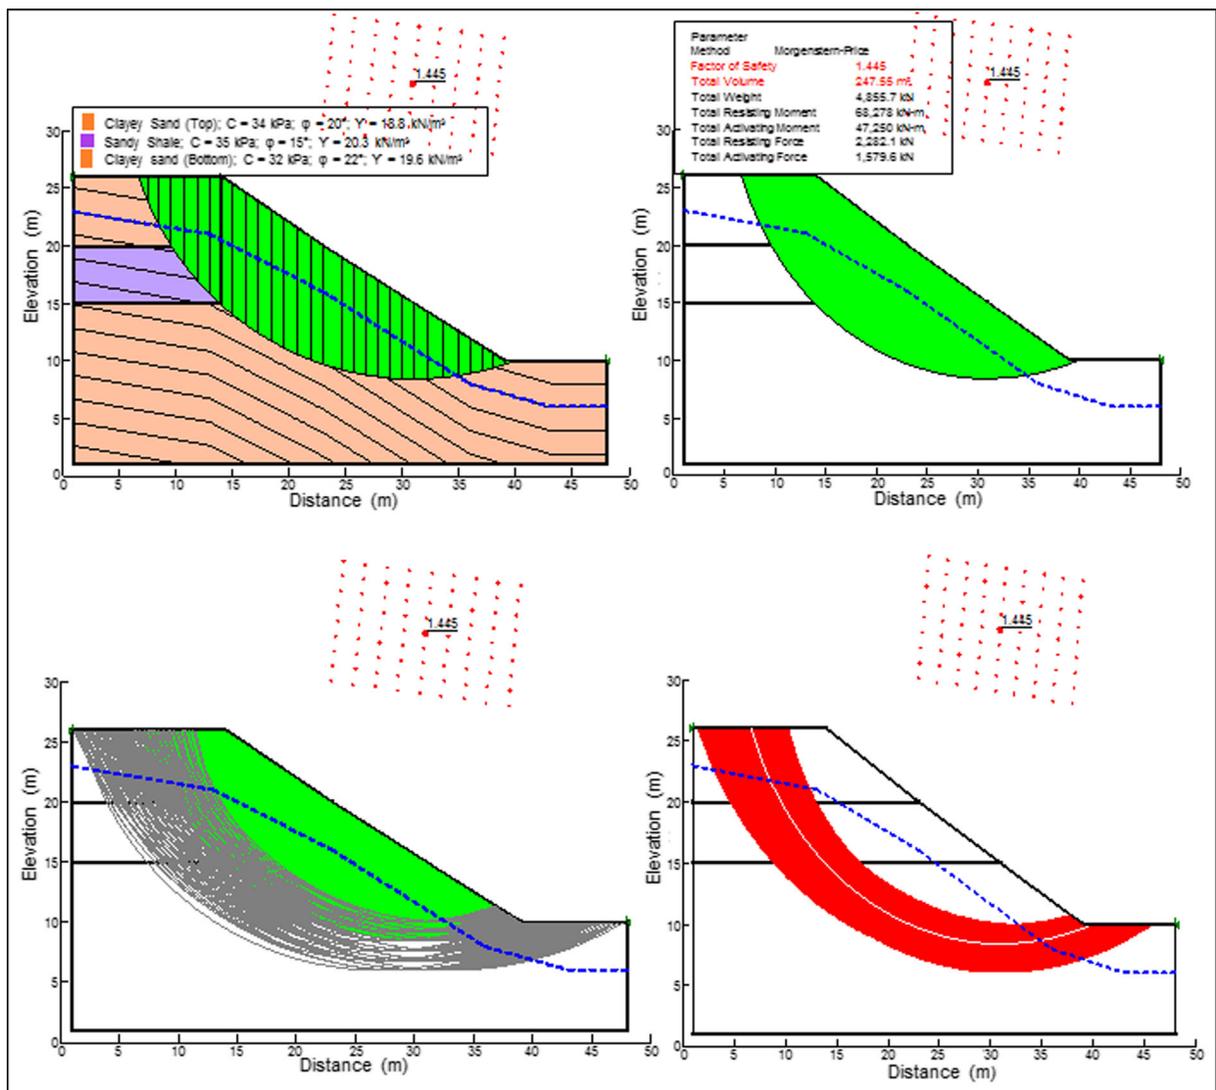
Fig. 8 Slope/W Geostudio model of a road cut along the highway

The factor of safety (FS) calculated from the Slope/W Geostudio model is presented in Fig. 8. A FS of 1.45 was computed for the analyzed slope (Fig. 8a). A factor of safety of 1 indicates incipient failure (Coduto 2007). Thus, any slope with FS greater than 1.0 will purportedly be stable. However, because of uncertainties in analysis that must be accounted for and the presence of triggers in the field, there is always a need to consider larger values of FS. Hence, most common design criterion requires a FS of at least 1.50 for stability.

In this paper, the extent of stability and instability is expressed as the closeness of FS values to 1.5 and 1.0, respectively. Therefore, the FS of 1.45 indicated that the slope is moderately stable but not at safe level required. Though the FS was apparently far from 1, which is the value required for an incipient failure, it was not up to 1.5 which is the value for satisfactory stability. Thus, landslides cannot be ruled out since the triggers could still be able to cause large soil movements. In the event of a possible failure, the model showed that the failure would be a rotational slip surface passing just below the toe of the slope, having a depth of about 10 m and a sliding mass of about 148 m³ as shown in Fig. 8b. A landslide with this geometry can be considered to be a medium to high magnitude soil movement.

Many slip surfaces were analyzed (Fig. 8c). The 150 most critical trial slip surfaces were considered to enable us to produce a safety map of the analyzed slope. The FS for these trial slip surfaces range from 1.45 to 6.55. However, the safe FS zone is area under the red band as shown in Fig. 8d. This area is considered to be a zone of potential failure in which the factor of safety of the trial slip surfaces is similar. In the present analysis, all the factors of safety within the red band are between 1.45 and 1.50, indicating a fairly good or moderate stability.

A good method to improve the stability of slopes is by lowering or completely removing the groundwater from slopes. The removal of groundwater from the slope in this analysis increased the factor of safety from 1.45 to 1.68 and also reduced the sliding mass from 248 to 199 m³ (Figs. 8 and 10a). However, methods of groundwater removal from a slope are expensive and can require a long time.

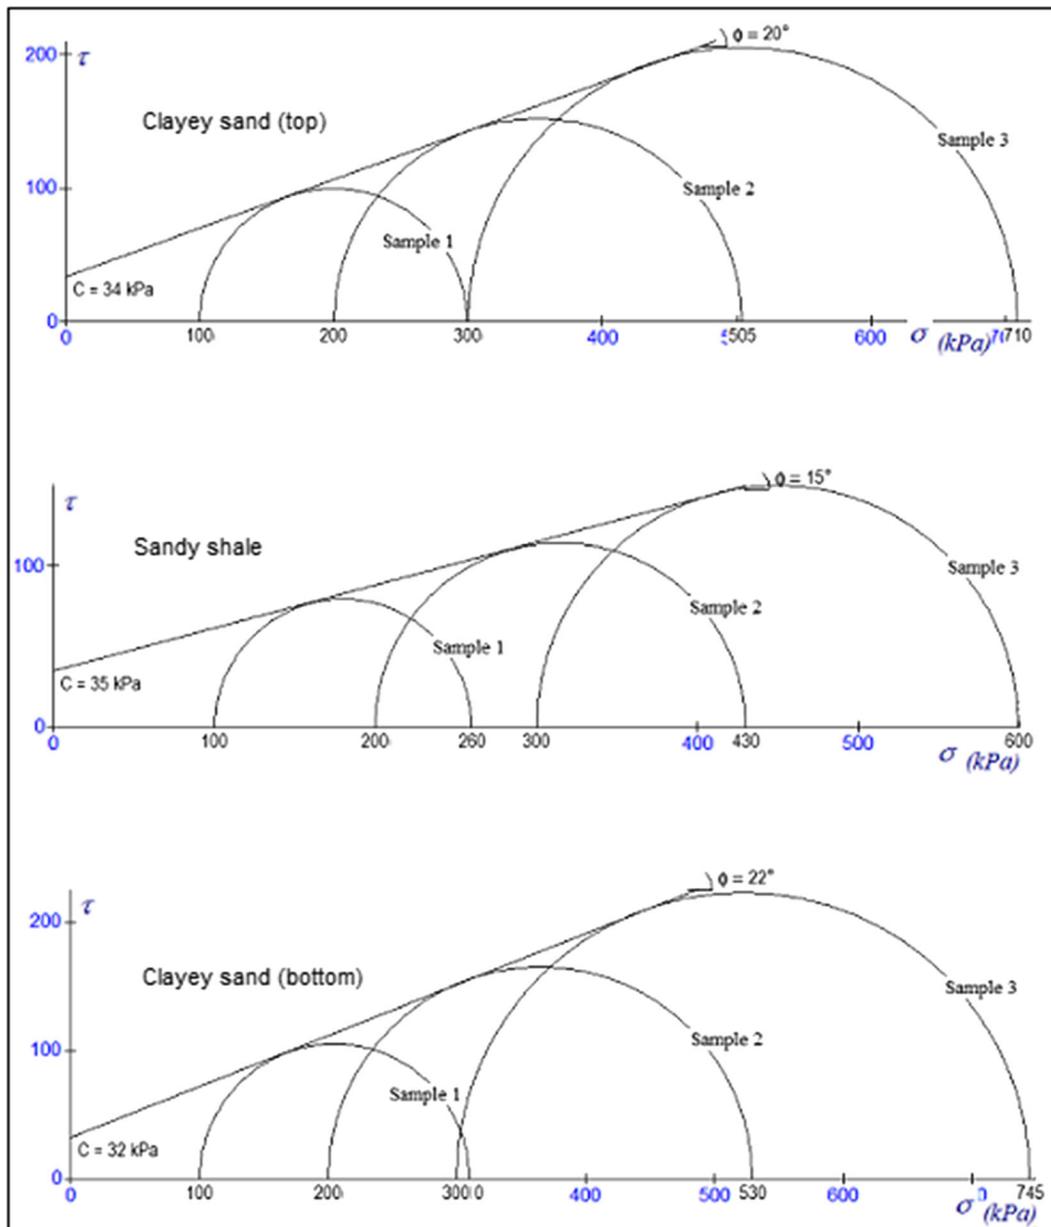
Fig. 9 Mohr envelopes and shear strength parameters of the various slope lithologies

The shear strength parameters such as cohesion and internal friction angle computed from the result of the undrained triaxial compression test done on consolidated road cut soil units by plotting the shear strength against the values of shear stress are shown in Fig. 9. The cohesion and angle of internal friction of the clayey sands (for the stress range of interest) range between 32 and 34 kPa and 20° – 22° , respectively, while the cohesion of the sandy shale was 35 kPa, and the internal friction angle was 15° . The unit weight of both lithologies averages 19.2 and 20.3 kN/m³, respectively.

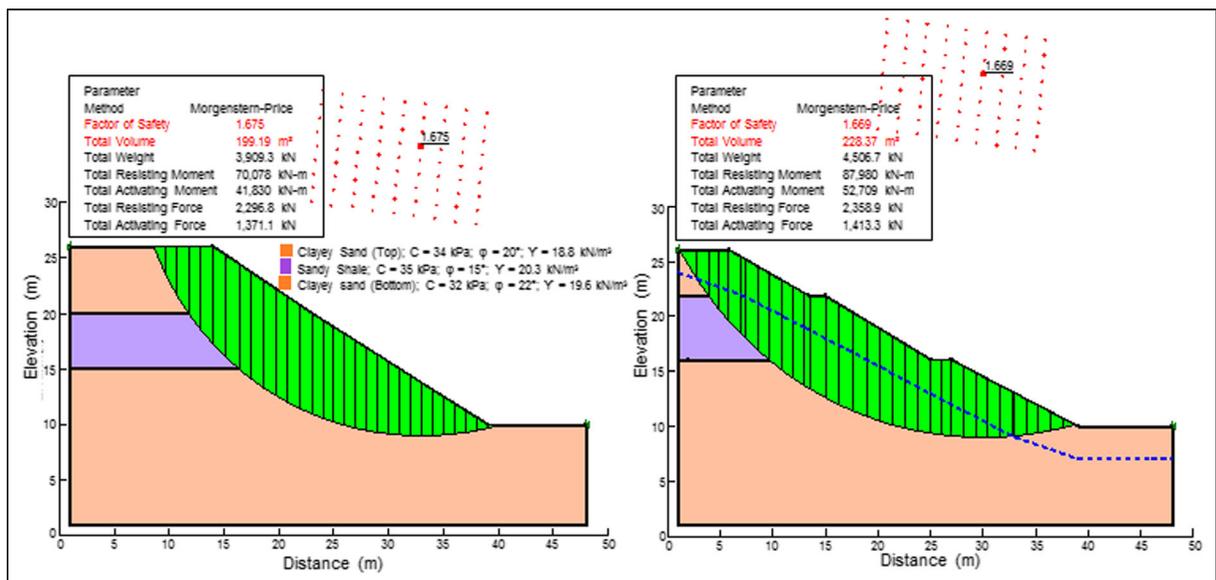
Fig. 10 Slope/W Geostudio model showing the effects of slope stabilization

The benching method improved the factor of safety from 1.45 to 1.67 and reduced the sliding mass from 248 to 228 m³ as seen in Figs. 8 and 10b, respectively. The values of this method were close to the results obtained from the drained slope model (Fig. 10a, b). Hence, the benching method was also efficient but less demanding to achieve and maintain.

The authors are suggesting that the method of benching be applied to other road cuts along the

highway to facilitate suitability, safety, and durability of the slopes and, by extension, increase effectiveness of the road alignment and security of lives and property.

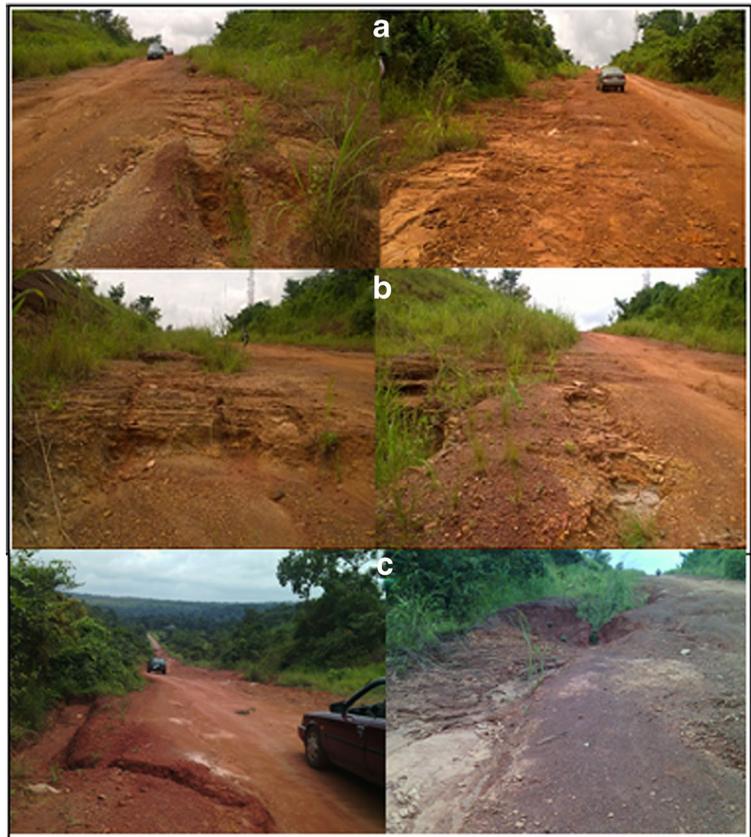
Fig. 11 Flood and erosion-ravaged spots on the highway around Okuje and Okutu communities

stress on the back of slopes, loss of lateral support, and increase strain behind slopes. An environmental impact assessment was carried out on the road to establish the impact of the road on the environment in terms of the physical, social, and economic conditions of the people. Severe flooding and soil erosion are constant occurrences within the extent of the road alignment, especially in those sections of the road where road cutting and in filling of materials were dominant during the construction process (Fig. 11).

along the surface that passes the toe of the slope. Erosion removes a slope lateral support and thus increases the slope angle (Fig. 11b), thereby increasing the chance of slope failure. Changes in topography and decrease in load on toe may lead to the development of some tension cracks (Youssef et al. 2014). The slopes could fail by rotation along a slip surface when water causes a reduction in effective stress by increasing pore pressures within its bedding planes (Figs. 8 and 10). These slopes could also undergo translational failure if a thin shale bed (weak layer) within a road cut provides a sliding surface when lubricated with water. Excessive water in the sand portends unduly high soil water content and thus increases the pore water pressure within the soil pores, which is one of the initiators of landslides.

clearing out, and weak road bed stabilization could cause erosion and water logging along the highway alignment and surrounding bushes (Fig. 11) and thereby triggering creeping of the clays through clay mineral activity and increased pore pressures within clay layers. The provision of surface drainage systems and the completion of the other mentioned construction services would go a long way in the maintenance of the highway and thus increase
