Study on shoreline migration and island dynamics over the last five decades in the Muriganga River using multi-temporal satellite images

Md Saddam Hossain · Ujjwal Saha

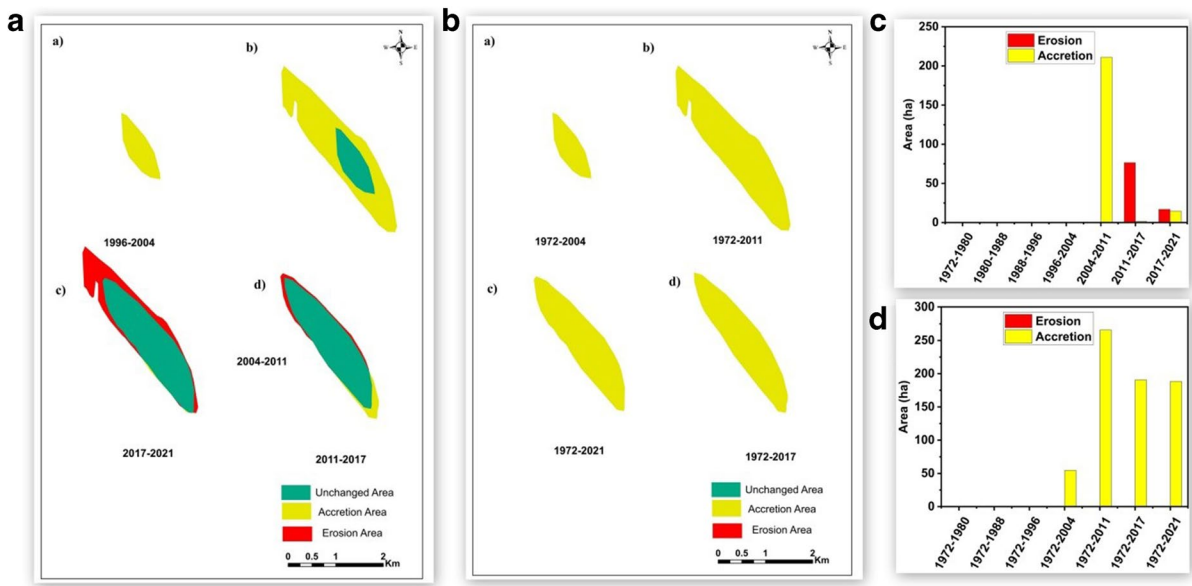
Fig. 7 Short-term erosion–accretion in Niogi island (a and b) and long-term erosion–accretion in Niogi island (c and d) (1:40,000 scale) during the different time periods from 1972 to 2021

With the help of the multi-temporal Landsat images, it is found that the Niogi island has emerged in 2004 onwards (Fig. 7). Before that, this island may be in submerged condition. The island becomes visible due to the gradual depositions over the years. This newly developed island had an area of 50.64 ha in 2004, and

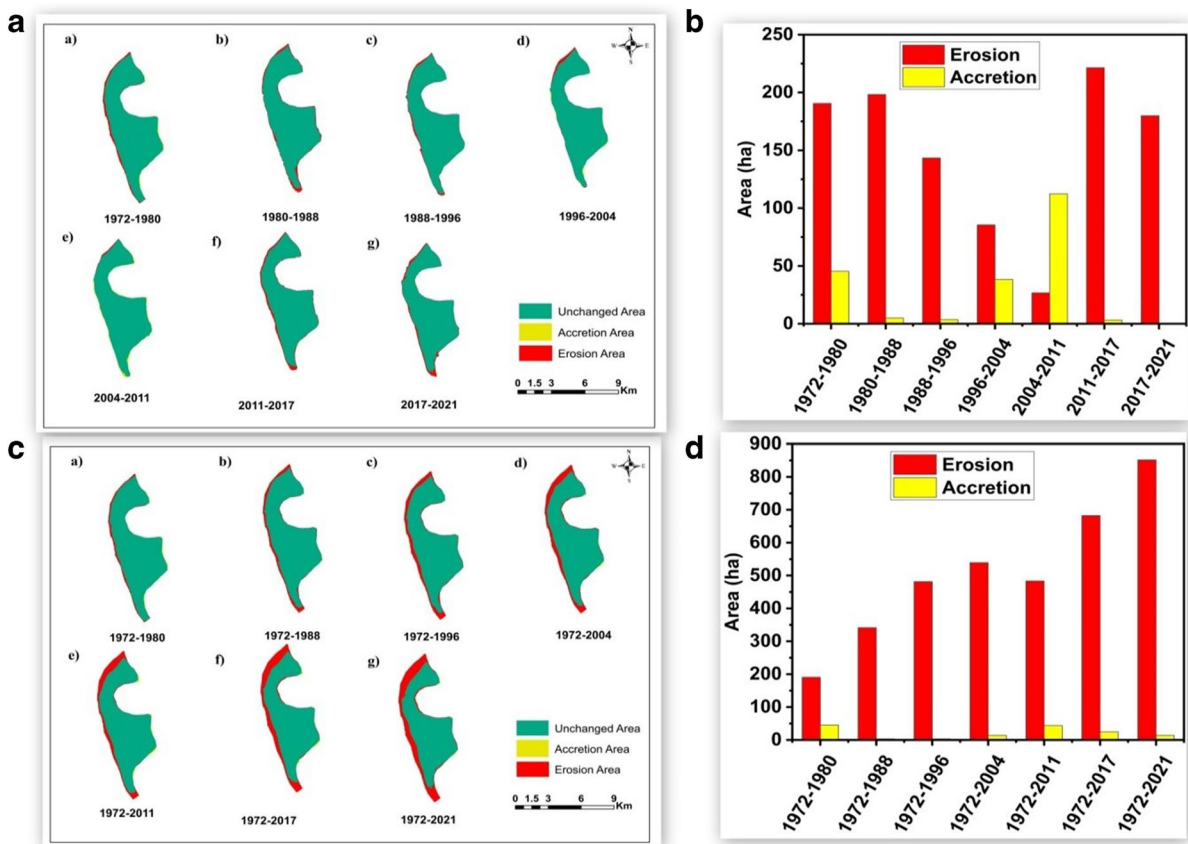
Fig. 10 Short-term erosion–accretion in Mousuni island (a and b) and long-term erosion–accretion in Mousuni island (c and d) (1:190,000 scale) during the different time periods from 1972 to 2021

tourist place. In Mousuni island, the short-term and long-term average erosion and accretion rates are 23.27 ha/year and 18.14 ha/year and 4.02 ha/year and 1.19 ha/year, respectively (Table 9). From short-term analysis, it is found that between the 2004 and 2011 period, the accretion is relatively greater than the erosion (Fig. 10a, b) on the southern side. From Fig. 10, it is clear that the main concern is the western side, which undergoes severe erosion.

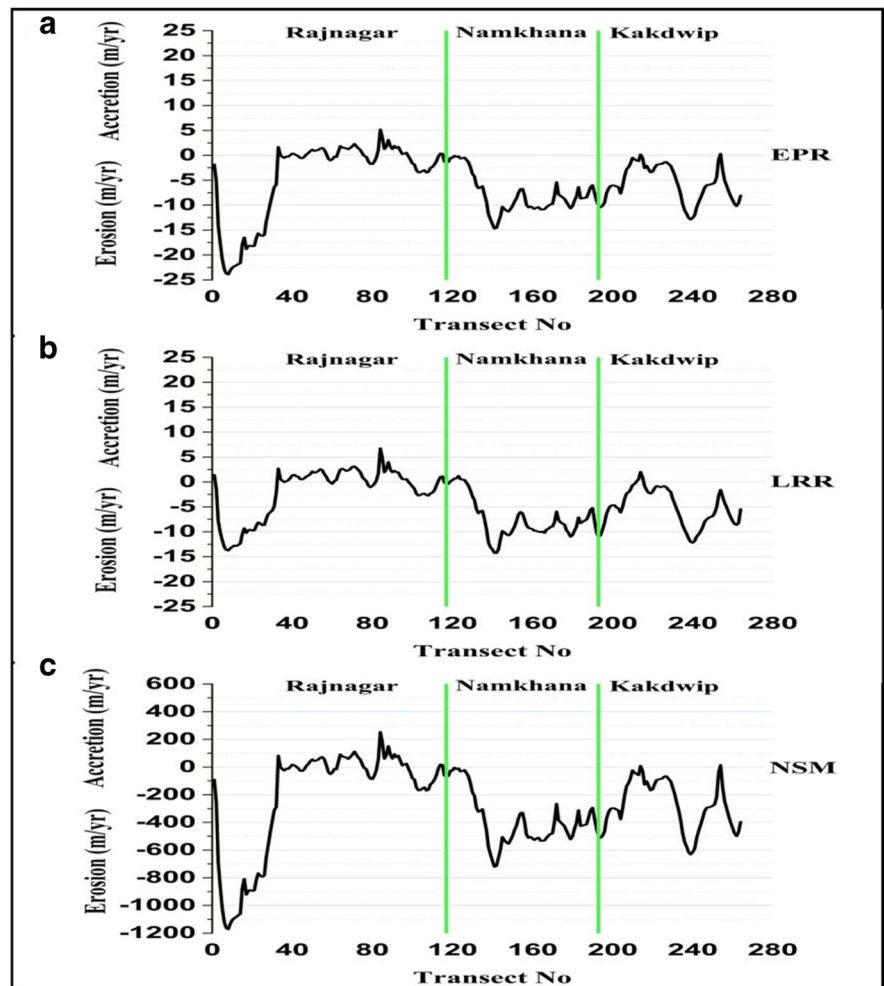
Fig. 13 Erosion–accretion profile at different sectors in the left bank of the Muriganga River calculated using EPR (a), LRR (b) and NSM (c) during the period of 1972 to 2021

Based on the EPR values, the maximum rate of erosion for left bank is 23.91 m/year at the Rajnagar sector near Fraseganj. Here, the LRR shows the erosion of 13.76 m/year. The maximum erosion based on LRR is 14.25 m/year at the Namkhana sector near Nadabhanga, where the EPR shows an erosion rate of 14.58 m/year. The maximum accretion rate for the left bank based on EPR is 5.18 m/year at the Rajnagar sector near Janamore, where the LRR also gives the maximum value of 6.75 m/year. The maximum erosion based on NSM is about 1170 m at the Rajnagar sector near Fraseganj, whereas the maximum accretion is about 253 m at the Rajnagar sector near Janamore. The overall average erosion throughout the entire left bank based on EPR, LRR and NSM are 7.31 m/year, 6.67 m/year and 358.57 m. Furthermore, the overall accretions are found as 1.19 m/year, 1.48 m/year and 58.24 m based on EPR, LRR and NSM, respectively. The erosion–accretion profile throughout the entire left and right bank is shown in Fig. 13 and

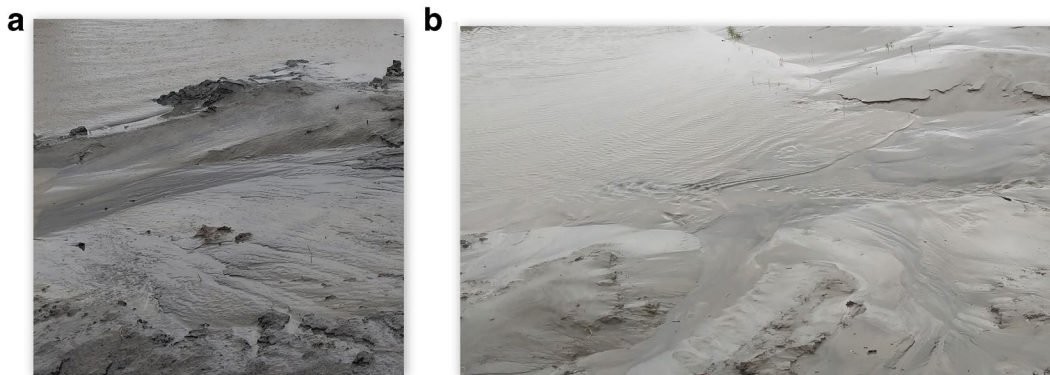
Fig. 21 Tidal flats on the left bank of the Muriganga River at the Kakkdip sector near Akshayanagar (a) and Kalinagar (b)

marsh etc. are found on the bank of the Muriganga River. Tidal flats are found within high tide and low tidal zones around the open shore. Silty sand and hard muddy patches are found in the high tidal flats. Mostly, silts and clay are found in the low tidal flats (Fig. 21). The left bank of the Muriganga River consists of three sectors Rajnagar, Namkhana and Kakkdwip. The right bank is nothing but the eastern side of Sagar island. This bank consists of three sectors Chemaguri, Kaylapara and Kachuberia sectors. The southwestern, southern and southeastern region of Sagar island mainly consists of sand where sand content is more than 80% (Nandi et al., 2016). These sandy beaches are highly erodible by the forces like wind, wave and tidal impacts.

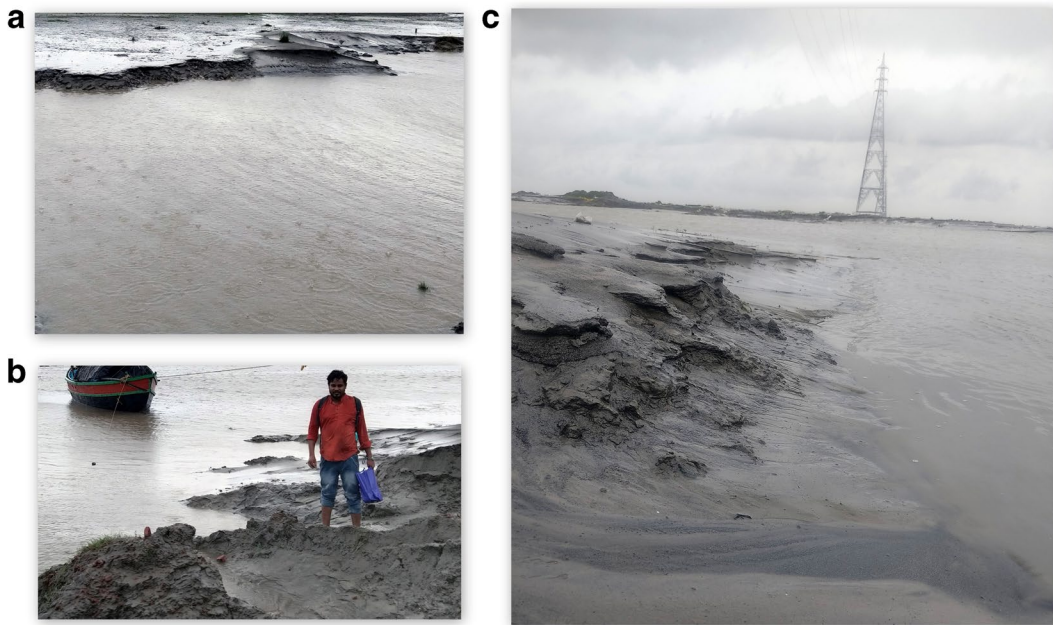
Fig. 22 Erosion at the Kakdwip sector near Kalinagar

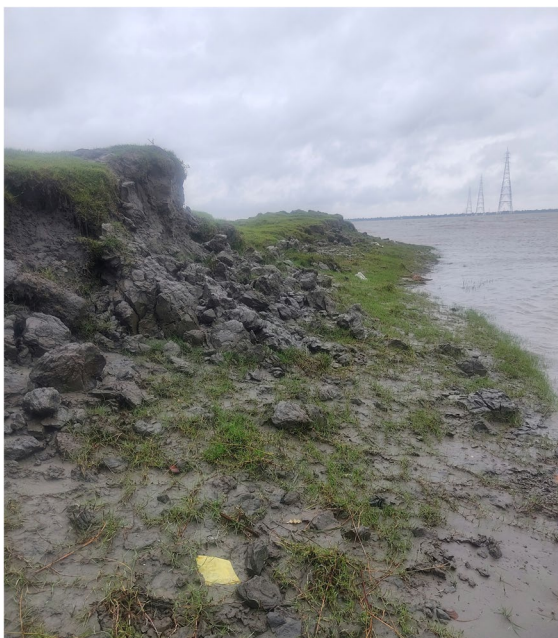
Fig. 23 Mud decoupling at the toe on the left bank near Akshyanagar

mud decoupling at the toe on the left bank is seen near Akshyanagar (Fig. 23).

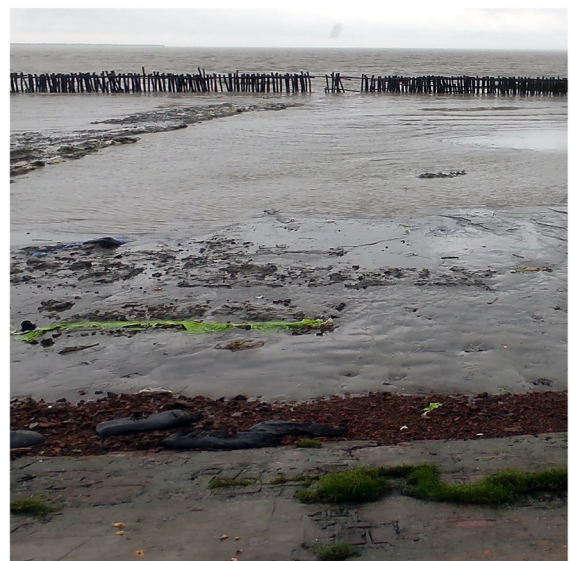
Fig. 24 Wooden embankment and brick kiln at the Kakdwip sector

In order to reduce the erosion, the local authorities have constructed wooden embankment along the river bank in the vulnerable locations (Fig. 24). These structures ultimately reduced the total erosion in these areas, and that is why these zones are of moderate erosion zone. These types of coastal management plans are required in areas where currently high erosion rate is observed (e.g. Fraserganj, Patibunia, entire Namkhana sector).
