Experimental Investigation on Dynamic Characteristics Changes of Fire Exposed Reinforced Concrete and Steel Members

Abstract. Damages to structures may occur due to construction defects during various stages such as design, construction, and operation phases, or due to natural disasters during their lifetime. The Operational Modal Analysis (OMA) method enables engineers to experimentally determine the changes in dynamic characteristics of the structures that resulted from these undesirable incidents. This method can also help to estimate the structural damages and determine the usage situations depending on stiffness changes. Fire is one of the most important effects that can cause changes in dynamic behavior of structures. Considering the damages caused by fire disasters in recent years, there is a crucial need to address the effects of high temperature on the relevant field of study. This study experimentally examined the effects of elevated temperature on changes in dynamic characteristics of reinforced concrete (RC) and steel structural members. In this regard, a total of 14 (10 columns and 4 frames) laboratory models are built. These models have been constructed with various

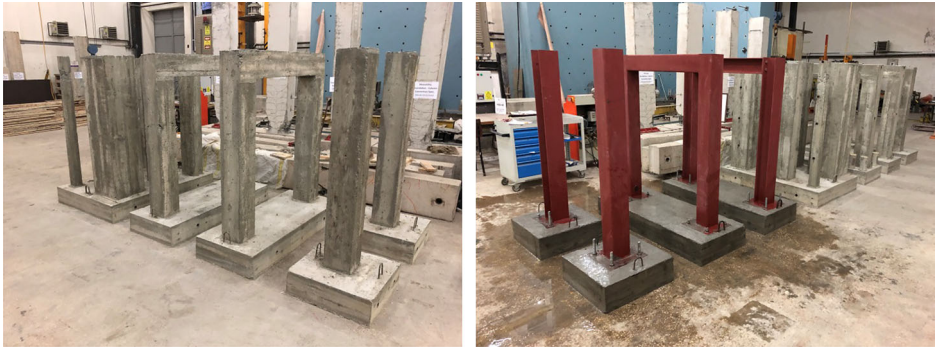
Figure 1. Some views of the RC and steel laboratory models.

The RC and steel columns and portal frames have been constructed in the laboratory to conduct non-destructive experimental measurements and evaluate the effects of fire on their behavior. Sections of the models have been selected in accordance with furnace dimensions and each of them having an RC foundation with 20 cm thickness. To construct the models, grade 50/60 concrete was used. The models are placed on the car-bottom of the test furnace, and they should have a minimum distance of 30 cm from heating elements and furnace ceiling. All models had an equal height of 1.5 m above their foundations. A clear cover of 25 mm and steel rebar with 8 mm diameter have been used for all RC models. In this study, reinforcements of RC frame configurations are non-seismically detailed. Steel columns and frames have been constructed using unprotected steel profiles painted after the sandblasting process. Figure 1 shows some views of the RC and steel laboratory models.

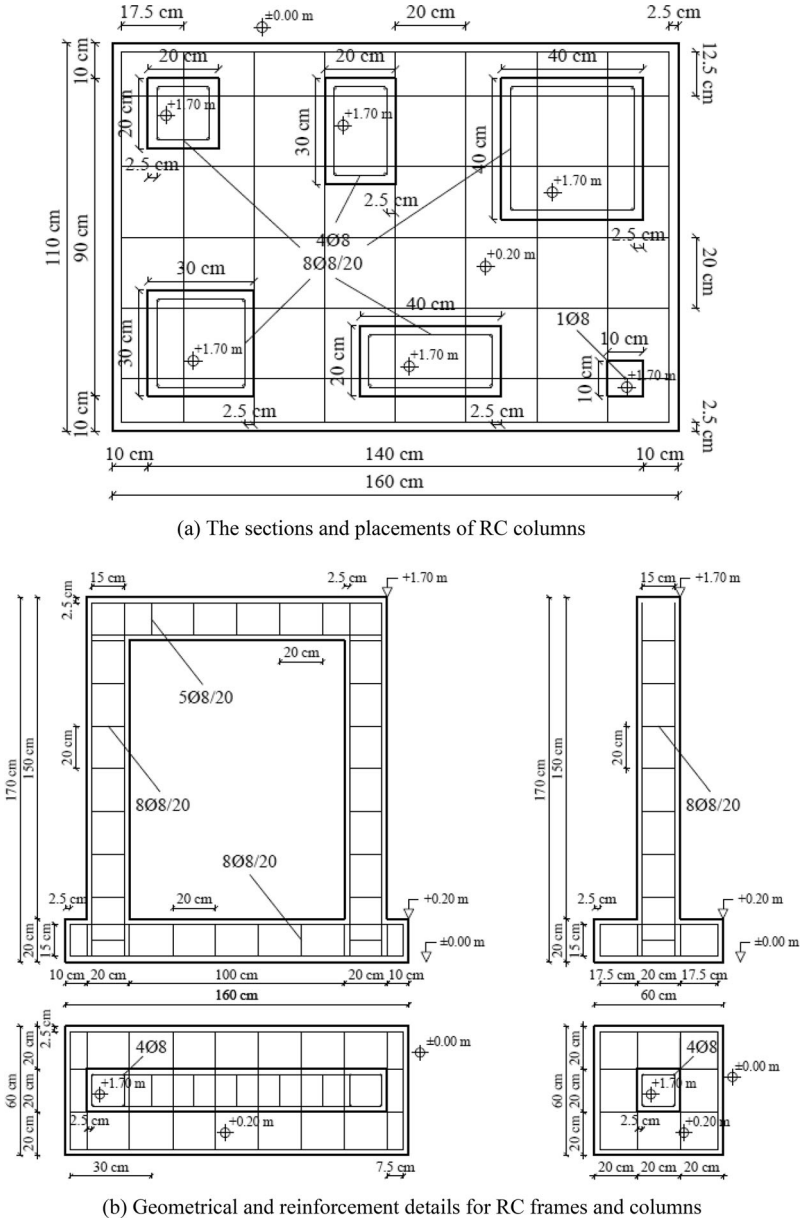
Figure 2. The geometrical configuration and reinforcement details of RC columns and frames. a The sections and placements of RC columns. b Geometrical and reinforcement details for RC frames and columns.

Figure 2 shows the geometrical configuration and reinforcement details of RC columns and frames. During the pouring procedure, temperature measurement stations have been positioned within certain intervals on RC models. For later

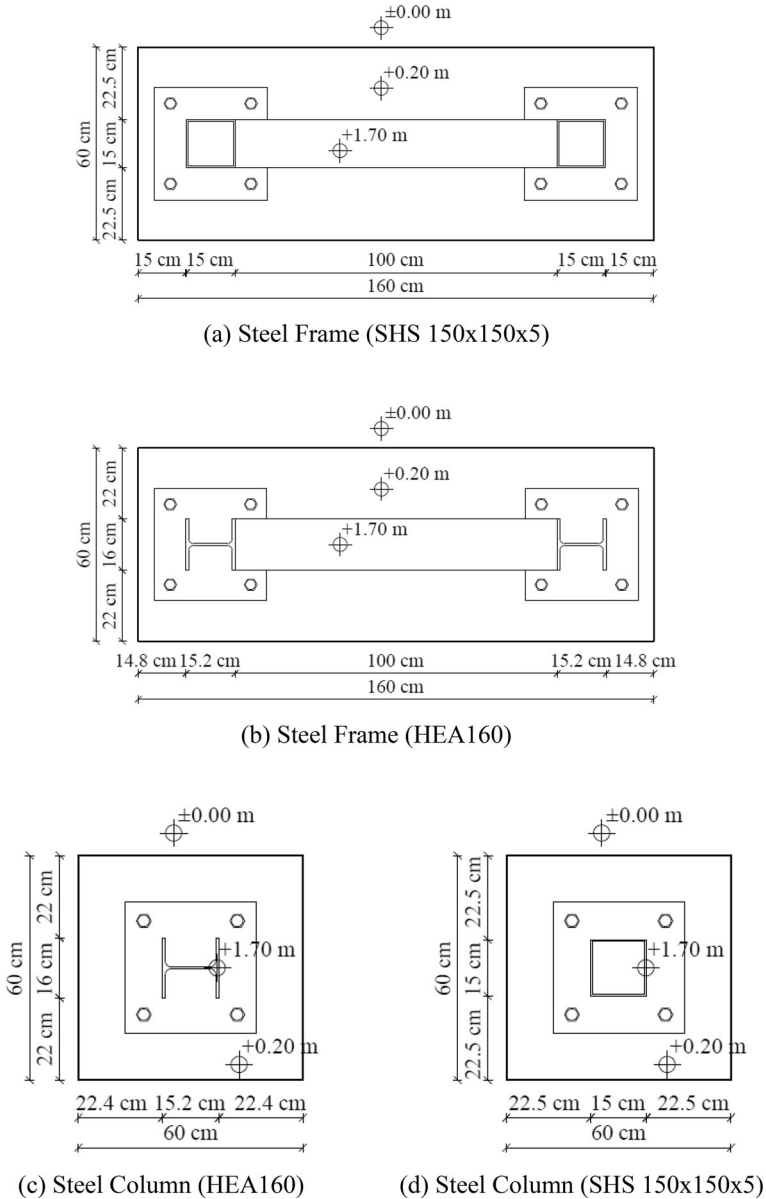
Figure 3. Geometrical configuration of steel frames and columns. a Steel Frame (SHS 150 × 150x5) b Steel Frame (HEA160). c Steel Column (HEA160) d Steel Column (SHS 150 × 150x5).

As for the column-beam joints, welded joints and joint connector bolts have been used for the SHS frame and HEA frame, respectively. The beam and columns of the HEA frame are connected using 4 pieces of M16 bolts and a plate having a thickness of 10 mm. The columns were welded to the base plate ($340 \times 340 \times 10$ mm) on top of their foundation and completely tightened to the foundation using 4 anchor bolts (M20). Figures 3 and 4 present the geometrical properties and connection details of steel columns and frames.

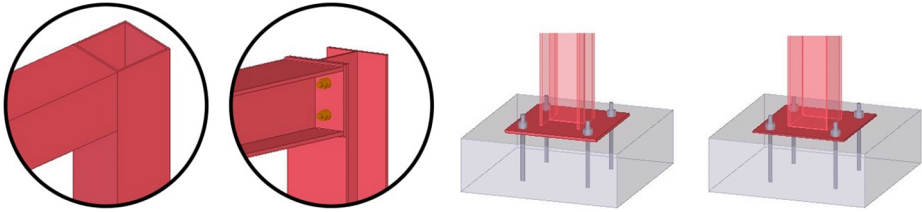
Figure 4. Connection details of steel frames and columns.

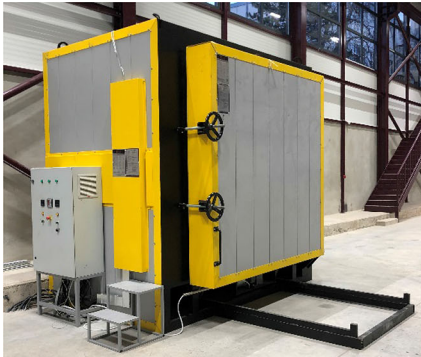
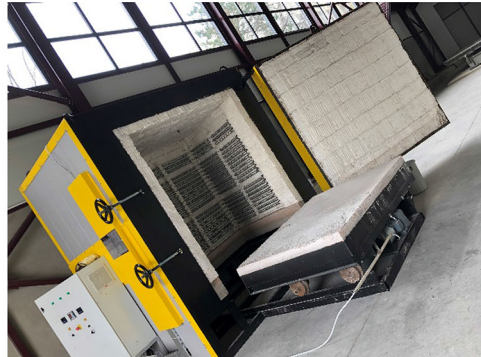
Type	Car-bottom annealing furnace
Chamber size	2000 × 1500 × 2000 (W x L x H) mm
Operating temperature	1100 °C
Maximum temperature	1120 °C
Heated by	Electricity
Heating power	210 kW

Figure 5. Car-bottom annealing furnace.

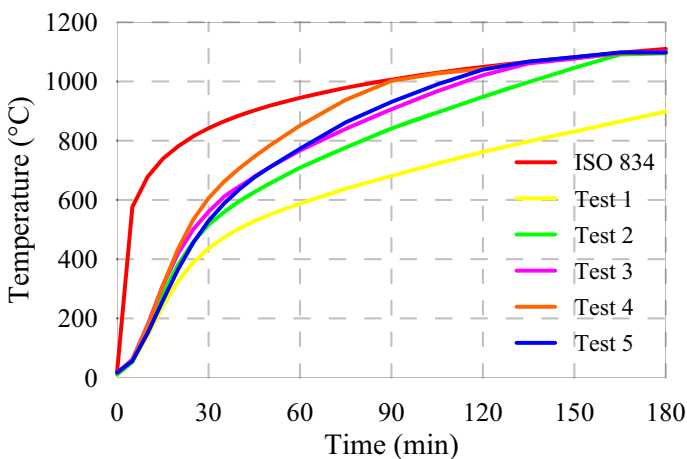
Figure 6. Furnace interior temperature developments during the tests and ISO 834 fire curve.

nance are not same. So, in each test, the furnace interior temperature was increased at different rates and the obtained temperature development curve from each test was distinctive. Since the furnace has high thermal power, this uniform temperature effect was achieved in the early stages of the tests. During the fire exposure of steel models, burning of the steel profile painting generated combustible gases. After the tests are over, while opening the furnace door, these gases came in contact with oxygen and flare up again.

The interior temperature of the furnace has reached to value of 1095 °C after 180 min of fire exposure (Fig. 6). The variations in temperature of measurement stations, within test duration, are presented in Fig. 12. It is observed that the surface temperatures of the model are in the range of 715–740 °C at the end of the test. It is determined that the surface temperatures measured 1 h after the various parts of the model in the cooling stage are between 240–320 °C, and the measured surface temperatures after 3 h are between 125–190 °C. Preparation and general overview of the test are illustrated in Figs. 13 and 14.

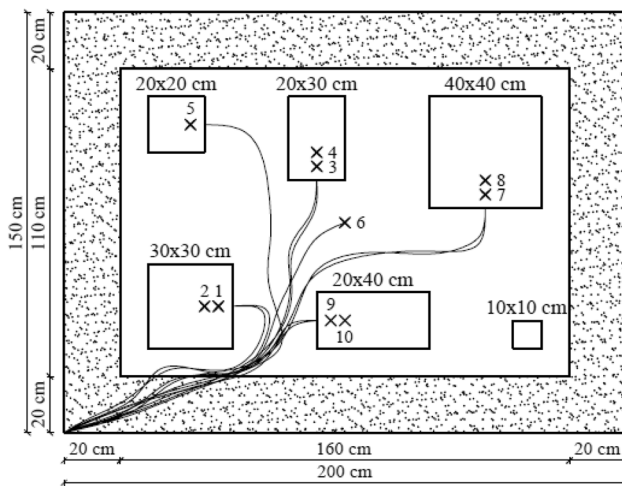
Figure 7. Schematic view of the RC columns and locations of measurement stations.

3.2.1. Test-1 The first test has been conducted on an RC specimen comprising of six columns having different cross-sectional sizes. A total of ten measurement stations, nine on the columns and one in the middle of the foundation, are located in this model (Fig. 7). The measurement stations on the columns have located at a distance of 1 m (± 2 cm) from the bottom. The details of the measurement stations are demonstrated in Table 2.

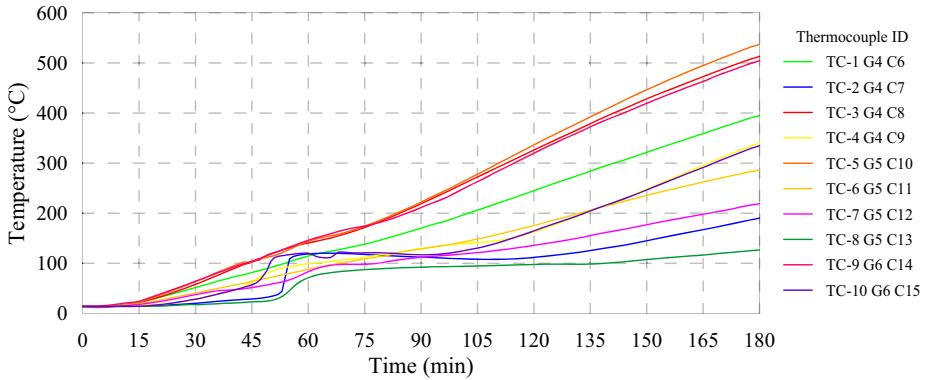
Figure 8. Temperature variations during Test-1.

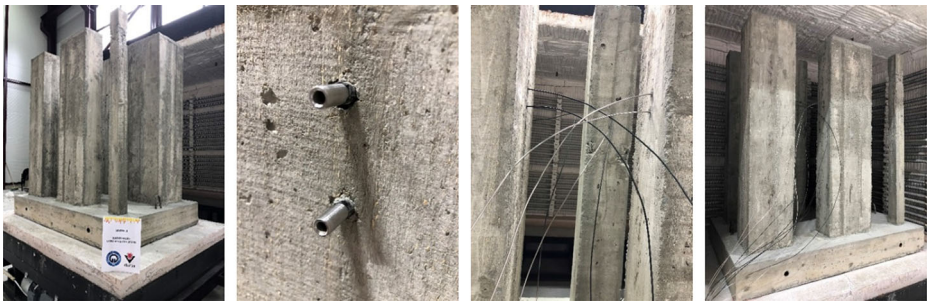
Figure 9. Pretest state of Test-1.

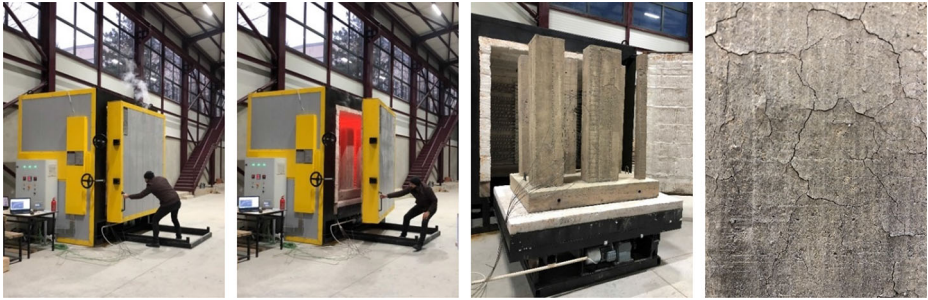
Figure 10. Posttest state of Test-1.

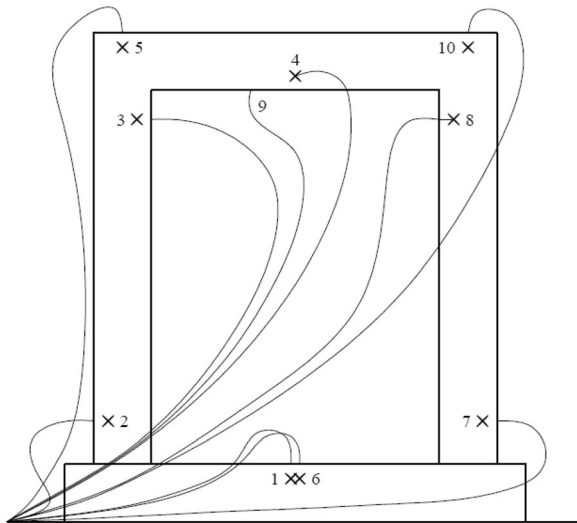
Figure 11. Schematic view of the RC frame and locations of measurement stations.

3.2.2. Test-2 The second test has been conducted on the RC frame model comprising of beam and columns with cross-sectional dimensions of 20 × 20 cm, having ten built-in measurement stations. These stations are located in sections close to joints of column-beam and column-foundation, as well as midpoints of beam and foundation (Fig. 11). The specifications of measurement stations are presented in Table 3.

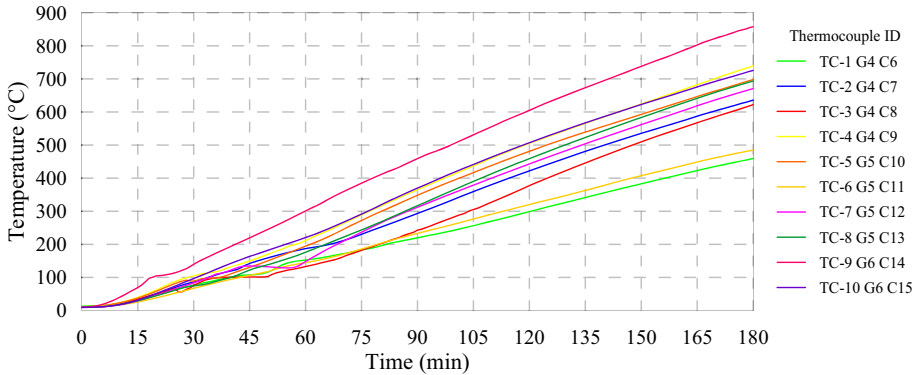
Figure 12. Temperature variations during Test-2.

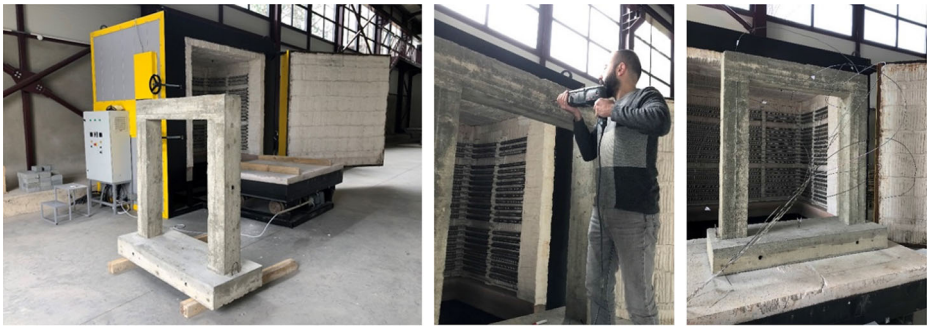
Figure 13. Pretest state of Test-2.

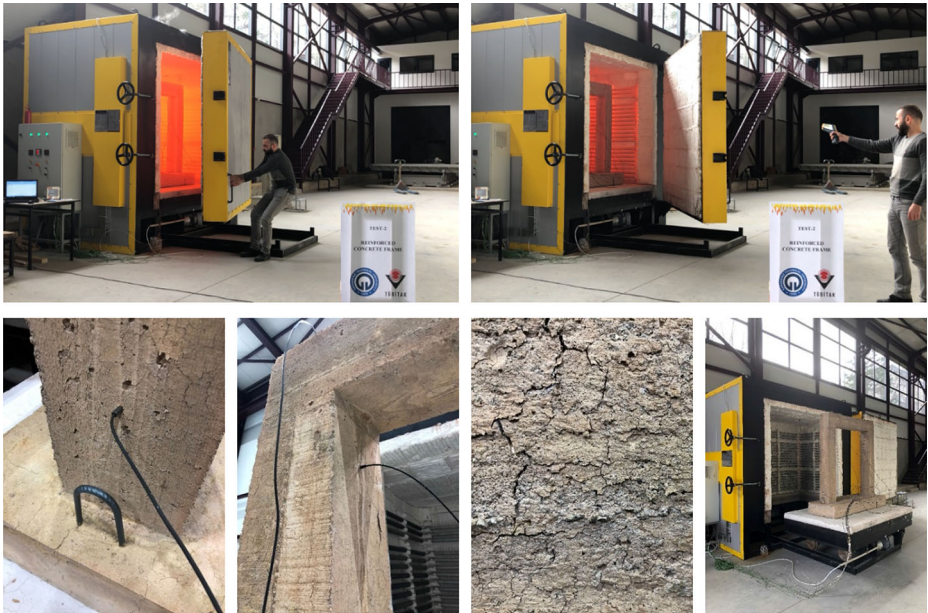
Figure 14. Posttest state of Test-2.

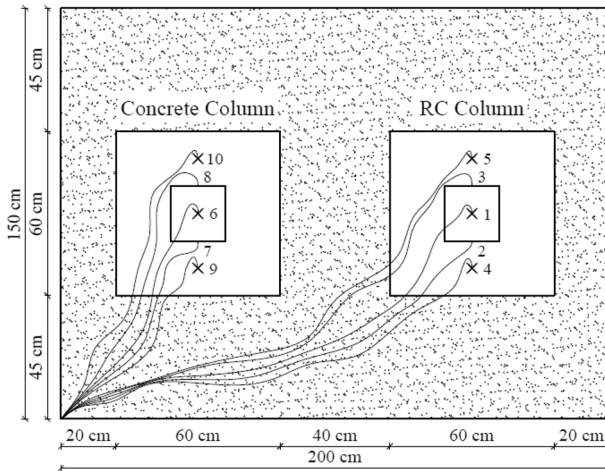
Figure 15. Schematic view of the columns and locations of measurement stations.

3.2.3. *Test-3* The third high temperature test has been conducted on column models. Both columns are having same cross-sectional dimensions of 20 × 20 cm, while only one of them has reinforcement bars. Five temperature stations have been formed on each of these models (Fig. 15). The measurement stations are

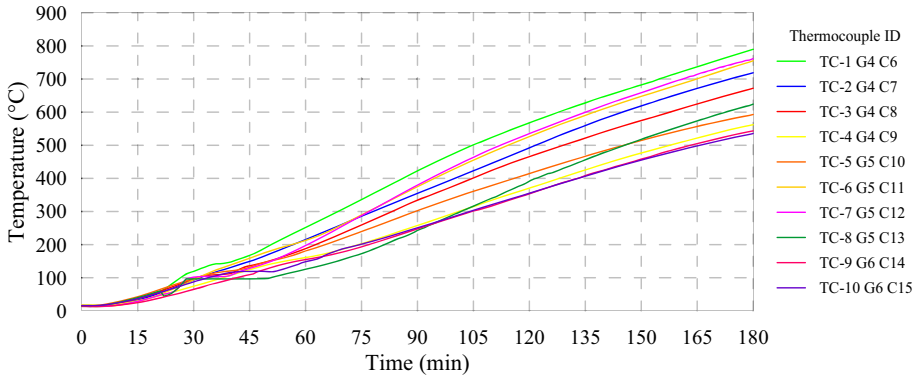
Figure 16. Temperature variations during Test-3.

located 1 m above the bottom of the columns (Table 4). After the 180 min exposure duration, the interior temperature of the furnace reached the value of 1101 °C (Fig. 6). The temperature changes occurred during the test are presented in Fig. 16.

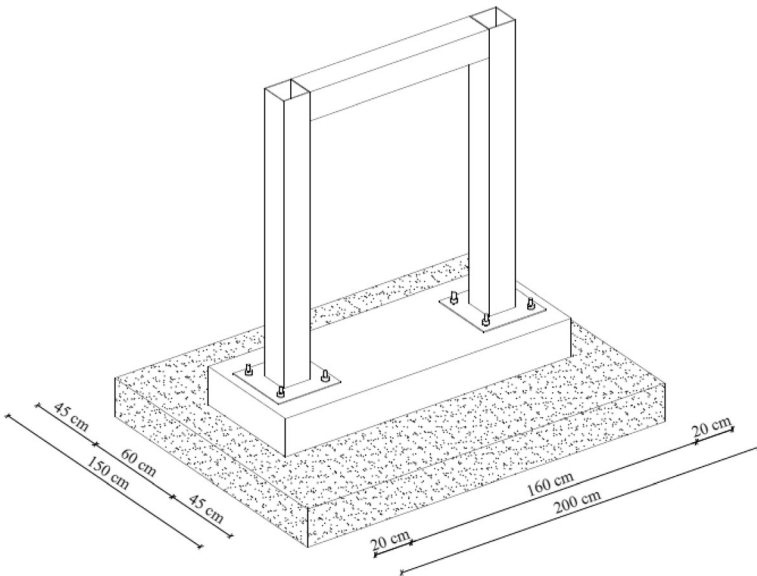
Figure 19. The location of the steel frame model consisting of SHS profile.

3.2.4. Test-4 To conduct the fourth test, a steel portal frame comprising a 150 × 150x5mm SHS profile assembled through a welded connection has been used. The position of the model in the furnace is presented in Fig. 19. The interior temperature of the furnace has reached the temperature value of 1097 °C after 180 min of fire exposure (Fig. 6). The surface temperature of different faces of the models showed a temperature range of 820–855 °C. The temperature measurements from various parts of the RC foundation are in the range of 650–740 °C. Figures 20 and 21 illustrate the different stages of this test.

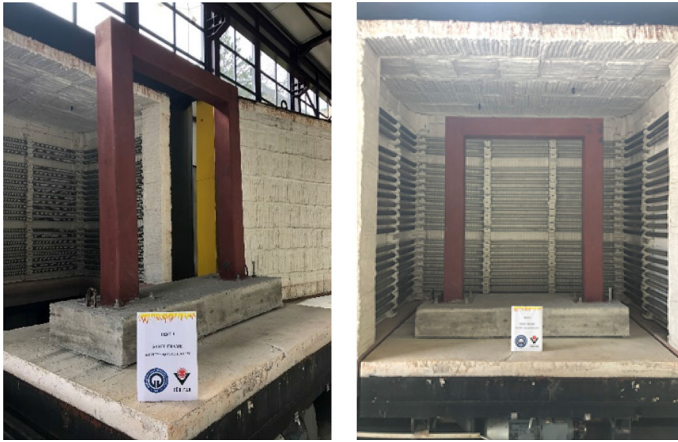
Figure 20. Pretest state of Test-4.

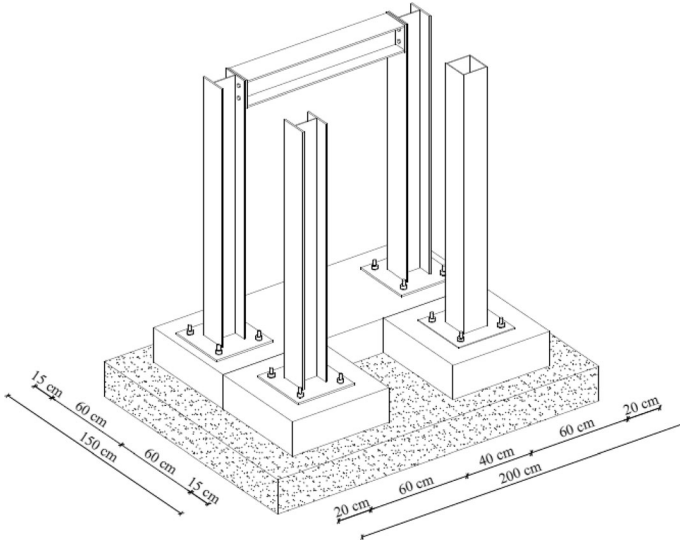
Figure 22. The location of the steel frame and columns consisting of HEA and SHS profiles.

3.2.5. *Test-5* The fifth test is carried out using a steel portal frame and two steel columns. Frame configuration comprises HEA160 profiles assembled using bolts connections. The two constructed columns comprised HEA160 and SHS with cross-sectional dimensions of $150 \times 150 \times 5$ mm. The position of the models in the furnace is given in Fig. 22. The interior temperature reached the value of $1098 \text{ }^\circ\text{C}$

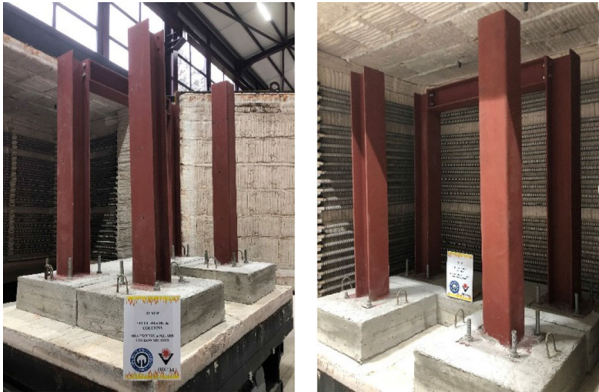
Figure 23. Pretest state of Test-5.

after completing 180 min of fire exposure (Fig. 6). After the test is over, the temperature of various locations on the surfaces is measured between 830 and 850 °C. The temperature measurements from various parts of the RC foundation are on average 740 °C. Visual overviews of this test are presented in Figs. 23 and 24.

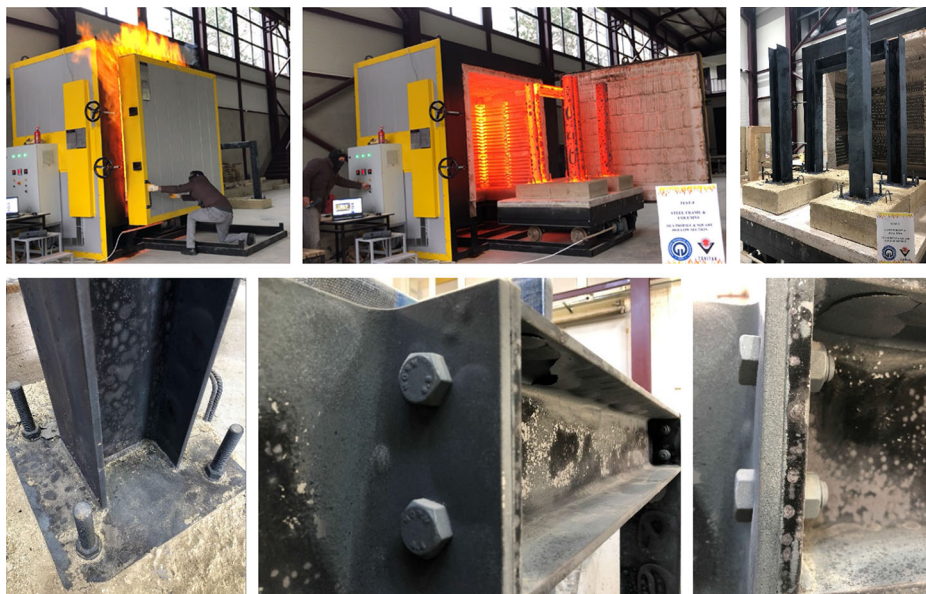
Figure 24. Posttest state of Test-5.

appeared on the outer surfaces. In addition, having different fire scenarios caused the models to experience different changes in their colors. The results of the fire exposure of concrete and RC columns in Test-3, point out the effectiveness of reinforcing steel on temperature distribution within the section. However, this effect is not very critical (Fig. 16). In tests on steel models, the oxidation on steel surface, which occurred due to fire, was peeled off during the cool down period.

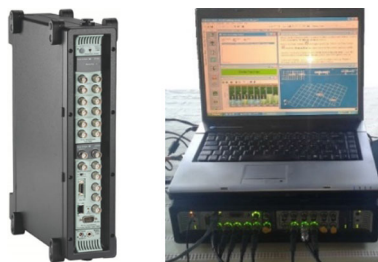
Figure 26. Data acquisition system.

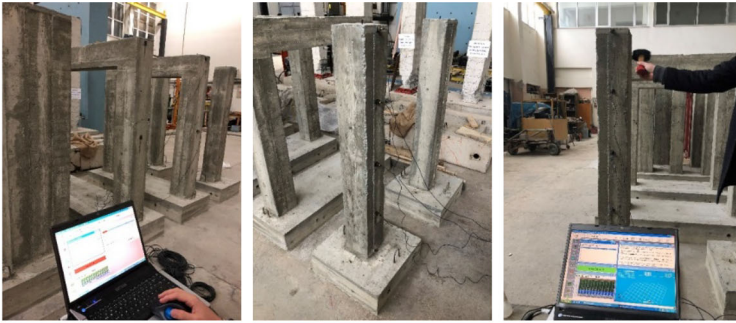
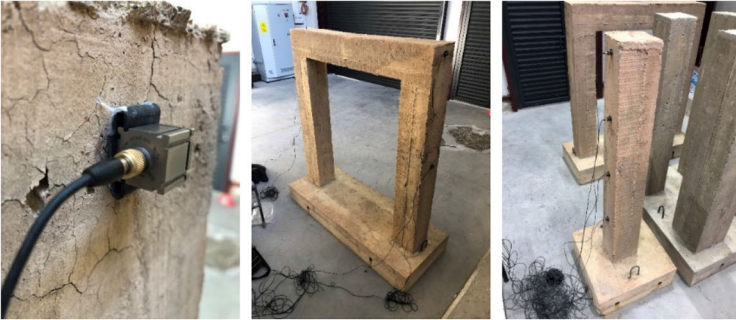
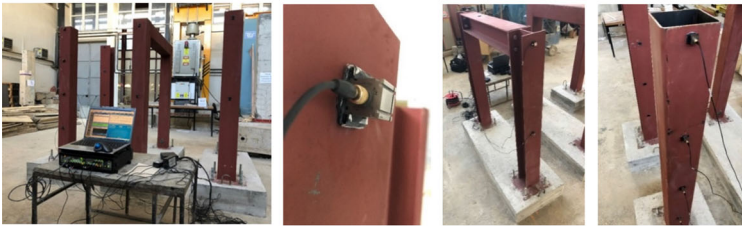
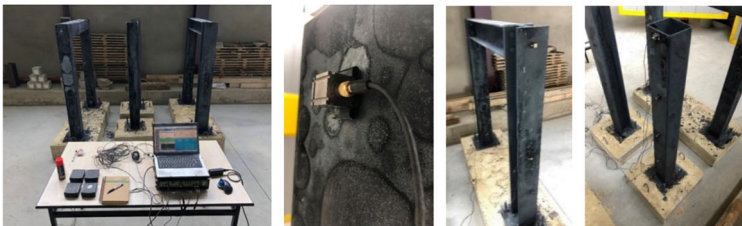
Figure 27. Some views from the non-destructive experimental measurements. a Undamaged concrete and RC models b Damaged concrete and RC models c Undamaged steel models d Damaged steel models.

Ambient vibration tests have been performed before fire exposure to determine the dynamic characteristics of each model at ambient temperature (20 °C). Later, all laboratory models were subjected to fire load in the test furnace and the high temperature imposed some physical changes such as deformations and cracks on the tested specimens. After fire exposure, experimental measurements are repeated. By comparing the measured values obtained from undamaged and damaged conditions, the changes in dynamic characteristics of test specimens are evaluated. Figure 27 shows an overview of the conducted non-destructive experimental measurements.

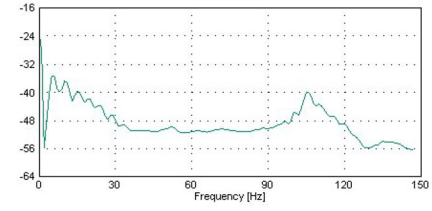
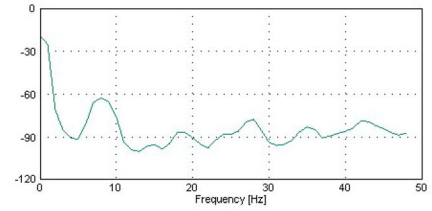
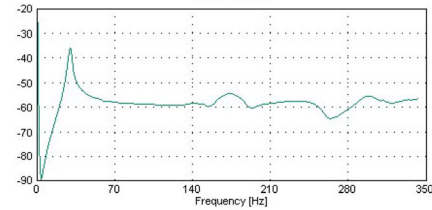
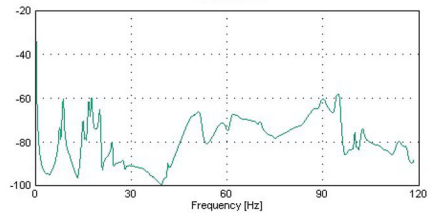
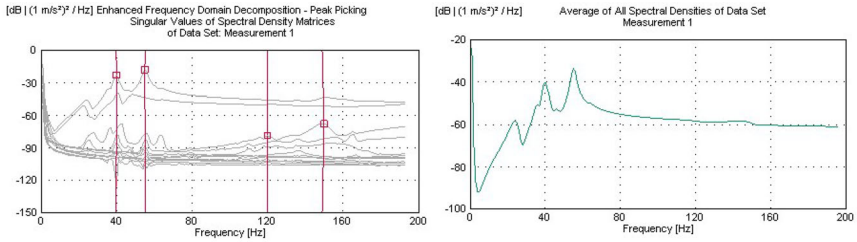
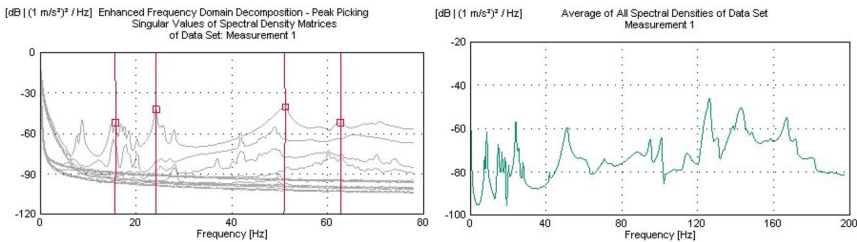
◀ **Figure 28. SVSDM and AASD obtained from all measurements before and after fire a Undamaged condition of RC column 10 × 10 b Damaged condition of RC column 10 × 10 c Undamaged condition of RC column 20 × 20 d Damaged condition of RC column 20 × 20 e Undamaged condition of RC column 20 × 30 f Damaged condition of RC column 20 × 30 g Undamaged condition of RC column 20 × 40 h Damaged condition of RC column 20 × 40 i Undamaged condition of RC column 30 × 30 j Damaged condition of RC column 30 × 30 k Undamaged condition of RC column 40 × 40 l Damaged condition of RC column 40 × 40 m Undamaged condition of concrete column 20 × 20 n Undamaged condition of RC frame 20 × 20 o Damaged condition of RC frame 20 × 20 p Undamaged condition of steel frame SHS 150 × 150x5 q Damaged condition of steel frame SHS 150 × 150x5 r Undamaged condition of steel frame HEA160 s Damaged condition of steel frame HEA160 t Undamaged condition of steel column HEA160 u Damaged condition of steel column HEA160 v Undamaged condition of steel column SHS 150 × 150x5 w Damaged condition of steel column SHS 150 × 150x5.**

The SVSDM and AASD obtained from all measurements, before and after fire exposure, are presented in Fig. 28. The extracted first four mode shapes are also presented in Table 5. Since the mode shapes obtained for both the undamaged and damaged cases of the same type of models are close to each other, only the data for one model and measurement are presented. Table 6 present the natural frequencies and damping ratios of the models before and after the fire exposure. Besides, the frequency values of all models and the percentage of changes in natural frequencies and damping ratios after fire are graphically presented (Fig. 29–31).

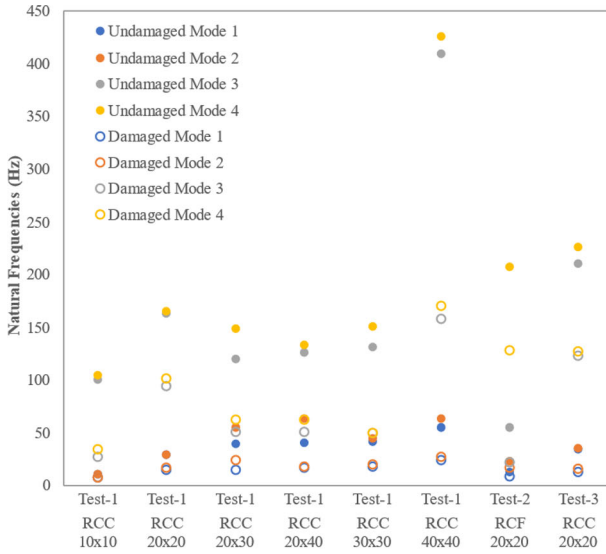
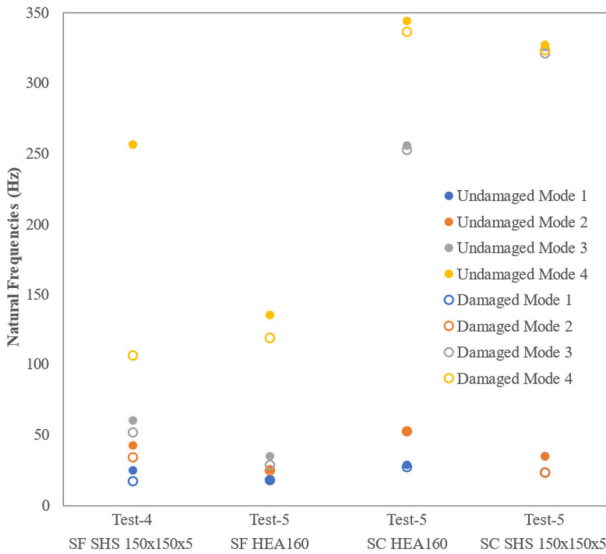
Figure 29. Frequency values related to undamaged and damaged conditions. a RC models b Steel models.

As demonstrated in the above figures and tables, the natural frequency values of the undamaged models are increasing with increases in their cross-sectional area. For models having symmetrical cross-sections, it was expected to have twin
