# Behaviour of Deteriorated Reinforced Concrete Columns under Elevated Temperatures

Lipi Mishra \* and Umesh Kumar Sharma, Department of Civil Engineering, Indian Institute of Technology, Roorkee 247667, India

**Abstract.** Corrosion of reinforcement is the primary causal factor for premature deterioration of reinforced concrete (RC) structures. Exposure to elevated temperatures such as fire events can further exacerbate the integrity of the structure. The cumulative impact of the presence of corrosion and exposure to elevated temperatures on the behaviour of short RC columns constitutes the objective of present study. An experimental investigation was conducted to evaluate the effect of the degree of corrosion on the behaviour of RC short columns exposed to elevated temperatures. Total twenty-one RC short square column specimens were cast. Twelve columns were corroded to 10% and 20% degree of corrosion in accelerated corrosion process. Subsequent to completion of the corrosion process, columns were subjected to elevated temperature exposure (500°C and 800°C) in an electric furnace. Uncorroded specimens underwent the same thermal exposure regime. Afterwards uniaxial compression t

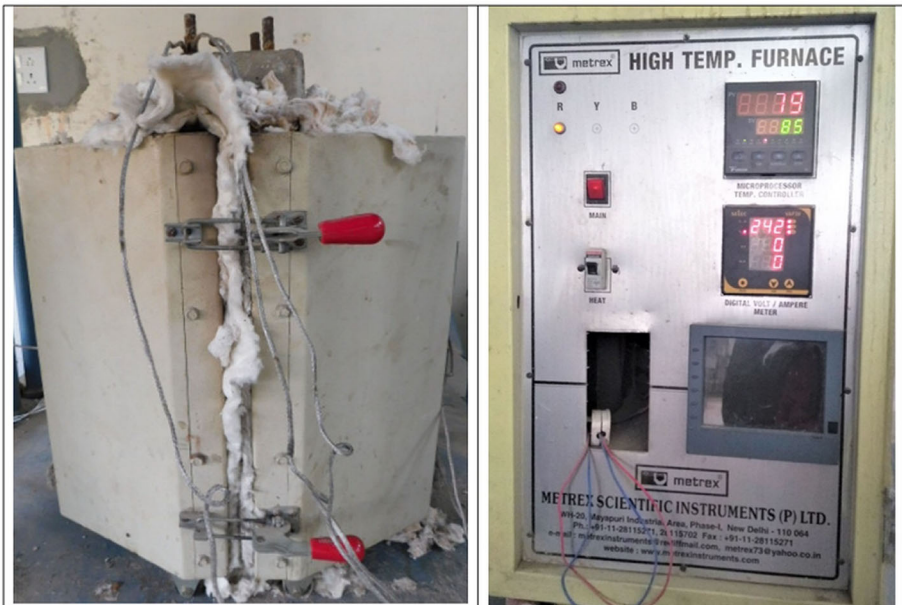
**Figure 3. Furnace set-up.**

Subsequent to completion of corrosion process, the columns were exposed to the designed heating and cooling regime in a vertical split type high temperature electrical furnace. The exterior of the furnace was octagonal, it had an inner compartment with 210 mm diameter and 450 mm height. It could accommodate a single specimen at a time. The specimen in the test length of 450 mm was kept inside the furnace. The 100 mm lengths at both ends were protruding out of the furnace, it was fully sealed with glass wool, insulating the column test length. The programmable electric furnace had a maximum heating capacity up to temperature of 1000°C and had an accuracy of 1°C. The furnace was controlled by microprocessor-based temperature controller with ‘K’ type thermocouples provided in the furnace chamber. Figure 3 shows a view of the complete setup of column with electrical furnace. All uncorroded and corroded column specimens underwent the same thermal exposure program. K-type chromel–alumel thermocouples, were fixed at mid-heights in the columns during casting, at two locations in the cross section: at the centre of the column and at the cover-core interface. For measurement of surface temperature, one thermocouple was placed inside the furnace. The columns were heated in the furnace to the target temperatures of 500°C and 800°C. The constraints of limited number of specimens led to design only two levels of target temperatures for the current experimental study. The minimum level of temperature to show some significant results in residual compressive strength degradation of columns, was chosen to be 500°C. In the context of simplified calculation for 500°C isotherm method in Annex B of Eurocode 2 [50], 500°C is assumed as the limiting temperature for concrete section contributing to the load bearing capacity of the RC member. 500°C is a level chosen in the Eurocode [50] to determine cross sectional areas, which may be assumed to be unaffected by high temperature exposure. However, even though temperatures in the remaining cross section may be considered lower than 500°C, rebar temperatures and corrosion of rebars, may still have significant impact on the residual strength of the RC member. Arguably, the chosen 500°C level of heating, is a level to verify the impact of the Eurocode

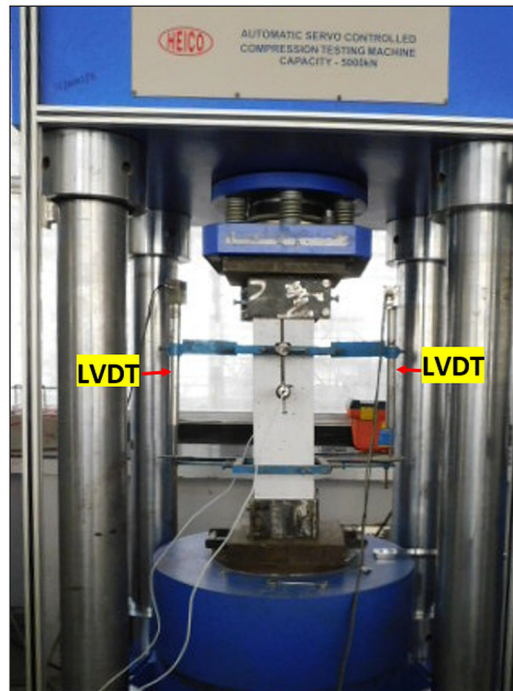
**Figure 4. Uniaxial compression test setup.**

Following the completion of designed heating and cooling regime, axial compression test of the specimens was carried out. The column specimens were tested using HEICO automatic servo-controlled compression testing machine with a capacity of 5000 kN, with displacement control capabilities (Fig. 4). A rate of 0.1 mm/minute was chosen for the monotonic concentric compression load to register the post peak response of columns properly. To prevent premature failure at the ends, external confinements were provided by fixing steel collars of 20 mm thickness and 100 mm length at the top and the bottom ends of the column. Failure of the column was designed to be in the test region of 450 mm in the middle section of the specimen. Two linear variable differential transducers (LVDTs) were employed to measure the axial contraction of the column specimens. They were attached at opposite sides of the square column using steel clamps along the gauge length of 300 mm. The average of the two deflections measured by the LVDTs was taken as the mean axial displacement of the centroidal section of the column. The inbuilt load cell in the HEICO instrument recorded the load values. The data from the load cell and LVDTs were registered into a data acquisition system.

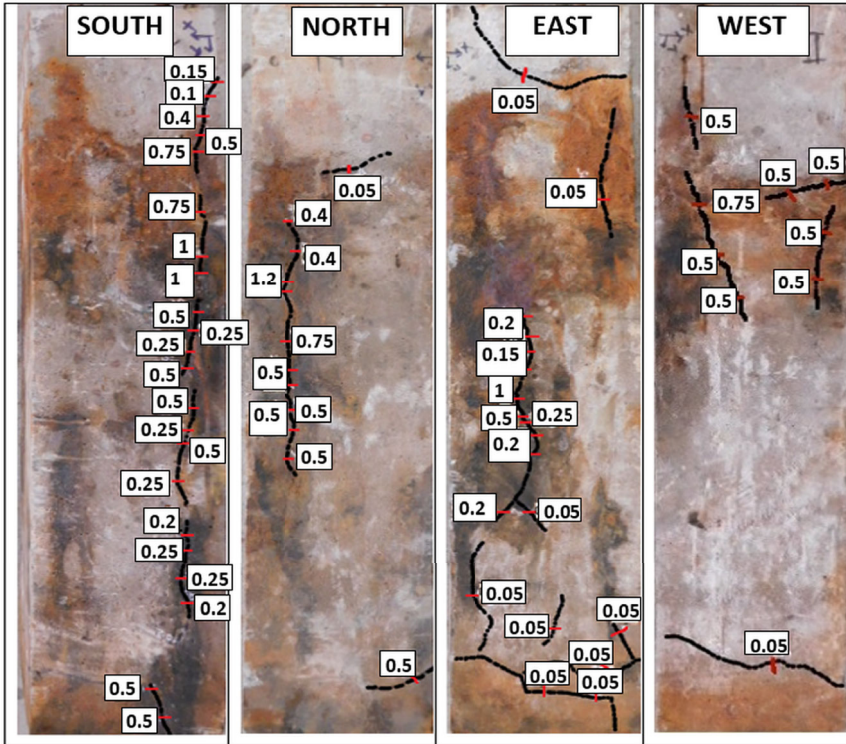
**◀Figure 5. Corrosion induced crack patterns (mm) in column with (a) 10% corrosion (b) 20% corrosion.**

Twelve column specimens were tested under accelerated corrosion process with a current density of  $200 \mu\text{A}/\text{cm}^2$ . After the exposure for required duration, the surfaces of the corroded specimens were thoroughly cleaned for the proper inspection of surface cracks. Crack widths were noted down using crack scope of least count 0.05 mm. The crack positions were also noted along the length and breadth of the surfaces, using a measuring tape, noting down the x and y coordinates of the cracks. Cracks orientations showed that cracks developed along all directions. Whereas majority of it was along longitudinal direction, cracks developed along diagonal directions as well. The crack locations were spread along the entire surface since all the longitudinal and transverse reinforcement bars were corroded simultaneously. Rajput et al. [22] observed that the orientation of reinforcing bars being corroded affect the direction of corrosion cracks. Most of the previous studies [18, 21] observed cracks developed only along a specific direction as they examined the effects of corrosion on only longitudinal bars or only transverse bars. Present study has targeted corrosion in the whole reinforcement cage, which is observed in ageing RC structures facing durability issues. The crack distributions over all four surfaces are shown in Fig. 5. The crack widths varied from 0.05 mm to 1.2 mm in samples with 10% corrosion degree. Severity of corrosion induced distress increased further in samples with 20% corrosion degree, the crack

widths varied from 0.05 mm to 2.1 mm. Although all samples had similar reinforcement configuration, with same materials being used to cast the specimens, further they were exposed to similar conditions in accelerated corrosion set-up, still the crack patterns were not uniform along all four surfaces of the columns. In Fig. 5a, the crack widths varied from 0.05 mm to 1.2 mm for South, North and East face, whereas West face had relatively lesser corrosion distress in terms of surface cracks and maximum crack width was 0.75 mm. Further as per Fig. 5b three faces of South, North and West showed more surface cracks with widths varying from 0.05 mm to 2.1 mm, whereas East face had relatively lesser cracks with maximum crack width being 0.5 mm. It may be due to the difference in resistance each face provided, which can be attributed to the non-uniformity of microstructure of reinforced concrete and variations with progression of corrosion process. Corrosion leads to dissolution of steel, resulting in loss in cross section of the bar. It generates expansive corrosion products, that generate internal stress on concrete. When the tensile strength of concrete is exceeded by these internal stresses, micro cracking starts in the surrounding concrete and cracks eventually appear on the external surface of structural element. If availability of oxygen at the anodic site is insufficient, the ferrous ion will stay in concrete pore solution or get transported and deposit elsewhere in pores and microcracks in the concrete, which results in significant loss in section without the distress caution given by concrete cracking or spalling [49]. Hence cracks may form away from anodic sites

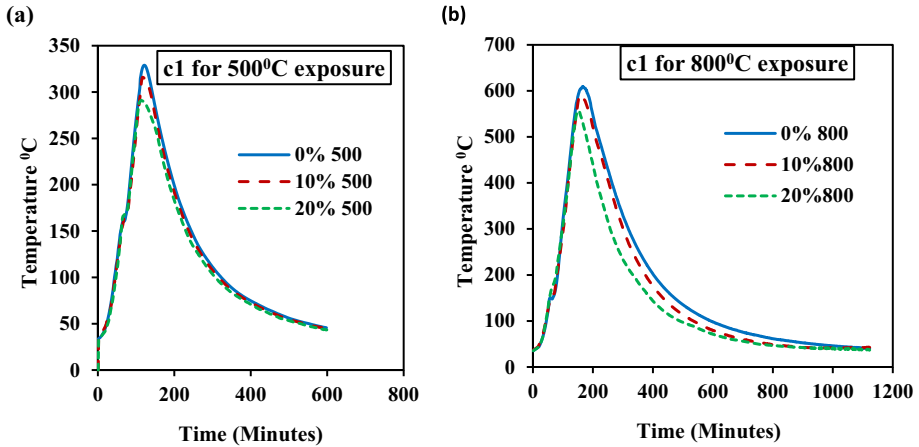
**Figure 7. Time-temperature curves at the centre of the columns exposed to temperature of (a) 500°C and (b) 800°C.**

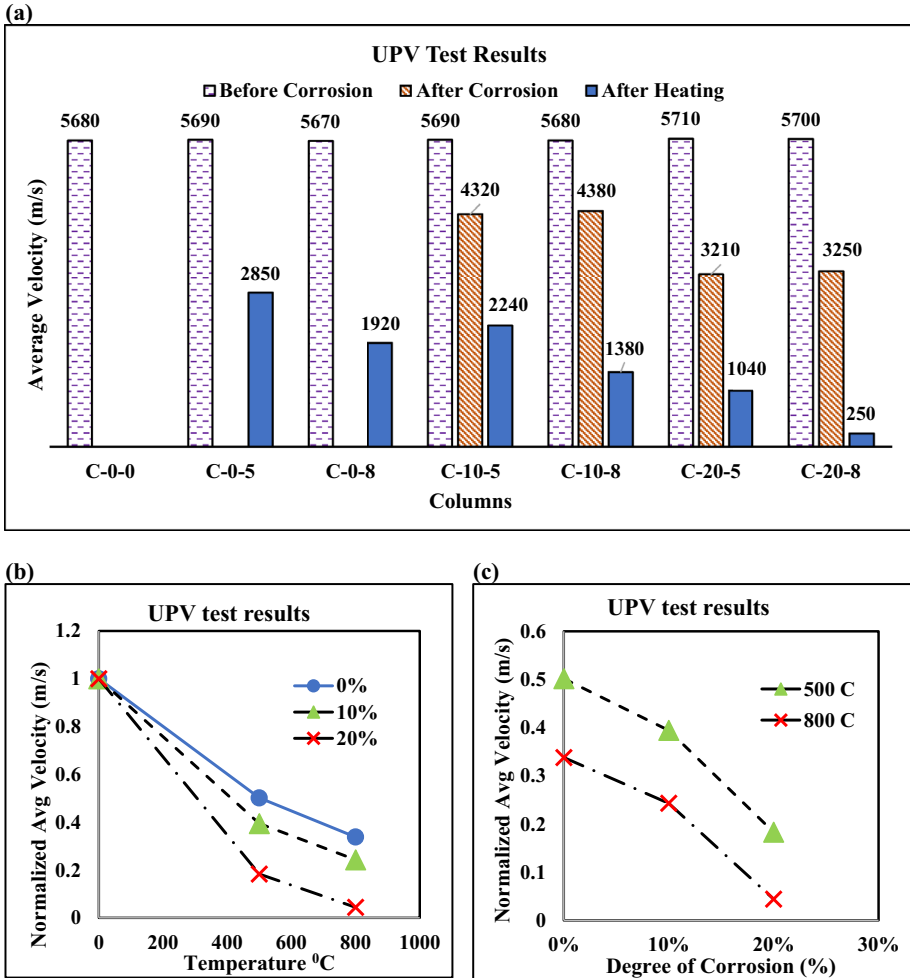
**Figure 9. UPV Test Results (m/s) of all columns; Variation of normalized UPV values with (b) temperature (c) degree of corrosion.**

umn surfaces until a constant reading was observed. The pulse velocity through the concrete was calculated by dividing the distance between the transducers with the transit time displayed. The UPV values at the centre of the column specimens were taken. Average UPV value of three specimens for each series is reported. The average UPV test results were plotted as shown in Fig. 9.

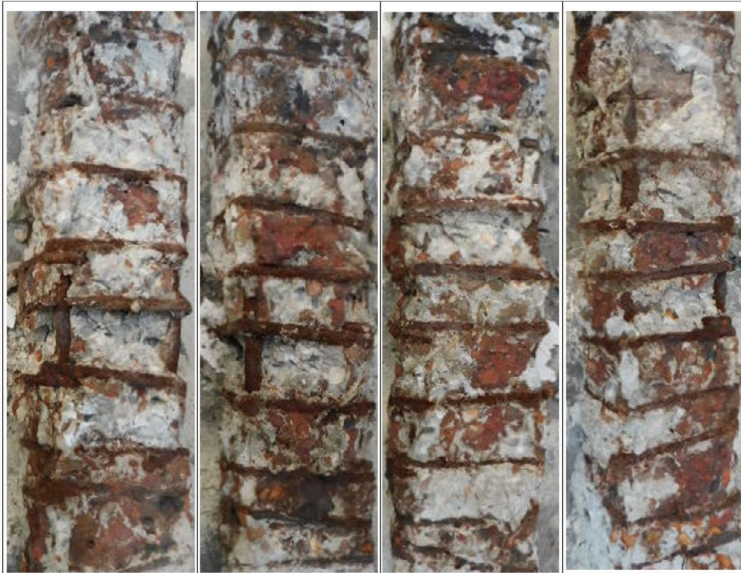
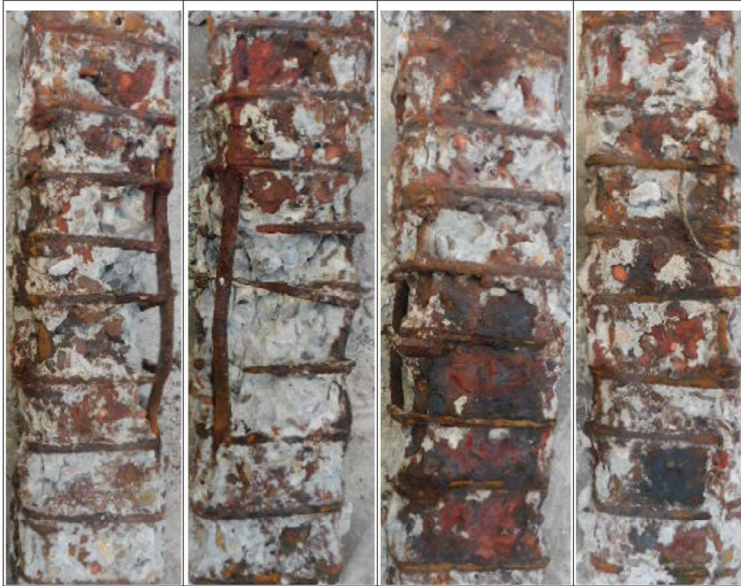
**Figure 11. Corrosion damage visuals of columns with corrosion (a) 10% (b) 20%. (a) 10% Corrosion. (b) 20% Corrosion.**

After axial compressive test was over, columns were taken out and demolished. Figures 11a & b shows the visuals of the columns before demolition, cover concrete was removed, and visual inspection of the corroded reinforcement was carried out. It can be seen from Fig. 11 that both longitudinal bars and stirrups suffered considerable damage due to corrosion. Severe pitting corrosion was seen along the longitudinal and transverse bars at some locations. Column with 10% corrosion shows moderate damage to stirrups and longitudinal bars. Some of the

transverse bars suffered more than 60% loss of cross section at the corner in some locations. In column with 20% corrosion, some of the transverse reinforcements had complete loss of cross section at the corner and severe pitting corrosion along longitudinal bars. It resulted in lack of lateral support transverse reinforcement were supposed to provide to the column, they were deemed ineffective. This led to increase in unsupported length of longitudinal bars, which was already damaged by severe pitting, which eventually induced premature buckling and failure of column. All columns failed under compression mode.

cross section in the stirrups. Thus, the functionality of stirrups for providing adequate confinement and shear strength to the column is compromised. In columns subjected to 20% degree of corrosion, some of the stirrups had part of the steel

completely consumed in the corrosion process at few locations, leaving it open-ended. It nullified the very purpose of the providing stirrups in the column. Pitting corrosion was observed along the longitudinal bars.

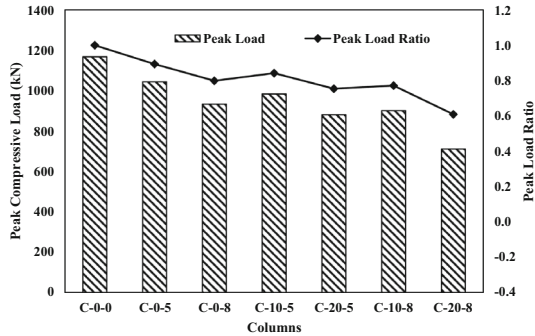
**Figure 13. Comparison of residual compressive strength of all columns.**

( $P_0$ ) was calculated for all column specimens. The results show that the peak load ratio  $P_{\max}/P_0$  varied from a maximum value of 1 to a minimum value of 0.61, i. e., a 39% reduction in peak compressive strength of column. The various values of the peak load ratios of columns were plotted and compared with each other as in Figs. 13, 14.

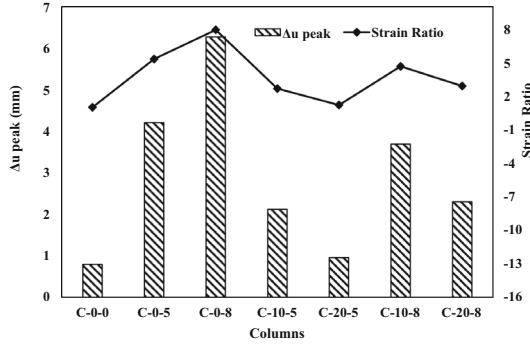
**Figure 15. Comparison of deflection and strain ratio at peak load of all columns.**

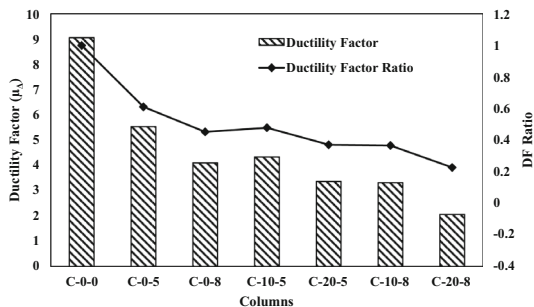
**Figure 18. Comparison of ductility factors for all columns.**
