# Study on the Stability and Deformation of the Roadway Subjected to High In-Situ Stresses

**Abstract** To investigate the deformation and failure mechanism of the roadway under high in situ stresses at the 958 section in 2# mine in Jin Chuan, China, field and numerical investigations were conducted. Field investigations on the loosen ring of the roadway show that great roadway deformations and failure in surrounding rocks may result from poorly functioned bolts. Based on the old supporting system, a new supporting system characterized by the installation of steel pipe beams and the elongated bolts was proposed and applied in field. Field data indicate that the roof sag, rib convergence and floor heave significantly decrease. The numerical study illustrates that the properly functioned bolts and steel pipe beams are

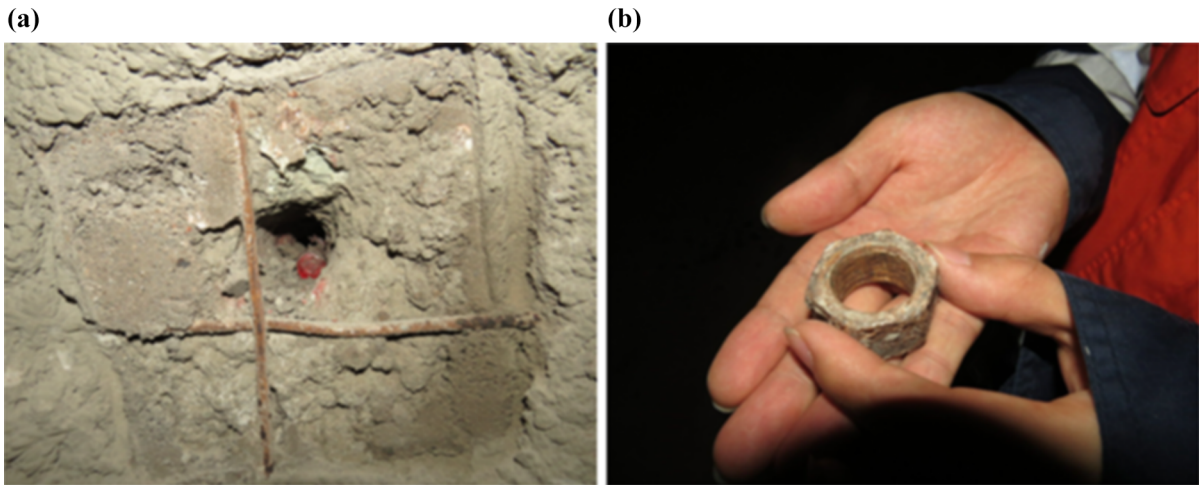
**Fig. 4** Bolting failures: **a** loading plates failures; **b** screw nut failures

bolts can function properly. Thus the loading plates, bolts and screws failures resulted from high axial forces were frequently encountered (Fig. 4). These failures may also result from the large spacing of 0.8 m between bolts and the failures in rib may aggravate floor heaves accordingly (He et al. 2009).

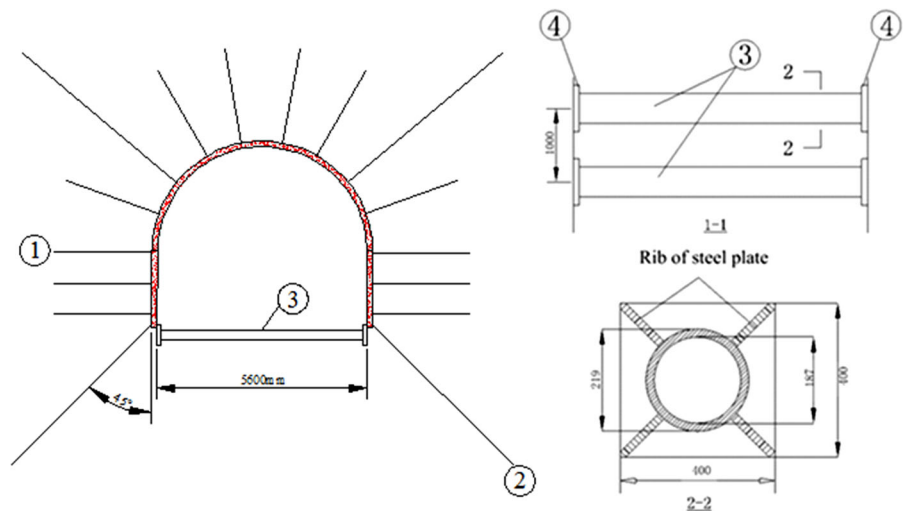
**Fig. 5** Schematic diagram of the proposed supporting system: 1 indicates short bolts; 2 indicate long bolts; 3 is the steel pipe beam; 4 is the end plate of the steel pipe beam

Based on aforementioned strategies, a combined supporting system in Fig. 5 was proposed. This system includes the short bolting, long bolting, concrete lining and steel pipe beams. Corresponding field experiments were conducted at a testing site which is shown in Fig. 1. Specifications of this supporting system are listed in Table 1.

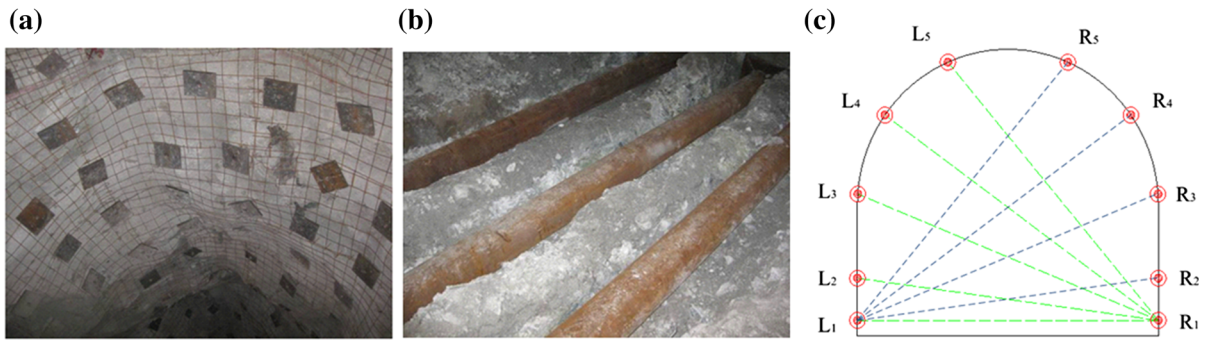
**Fig. 6** Construction procedures: **a** installations of fully grouted bolts and nets; **b** installations of steel pipe beams on the floor; **c** locations of monitoring points

- After the excavation of deformed surrounding rocks, a concrete lining, which was 50 mm in thickness, was immediately sprayed on the arch-shaped roof. Figure 6a shows that steel nets and

the fully grouted bolts were installed. Afterwards, the spray the concrete lining with 150 mm in thickness was applied on the roof again.

- Repeat Step (1) at ribs of the roadway.
- Install steel pipe beams which spacing was 1 m on the floor.
- To efficiently and economically monitor roadway deformations, Fig. 6c shows totally 10 measuring points at the left and right sides of the roadway were installed respectively on the sections, which distance was 1.6 m along the experimental roadway. The characteristics of the roadway deformation were obtained and analyzed according to MATLAB finally.

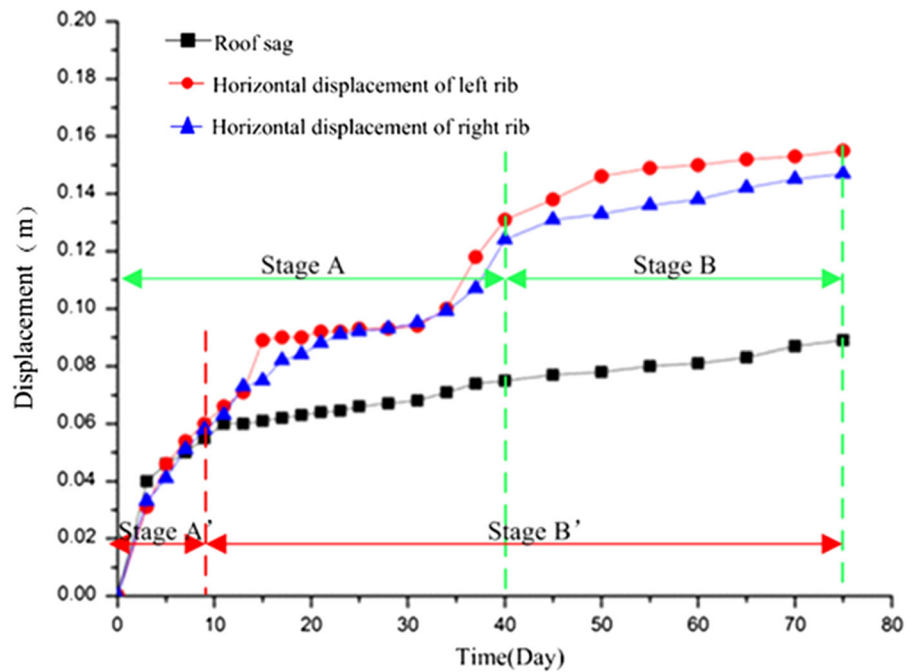
**Fig. 7** Typical displacement curves of surrounding rock

The typical displacement curves of the middle section are drawn in Fig. 7. Similar to the results reported in Wang et al. (2015), Kang et al. (2014) and Jiao et al. (2013) studies, two displacement stages are observed. The first stage which is named initial stage of rib convergences, Stage A, lasts for nearly 40 days after the support installation. In this stage, because of the high ground stresses at this experimental site, the release of ground stresses result in a high convergence rate in ribs, when the support time are 40 days, the rib displacement is nearly 120 mm. In the later stage, the convergence rates of both ribs decrease, and the rib

displacements tend to be stable. When the support time is 75 days, rib displacements increase by only 20 mm. A shorter initial stage, Stage A' and a longer steady deformation stage, Stage B' of the roof sag, are encountered. The curve shows that the initial stage

lasts for only 9 days after the installation of the combined support, and the corresponding roof subsidence at this stage is nearly 53 mm. As time goes, the roof sag is nearly 80 mm, which is only 27 mm greater than the value of the former stage, which supporting

time is 75 days. The difference between Stage A and Stage A' in lasting period may result from the differences of ground stresses in the vertical and horizontal direction.

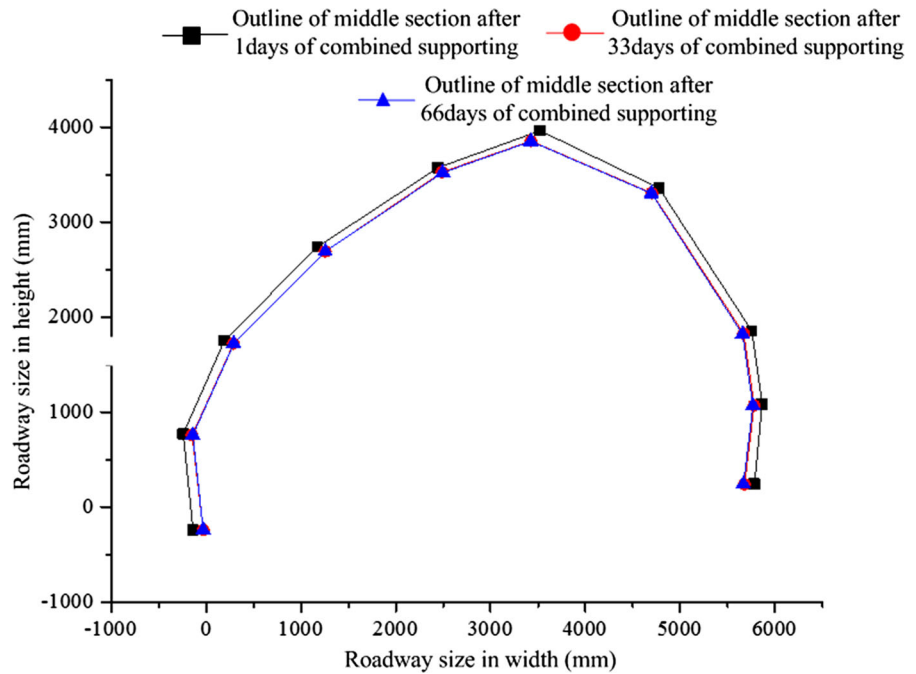
**Fig. 8** Outlines of roadway as time after supporting increases

The corresponding outlines of the middle section with the increase in support time are drawn in Fig. 8. It can be inferred that at the early deformation stage, large deformations of ribs and roof may result from the large roof-sag and rib-convergence rates. However, because of the decreased deformation rates at the later stage, small roadway deformations are caused. With roadway conditions with supporting time of 3 month,

these decreased convergence rates and minor differences in the outlines of cross sections indicate that deformations of ribs and the roof are successfully restrained by the present supporting system. It is interesting to note that the roadway deformation is unsymmetrical when the roadway was perpendicular to the maximum in situ stress. The red investigation point in Fig. 1 illustrate that this unsymmetrical deformation may result from the adjacent chamber excavation on the one side.

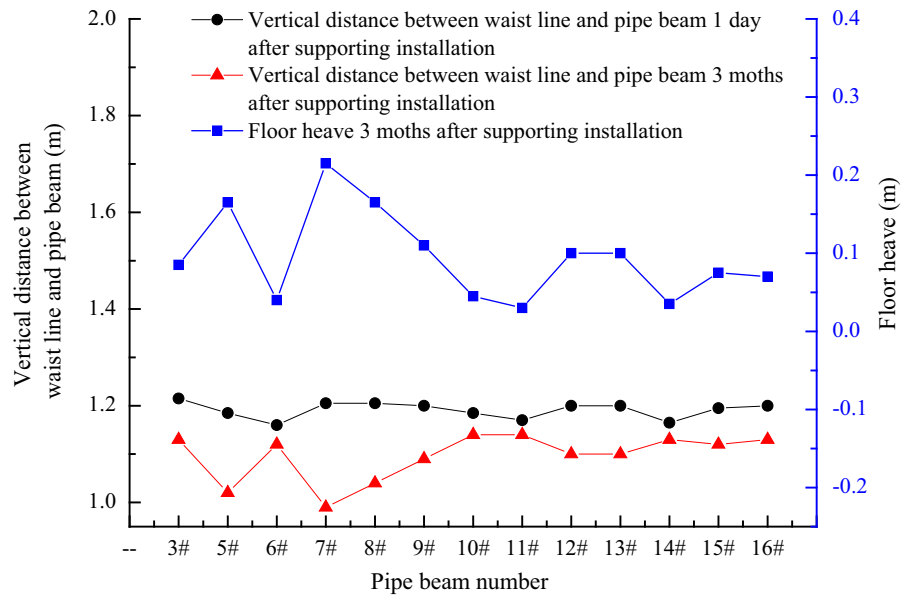
**Fig. 9** Floor heave 3 months after supporting installation

To evaluate the effect of combined supporting system on floor heaves, the distances between the waistline and pipe beam were recorded 1 day and 3 months after the application of the support system. Because of the disturbances from transportations, the values of some pipe beams were unable to obtain and only 13 groups of data were obtained. Figure 9 indicates that the floor heave: the averaged value is 94 mm and it varies from 40 to 215 mm at different roadway sections. Figure 10a depicts the floor heave of roadway which was supported by steel arch, sprayed concrete and short bolts. The maximum floor heave was 1200 mm which was much greater than that of the roadway supported by the combined-support system in Fig. 10b.

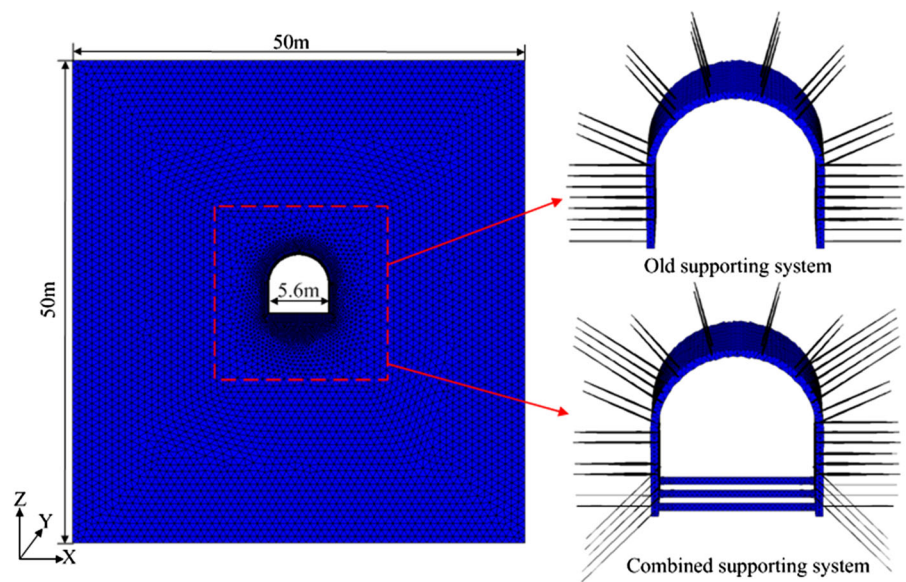
**Fig. 11** Numerical model

The numerical model consisted of 1,108,244 zones is drawn in Fig. 11 with different support systems. This model was 50, 50 and 20 m in length, height and thickness respectively. The distances between the

model boundaries and the roadway ribs were 22.7 m which was proven sufficient to eliminate the boundary effects (Kang et al. 2014). The target roadway was located in the rock mass which was thicker than 60 m. Therefore, this model was established in a simulated rock mass with the same mechanical properties. Based on the laboratory tests on specimens from Jin Chuan mine and the scaled reduction on elastic modulus proposed by Shen (2014), the properties of the model where the Mohr–Coulomb failure criterion with a

tension cut-off was applied to are listed in Table 2. According to the field observation on ground stresses, the horizontal in situ stress, which was 44.5 MPa, was applied in the X direction, the other horizontal in situ stress in the Y direction and the vertical stress in the Z direction were 32.9 and 22.2 MPa, respectively.

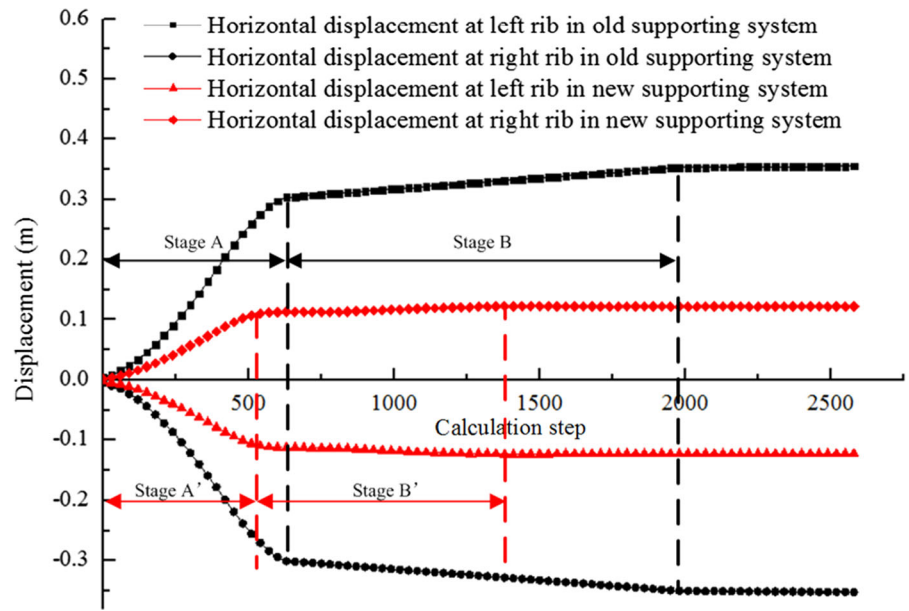
**Fig. 13** Rib convergences in old and new supporting systems

Monitored horizontal displacements at ribs in old and new support systems are drawn in Fig. 13. In the old supporting system, the duration of the initial rib convergence stage, Stage A, lasts for nearly 700 steps, and monitored horizontal displacements of the ribs are higher than 300 mm. At the upcoming steady deformation stage with decreased deformation rate, Stage B, the duration lasts for 1300 steps, at the end of this stage, the displacements increase slightly to 352 mm. In the new supporting system, a similar convergence tendency is observed. However, the convergence decreases by more than 50%, and the duration of

Stage A' and Stage B' lasts for only 1355 steps, these decreases in convergence values and the deformation duration indicate that new supporting system can control the rib convergence more effectively and immediately. The properly functioned short and long bolts may be responsible for these decreases. Furthermore, the horizontal stress of steel pipe beams in Fig. 14 demonstrates that the resistance force exerted by steel pipe beam can also restrain rib convergences. The tensile stress concentrations at the middle parts of pipe beams may partially result from the floor heave.

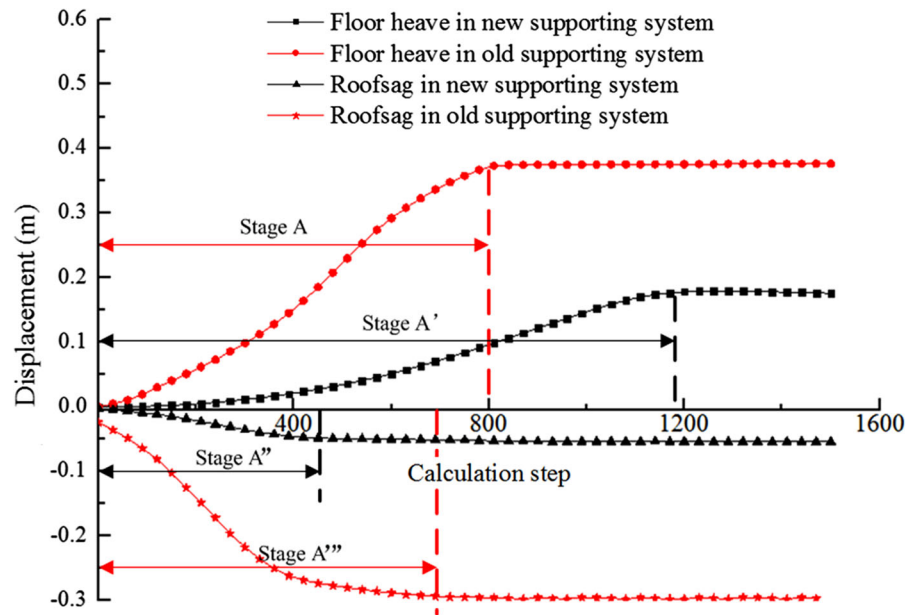
**Fig. 15** Vertical displacements at middle points of the roof and floor

Figure 15 depicts the vertical displacements at middle points of the roof and the floor. In the old support system, the maximum roof sag and floor heave in the roadway section are nearly 300 and 400 mm respectively. While the corresponding values drop to 50 and 172 mm in the new support system. These significant drops indicate that the deformations in the vertical direction are effectively restrained by the added long bolts and steel pipe beams. Similar tendencies of the deformation duration were observed.

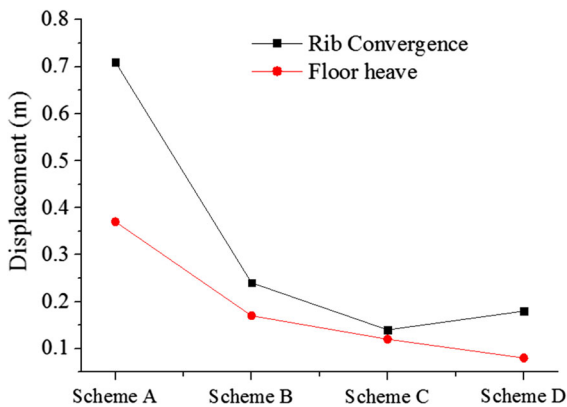
**Fig. 17** Rib convergences and floor heaves in four supporting systems: *Scheme A* is the old supporting system; *Scheme B* is the new supporting system; *Scheme C* and *Scheme D* are the supporting systems characterized by increased bolts at ribs and the floor bolts respectively

The corresponding maximum rib convergences and floor heaves in these supporting systems are drawn in Fig. 17. It shows that the reinforcement of ribs by increasing rock bolts is a feasible method for controlling rib failures and floor heaves.

The displacements of the rib convergence and the floor heave also show that rib convergence increases

because of the decreased bolting density at ribs and the arch, whereas the decreased floor heave is resulted from the floor reinforcement by the floor bolting. This analysis indicates that the installation of bolts at the floor is another effective method for restraining roadway deformations.
