Assessing the Hydrogeological Conditions Leading to the Corrosion and Deterioration of Pre-cast Segmental Concrete Linings (Case of Zagros Tunnel)

The Zagros water transfer tunnel with total length of 49 km and 6.73 m diameter has been designed to convey around $70 \text{ m}^3/\text{s}$ water from the Sirvan River to Dashtezahab area in Kermanshah province, Iran (see Fig. 1). This project is one of the longest water transfer project in Iran. The tunnel was divided into three main parts consisting of Lot 1A (14 km) as northeast section, Lot 1B (9 km) as middle section, and Lot 2 (26 km) as southwest section. The Zagros tunnel was

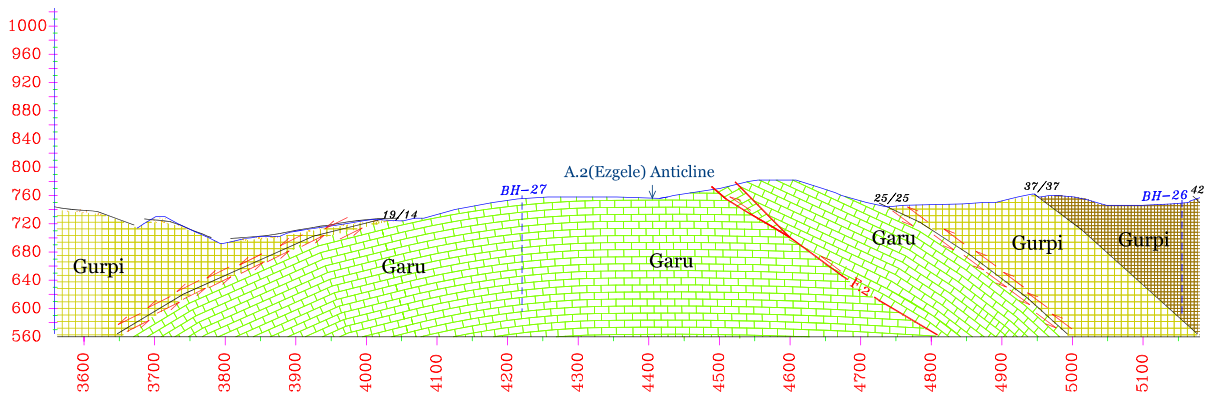
The geological and geotechnical characteristics of the ground have well been studied and reported in the relevant literature (Hassanpor et al. 2016; Shahriar et al. 2008). Based on these studies the main lithological units consist of shale, limestone and marl layers. The tunnel passes through several formations with rock mass conditions varies from weak to good, with RMR ranging from 17 to 75. The overburden strata frequently changed from hard rock to soft, dry to wet, stable to unstable, sticky to non-sticky ground, and vice versa. The maximum depth of the tunnel is also around 1000 m with the average depth equal 400 m (Khavé 2013; Shahriar et al. 2008). A schematic longitudinal profile of the geological formation along the Lot 2 of the tunnel (chainage 3 + 600 to 5 + 100) is shown in Fig. 2. Extensive H₂S and water flow were observed in this part of the tunnel.

Fig. 2 The longitudinal profile of a part of the Zagros tunnel with extensive H_2S and water flow

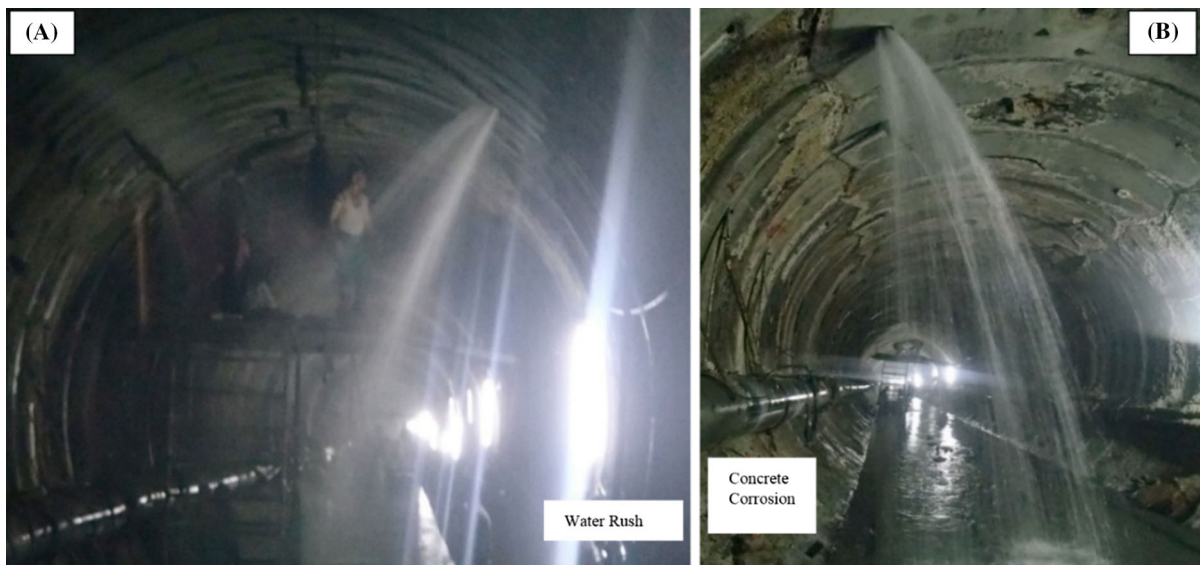
Fig. 3 The rush of groundwater into the tunnel (Nazemi 2017)

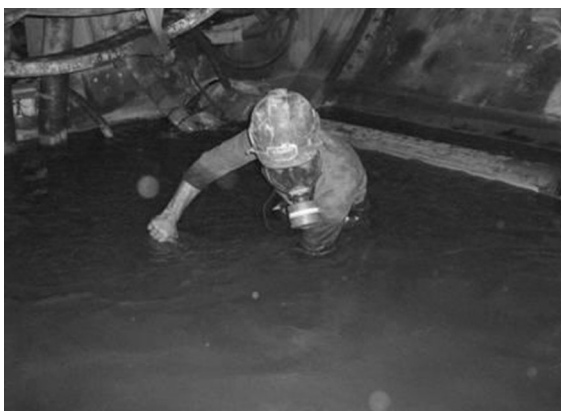
Fig. 4 Excessive water flow and the harsh environment at the Zagros tunnel. (Courtesy of Mirmehrabi et al. 2010)

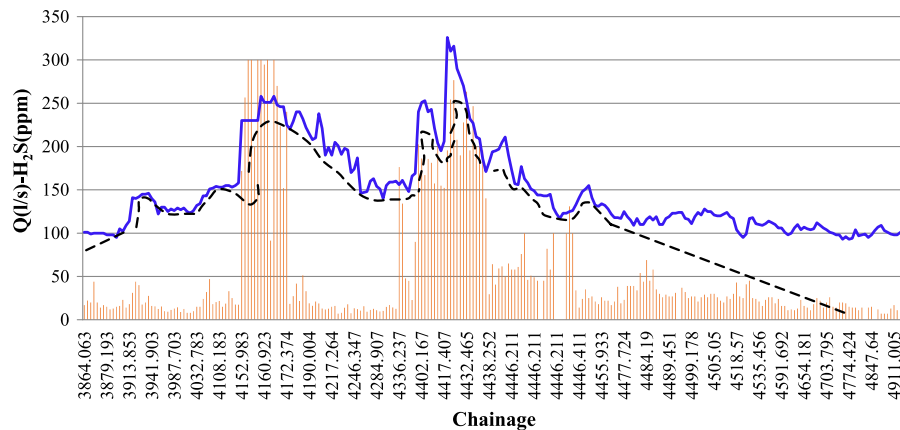
Site inspections indicated that water inrushes mainly seeped up through the filling washed discontinuities and conduits. Figure 5 shows the inflow of water and gas into the tunnel. The peaks show that water flows along filling washed discontinuities and conduits of folding hinge parts. Field investigation revealed that the inflow of water increases when dip of discontinuities (including bedding) increases. Additionally, the discharge of water decreases where joints

Fig. 5 Rush of water and H_2S gas into the Zagros tunnel in the Garu formation (chainage 3.8 to 4.1 km)

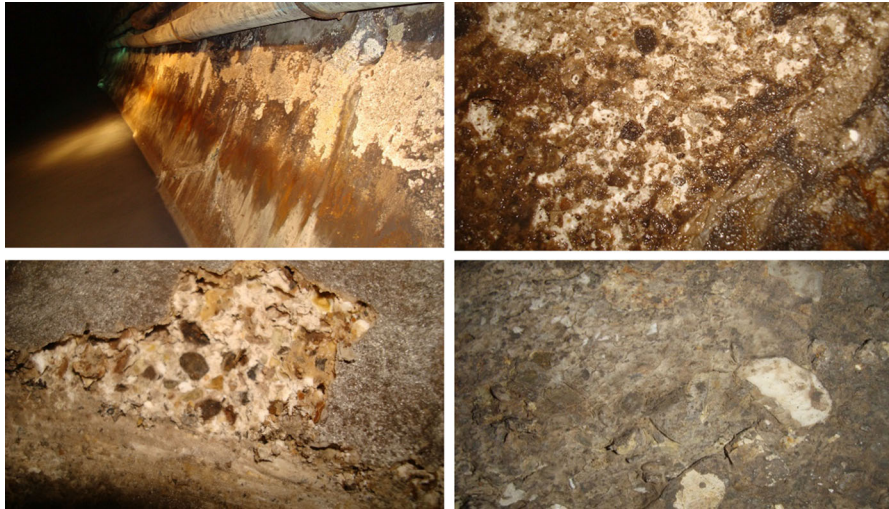
Field inspections at different tunnel locations were performed to assess the deterioration of the concrete linings. These inspections revealed that damage on the surface of linings is associated with swelling, spalling and the severe degradation of mortar. Deterioration was also significant where the segmental linings prone to cyclic wetting and drying. Field observations also indicated that sulfate attack could be a reason of the segmental linings deterioration. Figure 6 well depicts the decaying of the concrete linings at the Zagros tunnel.

Fig. 6 Typical examples of the segmental lining deterioration (spalling and swelling) at the Zagros tunnel

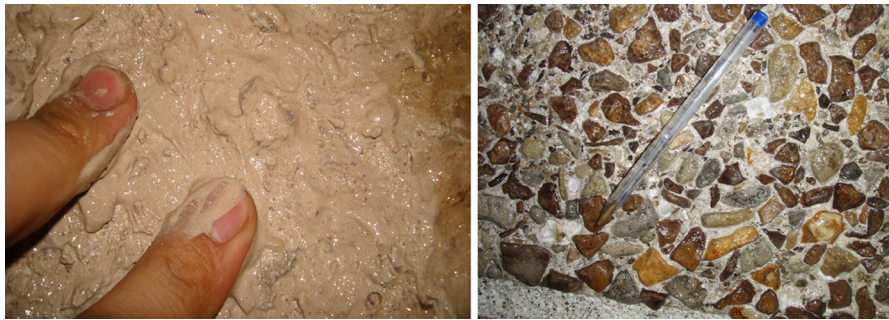
Fig. 7 Examples of concrete deterioration at the Zagros tunnel which resulted in the softening of concrete matrix, swelling and spalling

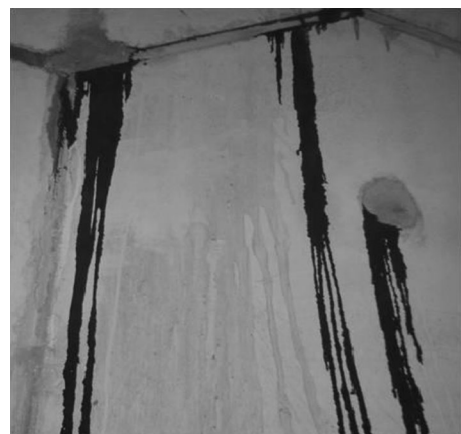
Fig. 8 Seepage of organic bitumen into the Zagros tunnel from segments' joints. (Courtesy of Mirmehrabi et al. 2010)

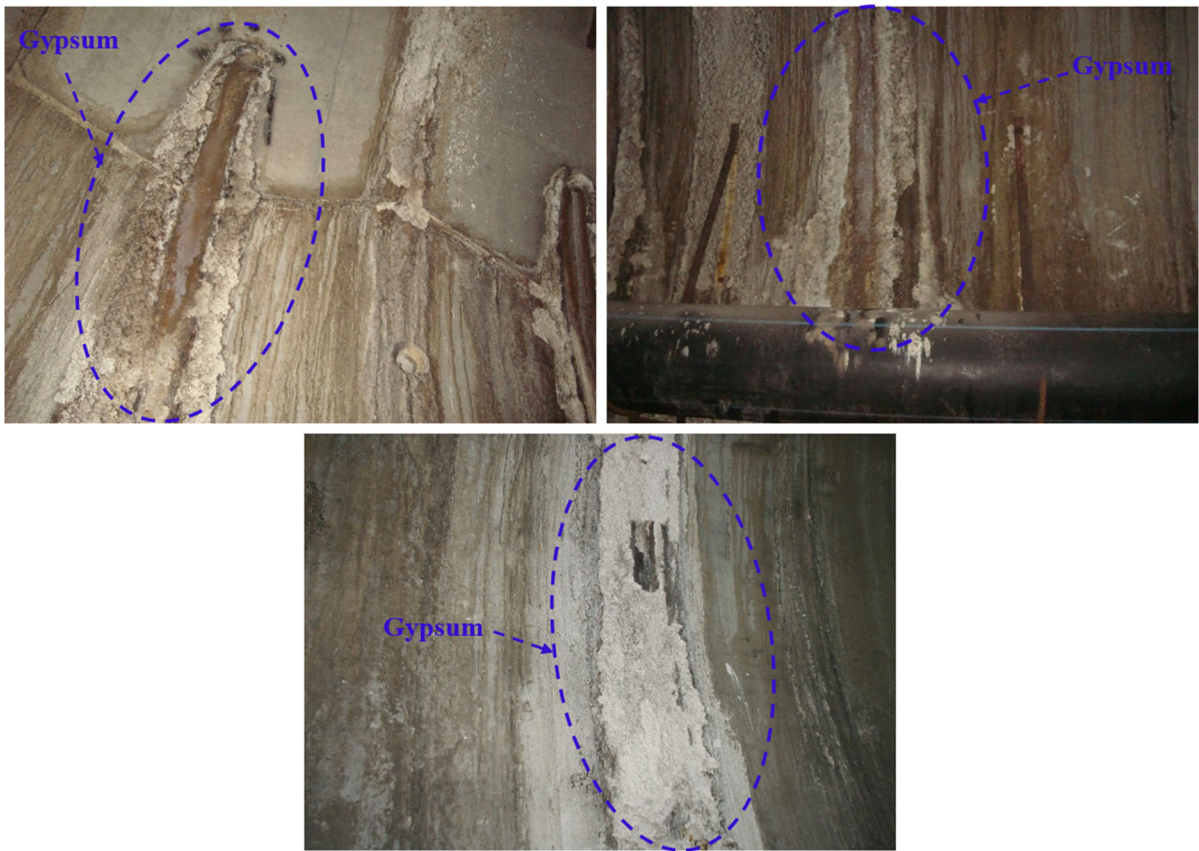
It is noted that the formation of mush on the surface of segmental tunnel linings, in severely deteriorated areas, supports the proposed corrosion theory and reactions (see Fig. 10). The results of the XRD tests indicated that the concrete samples mainly contain calcite (CaCO_3) and negligible amount of Quartz. Quartz is a durable mineral that is not dissolved in acidic solution.

The formation of gypsum is accompanied by volume expansion and swelling in the concrete materials. Swelling leads to spalling and the disintegration of concrete surface, which subsequently degrade the mechanical properties (e.g., strength) of concrete.

Fig. 10 The deposition of mush and gypsum on the surface of concrete linings at the Zagros tunnel

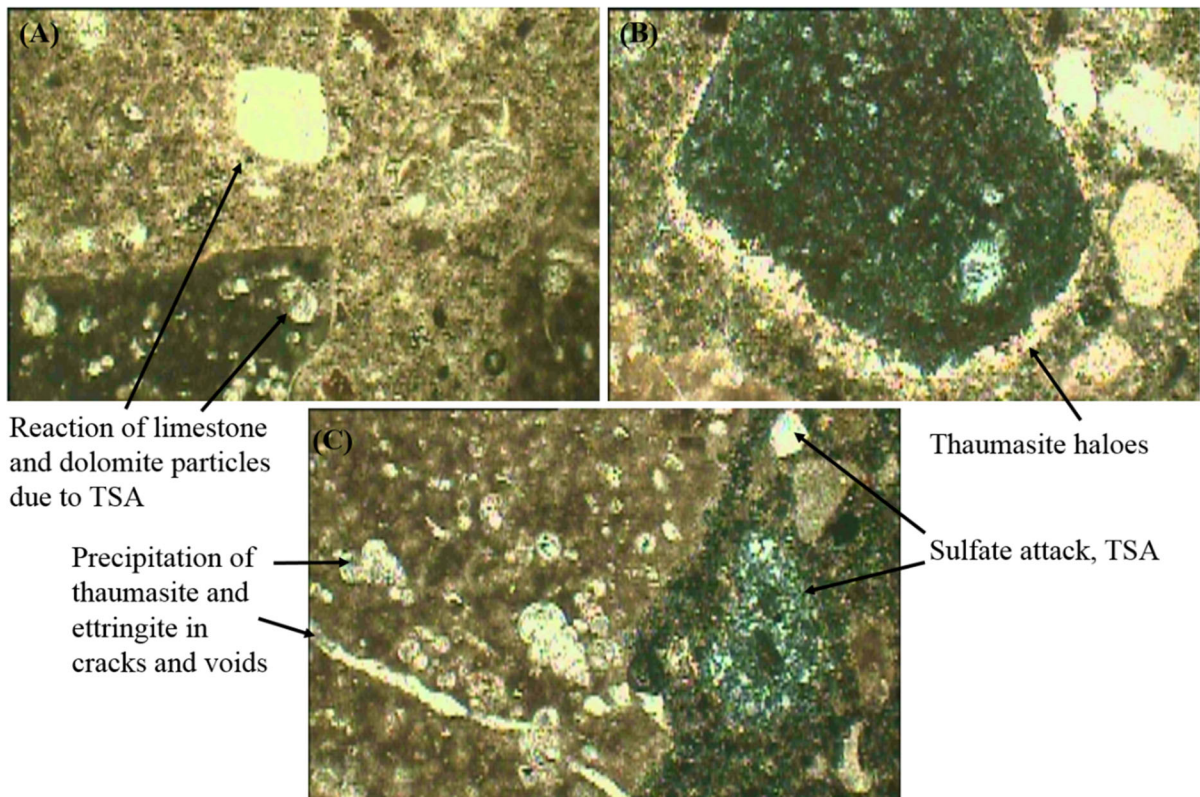
sections of three different concrete cores, A, B, and C, respectively. Particles of limestone micrite and dolomite, which contain crystals of calcite and some clay minerals, can be seen in the thin sections. A limited amount of micro-fossil particles were also detected in a few of the prepared thin sections. Some calcite crystals also contain iron oxides (magnetite, Fe₃O₄, and hematite, Fe₂O₃), which do not seem to be reactive in the concrete matrix. The MA also disclosed the existence of some calcite crystals around the small blocks of cherts in the concrete. There is also a limited amount of clinkers in the paste that have not reacted and may never be hydrated during the lifetime of the structure.

Fig. 11 Examples of Microscopy Analysis of deteriorated concrete prepared from the top section of samples A, B, and C

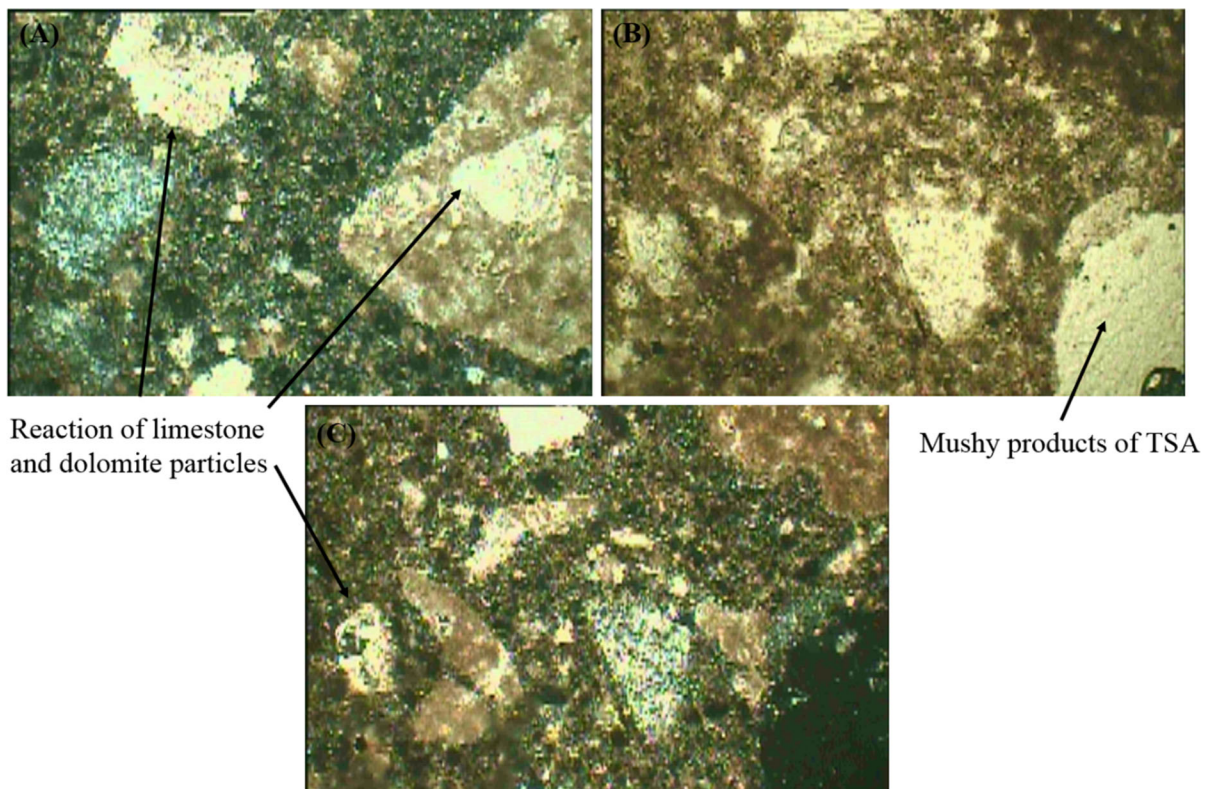
Fig. 12 Examples of Microscopy Analysis of deteriorated concrete prepared from the middle section of samples A, B, and C

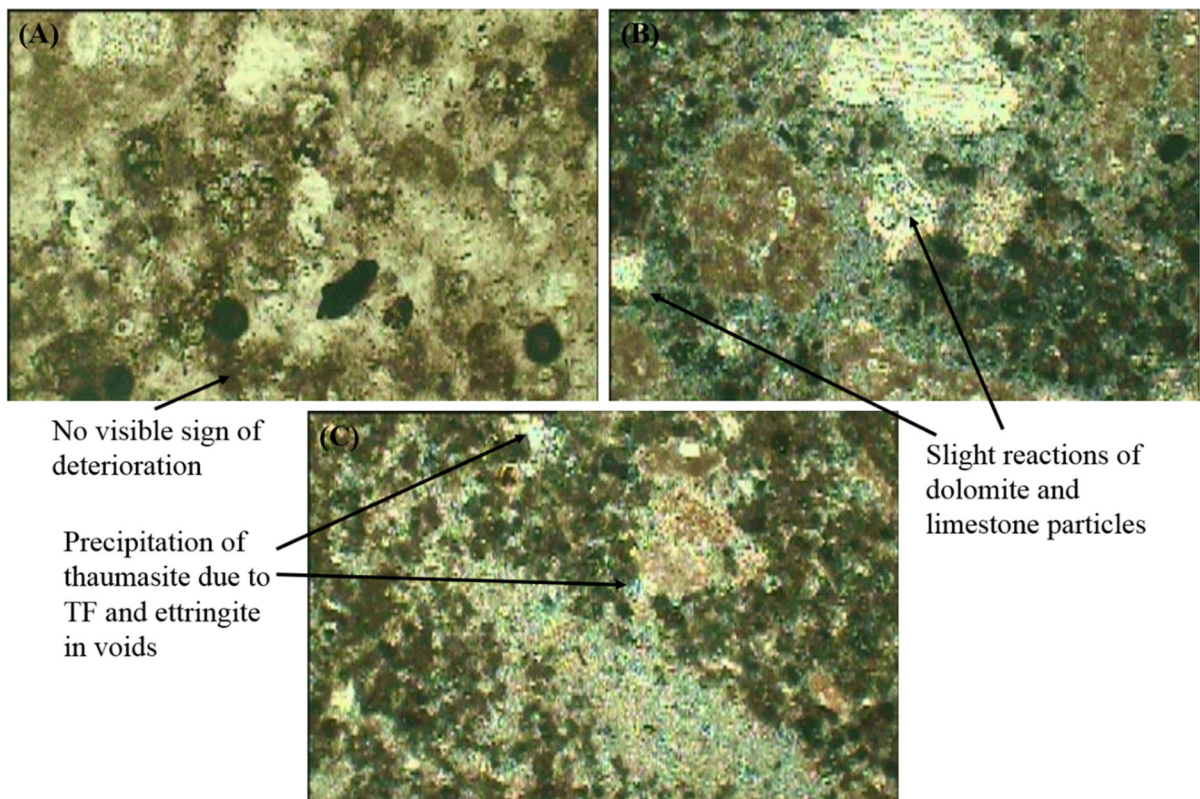
Fig. 13 Examples of Microscopy Analysis of deteriorated concrete prepared from the bottom section of samples A, B, and C

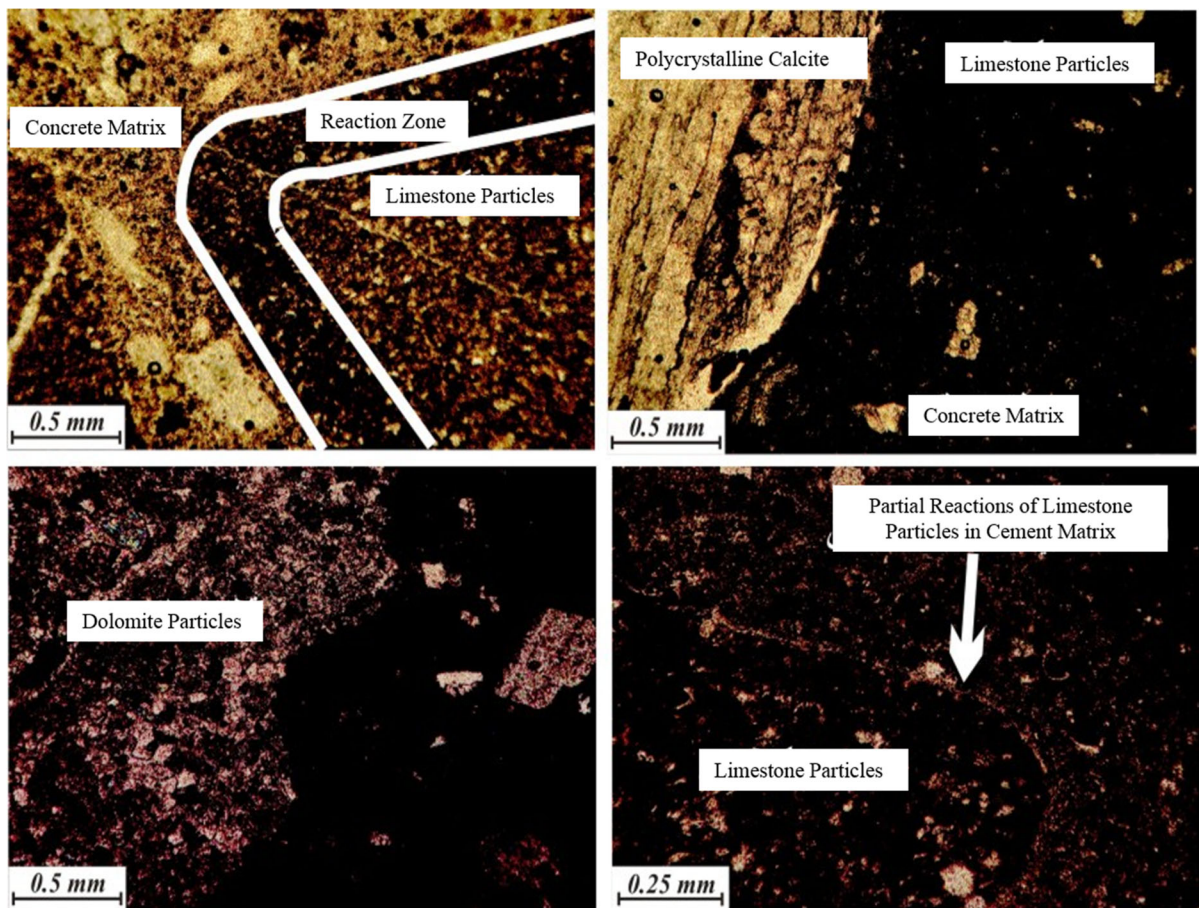
Figure 14 also shows typical examples of the performed Microscopy Analysis (MA) of a deteriorated concrete sample. This figure well shows that sulfate ions gradually react with the limestone/dolomite particles and cement paste, and alter the concrete materials. These chemical reactions gradually led to the deterioration of the concrete linings.

Fig. 14 Examples of MA of cored concrete samples at the Zagros tunnel

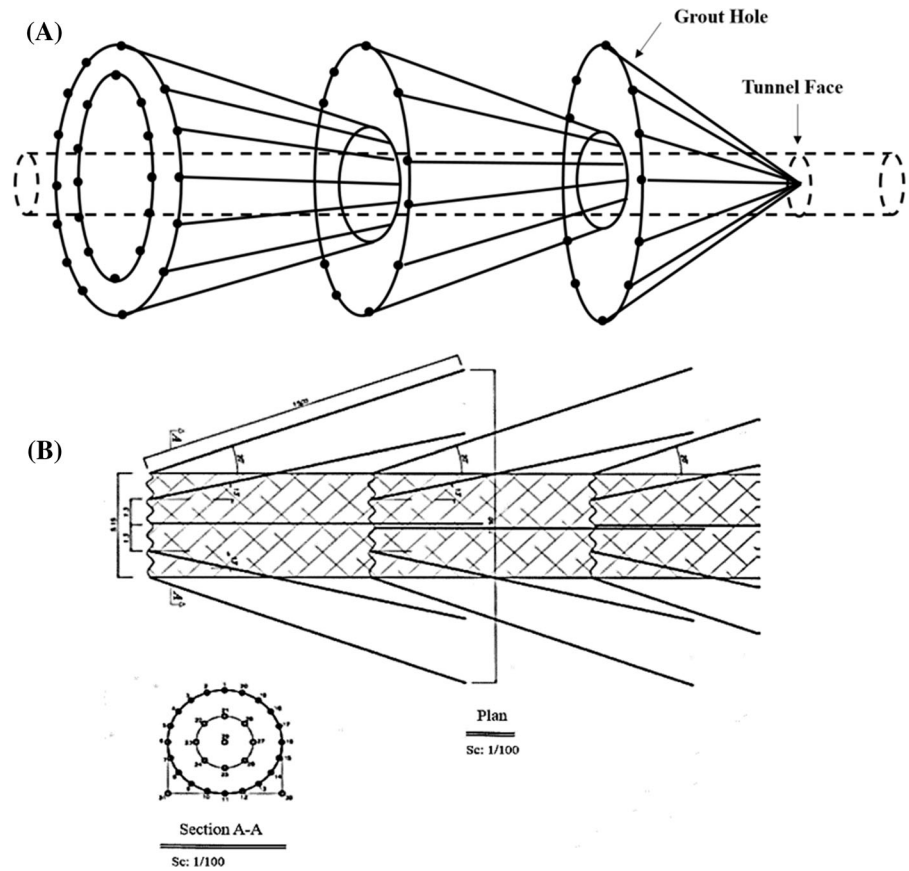
Fig. 15 Typical examples of grouting pattern to reduce water rush into tunnels. (Adopted and modified from Tseng et al. 2001; Fouladgar 2004)

Since the Zagros tunnel excavated by a Double Shield TBM and lined by segmental linings, the exact locations of the discharging conduits and their morphology have not well been identified. An elaborate post-grouting plan may, therefore, be useful to reduce the inflow of water and to reclaim the aquifer. The cost of such a systematic grouting might be considerable

Chemical grout may also be used to fill the gap behind the segmental linings and to protect the outer surfaces of the linings. Grout may also be injected into the rock mass behind the installed segmental linings. This can help to reduce the permeability of the rock mass around the tunnel and to decrease the ingress of water. Reinforcing the rock mass can also reduce the rock loads on the tunnel support and increase the long-term stability of the tunnels. Filling the gap between the segmental linings may also protect the outer surfaces of the concrete linings against deterioration (Annett 1994). The use of chemical grouting agents may, however, bring about a new emission problem which should be considered in the design. Chemical grouting may pollute the groundwater and the tunnel environment (Vik et al. 2000). The use of grouting products in tunnel construction may lead to relatively large local releases of chemical materials into the environment. This can result in considerable environmental issues.

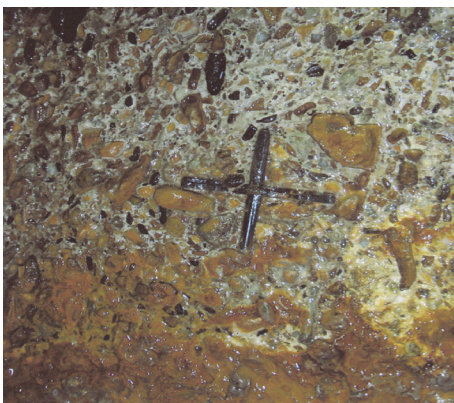
Further analyses is also needed to identify the potential of the corrosion of concrete reinforcement in the tunnel environment. For example, Hobbs and Taylor (2000) investigated the nature of thaumasite sulfate attack in concrete in several real cases in the UK. Several bridges and houses were considered in the study. Field inspections revealed that in some cases the overall integrity of the concrete structures were not severely impacted by the procedure of sulfate attack. However, significant thaumasite formation was accompanied by concrete deterioration which subsequently reduced the effective cover to the reinforcement. This indeed has increased the potential of reinforcement corrosion due to chloride ion ingress. Similar phenomenon was observed in a few locations at the Zagros tunnel (see Fig. 16). The corrosion of reinforced pre-cast concrete segmental linings has been investigated by researchers and well documented in the references (Mohammed and Hamada 2006; Mohammed et al. 2004). In particular, Abbas and co-workers (2012, 2014) performed large-scale tests to assess the performance of conventional Reinforced Concrete, RC, and Steel-Fiber Reinforced Concrete, SFRC, segmental linings against chloride ions. Outcomes of these studies indicated that SFRC segments showing a higher cracking load and more stable post-peak behavior in comparison with the conventional RC segments. The SFRC segments might, therefore, be a more durable alternative for precast segmental tunnel linings in terms of resistance against the corrosive factors (Abbas et al. 2012, 2014). The

Fig. 16 Deterioration of the concrete cover and the exposed reinforcement, at the Zagros tunnel
