Seismic Damage and Possible Influencing Factors of the Damages in the Melamchi Tunnel in Nepal Due to Gorkha Earthquake 2015

Keywords Gorkha earthquake 2015 · Damages in the tunnel · Damage assessment · Damage influencing factors

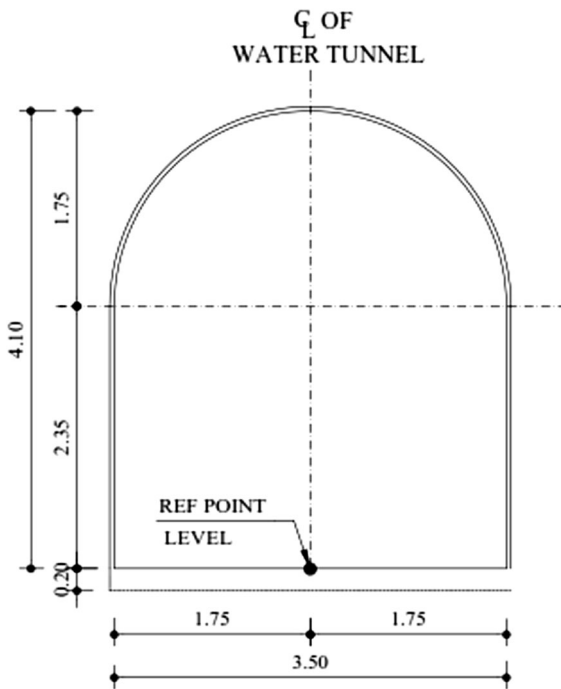
Fig. 1 Typical Section of Melamchi Tunnel; Unit m

This project consists of 26.3 km long tunnel with 3 audits and intake structures. Maximum overburden depth is about 1150 m. Including the three audits, namely Ambathan, Gyalthum and Sindhu, access was provided to seven working areas along the tunnel alignment. The theoretical cross-sectional area of the tunnel is 12.7m² (EDCO 2001). Drill and blast techniques are adopted for tunnel excavation (Bhattarai -Executive et al. 2015). A strict accounting system is in place for explosives. Figure 1 shows the typical section of Melamchi Tunnel.

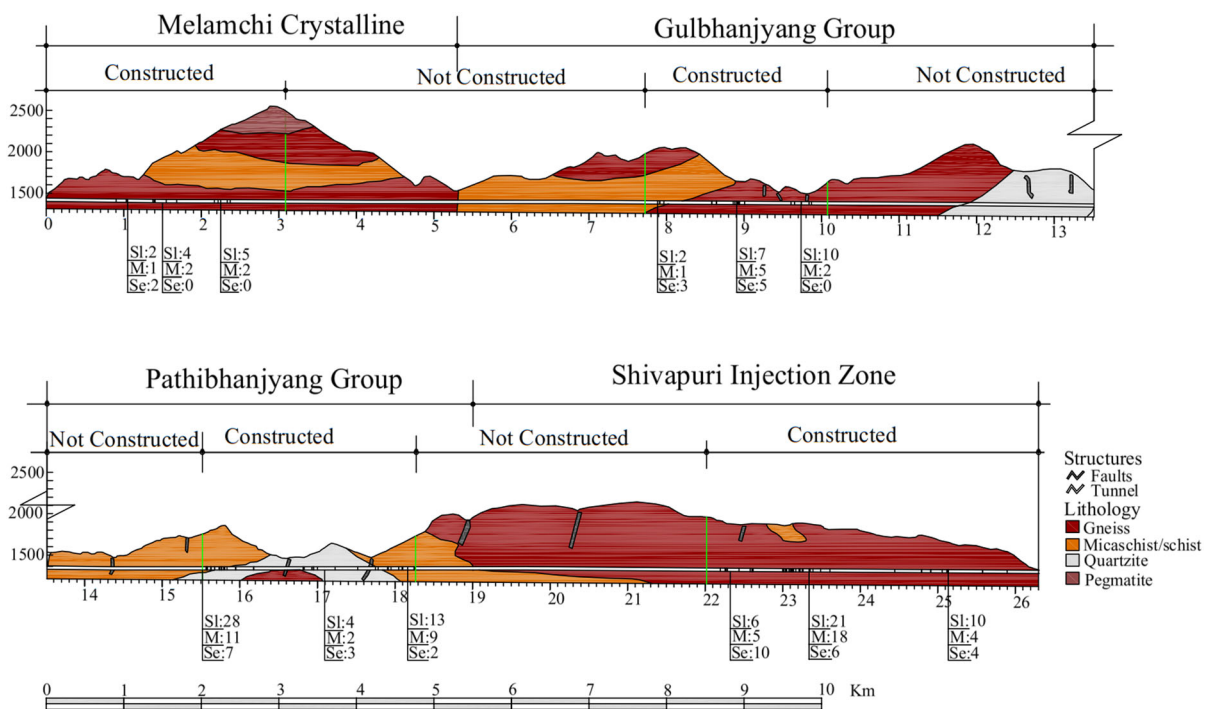
Fig. 6 Longitudinal profile and damage locations of Melamchi tunnel

according to the field investigation, is described in detail later. We start from headrace of the tunnel. At the headrace, there was slope failure. The interior of the tunnel also suffered significant damage. There are longitudinal cracks, vertical cracks, and even cracks in the crown. In some places, the steel reinforcement was also exposed. There were many damages which needed retrofitting. The Melamchi water conveyance tunnel suffered from small to heavy damages both at the portal and inside of the tunnel. The location of damages on the project, in detail, are shown in Fig. 6.

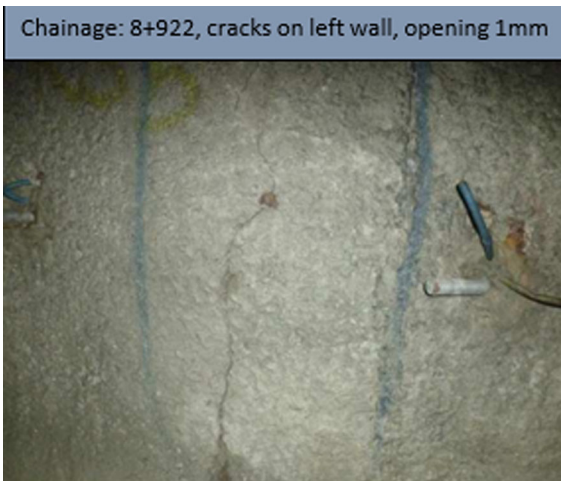
Fig. 7 Sight damage

Some damages found in Melamchi Tunnel are shown in Figs. 7,8 and 9.

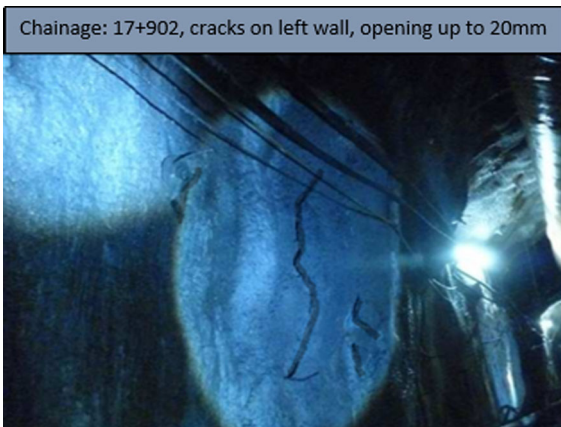
Fig. 8 Moderate damage

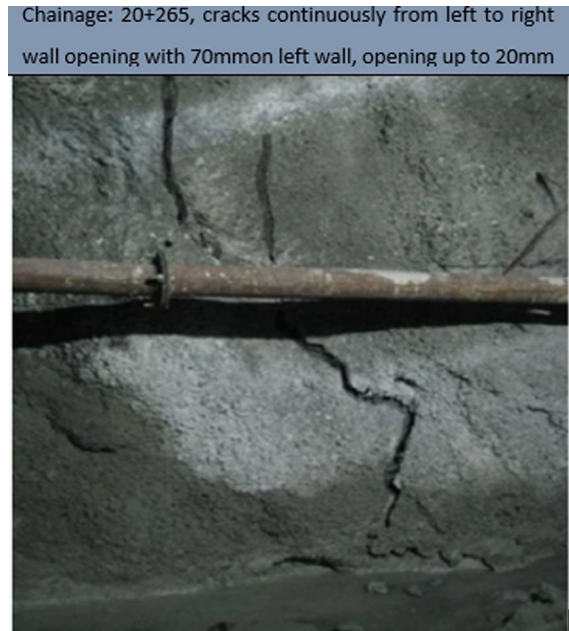
Fig. 9 Severe damage

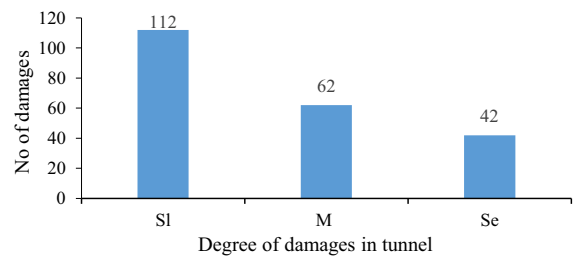
Fig. 10 Degree of damages in tunnel

From the observation result, it was found that 51.85% of total damages were slight damages, 28.70% were moderate damages, and 19.45% were severe damages. So, here slight damages were maximum and severe were the minimum. Distribution of damage degree is shown in Fig. 10. Past studies also show that the slight damages in tunnels are more than severe damages. In some earthquakes, (Asakura and Sato 1998), about 50% of tunnels needed reinforcement and repair because these tunnels were very near to epicentre and epicenter-depth was also less.

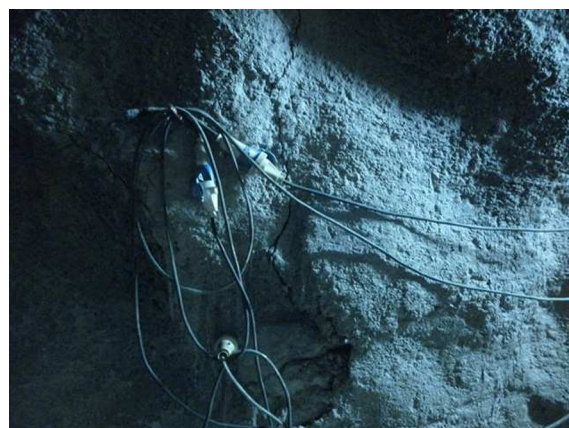
Fig. 11 Lining crack, up to 7 mm at chainage 18 + 239

Various patterns of seismic damages in the Melamchi Tunnel caused by 2015 Earthquake were observed Figs. 11,12 and 13. Some of the major patterns were

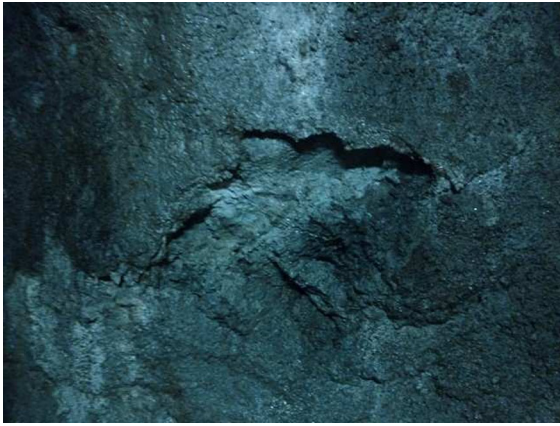
Fig. 12 Spalling, shotcrete fall from right wall along shear band, area up 1sqm at chainage 16 + 823

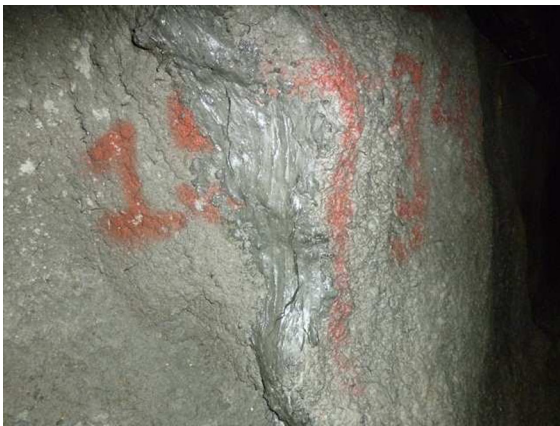
Fig. 13 Ring crack, several shotcrete cracks observed along the crown and both walls with opening up to 1.50 cm at chainage 15 + 937

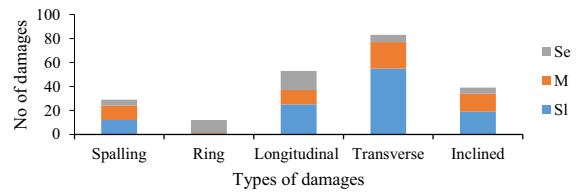
Fig. 14 Seismic damage distribution of tunnel

Among all the damages 86.57% were lining cracks and 13.43% were spalling. Lining cracks are the most frequent type of damage to tunnels caused by earthquakes. Lining cracks are further divided into ring cracks, longitudinal cracks, transverse cracks and inclined cracks. Transverse cracks are perpendicular to the direction of the tunnel axis and inclined cracks with inclination of 40–70°(Zhang et al. 2018). Among 86.57%, 5.56% are ring cracks, 24.54% are longitudinal cracks, 38.43% are transverse cracks and 18.04% are inclined cracks. Seismic damage distribution of tunnel is shown in Fig. 14 and Table 4.

As illustrated in the above table and Fig. 14, the observation was made to identify the severity of

damages in all different types of damages. And thus we can see that in spalling, severe damages were very little as compared to slight and moderate. In-ring cracks, severe damages were much higher than the other two. In longitudinal cracks, slight damages are more, almost half of them, than the other two. In transverse cracks, slight damages are much more, about two-thirds and severe damages were very few. In inclined cracks also slight damages were more, about half of them, and gradually followed by moderate and then severe the least. Here we can see that all of the damages has a lower percentage of severe barring one damages and more of slight damages, the ring cracks had much more severe cracks.

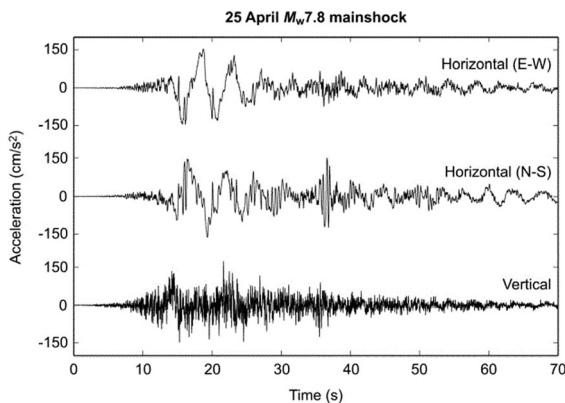
Fig. 15 Wave acceleration measured at KNTF station during 25th April mainshock

With regards to the influence on structural damage, earthquake parameters mainly consist of magnitude, depth of earthquake source, epicentral distance and shaking duration. In conjunction, these four factors determine the earthquake intensity in a particular area: with a higher magnitude, shallower epicentre depth, shorter epicentral distance, longer shaking duration, the earthquake will be more intense in the area and exert a stronger influence (Hashash et al. 2001). Okamoto and Tamura (1972) concluded after the study of seismic tunnel damage in Japan, that the tunnels over 50 km far from the epicentre do not get influenced. And in this project, head race -Melamchi—portal is 83.88 km far from epicenter of 7.8Mw earthquake and 55.55 km far from epicenter of 7.3 Mw earthquake. And the tailrace, Sundarijal portal is 85.5 km far from epicenter of 7.8Mw earthquake and 64.7 km far from epicenter of 7.3 Mw earthquake. Acceleration waves measured during main shock and 12th May aftershock are shown in Figs. 15 and 16 respectively.

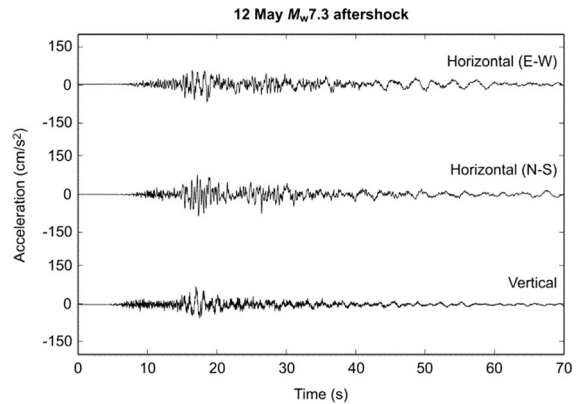
Fig. 16 Wave acceleration measures at KNTF station during 12th May aftershock

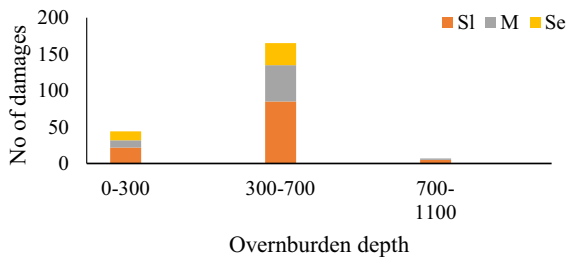
**Fig. 17** Damage in tunnel with overburden depth

As expected for very high overburden depth there is less damage, for 700–1100 m there are no severe damages at all and the highest proportion for severe damage is for 0–300 m being 22.27%. Figure 17 shows damages with respect to overburden depth.

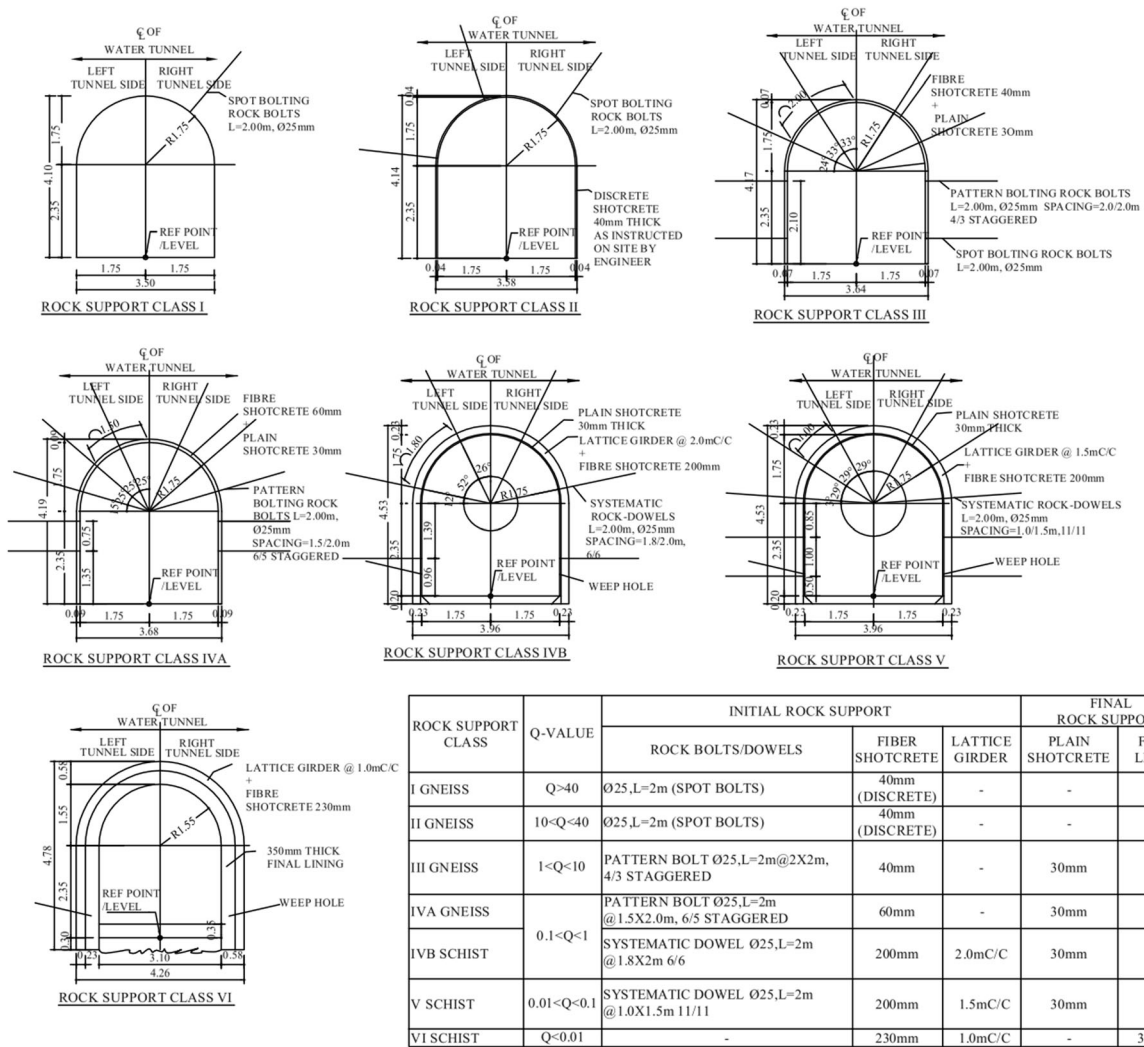
Fig. 18 Rock support class

The design of rock support is based on the Q-system (Barton et al. 1974). Based of rock quality it was divided into six different support types (Fig. 18 and Table 7). There were class I, II, III, IV, V & VI in which class I is the strongest and VI is the weakest.

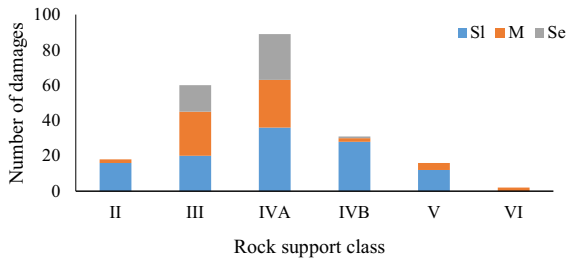
Fig. 19 Damages with respect to rock support class

In Fig. 19, we see that big portion of the damages are slight damages and then decreasingly moderate and then severe in almost all types of rock which is obvious. There are few exceptions as in class III, and class VI moderate is higher. This can be due to various

aspects as the location in the tunnel and the state of the tunnel as stabilized for construction. And for class VI there was very little portion of this rock, and hence very little damages, so cannot be concluded on pattern of damage occurrence (it was only 88 m and only 2 damages).

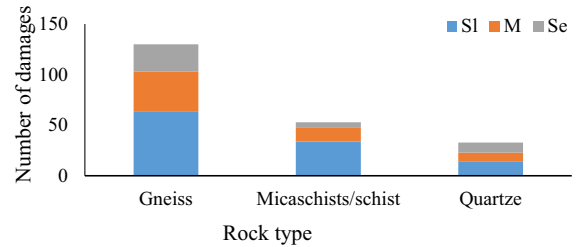
Fig. 20 Degree of damages with respect to rock type

Here in Table 11 and Fig. 20, the damages occurred in different types of rocks are further observed in detail and categorized by the degree of damage. This shows that in all the rocks the slight damages comprise the highest percentage. In Gneiss and Micaschist the slight damage is much more (nearly 50% and more than 50%) while in quartz it is even for all degree of damages with slight about 45% and the other two about 30%. This shows that the occurrence different degree of damages may also depend on the rock type, making it an influencing factor.
