CARINA AS A USEFUL AND RELIABLE RADIOLOGICAL LANDMARK FOR DETECTION OF ACCIDENTAL ARTERIAL PLACEMENT OF CENTRAL VENOUS CATHETERS

J Clin Monit Comput 2010; 24:403–406

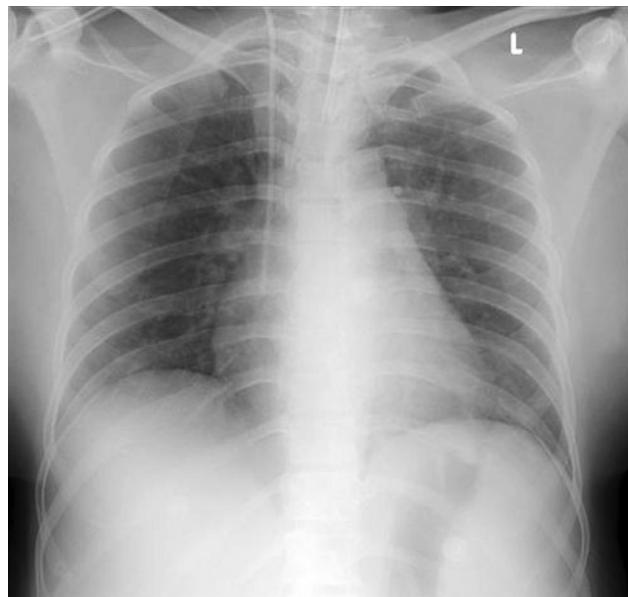
Fig. 2. A central venous catheter inserted from right internal jugular vein remains on the right side of the trachea and does not cross the carina.

It was found that all right sided CVCs remained on the right side of the trachea and did not cross the carina at any point (Figure 2). All left sided CVCs crossed the trachea well above the carina to lie on the right side of the trachea (Figure 3). All angiocatheters inserted from right radial artery crossed the trachea well above the carina and remained on left side of the trachea (Figure 4). All angiocatheters inserted from femoral artery remained on left side of the trachea while in descending aorta and part of the angiocatheter that was in the ascending aorta remained almost in line with the carina (Figure 5).

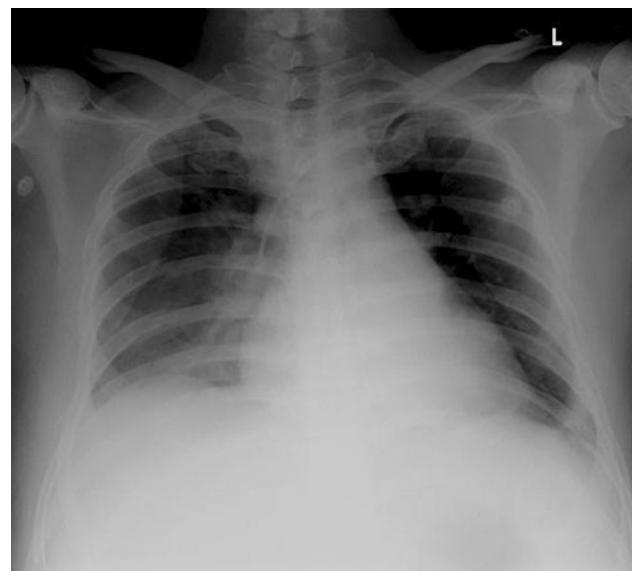
Fig. 3. A central venous catheter inserted from left subclavian vein crosses the trachea well above the carina through the innominate vein to lie on the right side of the trachea.

the trachea well above the carina from left to right and come to lie on the right side of the trachea (Figure 3) unless they are in the artery or are malpositioned where

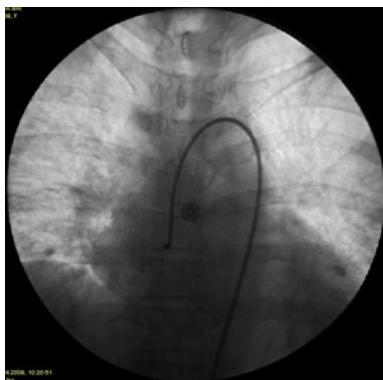
Fig. 5. An angiocatheter inserted from femoral artery enters ascending aorta and then to descending aorta and always remains on the left side of the trachea (simulation of accidental arterial placement of CVC from left side).
