Identifying archaeological evidence of past earthquakes in a contemporary disaster scenario: case studies of damage, resilience and risk reduction from the 2015 Gorkha Earthquake and past seismic events within the Kathmandu Valley UNESCO World Heritage Property (Nepal)

Christopher Davis

Keywords Kathmandu · Nepal · South Asia · Archaeoseismology · Earthquake Archaeological Effects (EAEs) · Resilience · Seismic adaptations · Rehabilitation

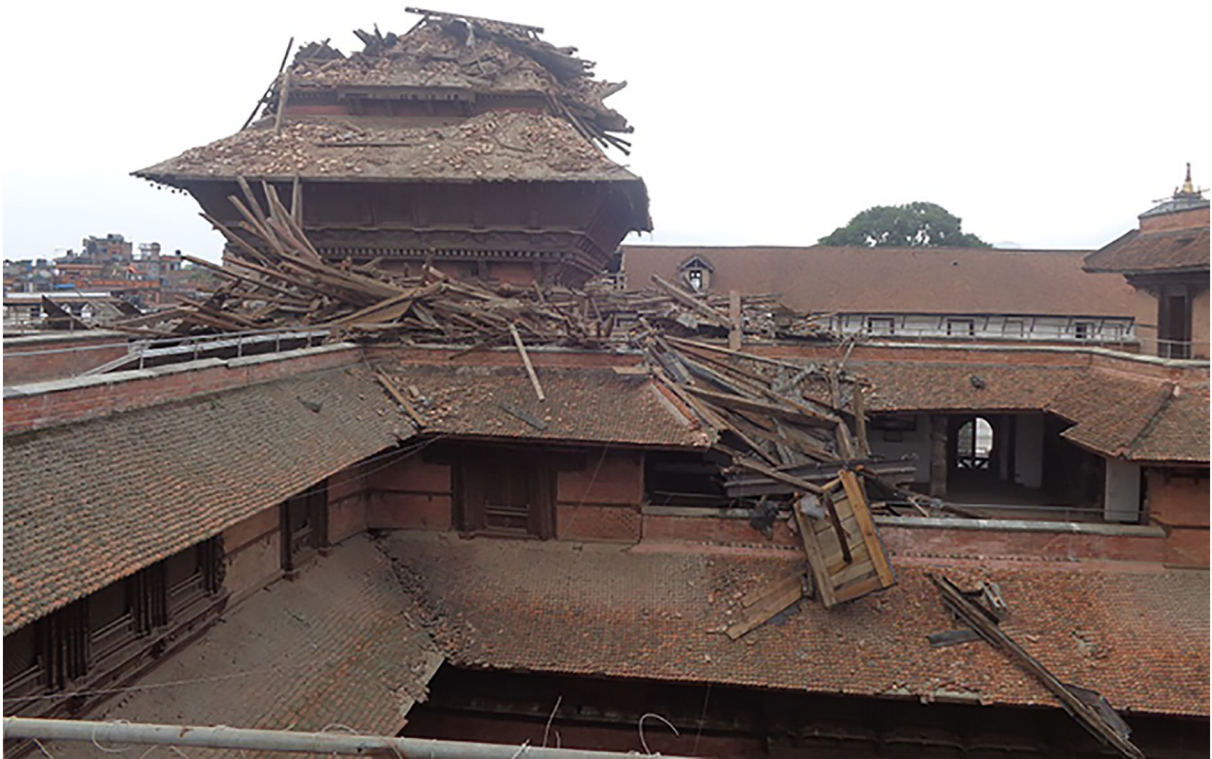
Fig. 2 Damage to the nine-storey palace in Hanuman Dhoka after the 2015 Gorkha Earthquake (image: Kai Weise)

As noted above, the 2015 Gorkha Earthquake damaged 691 historic buildings across Nepal, including monuments located within Kathmandu's UNESCO World Heritage Property, with many collapsing (Fig. 2). Initial damage assessment and salvage efforts were undertaken by the newly established Earthquake Response Coordination Office within the Department of Archaeology (Government of Nepal), which was followed by the preparation of a Post-Disaster Needs Assessment (Weise et al. 2017: 72). Completed on the 10th of June 2015 by the Department of Archaeology and UNESCO Kathmandu, the Post-Disaster Needs Assessment (PDNA 2015) estimated the damage to Nepal's cultural heritage at about US\$169 million, with an associated loss of US\$23 million from damage and impact on livelihoods (PDNA 2015: 1). As major visitor attractions, partially accounting for the 7.6% of GDP generated by tourism to Nepal's Gross Domestic Product, and as foci for veneration, community gatherings and local markets, damaged heritage sites were subject to a major programme of consultation, reconstruction and conservation.

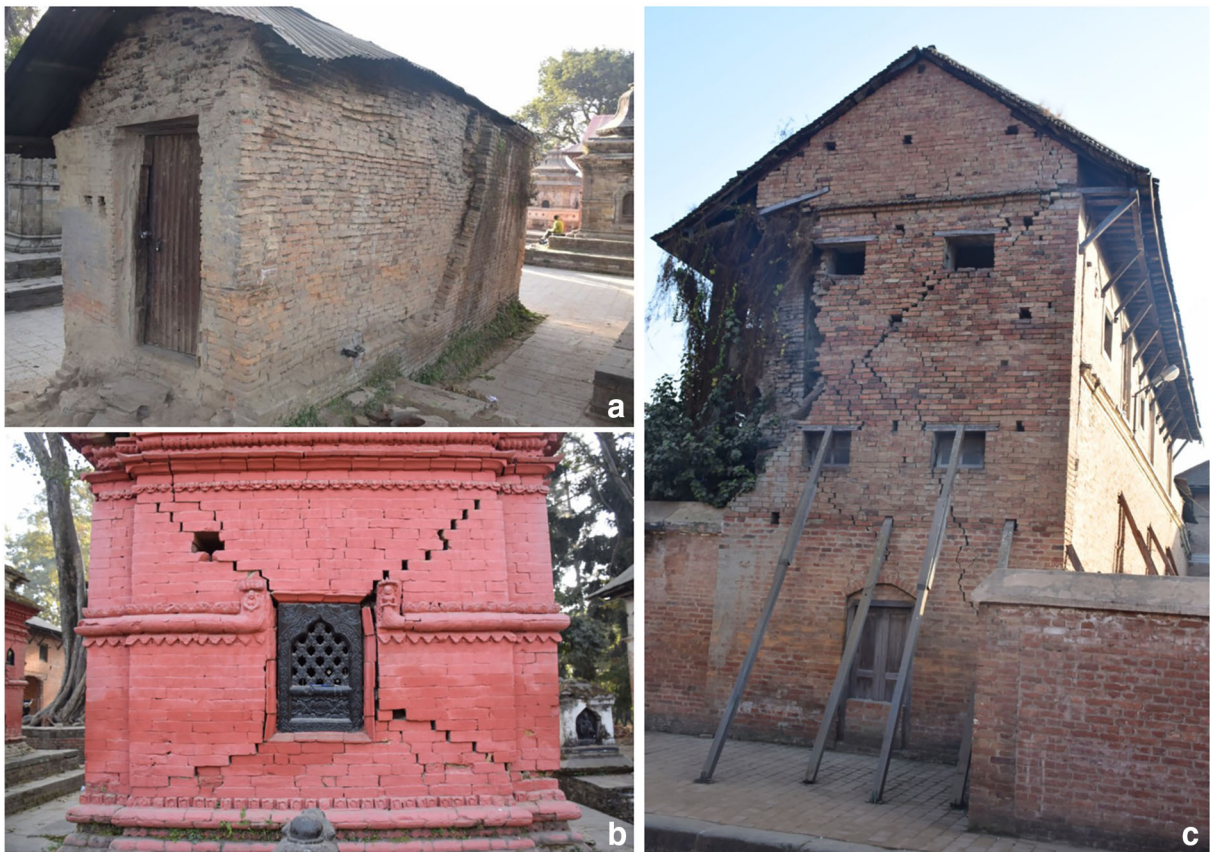
Fig. 3 Tilted wall at a structure at Mrigasthali in Pashupati (a); ‘X’ fracture through a brick built shrine at Mrigasthali in Pashupati (b); shear cracks through one of the walls within Bhaktapur Palace Complex (c)

Tilted walls, close to collapse, were found at several structures, including a clear example at a building within the Mrigasthali area of Pashupati (Fig. 3a). Of monuments where full collapse had not occurred, fractured walls, including shear cracks and 'X' fracture patterns through wall facades were common at stone and brick structures, particularly wood-framed buildings with brick infills. Occasionally, these cracks were caused by wall extrusions across the facades of structures. Examples of fracturing were found, but were not limited to, structures in Mrigasthali (Fig. 3b), the Jagannath temple in Hanuman Dhoka's Durbar, or palace, Square and at structures within Bhaktapur's palace complex (Fig. 3c). At Pashupati, in some instances, it was possible to identify vertical cracks linked to the displacement of walls. More complex patterns of cracks were identified at the Shiva temple located within Hanuman Dhoka Durbar Square. Here, there was evidence of composite shear cracks associated with the extrusion of a wall, with the wall profile also appearing to be folded. Such seismic damage patterns are caused by horizontal motion, but there was also a strong vertical component present, testified by sub-vertical fractures penetrating vertically. These EAEs were found at the base of the shrine, which is not entirely surprising due to

this being the location where architectural stresses would be higher. Extrusions and the shifting of masonry blocks was also identified, both at collapsed monuments such as the Vatsala Temple in Bhaktapur (Coningham et al. 2016b), but also within the lion statues that are located just within the western gateway of Bhaktapur’s Durbar Square, which now flank the entrance to the Shree Padma Secondary High School (Fig. 4).

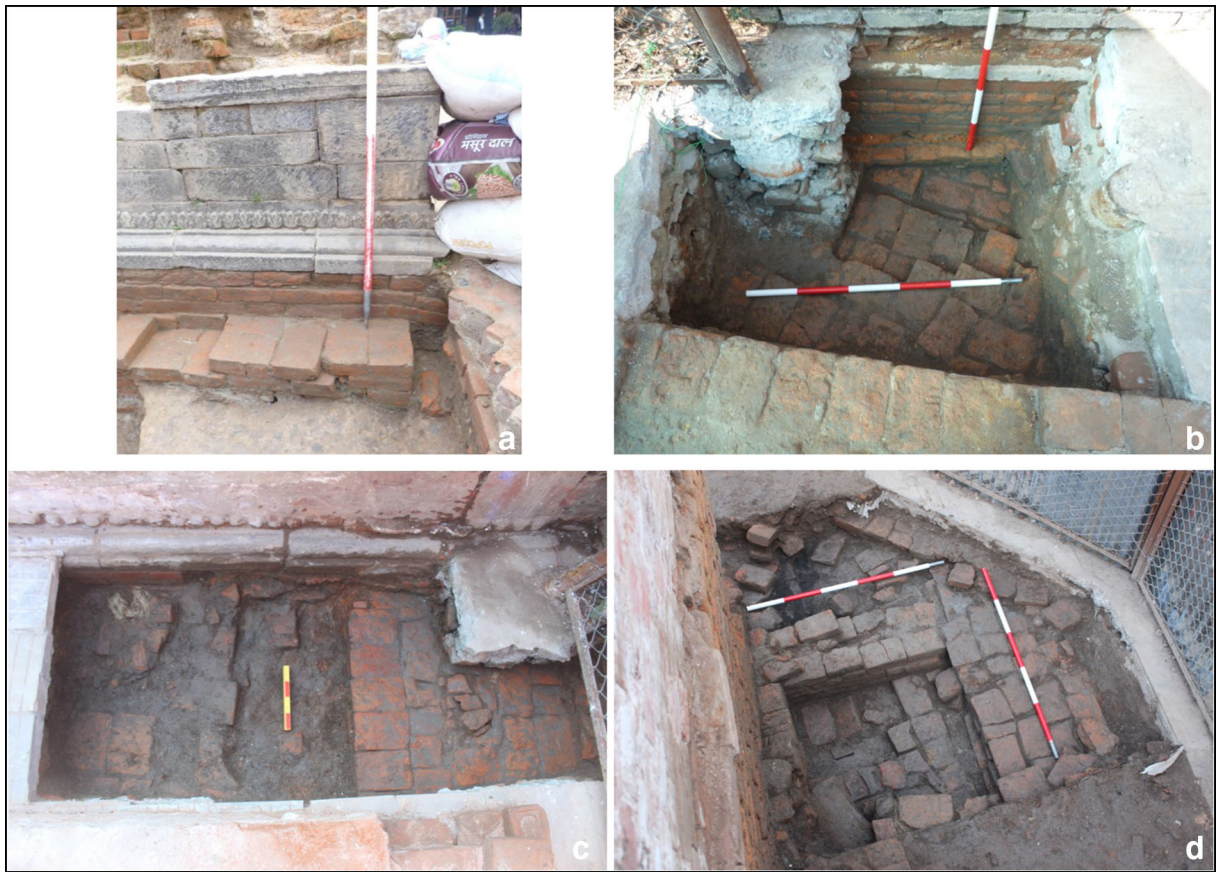
Fig. 6 The current footprint of the Vatsala Temple in Bhaktapur overlaying and overhanging an earlier brick foundation (a); a large brick wall on a differing alignment running under the plinths of the

Maju Dega Temple, Hanuman Dhoka (b); a structure located below the Trailokiya Mohan Temple to the east (c); and a further structure identified to the south (d)

Furthermore, our archaeological investigations have demonstrated that several current standing structures were erected directly on top of earlier phases. For instance, the footprint of the current stone-clad Vatsala temple within Bhaktapur's Durbar Square, thought to date to between the late seventeenth and early eighteenth century CE (Korn 2014: 29–33, 44, Basukala et al. 2014: 33), is off-set from the brick foundations below. These foundations step out to the west, whilst the superstructure overhangs this lower alignment to the south (Fig. 6a). This suggests the strong possibility of two quite separate phases of construction (Coningham et al. 2016b). Similarly, within Hanuman Dhoka's Durbar Square, we found that the current monumental plinths of the Maju Dega (Fig. 6b) and Trailokiya

Mohan Temples (Fig. 6c, d) had been built directly over earlier phases of construction (Coningham et al. 2018: 165). The scientific date for a structure identified running under the west of the Trailokiya Mohan temple, extracted from an Optically Stimulated Luminescence sample of the soil forming the wall's construction surface, was 1040 ± 120 CE. This is around 600 years prior to the traditional date of 1679 CE for the monument constructed above. This earlier wall may relate to a monument that was cleared to make way for its development (Hutt 1994: 85), although whether this earlier monument was damaged by earthquakes is not clear as the traditional construction date is slightly prior to the historic record of the 1681 CE earthquake. Such a scenario may be more plausible for the Maju Dega temple, with construction traditionally ascribed to 1690 CE (Hutt 1994: 88), and would link to the proliferation of large stepped plinth temples in the Kathmandu Valley in the late seventeenth century (Tiwari 2009). However, without historic records and until clearer scientific dating sequences are available, such an assertion is conjectural and it is not possible to link these episodes of levelling or reconstruction definitively as responses to seismic events. However, it remains a possibility alongside other opportunistic reasons for remodelling urban space.

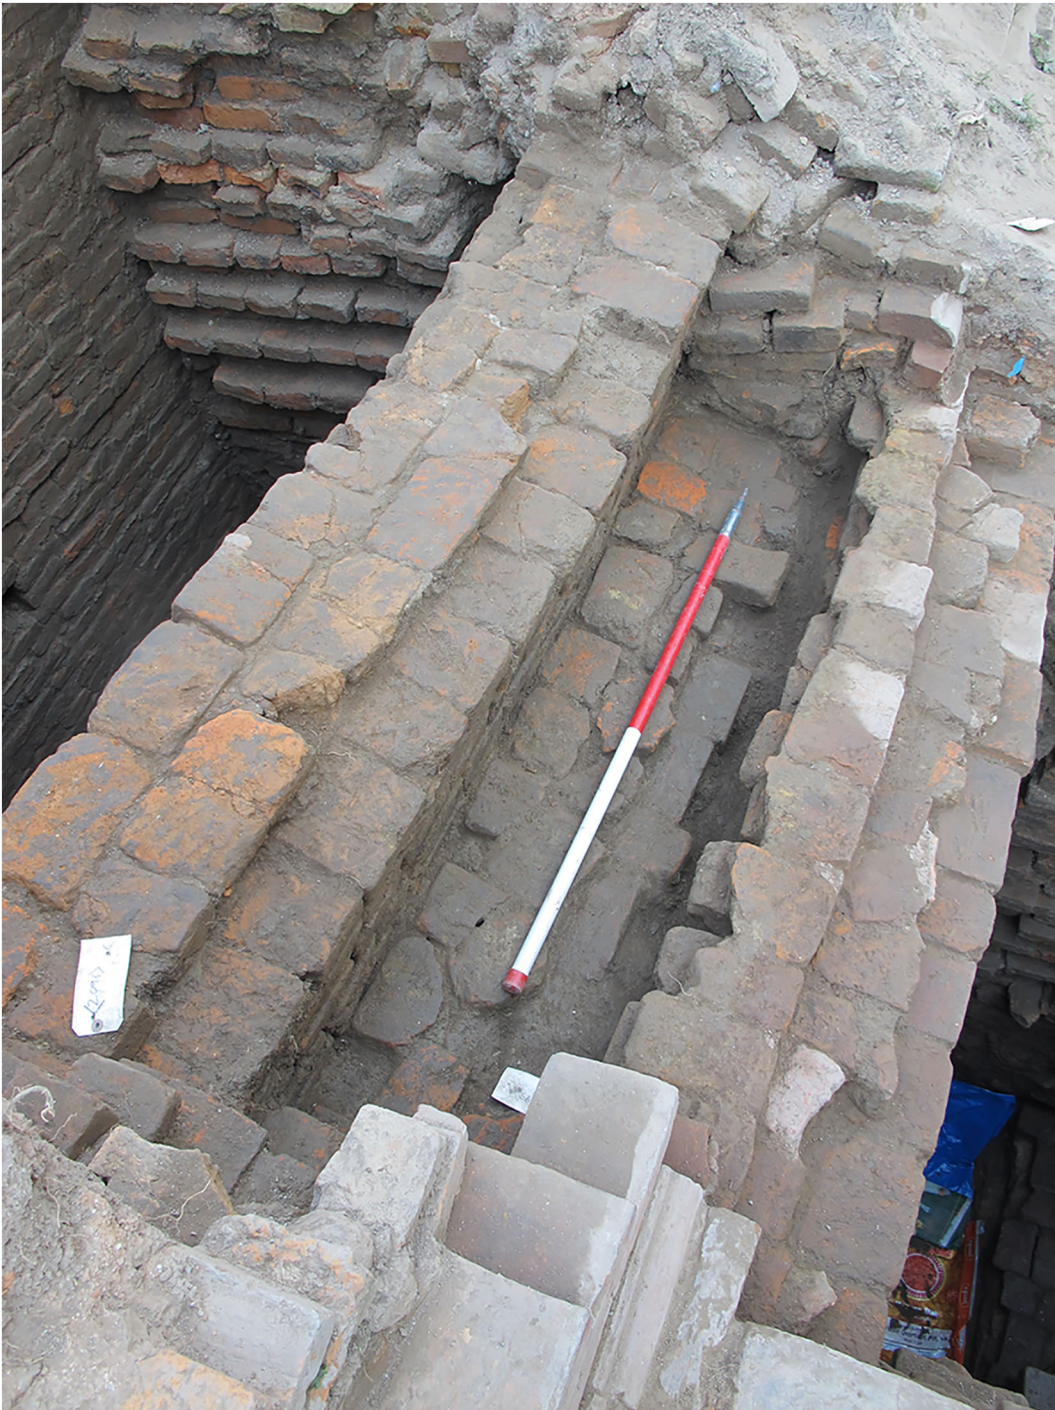
Fig. 7 Deformed and tilted wall, with later bracing, at Jaisidewal Temple (image: Keir Strickland)

The damage exhibited at the Jaisidewal Temple might suggest that the traditional building technique of mud mortar and brick foundations was not seismically resilient. However, monuments with similar foundation construction across the Kathmandu Valley have not been found to display EAEs. Indeed, the longevity of settlement in the Kathmandu Valley suggests a resilience within architecture and design in the face of regular earthquakes. Therefore, as the following section will outline, it is critical that archaeological rescue excavations and assessments are undertaken to understand traditional construction techniques and also ascertain why monuments may have been damaged or collapsed in certain locations, particularly when linked to local geological conditions.

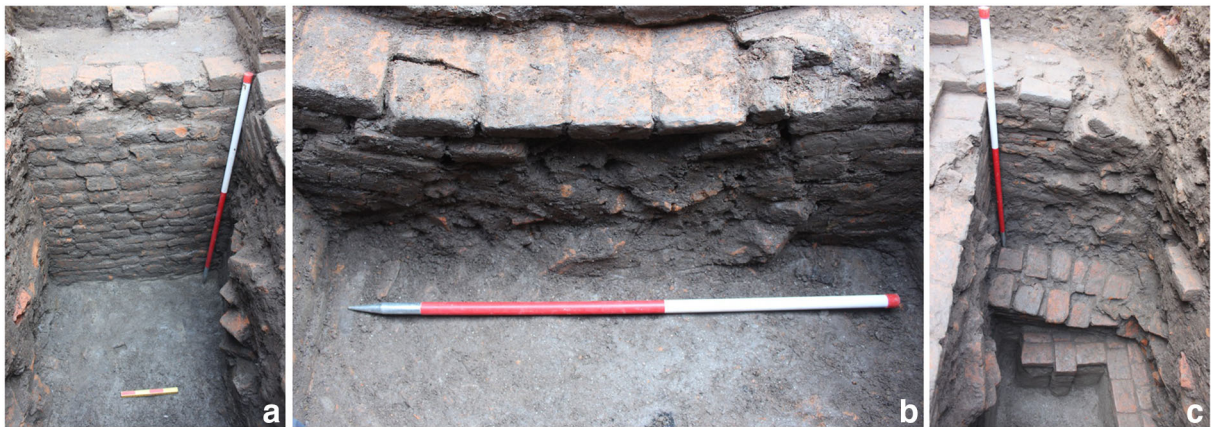
Fig. 8 Trench to the southwest of Jaisidewal Temple, with sequence of brick walls exhibiting shear crack and slight extrusion (a); tilting and collapse (b); crack and collapse of upper wall; and tilting of lower wall below (c)

To the southwest of the temple, a further trench was opened to record archaeological sequences prior to the drilling of geotechnical boreholes into natural soil profiles. Here, we identified a series of earlier brick wall alignments exhibiting EAEs, though unfortunately it was not possible to provide specific scientific dates for when this damage occurred. An east-west running wall, which was one brick thick, exhibited a shear crack and slight extrusion (Fig. 8a). A further brick wall running north-south, to the east of the alignment with the shear crack, tilted towards the west with several courses collapsing in antiquity to form a rubble spill (Fig. 8b). This wall was then abutted at its south by an east-west wall, which was fractured, with a large crack causing the wall to displace, break in two and lean outwards towards the northwest. Directly below this wall, and from an earlier phase, was an earlier east-west brick wall alignment, which also leaned and tilted towards the north (Fig. 8c). Though archaeological evidence for such damage may not always relate to earthquakes (Ambraseys 2006: 1009), a number of factors support this hypothesis. Not only located within

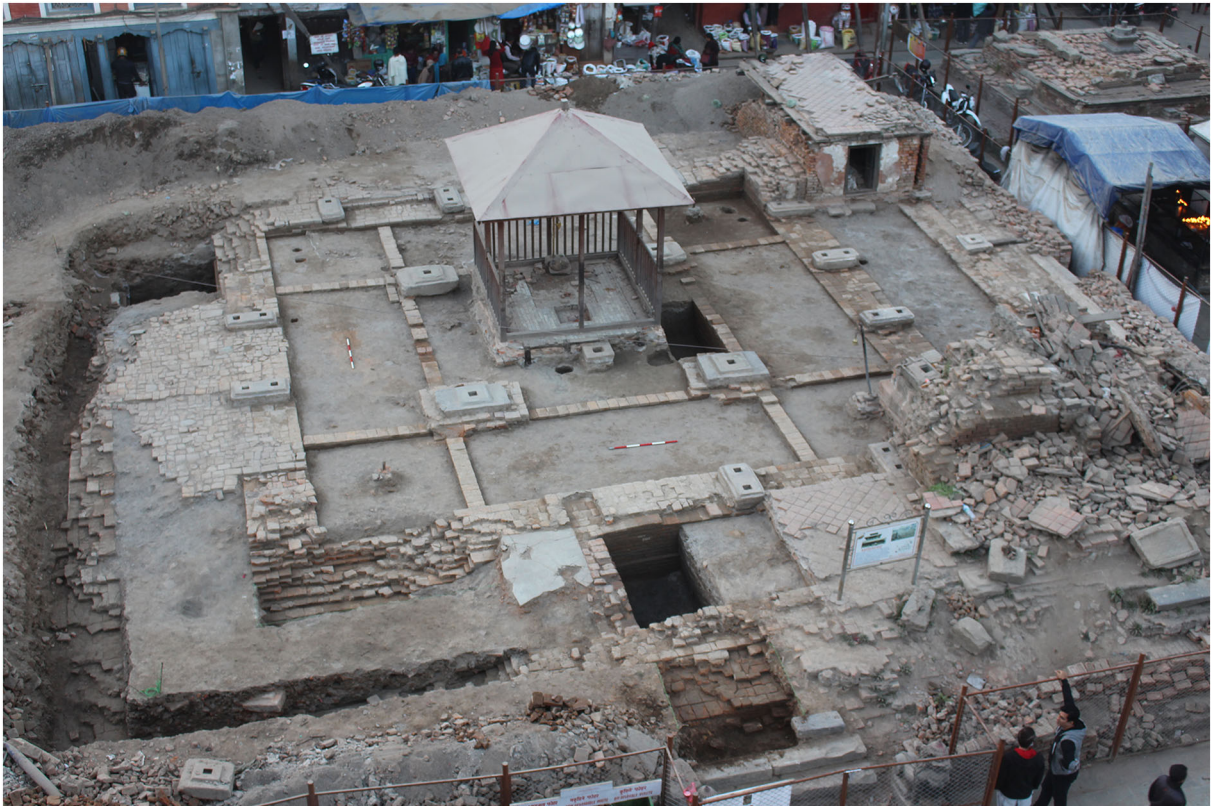
Fig. 9 Nine-celled mandala formed through brick-piers, foundation wall and cross-walls uncovered during archaeological assessments at the Kasthamandap

Collapsing during the hosting of a temporary blood donation clinic, efforts to recover the trapped, injured and dead included the use of heavy machinery. During our excavations, we found evidence of the damage caused by this post-earthquake emergency intervention in the form of dug-out foundations and scrape marks scoring the surface of the tiled floor (Coningham et al. 2016d). This floor had been laid around several saddle stones, which contained sockets to interconnect with the tenons of the wooden superstructure. In particular, the four major wooden pillars of the Kasthamandap were linked to four large saddle stones around the central Gorakhnath shrine. Excavations revealed that these saddle stones sat on brick piers set in mud mortar, each 2 m deep. These were surrounded by a large squared 12×12 -m foundation wall, also 2 m deep and constructed from brick and mud mortar, with smaller double saddle stones placed on its surface to link to the timber superstructure (Fig. 9). We identified that the large saddle

We also identified that the monument may have had been designed with inbuilt cosmological protection, as cross-walls, scientifically dated to 200 years after the monument's original construction, running between the brick piers and foundations, forming a nine-celled mandala design (a representation of the universe in microcosm). These cross-walls may have also formed some aspect of seismic bracing for the foundations. It has further been identified that the infills deposited within

the ‘cells’ formed by the cross-walls were purposefully prepared with soils and materials brought from outside. Preliminary geoarchaeological analysis suggesting that these deposits may have aided earthquake dampening for the monument’s foundations, and the thoughtful compositions of soils placed within the monument’s foundations may have taken on a symbolic significance, which has been recorded in textual sources (Coningham et al. 2019: 63). Further cosmological protection was identified with the recovery of gold foil discs with mandala designs within each of the sockets of the central saddle stones (Coningham et al. 2016d). Such deposits may have provided a ‘life-breath’ to a building and afforded its protection, as well as the prosperity and welfare to those performing the ceremony during the construction of a monument (Slaczka 2007: 84, 201).

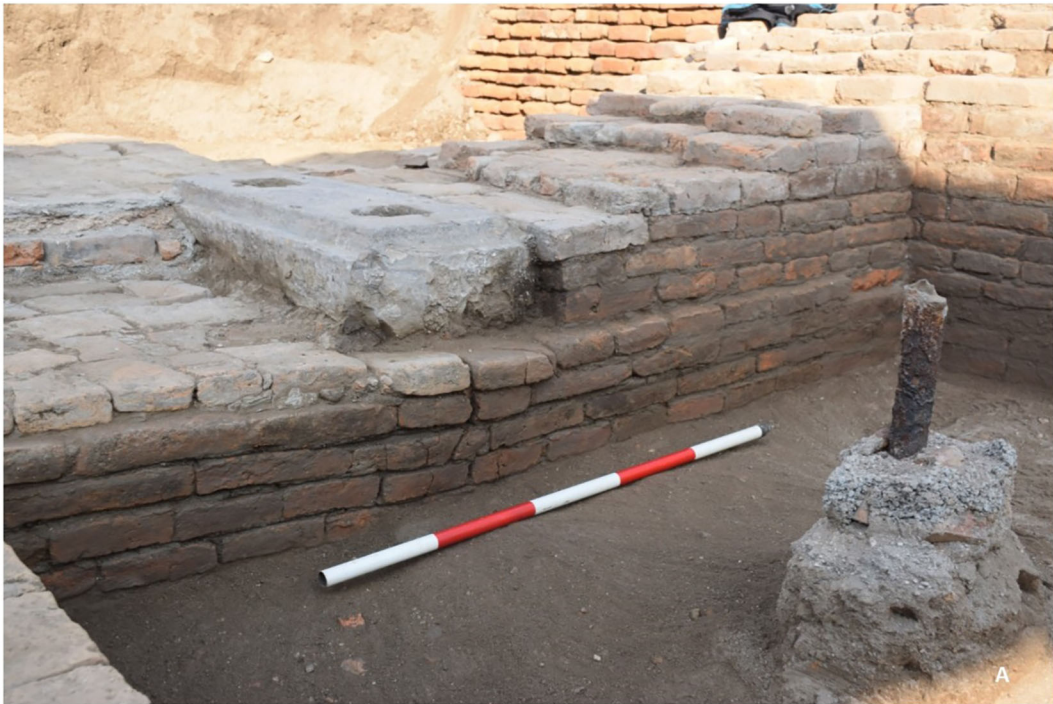
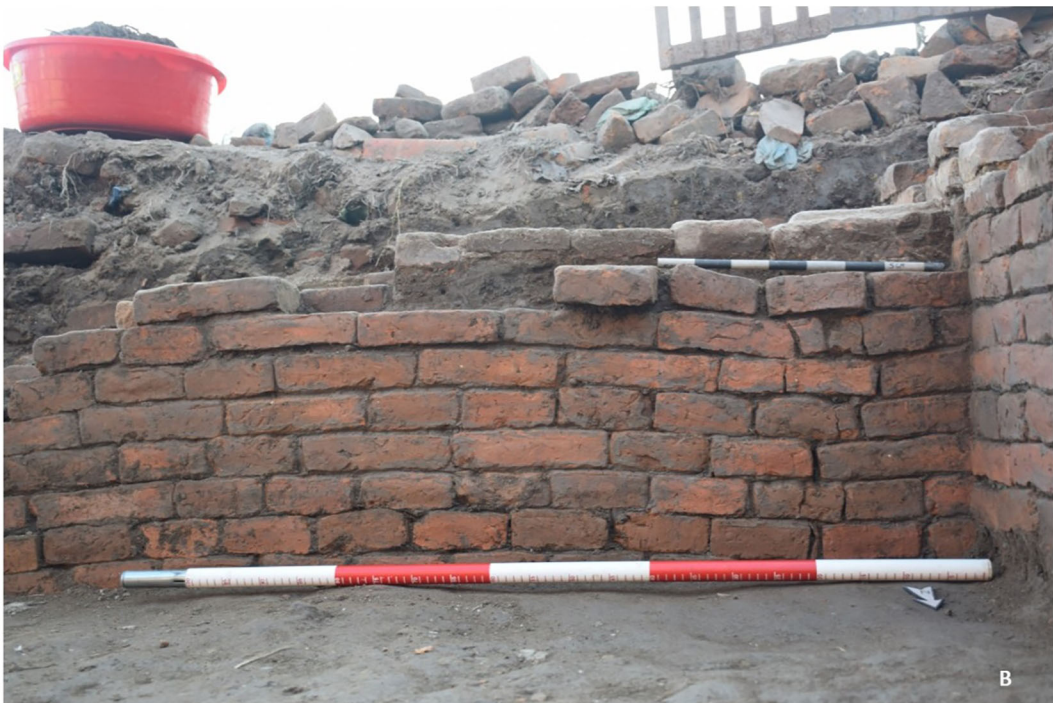
Fig. 10 Vertical cracks identified below a double saddle stone in the foundations of the Kasthamandap (a) and below a saddle stone in the foundations of the Gurujyu Sattal, Pashupati (b)

It would appear that the use of mud mortars within the foundations allowed for flexibility of the monument during seismic events. The only damage that could be linked to earthquakes was the identification of short vertical cracks located below a double saddle stone on the western length of the main foundation of the structure. Limited to the upper courses, it indicates stress of the load of the saddle stone and its interlinked superstructure, primarily induced by the pressure of vertical movement during a seismic event, causing the foundation below to be damaged (Coningham et al. 2018: 171; Fig. 10a). This also indicates that potential areas of stress and damage were minimised and localised, rather than causing catastrophic failures. It is likely that such a design with mud mortar brick masonry foundations linked to saddle stones and the superstructure above was designed to save the structure from further seismic stress, limiting damage to a few specific locations. Similar damage patterns and deformation of brickwork were also identified during excavations at the Gurujyu Sattal

at Pashupati (Fig. 10b). Again, the load of the timbers placed within the saddle stones, which were bonded by mud mortar to the brick foundations, caused small concentrated areas of vertical cracks below.
