Monumental articulated ancient Greek and Roman columns and temples and earthquakes: archaeological, historical, and engineering approaches

Stathis C. Stiros

Abstract Structural analyses indicate that monumental articulated ancient Greek and Roman (MAGR) columns and temples have a very particular seismic response, differing from rigid structures (made with mortar); tall columns in particular, have an excellent seismic performance, favoring anthropogenic effects as causes of their destruction. Archeoseismological studies, on the other hand, provide evidence of seismic damage in MAGR structures. To investigate this apparent conflict, we analyzed the conditions and limitations of structural models, as well as historical and archeological evidence of response of such structures to natural and anthropogenic effects. In addition, we examined two groups of MAGR structures: first, structures damaged or destroyed by known causes, including earthquakes and wind; second, structures damaged by unknown causes, based on comparative damage analyses with emphasis on geotechnical (soil dynamics) effects. This analysis indicates that

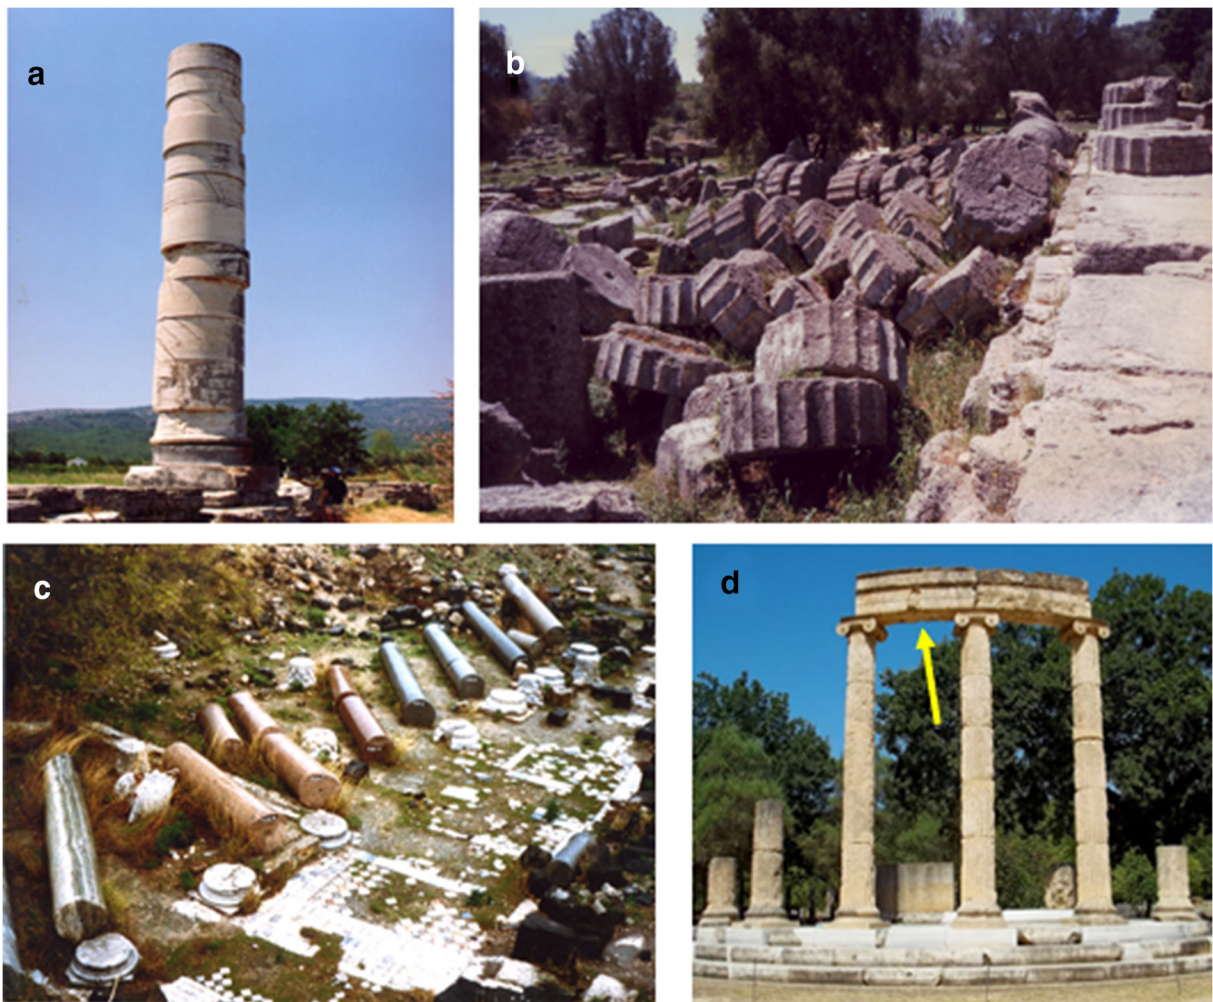
Fig. 2 Damage and repairs in ancient columns. **a** Offsets in drums in the Hera Temple, Samos Island, Greece. **b** Temple of Zeus, Olympia, drums of columns collapsed in a domino-type pattern. This collapse in Later Antiquity postdates a repair of the temple probably in the second century BC. **c** A well-known case of oriented collapse of columns in the internal part of a basilica at

Susita, Galilee, not corresponding to a MAGR structure. Photo by A. Nur, reproduced from the original of the cover of a book with an article of Nur and Ron (1996). **d** Philippeion Temple, Olympia. A notch for metal clamp (marked with arrow) indicates a beam in second use, and restoration in ancient times, possibly after a damaging earthquake

Of course, there were exceptions, and reasonable arguments for earthquake occurrence were presented. Concerning ancient columns, Dinsmoor (1941a) assigned dislocations among column drums (such as of Fig. 2d) to seismic effects. In particular, he observed repairs in certain drums for the temple of Zeus at Olympia, long before its final collapse several centuries later (Fig. 2b). His suggestion was that these repairs became necessary because seismic dislocations among drums produced disfiguration of a part of the temple and led to dismantling and restoration of a part of the temple, probably in the second century BC. Similar repairs are clearly observed in other nearby temples in antiquity, for example in the circular Philippeion temple (Fig. 2d). Offsets (sliding) along column drums in the Hephaesteion (Theseion) Temple in Athens, one of the most well-preserved ancient Greek temples, have also been regarded as signs of rocking during strong earthquakes (Fig. 3d) and as evidence that Athens, assumed till then as earthquake free, had been shaken in the past by strong earthquakes (Galanopoulos 1956).

In some cases, column damage or failure in isolated structures is observed (for example, sliding of drums of an isolated column as in the Heraion Temple, Samos (Fig. 2a) or displaced drums in columns of the Poseidon

1989), and lead to transient and permanent offsets such as those of Figs. 2a and 3d and occasionally fracturing of the drums (cf. Pecchioli et al. 2018).

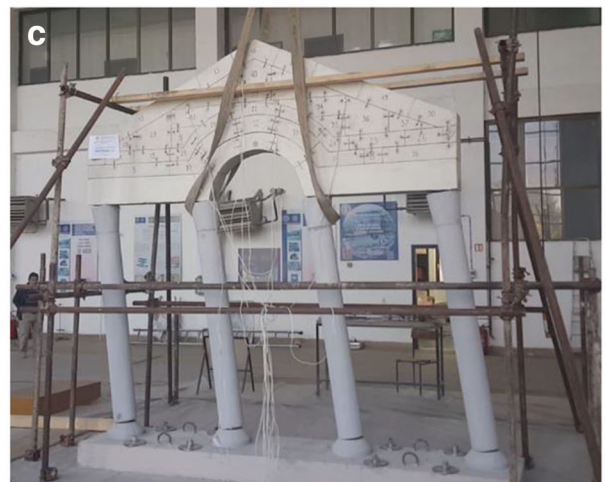
Fig. 6 Predicted characteristic patterns of column collapse in response to earthquakes: **a** domino-type arrangement of drums (computational model, redrafted after Sarhosis et al. 2019) Fig.

18); **b** oriented collapse of columns (computational model, after Hinzen 2009/2010), Fig 14); (c): set of columns just before oriented collapse (experimental, after Nikolić et al 2019).

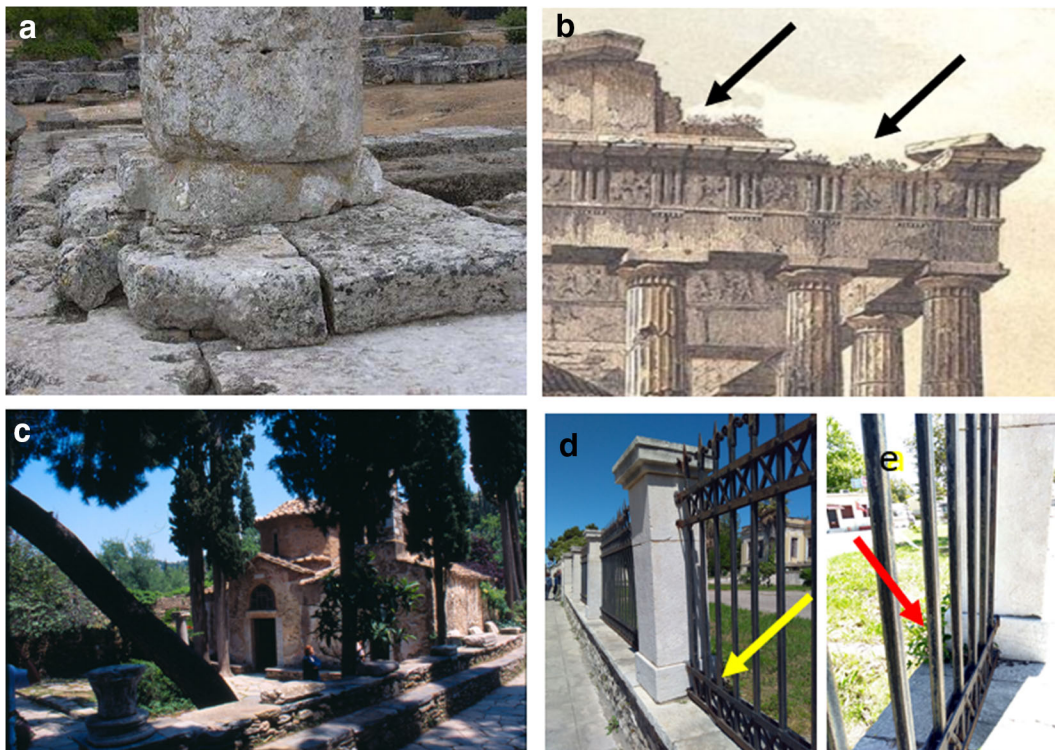
Fig. 10 Effects of plants in the structural stability of ancient monuments. **a** Poor condition of the base of one of the three surviving columns of the Nemea Temple, assigned to root action before the excavation of the lower part of the column (Hill 1966) or to unsuccessful efforts at undermining the column (Miller 1986) (after Makris and Psychogios 2004 and Miller 1986). **b** Plants in the superstructure of the east façade of Hephaisteion Temple in

1882, enlarged top right part of Fig. 3 a. **c** The roots of an inclined pine tree represented a threat for the eleventh-century church of the Kaisariani Monastery in Athens. **d, e** Marble block tilted because of intrusion of roots of a fig tree in the fence wall of the nineteenth-century hospital of Mesolongi, Greece. If these roots were removed, tilting might have been misinterpreted as a seismic effect

discontinuities (cemented breccia, joints, and fractures) with obvious implications in the static and dynamic stability of the columns (Fig. 10a).

then tend to expand them. This affects both superstructure and especially foundations (or parts during burial; cf. Hill 1966). Penrose (1897) mentions plants at the upper parts of Parthenon, while the engraving of 1882 in Fig. 10 b shows plants also at the upper part of Hephaisteion. Tensile stresses or torsion by root plants may have contributed in the decay of various structures, as exemplified in Fig. 10 d and e. Such plant-induced deformations (block tilting, extrusion, etc.) are frequently misinterpreted as indicators of earthquakes.
