# Changes in the riparian zone of the lower Eygues River, France, since 1830

G. Mathias Kondolf · Hervé Piégay ·  
Norbert Landon

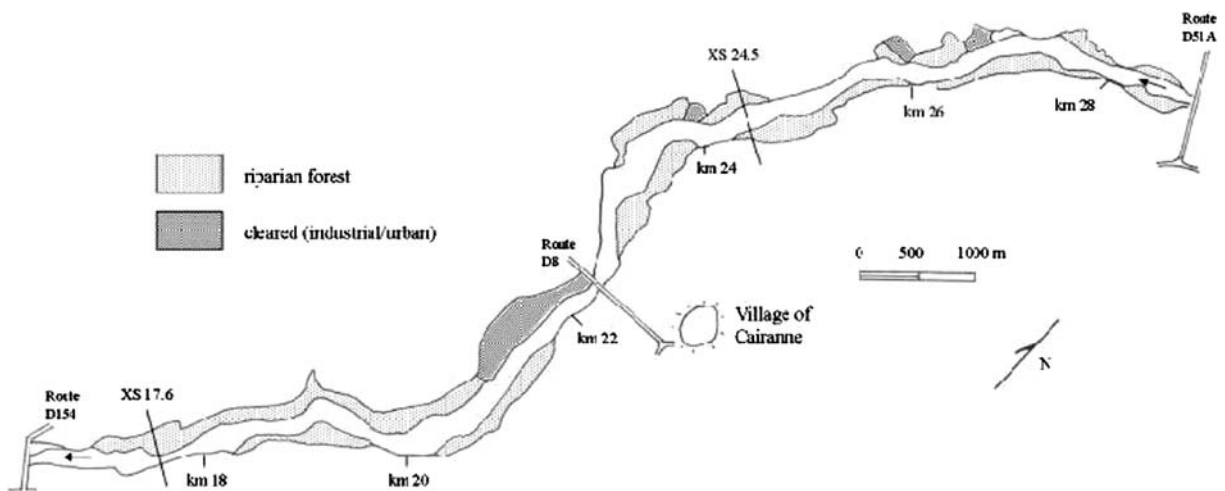
**Fig. 2** Map of riparian forest along the Lower Eygues River from km 16.4 to 28.8, drawn from 1996 aerial photographs at 1:25 000 scale (source of photos: Institut Géographique National, Paris)

The riparian forest in 1996 was not continuous, but flanked well over half the banks, and would be more extensive but for areas cleared for agricultural, industrial, and urban uses (Fig. 2). The vegetation surveys along the cross sections (Fig. 3), supported by analysis of the aerial photographs, show that the riparian corridor is characterized by two principal vegetation associations: a poplar (*Populus nigra* and *P. alba*)-dominated unit, and an alder (*Alnus glutinosa*)-dominated unit. The poplar unit colonizes gravel bars, which characterize most of the surface abandoned by the formerly active channels. Its early successional stands consist of poplars mixed with shrubby willows (*Salix alba*) mainly. In later successional stands, an understory of ash (*Fraxinus angustifolia*), elm (*Ulmus minor*), and young oaks (*Quercus pubescens* and *Quercus ilex*) occurs. Robinia, or black locust (*Robinia pseudoacacia*), an invasive species occurs in some recently-harvested units. By the time the poplar units are 20 years old, they present an extremely dense understory, which may include dogwood (*Cornus sanguinea*), hazel (*Corylus avellana*), and hawthorn (*Crataegus monogyna*).

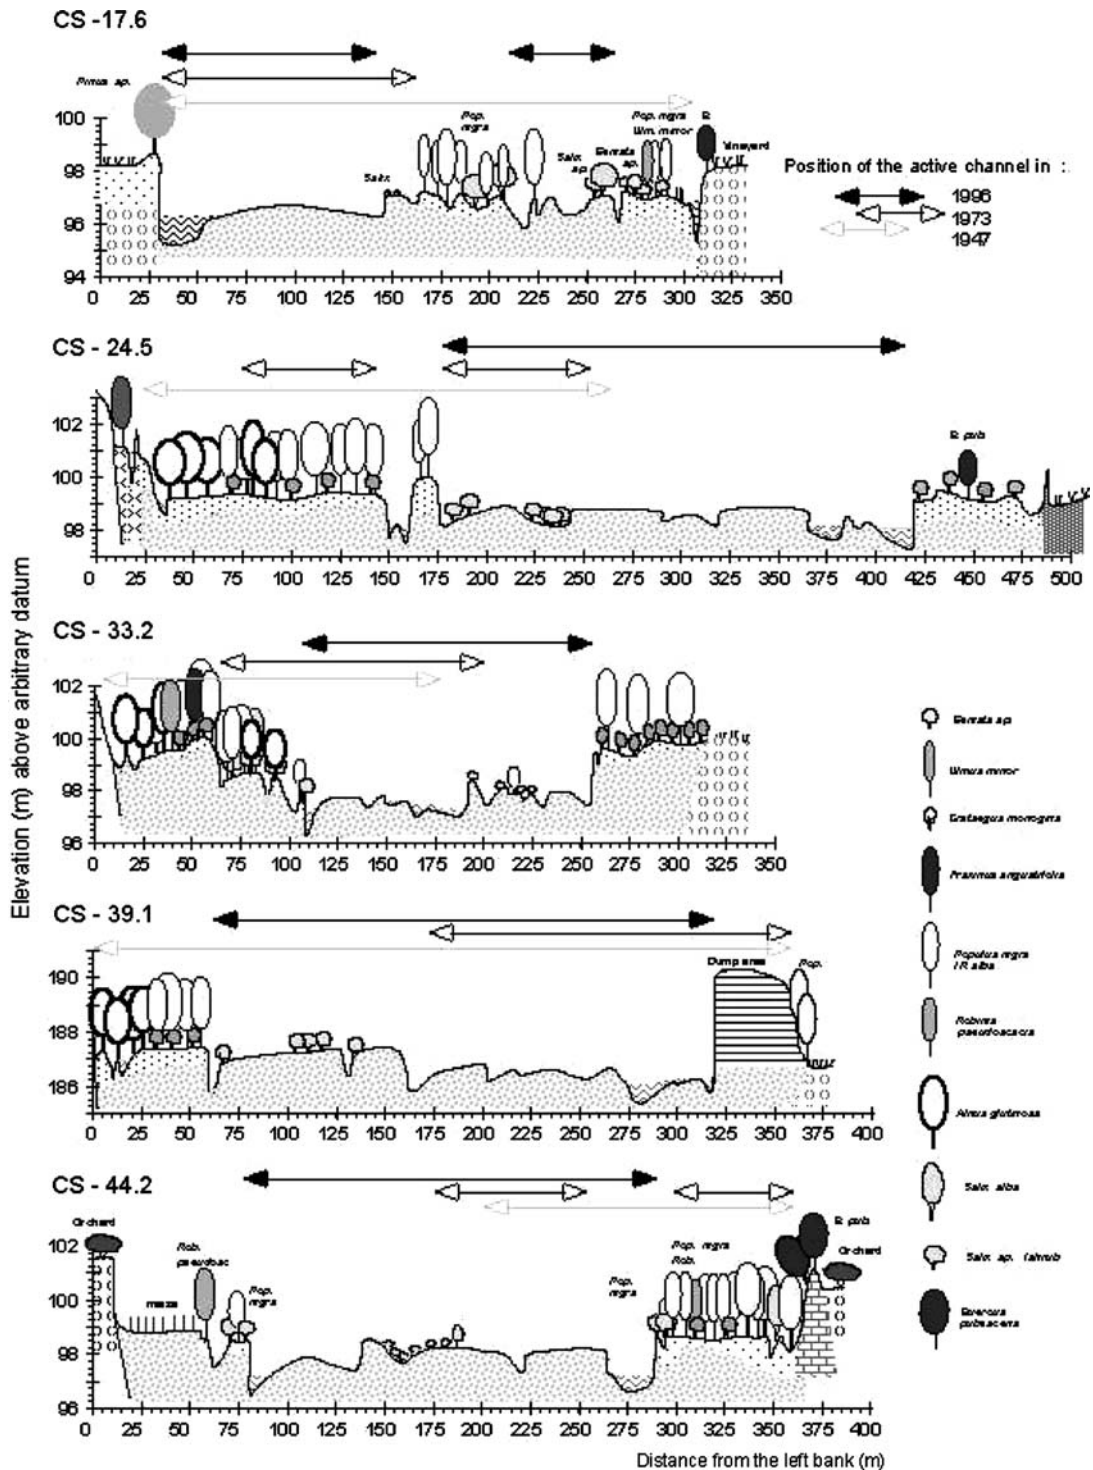
**Fig. 3** Cross sections showing the present alluvial forest mosaic in relation to channel and floodplain topography, from 1998 field surveys. Cross section designations are based on distance upstream from the Rhône confluence,

i.e., CS 17.6 is 17.6 km upstream of the Rhône. Elevations are above arbitrary data at each site. Flow at time of field survey in June 1998 was approximately  $0.3 \text{ m}^3 \text{ s}^{-1}$ , a typical summer baseflow

On levees and areas devegetated for human use, oaks occur. Where the terraces have been cleared of vegetation for human use and then abandoned, the cleared surfaces are not colonized by poplars or other pioneer species, as these cannot establish on these now-xeric surfaces above the incised channel. Rather, they tend to be vegetated by an assemblage of plants that is more open, and which contains more xerophytic and thermophylic plants. Holm oak (*Quercus ilex*), broom (*Ginesta spp.*), and argousier (*Hypophae ramnoïdes*) occur with mature individuals of the understory species such as hedge (*Ligustrum vulgare*), and dogwood, as illustrated on the right bank of CS 24.5 (Fig. 3).

Cross section surveys (Fig. 3) showed that in three of the five cases, the current channel is 1–4 m below the level of the 1830 channel (now

preserved as terrace), but in CS 24.5 and CS 39.1, little or no incision was apparent. Along the right bank of CS 39.1, a former dump now functions as a dyke, constraining the channel. There is a wide variation when comparing the current channel width with past channel widths (shown in Fig. 3 by arrows) measured from aerial photographs.

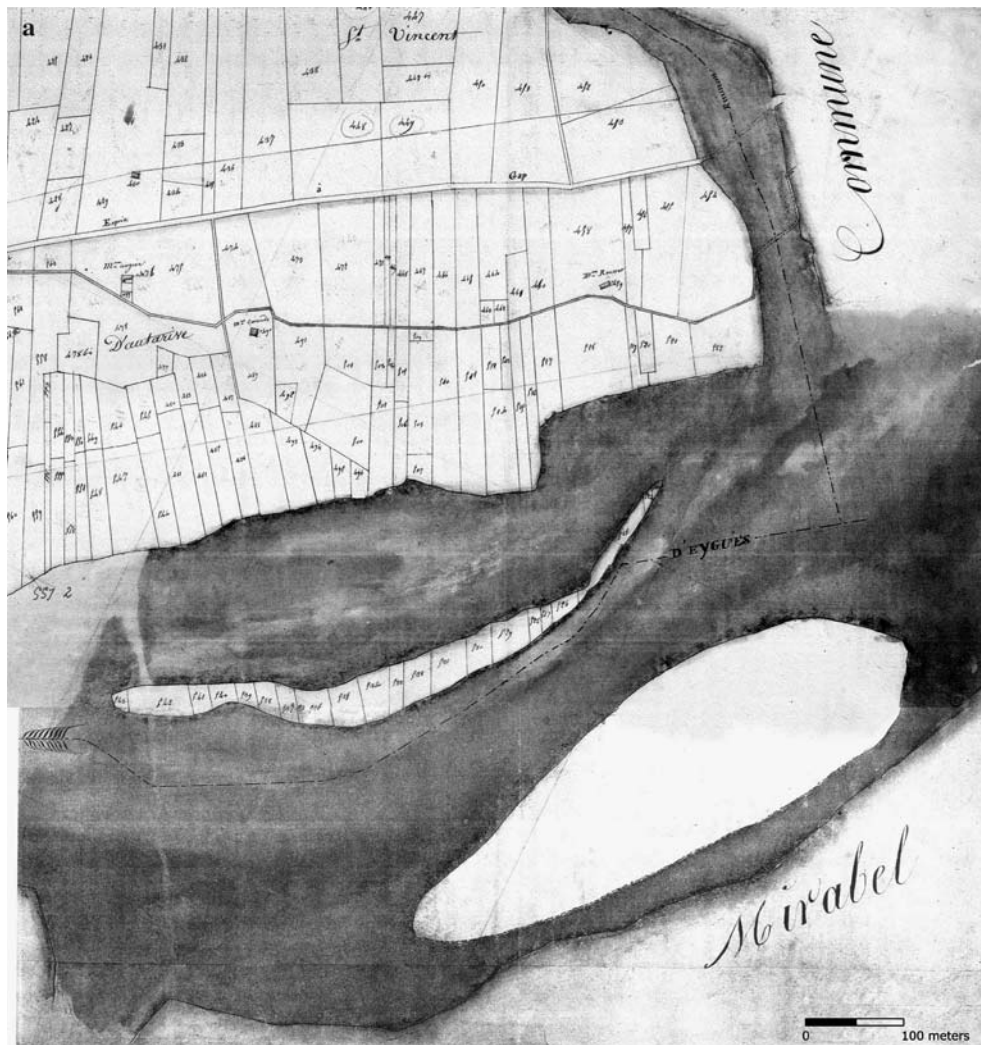
**Fig. 4** Cadastral maps of the Eygues River (a) in the Commune of Vinsobres, 5 km downstream of Nyons at km 43, showing individual parcels, for each of which land use was recorded (1830); (b) land-use types by parcel superimposed on screened version of the Vinsobres map

(Source: Archives Départementales de la Drôme); (c) cadastral map of the commune of Saint Roman de Mallegarde (1828), showing area of newly reclaimed river bed used to grow willows, termed “new oeserie”

parcels resulting from the division of land equally amongst all the children in a family. An example of the cadastral maps in the Commune of Vinsobres (Fig. 4) illustrates the complexity of land ownership and intensive land use. Summarizing over the entire study reach, the most common land use in parcels adjacent to the channel was *oseraie* (the term used in the Drôme, or from approximately km 25 upstream), or *hermes* (the term used downstream, in the Vaucluse) (Fig. 5). These units evidently contained willow stands

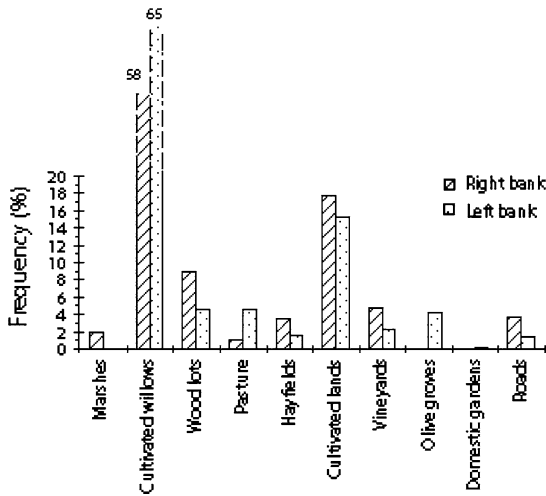
**Fig. 5** Percentage of different land use in parcels adjacent to the river channel as shown on Napoleanean cadastral maps 1824–1830

*oseraie*” (Fig. 4C). The next most common land use was plowed land or row crops, which often extended right down to the low-flow channel margins, which suggests pressure for arable land was enormous by the then-large rural population. Less common land uses adjacent to the low flow channel included (in order of importance) woodlots cut frequently, to leave only small trees, pasture, hayfields, vineyards, olive trees, roads, marsh, and domestic gardens (Fig. 5).

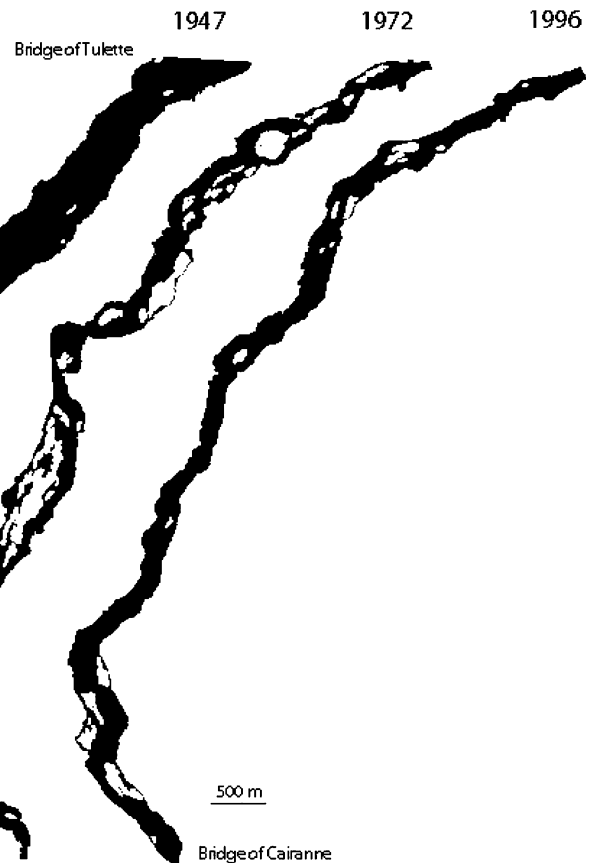
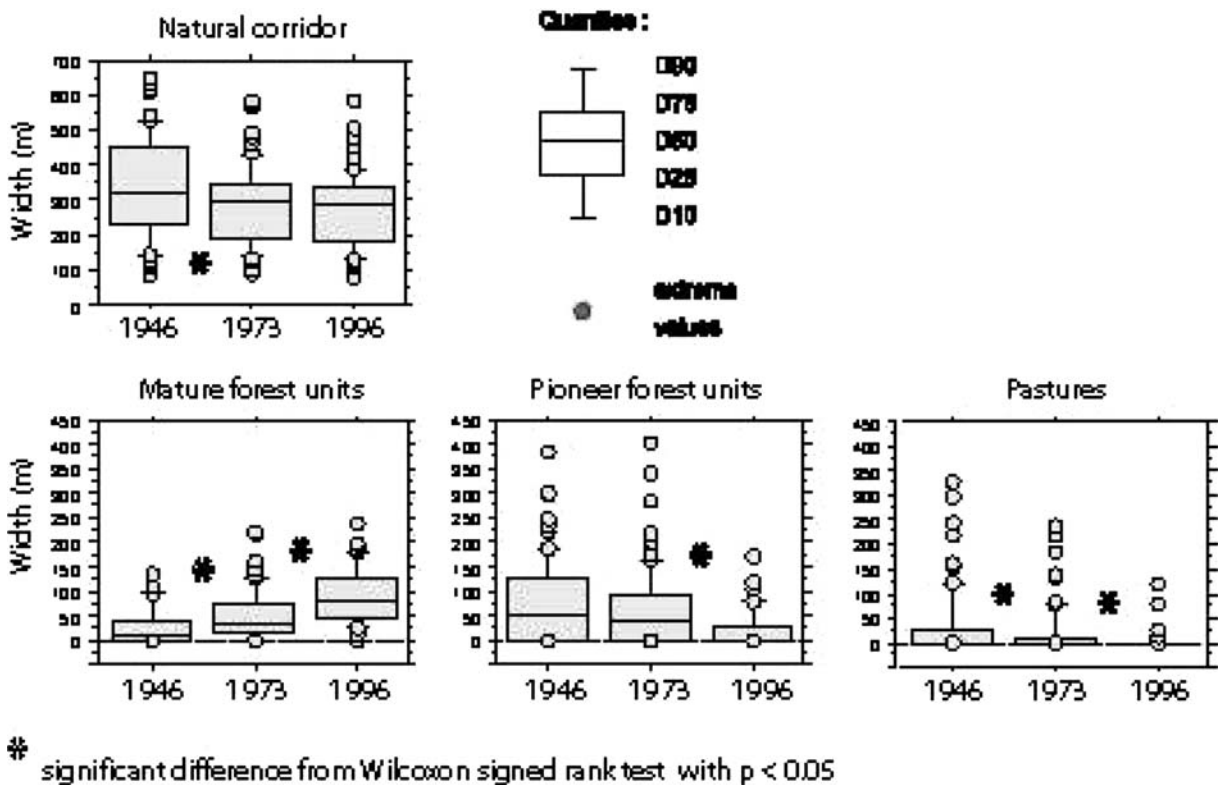
**Fig. 6** Extent of unvegetated active channel of the Eygues River from Cairanne (km 22.4) to Tulette (km 29) mapped from aerial photographs of 1947, 1972, and 1996

**Fig. 7** Distribution of the width of the different vegetative units in the valley corridor on aerial photographs of 1947, 1972, and 1996 ( $n = 67$ )

The extent of unvegetated active channel decreased as vegetation established, as illustrated in maps of active channel from Tulette to Cairanne (as visible on aerial photographs from

1947 to 1972 to 1996) (Fig. 6). The width of different vegetative units along the cross sections changed substantially (Fig. 7). In 1947, the cross sections were dominated by pioneer (early successional stage) vegetation (median width = 76.9 m), with pasture (maintained by grazing animals) important in some reaches (median width = 34.5 m). While the combined total area occupied by both pioneer and mature patches was roughly constant (345 ha in 1947 vs. 356 ha in 1996), many of the 1947 pioneer units had been replaced by mature forest in 1996. Open pasture vegetation was also lost to colonization by trees. In sum, the floodplain corridor changed from

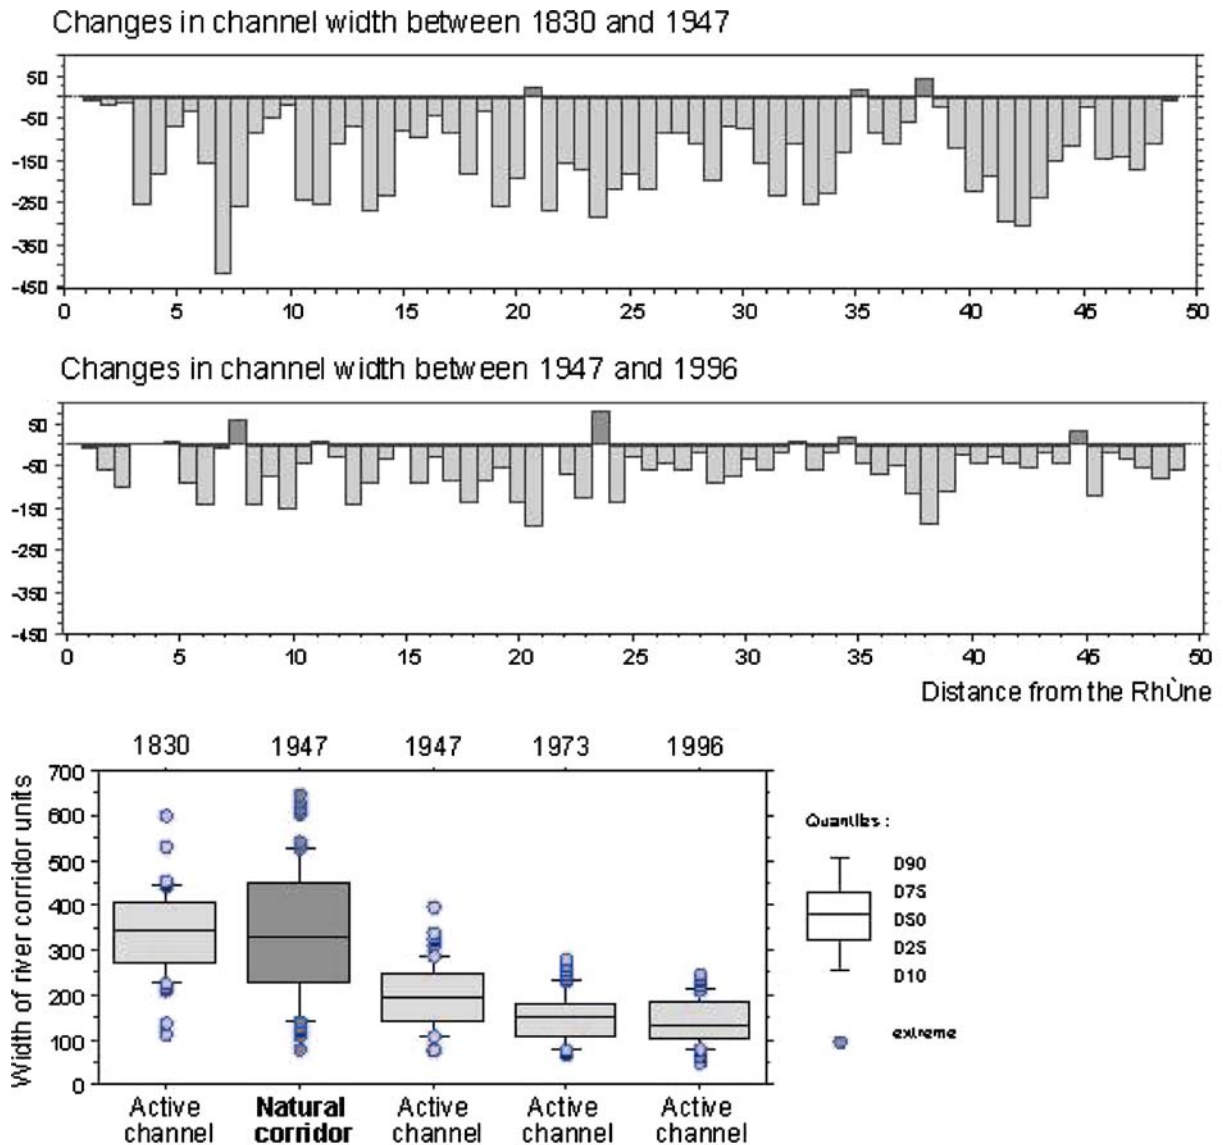
**Fig. 10** Evolution of channel width in the Eygues River downstream of Nyons. (a) Changes in channel width from 1830 to 1996, (b) Changes in channel width from 1947 to 1996, (c) Distribution of channel width per 500 m length

segments in 1830, 1947, 1972 and 1996 and of natural corridor (channel and uncultivated riparian zone) in 1947, based on analysis of aerial photographs

Active channel width, as measured at 500-m intervals, narrowed from 1830 to 1947 in nearly all sections, and continued to narrow from 1947 to 1996 (Fig. 10). The median width of the active, unvegetated channel (from Nyons downstream) was 340 m in 1830, 200 m in 1947, 152 in 1972, and 139 m in 1996. When we add the 1947 transect widths occupied by pasture, pioneer and mature forest units to the active channel width, the combined natural corridor width is 338 m, roughly equivalent to the 1830 active channel width.
