# Damage from the Great East Japan Earthquake and Tsunami - A quick report

**Abstract** The Tohoku region, Northeast Japan, was hit by a gigantic earthquake which occurred in the Pacific close to Tohoku, and subsequently by a giant tsunami. These hazards have caused huge damage on the eastern coast Japan. The earthquake's magnitude was 9.0, the strongest ever recorded in Japan. The tsunami was also historical as its run-up height reached over 39 m. As of early May, 2011, over 24 thousand people were reported as dead or missing. Moreover, serious accidents at the Fukushima Nuclear Power Plants No.1 were caused by the effects of the tsunami. Therefore, the damage faced by Japanese people can be seen as a giant composite disaster. Although Japan, and the northeast of Japan in particular, has over a long time period increased its preparedness against earthquakes and tsunamis, huge damage still occurred. This paper considers why this tragedy occurred, and what unrecognized factors contributed to the high vulnerability of the area. To assist in answering such questions, this paper presents a timely report of the features of the earthquake and tsunami, the damage they caused, and the ear

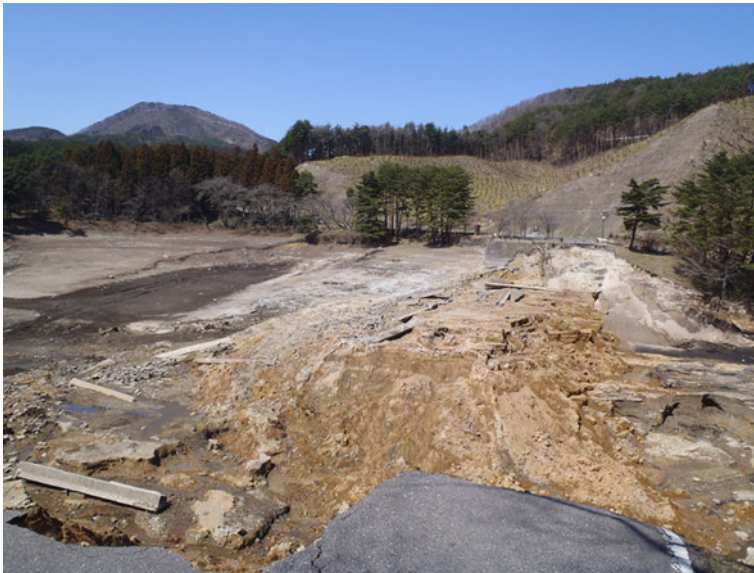
**Fig. 4** Burst dam (Fujinuma reservoir)

As a result of such motions, many impacts occurred on artificially reclaimed lands, soft alluvial plains, and fragile slopes. These are common land features in Japan. Land slides also created strong damage, because the sediment mass has large weight, and hence apply stronger impulse forces to buildings and other features. For example, in Sukagawa-city, Fukushima Prefecture, a 18.1 m high earth dam was broken, causing eight deaths and missing people (Fig. 4). Another landslide and debris flow occurred in Shirakawa-city and Nasukarasuyama-city killing 13 people, and with two people still missing.

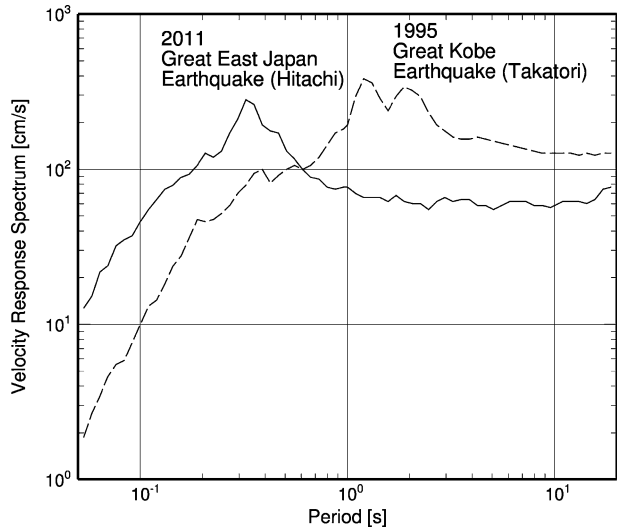
Building damage is closely related to the frequency responses. The frequency of the ground motion is higher than that of 1995 Great Kobe Earthquake, as shown in Fig. 5. This results in smaller effects on the structure of buildings. Therefore, the destroyed houses and buildings in the coastal areas were mainly due to the tsunami. However, in Ibaraki Prefecture, at the southern end of the damaged region, there were completely or half collapsed houses in inland areas. They were not damaged by the tsunami, but by the earthquake and resulting foundation failure.

**Fig. 5** Frequency characteristics of velocity response spectrum (Revised from Earthquake Research Institute (2011))

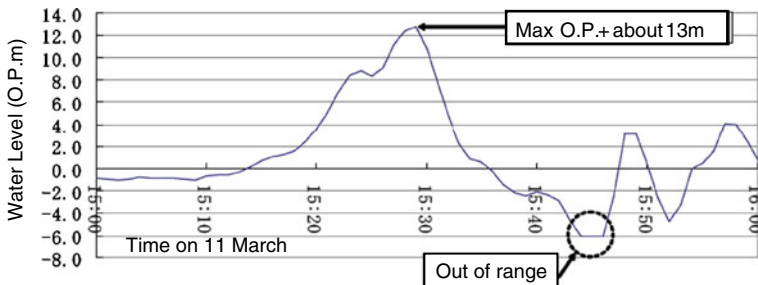
**Fig. 7** Tsunami wave profile observed at Onagawa coast, Miyagi Prefecture. Note: O.P. is the datum at Onahama Port, Fukushima Prefecture. (Revised from Tohoku Electric Power Co. (2011))

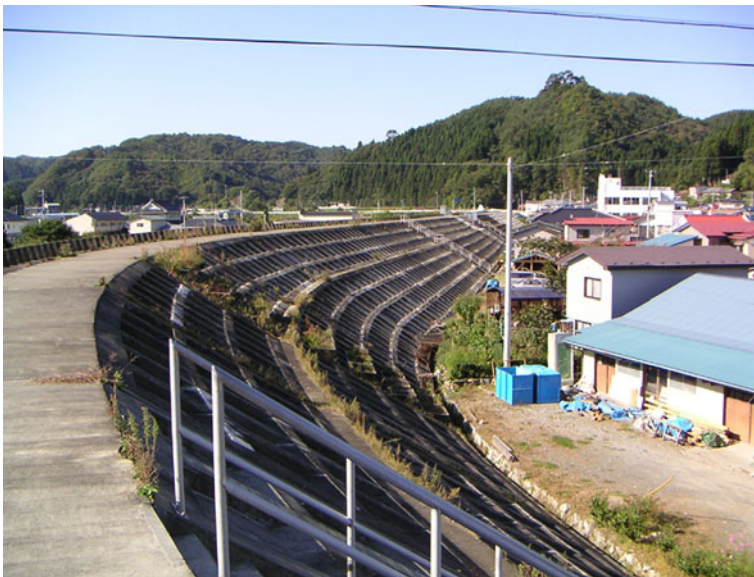
Taro district, in Miyako City, was surrounded by high coastal dykes called “Great Walls”. They were 10 m high and 10 km in total length (Fig. 8). Taro experienced a tragedy after being hit by a 10 m tsunami which killed over 900 people in 1933. They started to build the coastal dykes the following year. In 1958 a 10 m dyke system with a length of 1.4 km was completed. It worked very well in the occasion of the Chilean Tsunami in 1960, with no casualties. In 1979 the dyke system was partially upgraded to a great wall with a two-track structure. After that it continued to be effective.

**Fig. 8** Ten meter high coastal dykes in Taro, Miyako City (Before the tsunami; Ministry of Land, Infrastructure, Transport and Tourism)

The recent Great East Japan Tsunami flew over these structures, attacking cities and causing huge casualties. The bay-mouth breakwaters were destroyed in Kamaishi and Ofunato. The great coastal dykes in Taro could not prevent overflows and were destroyed as well. Some people claimed that the structures had no effect, and that disaster prevention education should be more effective. However, evidence from videos, photos and witnesses confirms that the coastal structures reduced the damage to some extent. Thus the role of coastal structures remains a controversial issue. However, it is true that the structures played a preventive role against past tsunamis which had heights lower than their design heights. Therefore, the role and effectiveness of structures when the tsunami is higher than the design criterion is a matter for further study.

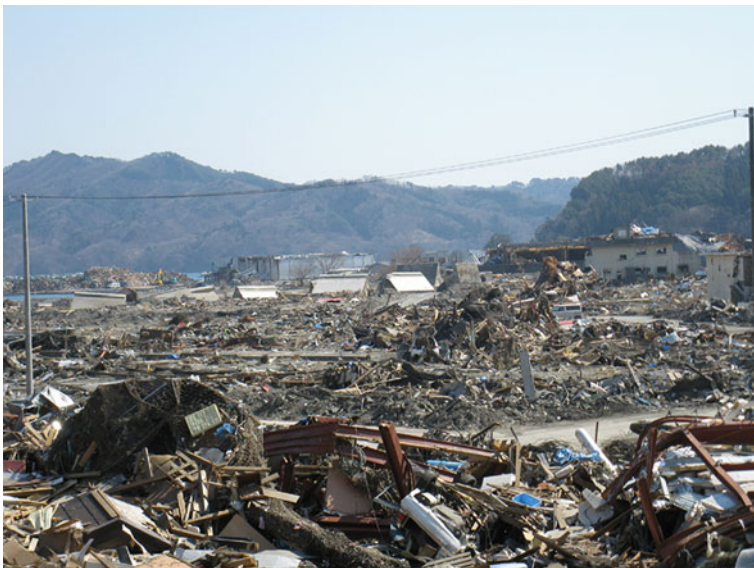
**Fig. 9** Damages in Otsuchi (Photo: So Kazama, 5th April)
