## Damage to residential buildings due to flooding of New Orleans after hurricane Katrina

Aimilia K. Pistrika · Sebastiaan N. Jonkman

**Abstract** This article analyzes the direct damage to residential buildings caused by the flooding of New Orleans after hurricane Katrina in the year 2005. A public dataset has been analyzed that contains information on the economic damage levels for approximately 95,000 residential buildings in the flooded area. The relationship between the flood characteristics and economic damage to residential buildings has been investigated. Results of hydrodynamic flood simulations have been used that give insight in water depths and flow velocities in the study area. In general, differences between the three polders in the observed distributions of damage estimates are related to differences in flood conditions. The highest damage percentages and structural damage mainly occurred in areas where higher flow velocities occurred, especially near the breaches in the Lower 9th Ward neighborhood. Further statistical analysis indicated that there is not any strong one-to-one relationship between the damage percentage and the water depth or the depth–velocity prod

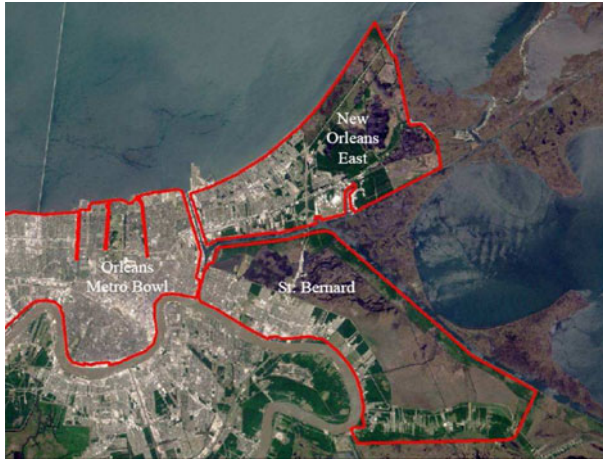
**Fig. 3** The three bowls that comprise Greater New Orleans (Kok et al. 2007)

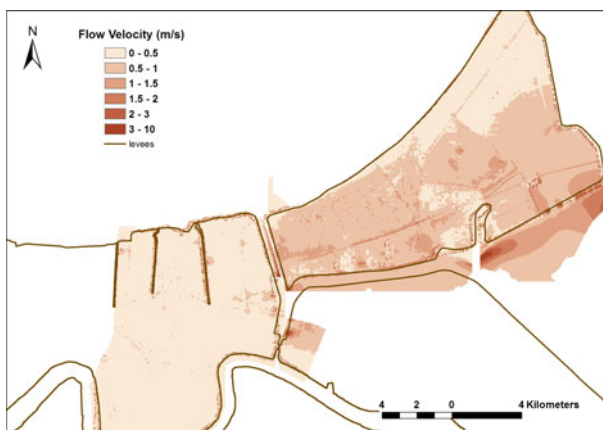
**Fig. 5** Maximum flow velocity values as resulted from the simulation

The simulations show that the most severe flooding conditions occurred in the Lower 9th Ward neighborhood of the St. Bernard polder. Depths in Lower 9th reached 4–5 m in the deepest parts and high flow velocities (3–10 m/s) were found in the simulations near the two breaches of the levees. In the Central polder, the flow velocities were high (1–2 m/s) only very near the breaches, and the water depths were relatively large (>3 m) only in some locations, especially in the northern part of the polder. Finally, we observed that the New Orleans East polder suffered large water depths (>4 m) that covered gradually most of the area of the polder. However, maximum flow velocities in this area were lower than those in the Lower 9th Ward.

In the Central polder, the highest values of flood depth were observed in the northern part of the polder, and the highest values of flow velocity were calculated only to the areas immediately behind of the breaches in the levees. The damage levels here varied largely, and the majority of damage values were lower than 50%. A relatively large number of houses with a low damage percentage (<10%) was found in this area. The relatively high standard deviation in the Central polder is expected to be related to the wide range of flooding conditions (see Figs. 4, 5) and the variation in the building types.

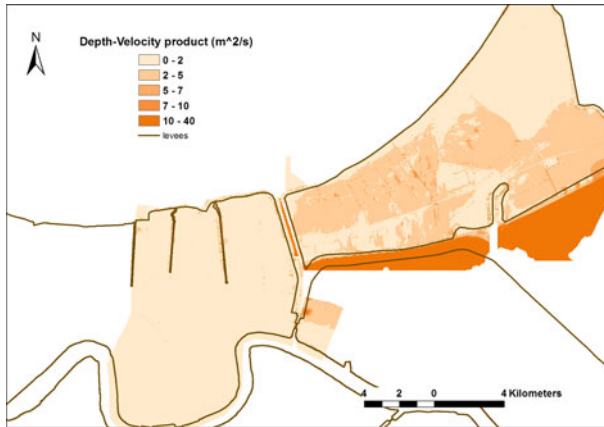
**Fig. 6** Product of maximum values of depth and velocity as resulted from the simulation

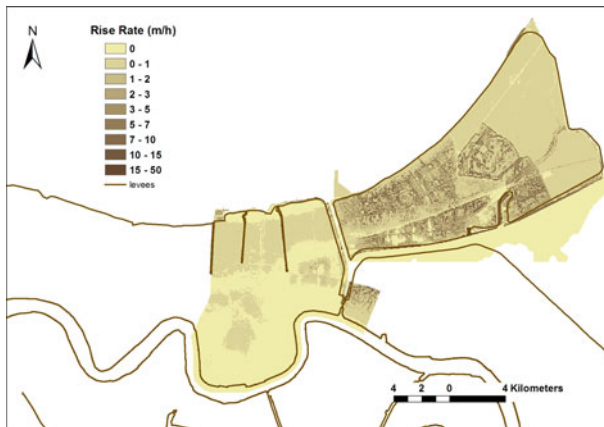
**Fig. 7** Maximum rise rate values over the first 1.5 m as resulted from the simulation

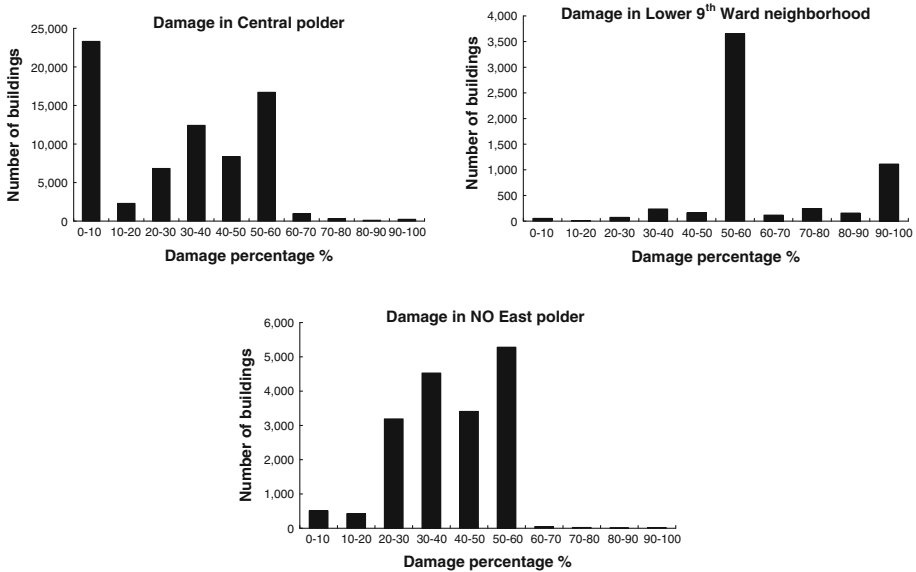
As of March 2nd 2006, city officials and FEMA contractors had completed almost 95,000 residential damage assessments. Table 1 and Fig. 9 summarize the properties of the dataset. The average damage rating is 43.3%, and approximately 27.6% of the units received a damage rating higher than 50% indicating some level of structural damage.

**Fig. 9** Histograms of damage levels for each of the three polders in New Orleans. (Note: the vertical scales of the three pictures differ)

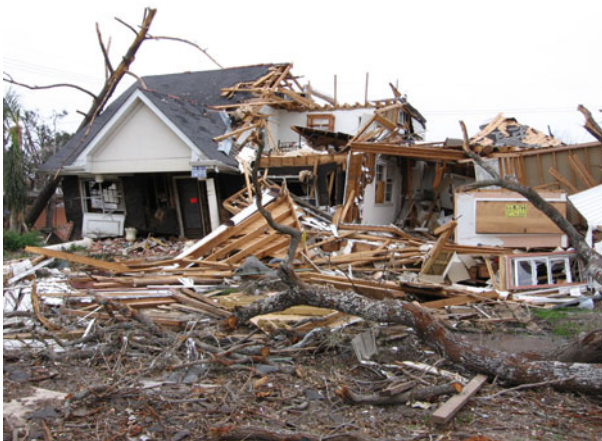
According to MAT (FEMA 2006), severe structural building damage or total failure in the Central Polder was restricted mostly to residential buildings immediately behind levees breaches, such as 17th Street Canal levee breach. Figure 10 shows an example of observed damage in that area. MAT reported that these buildings suffered failure of load-bearing walls and extensive scour around slab foundations from large hydrodynamic forces generated by the breach. For other parts of Central polder and also for the New Orleans East polder, widespread non-structural damage was considered as the typical damage pattern to residential buildings. MAT gave two primary reasons for this observation. First, the flooding in most of the areas of New Orleans was characterized by slow-moving floodwaters which greatly reduced or eliminated the damaging effects of hydrodynamic forces and flood borne debris impacts on buildings. Second, the crawl-spaces, garage bay doors, and other openings allowed hydrostatic pressures on walls and floors from floodwaters to equalize as floodwaters gradually rose and receded, which greatly reduced the net hydrostatic force on load-bearing walls, floors, and other structural elements.

**Fig. 10** Structural damage to a residential building located in the Central polder near the 17th Street Canal breach

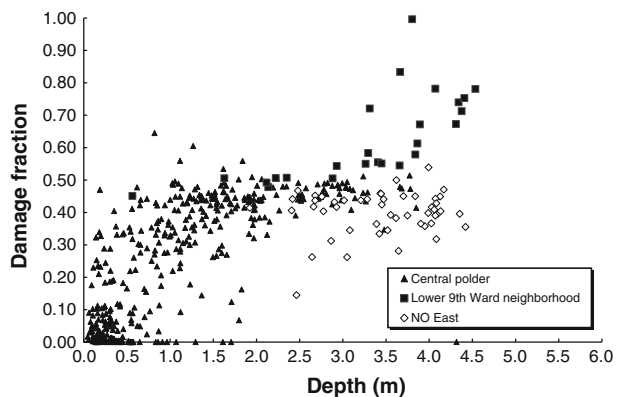
Figure 11 shows the relationship between water depth and damage estimates, both averaged over block groups for all the three polders. There are two primary observations. First, there is a cluster of damage estimates in Central polder that is characterized by water depth values less than 0.5 m and damage values less than 10%. The occurrence of this cluster can likely be explained by two factors: (a) the typical type of residential building within the Central polder is a single-story building with some crawlspace under it, and these buildings are usually elevated a few decimeters above the ground (b) due to topography a large part of the Central polder had limited flood depths, especially along the edges of the flood zone (see also Fig. 4).

**Fig. 11** Relationship between depth and economic damage estimates over block groups

A second observation for the scatter plots of Fig. 11 is that a large part of the damage estimates was rated equal or below the 51% threshold value of substantial damage with the exception of the damage estimates in Lower 9th Ward area. Most of the damage estimates for the Lower 9th Ward are rated over 50% value, although the flood depth was similar to the depth in New Orleans East. This observation leads to the expectation that flood depth alone can not cause substantial damage unless high values of velocity are also involved.

Several statistical distributions have been examined to provide a best fit function for the dataset, but, even for the best fitting functions (exponential and power fits), the squared correlation coefficient ( $R^2$ ) remained below a value of 0.5.

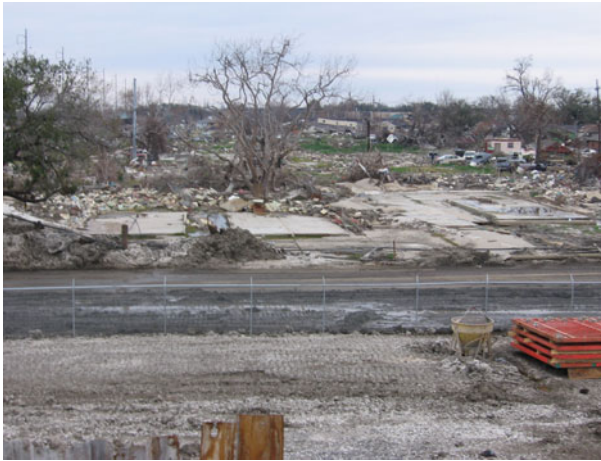
Figure 13 shows a typical scene from near the southern breach in the levees along the Industrial Canal. The photo was taken from the levee, and the view is in the eastern direction. It shows that many buildings near the breach were totally destroyed, and this is consistent with the damage estimates in Fig. 12 that show values near a 100% for this zone.

**Fig. 13** Lower 9th Ward; view in the eastern direction from the levee at the location of the southern breach in the levees (February 20, 2006)

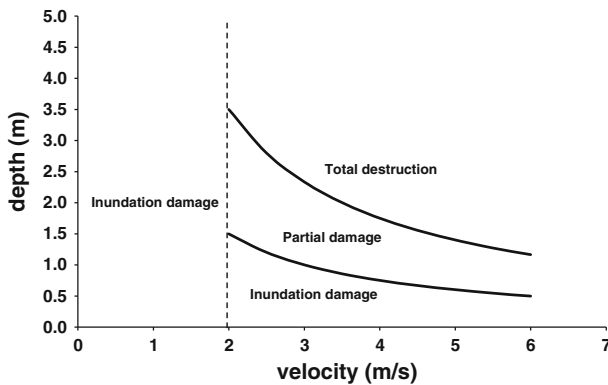
Dale Dyke catastrophe (Clausen 1989). Three damage levels were distinguished: inundation damage, partial damage, and total destruction. These categories were defined in qualitative terms and described which level of structural damage they represented. Because these damage levels are linked to flood characteristics (discussed later) they can be used to distinguish different flood hazard zones with different structural damage patterns. The following criteria were proposed (see also Fig. 14):

- $v < 2 \text{ m/s}$  or  $dv < 3 \text{ m}^2/\text{s}$  yields only “inundation damage”
- $v > 2 \text{ m/s}$  and  $3 \text{ m}^2/\text{s} < dv < 7 \text{ m}^2/\text{s}$  yields “partial damage”
- $v > 2 \text{ m/s}$  and  $dv > 7 \text{ m}^2/\text{s}$  yields “total destruction”

Fig. 14 Clausen structural damage criterion for brick and masonry buildings (Clausen 1989)

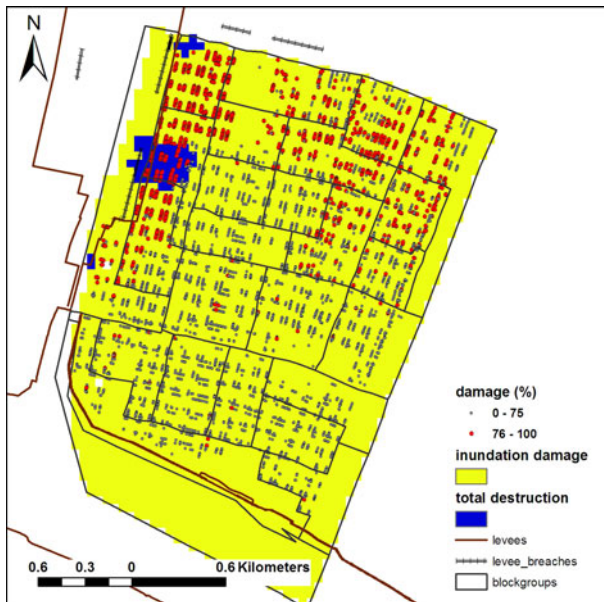
Clausen damage criterion has been applied to Lower 9th Ward neighborhood in an attempt to investigate whether the damage observations correspond to the predictions with Clausen criterion. The  $dv$  product values are shown in Fig. 15. The damage zones that follow from Clausen’s approach and the damage observations are shown in Fig. 16. It is found that the Clausen criterion, including the velocity and depth–velocity thresholds, did

**Fig. 16** Clausen's criteria applied to Lower 9th Ward neighborhood

not accurately predict the economic damage observations of Lower 9th Ward. In particular, the second damage category of “partial damage” is not present in the developed map because the velocity threshold of 2 m/s is only exceeded when the depth–velocity product is larger than 7 m<sup>2</sup>/s.

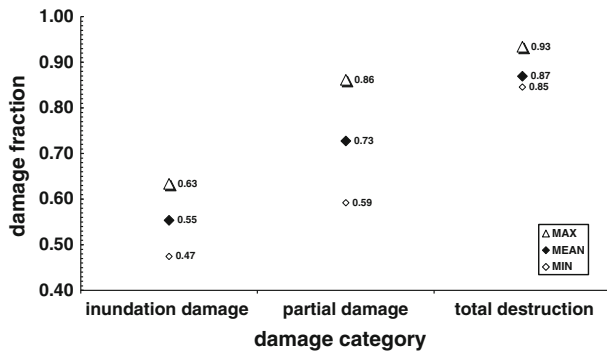
**Fig. 18** Damage value averaged over blocks for the three zones distinguished in the adjusted Clausen criterion

percentages for the three zones. The highest average damage value is found for the total destruction zone. This approach could be useful to determine the extent of flood damage and distinguish the main damage zones for an area affected by flooding due to breaching of flood defenses.

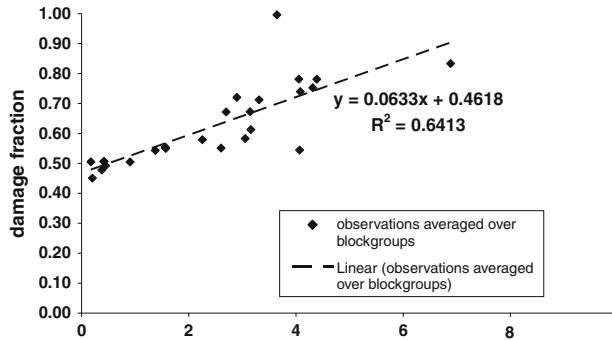
In this section, the relationship between the depth–velocity product and the damage percentage is further analyzed for the Lower 9th Ward neighborhood. Figure 19 shows the relationship between the damage percentage and the depth–velocity product at the block group level ( $R^2 = 0.64$ ). Analysis at the more detailed block level resulted in a similar relationship, but the value of the correlation coefficient was lower ( $R^2 = 0.35$ ).

The relationship in Fig. 19 is based on the product of depth and velocity and thus shows a linear trendline. However, other non-linear combinations of depth and velocity are possible and can be related to the damage level. Several types of statistical distributions

**Fig. 19** Relationship between depth–velocity product and economic damage estimates over block groups

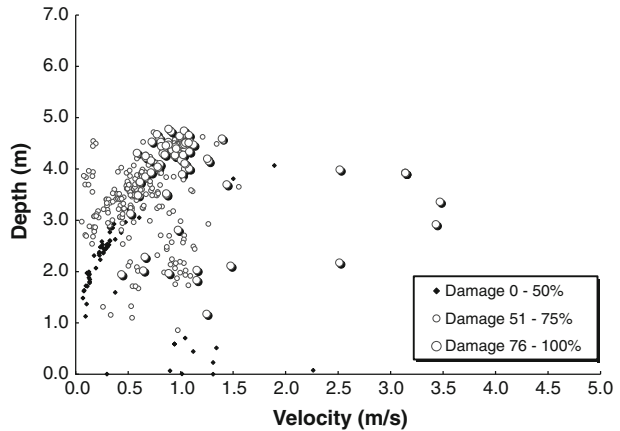
In order to visualize the effect of the combination of water depth and flow velocity on damage observations, the different damage categories (0–50, 51–75, 76–100%) are plotted as a function of depth and velocity in Fig. 20.

The figure shows that higher damage values are associated with high depth–velocity combinations. The graph includes the observations for the Lower 9th Ward neighborhood. If the observations for the Central polder would be added to the graph, most of them would be in the lower left side of the figure (i.e. in the area approximately bounded by the values  $d = 3$  m and  $v = 0.5$  m/s). Most of the block groups in the Central polder were characterized by depth values below 3 m and low velocities (see also Figs. 4, 5). As most of the observations for the Central polder had damage levels below 50% this corresponds to the observation from Fig. 20 for the smaller damage values (<50%). The figure shows that, although the main damage categories show some clustering, there is not a very strong or direct relationship between the flood characteristics and damage level.

**Fig. 20** Damage values for the Lower 9th Ward (averaged by block) as a function of water depth and flow velocity
