Natural hazards in the Ghaghara River area, Ganga Plain, India

Dhruv Sen Singh · Amit Awasthi

Abstract The Ganga Plain is one of the most densely populated regions of the world due to its fertile soil and availability of water. The rivers of this plain are the lifeline for millions of people of this vast alluvial plain. All rivers of this plain are characterized by narrow channel confined within wide valley. Continuously increasing pressure of population on this plain has led to the intensification of settlement even into the valley of the river. This unplanned expansion has enhanced the damage due to flooding during high-discharge period and lateral erosion during low-discharge period. Flooding and lateral erosion are identified as fluvial hazards in the Ghaghara River area. Extensive studies have been carried out on flooding, but not much attention has been paid to the phenomenon of lateral erosion. However, it has been observed that lateral erosion is an independent fluvial hazard that operates during low-discharge period. Low degree of compaction due to the presence of sandy and silty facies in the river valley deposits, mass movement, palaeo-current pattern, and fractures in

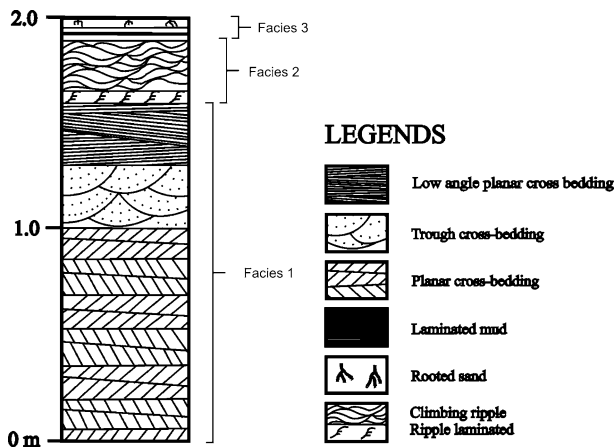
Fig. 2 Litholog showing facies of the channel bar deposits

and their association. The lithologs prepared provide information about the facies and substrate for sand-bar deposits (Fig. 2). Three major facies in the channel bar deposits and three in the river bank deposits have been identified.

Facies 1: sandy facies It is very common and present in the lower to middle part of the channel bar deposits. It consists of 0.20- to 2-m thick lensoid/tabular units, which are laterally persistent for several hundreds of metres. It occurs mostly in co-sets where thickness of individual unit varies from 10 to 20 cm. This unit shows sedimentary structures such as planar cross-bedding, trough cross-bedding, and ripple laminations. The azimuths of the planar cross-bedding were measured for palaeocurrent analysis.

Facies 2: silty and clayey facies This lithofacies is developed near the top of bar sequence. It is characterized by 5- to 20-cm thick climbing ripple lamination in silt and parallel laminations in silty clay with mud lenses. Climbing ripple lamination is produced by the migration of small ripples when much sediment is available in suspension.

Facies 3: aeolian rooted sandy facies During summer, aeolian processes dominate over fluvial ones and may form sand dunes in pockets on top surface of the channel bar deposits. Dunes are 1.5–4 m in length and 0.5–1.0 m in height. It is characterized by 20- to 50-cm thick solitary planar cross-bedding. This facies is made up of well-sorted fine sand and silt.

The sandy unit showing planar cross-bedding, trough cross-bedding, and ripple lamination makes the major portion and is present in the lower to middle part of the channel bar deposits. Silt and clay unit, showing climbing ripple lamination and laminated mud, constitutes minor portion and is present above the sandy facies. Aeolian sandy facies, if present, makes the negligible percentage of the channel bar deposits.

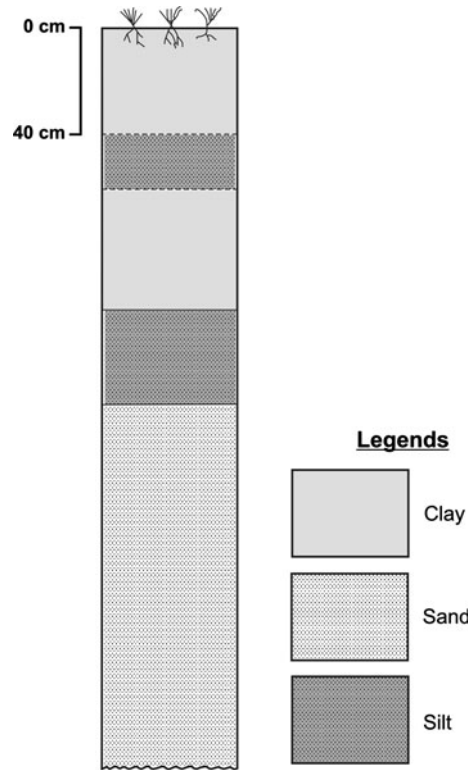
Fig. 3 Litholog showing facies of the river bank deposits

The facies of the river bank deposits are sandy, silty, and clayey (Fig. 3). The sandy facies is prominent in the lower and middle part. This 120- to 200-cm thick unit is devoid of sedimentary structures, only faint low-angle discordances are visible at some places. The sandy unit is underlain by 20- to 40-cm thick silty unit. The upper most part is 40- to 50-cm thick clayey unit. The facies of the river bank deposits are laterally persistent, only thickness and percentage of different litho units may vary from place to place.

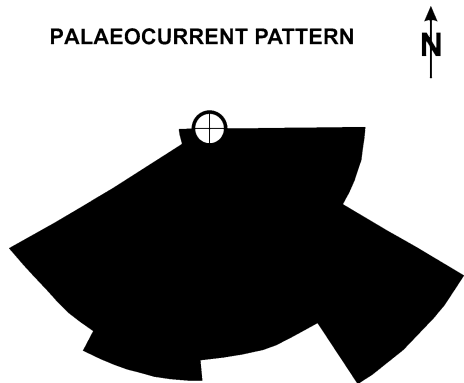
Fig. 4 Rose diagram showing Palaeocurrent pattern

The channel bar deposits consist of large scale cross-bedding, formed in response to prevalent flow direction by the migration of large bed forms. The palaeocurrent was analysed to determine the direction of palaeo-flow of the river and also the movement of bed forms. Statistical parameters such as vector mean (θ_v) indicate that the average current direction is

168°. Vector strength or vector magnitude ($L\%$) also known as consistency ratio, the measure of dispersion or consistency of the current direction is 81, and variance (S^2), the quantitative estimate of palaeocurrent variability is 1,343. The palaeocurrent pattern (Rose diagram) as measured from planar and trough cross-bedding in the channel bar deposits shows distinct bimodality (Fig. 4). It indicates that there are two main directions for the movement of bed forms and the flow of water in the channel. Palaeocurrent pattern (vector mean) suggests a general southward flow. High vector magnitude values indicate the presence of persistent unidirectional current.

The palaeocurrent analysis tells us about the palaeo-flow direction of the river, and so the future current direction can be predicted. The Palaeocurrent pattern is bimodal; however, the river is flowing in a single general direction; it means one component of the flow is active in different directions that may be responsible for lateral erosion.

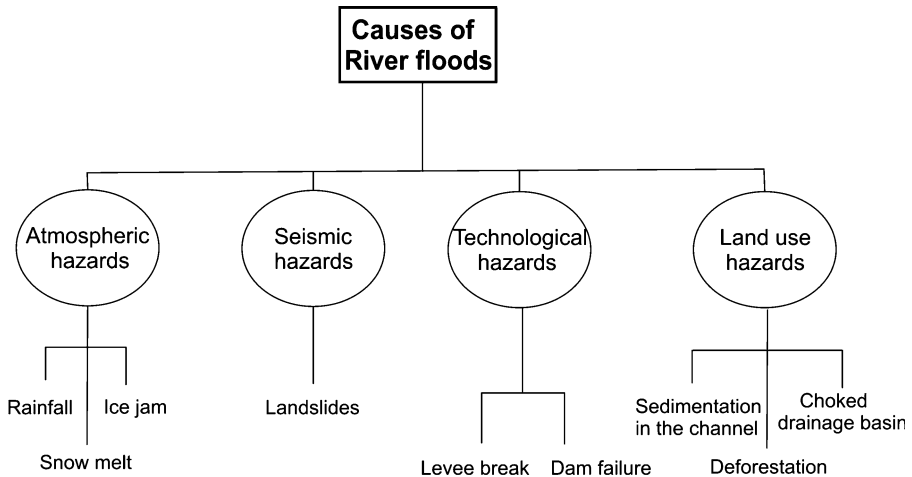
Fig. 5 Causes of flooding

It is the most widespread of all the natural hazards. Floods have a very high impact upon homeless, moderate in terms of injuries, and low loss of life in comparison with other natural hazards (Foster 2000). The main reasons of flooding in this area are high snow melt, and mass movement in the upper reaches and poor drainage, blockade, and high rain fall in the catchments area, and dam/levee failure (Fig. 5). The river valley is narrowed by constructing artificial levees to provide the land for settlements for continuously increasing population. When discharge exceeds the capacity of the channel, flooding occurs on adjacent areas and can have destructive effects. It originates in two ways: a—logging and spreading of water due to heavy rains and b—breaking of levee due to rise of water level in

the river channel. At Turtipar, gauge site located between Barhaj and Gothani, flood has occurred for 56 times in 1983, 1988, and 1996 (Dhar and Nandargi 1998) due to heavy rainfall in the catchment. The levee failure is the main reason of flooding in this area.

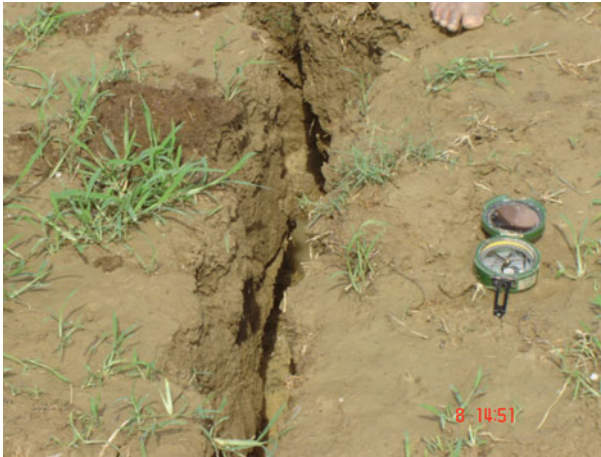
Fig. 6 Fractures at the left bank of Ghaghara River near Barhaj

It has been identified that rivers of the Ganga Plain are aligned in a preferred direction due to lineaments (Singh and Rastogi 1973; Singh et al. 1996). Rohini, Rapti, Gandak, Ghaghara, and Ganga faults in eastern Ganga Plain were identified and described by Mohindra and Parkash 1994; Singh and Singh 2005. Ghaghara is oriented in WNW–ESE to W–E direction; it means it is aligned parallel to the lineament/fault. The fractures developed during dry season in the clayey facies of the river bank deposits are parallel to the direction of the river/lineament/fault. During low-discharge period, frequency of the formation of these fractures is high. These fractures are 5–10 cm wide and 10–20 m in length (Fig. 6). With time, these fractures widen, collapse, and fall due to mass movement and enhance lateral erosion.

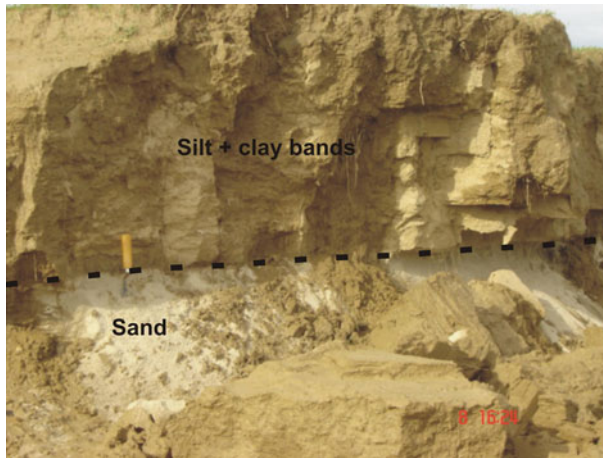
Fig. 7 Mass movement in Sandy facies near Barhaj

During high-discharge period, when sandy facies are submerged, sand becomes wet and consolidated. However, during low-discharge period, the sandy facies that makes the middle and lower part of the channel bar and river bank is exposed. The exposed non-cohesive dry sand with low degree of compaction slides due to mass movement. It moves/slides to achieve the stability, i.e. the angle of repose (sand cannot stabilize at steeper angle). Sliding and removal of sand from the river bank and bar deposits is a continuous process during low-discharge period. It results in the slumping of the upper fine grained clayey unit (Fig. 7) and causes lateral erosion. Thirty years of observations due to residence of corresponding author in the study area and local information indicate that the rate of lateral erosion is not uniform and varies between 1 and 5 m yr⁻¹. At many places, river has come very close to the settlement, and people are in continuous threat because of the lateral erosion (Fig. 8). Within a year, Kurhe Parasia village near Barhaj has disappeared due to lateral erosion.
