The effects of the July 2005 catastrophic inundations in the Siret River's Lower Watershed, Romania

Gheorghe Romanescu · Ioan Nistor

Abstract The Siret River originates from the Wooded Carpathians (Ukraine) and has a length of 559 km on the Romanian territory. The upper river course is set on the Ukrainian territory, the middle course flows through the Suceava Tableland, and then the limit between the Moldavian Subcarpathians and the Bârlad Tableland, followed by the lower course crosses the Inferior Siret Plain. The hydrographical network includes 1,013 water tributaries (representing the richest river from this point of view in Romania) and has a length of 15,157 km, which represents 19.2% of the total length of the Romanian river network. This materializes in a density of 0.35 km/km², compared to 0.33 km/km² which is the average for Romania. The Siret River has the greatest watershed area, with a total surface of 42,890 km², which represents 18.1% of the Romanian territory. Its discharge is the highest of all internal rivers of Romania, with an average discharge of 210 m³/s at the river mouth, and this is caused by the fact that most of the tributaries come from mountainous se

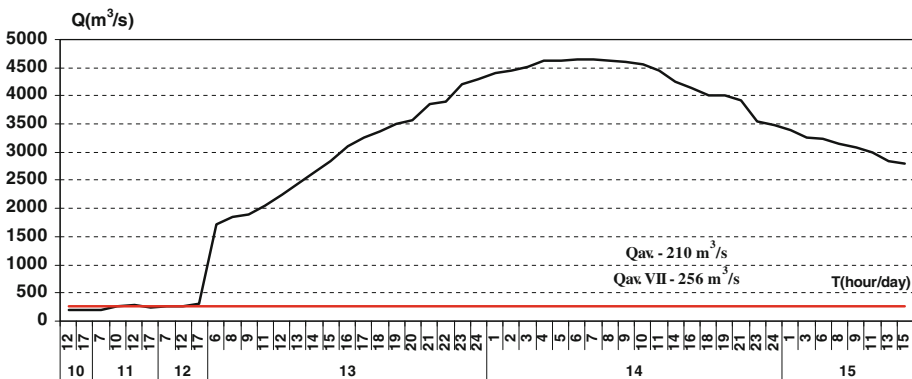
Fig. 7 Flood hydrograph for Siret River at Lungoci hydrometric station; the red line represents the multiannual base flow for July

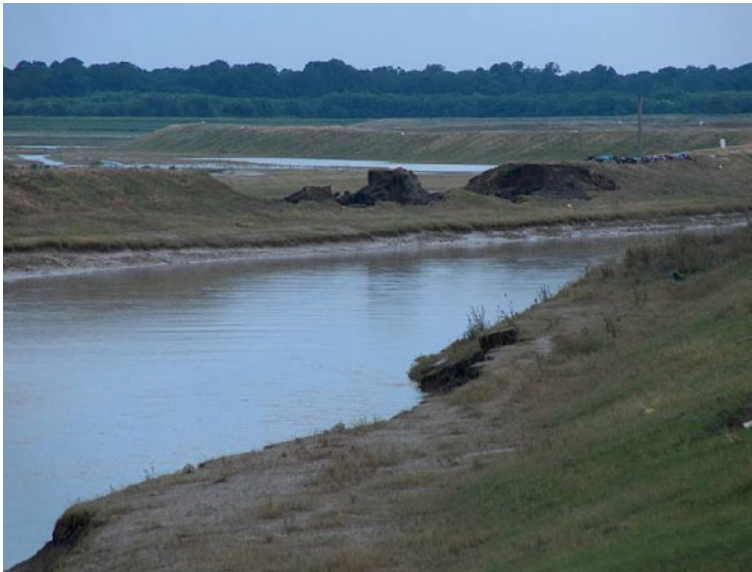
Fig. 9 Dike breached by flood in the Siret River lower watershed (Romanescu 2005)

Unfortunately, downstream of the confluence with Trotus River, the continuous monitoring of the flow discharge on Siret River is performed only in the Lungoci section. At the other two hydrometric stations (Cosmesti and Sendreni), only level observations are performed, as these stations do not have operative gauging equipment. The authors were able to prepare a stage–discharge relationship for the Cosmesti hydrometric station. According to it, the maximum flow rate evacuated from Calimanesti Lake would be $4,500 \text{ m}^3/\text{s}$, if the lateral inflow is not taken into account. For Sendreni cross-section, the estimation of the water levels was rather difficult, because of the significant backwater curve generated by the confluence with the Danube River. Some of the significant destructions generated by the flood in the lower Siret River watershed are presented in Figs. 9, 10 and 11.

Besides the material losses that had a negative impact on the local and national economy, the authors would like to draw the attention to a number of other important changes associated with the river geomorphology or the soil cover. Several phenomena were observed: the occurrence of islets and the disappearance of others, the extension of the concave banks through the erosion and subsequent accentuation of the steep banks, the spatial modification of the minor riverbeds, modifications of the water courses as a consequence of auto-capture through overflows, the re-inundation of old river courses, the sedimentation of polders and the occurrence on new, young soils. Some of these aspects have been illustrated in Figs. 9 and 10.

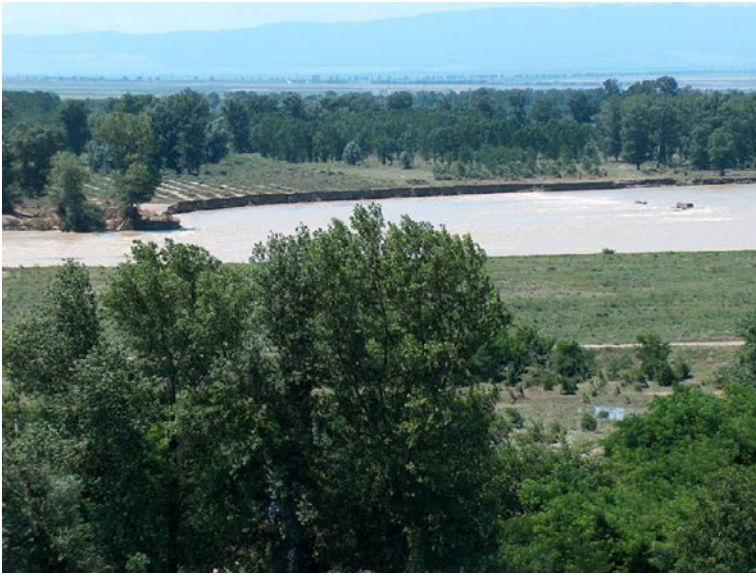
Fig. 10 Riverbank erosion on Siret River in the Cosmesti de Jos sector (Romanescu 2005)

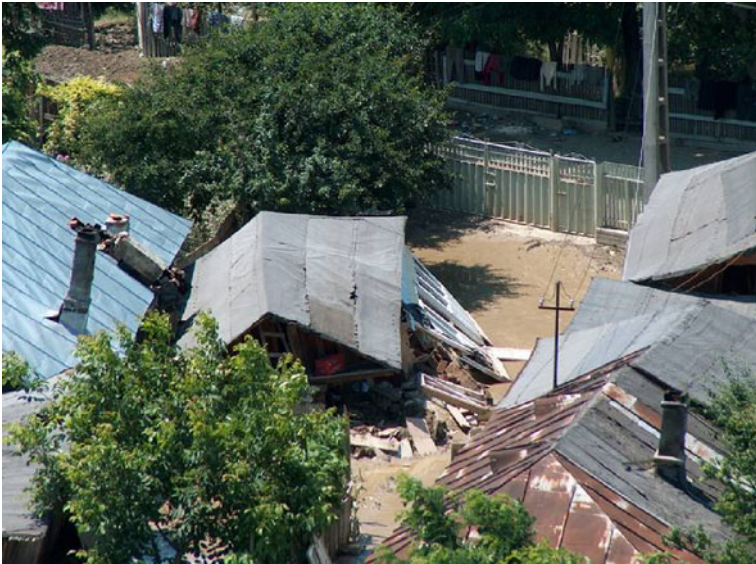
Fig. 11 Destroyed houses in the village of Cosmesti de Jos, on the Siret River (Romanescu 2005)

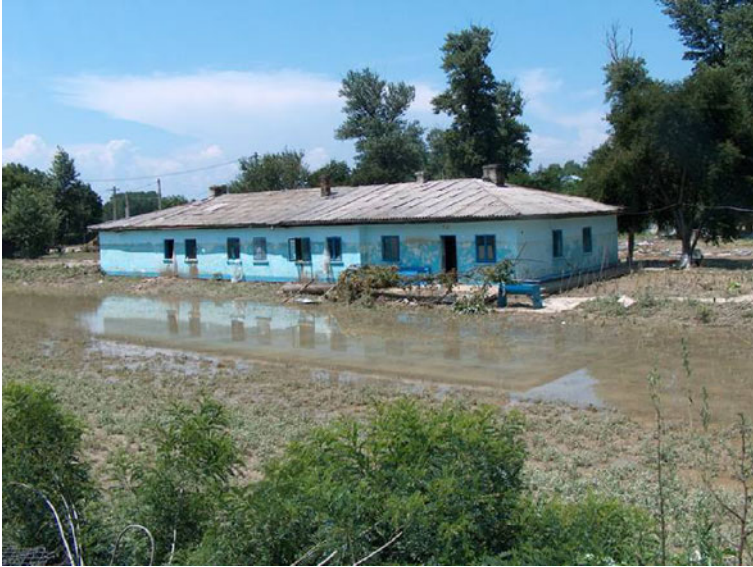
Fig. 13 The mark level (on the building's walls) of the Siret River's waters at Cosmestii de Jos (Romanescu 2005)

management of this extreme hydrologic phenomenon. In many cases, human settlements were partially or completely affected (Vadu Rosca). The situation described in this case occurs almost on an annual basis, mainly at the end of spring and beginning of summer, when the snow completely melts and fall great quantities of liquid precipitations (Figs. 13 and 14).

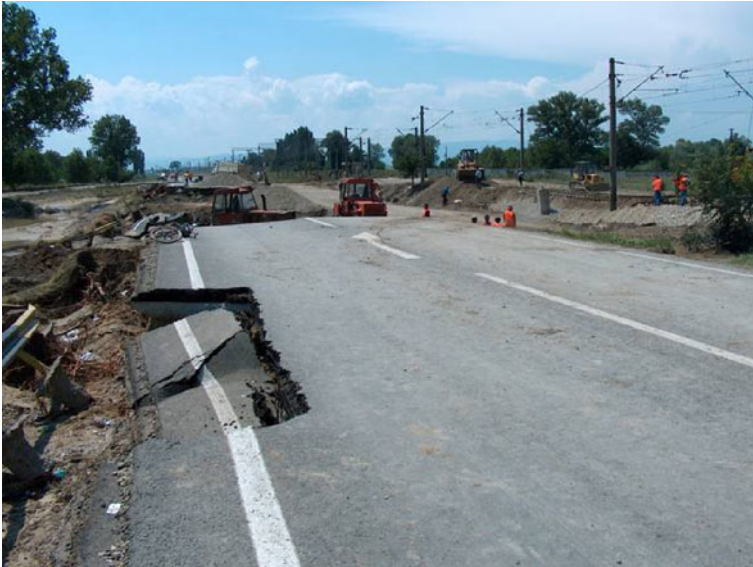
Fig. 14 The destruction of the national road and railway Tecuci-Marasesti (Romanescu 2005)
