Recent landslides on the Istrian Peninsula, Croatia

Sanja Dugonjić Jovančević · Željko Arbanas

Abstract This study presents a review of recently recorded instability phenomena on the flysch slopes of Istria, Croatia. The northeastern part of the Istrian Peninsula, the so-called Gray Istria, is built of Paleogene flysch deposits, where instability phenomena are frequent and where a large number of landslides, with significant consequences, have been recorded over the past 35 years. Based on field investigations conducted for the purpose of remedial study design, a database of these landslides was created. An investigation of the documented landslides and their elements found some common features that enabled general conclusions about the conditions and causes of landslide occurrence. In total, 19 documented landslides have been analyzed as individual phenomena, and from the results of these analyses, general conclusions were drawn about sliding conditions and the main triggering factors. Geological conditions and processes on slopes where landslides occurred are shown in detail, and geotechnical properties have been systematically represented. The sliding conditions and dimensions

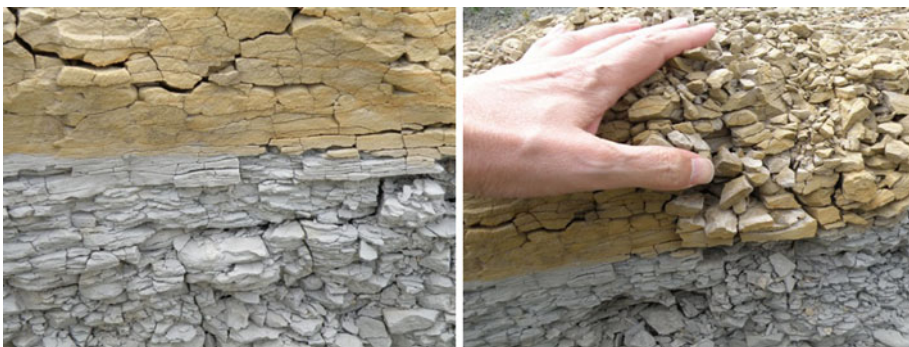
Fig. 2 Weathering and decomposition of flysch rock mass exposed to water and atmospheric conditions

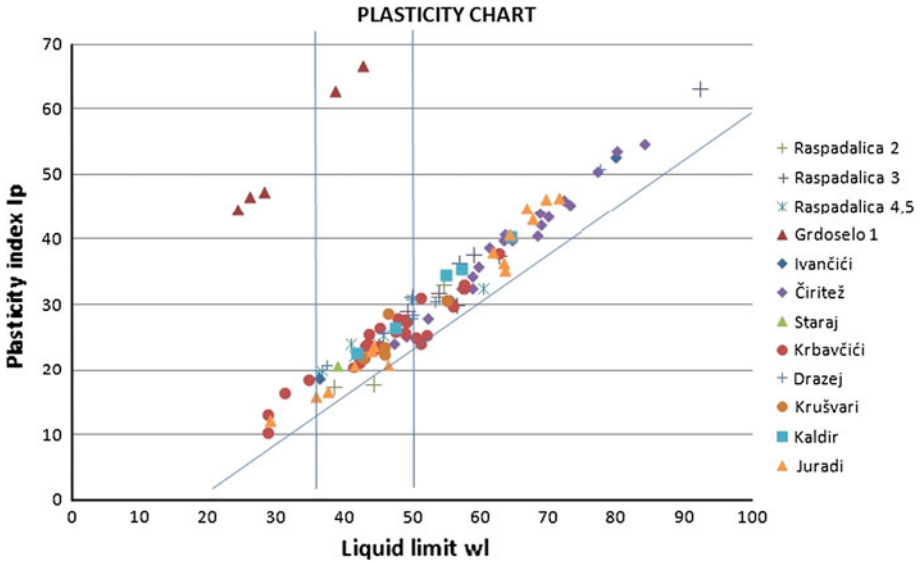
Fig. 4 Plasticity chart with the distribution of soils from landslide locations

In slope stability analyses, the gravitational/colluvial cover and the residual soil can be considered as materials with similar properties (Figs. 4, 5). The cover is, as a rule, formed of clay of intermediate- (CI) to-high (CH) plasticity and is semisolid to plastic in consistency, depending on the water content. In cases where the cover was brought from the higher slope areas, it can contain an even larger portion of rocky fragments, mostly

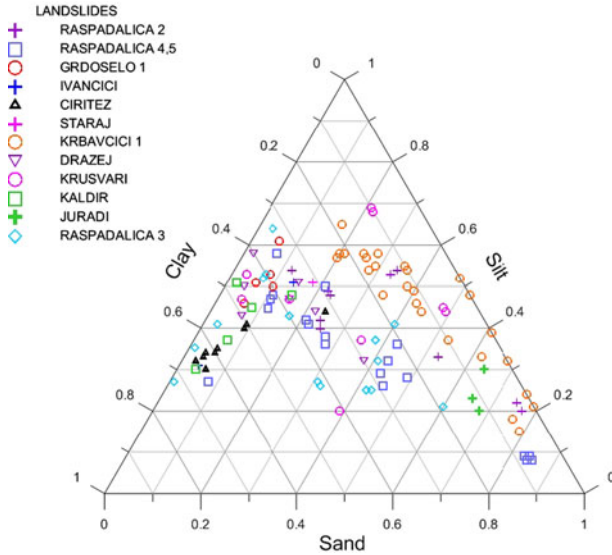
Fig. 5 Granulometrical composition of soils from landslide locations

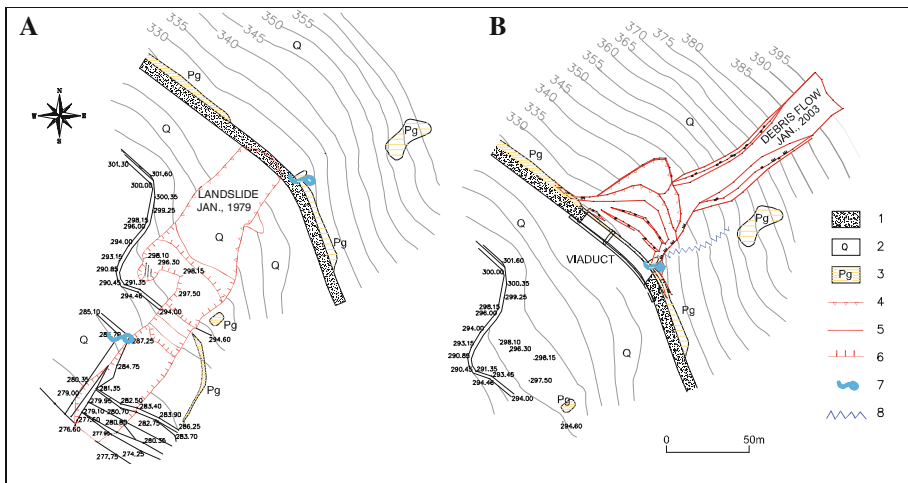
Fig. 7 Geological map of the Krbavčiči landslide in 1979 (a) and debris flow in 2003 (b). 1 road embankment fill, 2 Quaternary deposits, 3 marl and siltstone outcrops, 4 main scarp, 5 shear cracks, 6 compression cracks, 7 temporary spring, 8 ravine

The first signs of sliding on the slope in the Krbavčiči village area, near the city of Buzet, appeared in 1961, but the most important movements occurred during the night between January 30 and 31 of 1979, when multiple retrogressive sliding occurred after a prolonged rainy period from October 1978 through January 1979 (Fig. 7a). The landslide involved the clayey superficial deposit of colluvium and residual soil that was 10 m thick, together with the road embankment, bringing material down the slope for 200 m and burying a vineyard in the landslide toe. Field investigations were performed in the spring of 1979 and consisted of geological mapping, borehole drilling and laboratory testing. The investigation indicated the surface of rupture between the superficial deposits and the siltstone bedrock. The landslide was naturally suspended, the damaged road was repaired, and the landslide body was overbridged. A new reactivation of the Krbavčiči landslide occurred in the winter of 2003, resulting in movements in the upper part of the slope above the viaduct (Figs. 7b, 8a). The first movements occurred in December 2002, and the widening progressed until the initiation of debris/earth flow in early January 2003 (Arbanas et al. 2006). To clearly

ascertain the dimensions of the new appearance, a geodetical survey and geological mapping were conducted. It was found that approximately 35,000 m³ of colluvium material, mostly silt with 25–55 % limestone, was sliding down the slope.

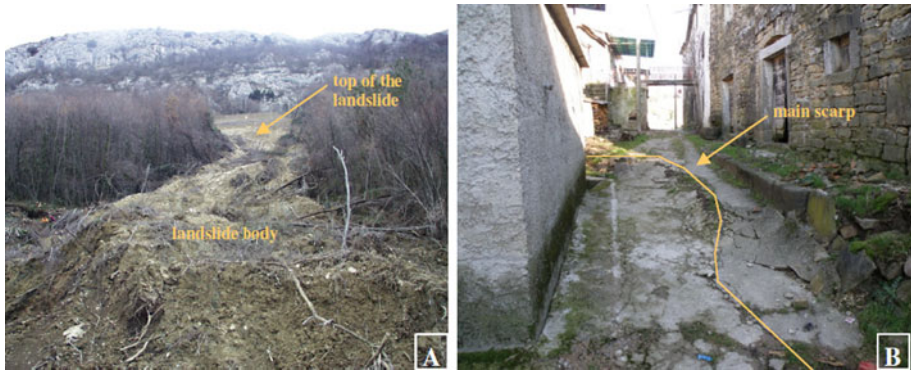
Fig. 8 Photographs taken after sliding. **a** Krbavčiči landslide (photo taken in January 2003), **b** Juradi landslide (photo taken in January 2011)

The main scarp of this landslide divides Juradi, a small village located in the central part of the Istrian Peninsula (Fig. 8b). The last reactivation of this landslide occurred on December 1, 2010, but according to village inhabitants, movements have been repeatedly occurring for the last 80 years. The landslide was temporarily suspended by the construction of surface drainage trenches and by the end of the heavy rainfall season. In spring 2011, field investigations were performed, and it was established that the Juradi slope is made up of flysch bedrock (tabular layers of prevailing siltstone and marl with sporadic sandstone interbeds, Fig. 11), covered by a 5- to 14-m-thick clayey cover (colluvium deposits and residual soil). The surface of rupture was positioned on the contact between the cover deposit and the siltstone bedrock layers, whose orientation (340/08) is similar to and dipping out from the slope. The dimensions of the landslide cannot be precisely measured because only the main scarp in the head of the landslide is clearly visible (Figs. 8b, 11). Despite this, it was estimated that the volume of the landslide body is approximately 47,000 m³. During the study, it was concluded that, due to the low permeability of the soil, only a small fraction of precipitation (<15 %) was infiltrating the subsoil.

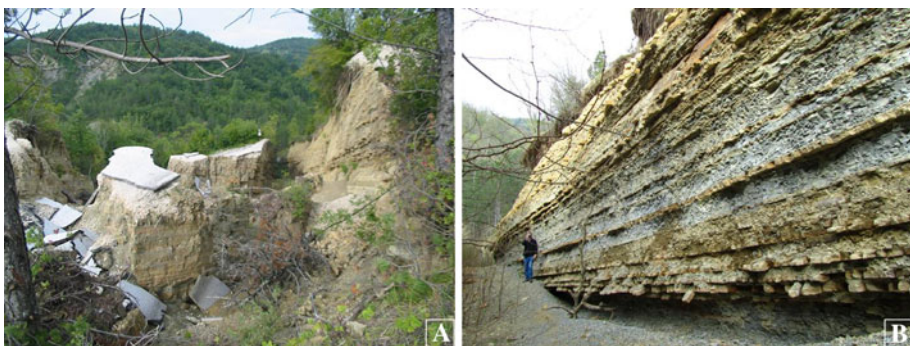
Fig. 10 The Brus landslide-view on the old road remains (photo taken in August 2005) (a) and the flank scarp of the landslide (photo taken in January 2010) (b)

Field investigations were carried out in the spring of 2004 and consisted of a geodetical survey and geological mapping. Because of the clearly visible geological outcrop on the flank scarp, it was not necessary to perform borehole drilling. The involved rock mass consists of alternating tabular layers of sandstone and marl (Fig. 10), covered by a thin,

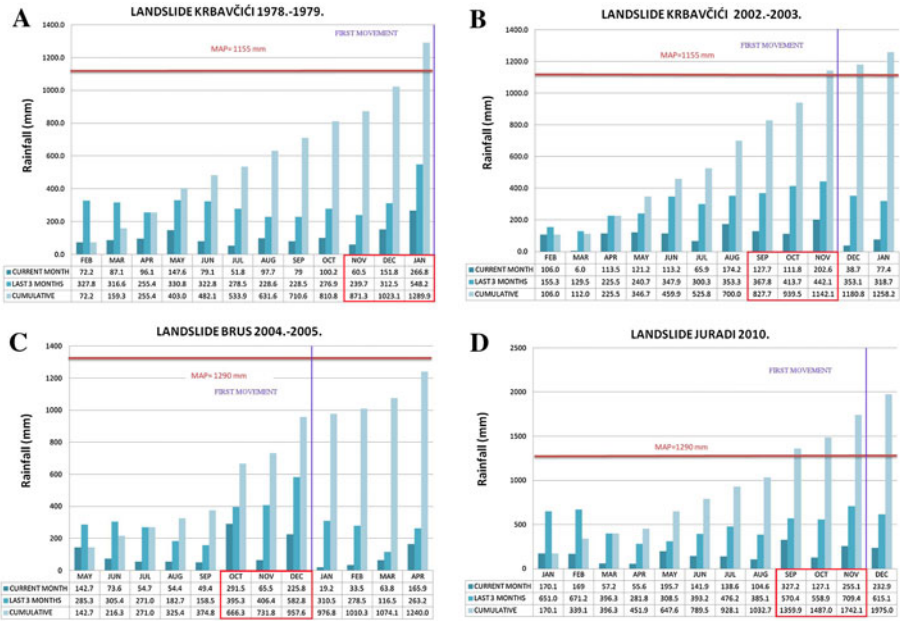
Fig. 12 Rainfall diagram showing the precipitation for the current month and cumulative precipitation for 3 and 12 months before sliding. **a** Krbavčiči landslide, 1978–1979 (Abrami weather station). **b** Krbavčiči debris flow, 2002–2003 (Abrami weather station). **c** Brus landslide, 2004–2005 (Lupoglav weather station). **d** Juradi landslide, 2010 (Lupoglav weather station). Red lines show the mean annual precipitation, and red squares are the 3-month period before the first movement occurred

Using a summation of daily precipitation during the period from 1 week to 6 months, the cumulative precipitation values for different time periods were obtained. On 4 of the studied landslides, cumulative monthly precipitation values were compared with total precipitation values for an equal time period using historical rainfall data (Fig. 12).

It appears that precipitation from the 3 months prior to landslide initiation, with relatively high monthly totals, probably has the primary influence on rising infiltration and water levels. This period varies from 70 to 100 days, depending on local morphological, geological and hydrogeological conditions, vegetation and land use, and cumulative precipitation values. As confirmation of this statement, in the period before sliding, many shorter periods with higher cumulative precipitation were recorded, although sliding did not occur. It was also determined that the analyzed landslides are activated primarily during the late autumn and early winter period, when the number of rainy days during a 3-month period was large and the evapotranspiration values were low.

From the cumulative precipitation analyses within 90 days that preceded first movements on the landslide, it can be observed that landslides occurred when the cumulative precipitation values ranged from 400 to 700 mm (Fig. 12). These could be compared to experience in the Polish Flysch Carpathians, where Gil and Dlugosz (2006) defined 250–300 mm of cumulative precipitation values as a threshold between 25 and 45 days. Due to the insufficient infiltration data and the measurements of groundwater level changes, it is difficult to define a rainfall-duration threshold for the possible initiation of landslides in the flysch area of Gray Istria. However, it is important information that first movements on the landslides occurred after a 3-month rainy period with approximately 50 % rainy days without longer dry interruptions. Maximum daily precipitations within these periods were from 48.5 mm/day (the Brus landslide) to 114.1 mm/day (the Juradi landslide). This period suggests conditions in which the risk of landslide reactivation increases and that requires initiation of enhanced monitoring. It would be possible to determine the threshold value expressed as cumulative precipitation of rainfall by further analysis of the long-term ground water level measurements associated with the precipitation levels during the monitoring.
