# Building damage characteristics based on surveyed data and fragility curves of the 2011 Great East Japan tsunami

Anawat Suppasri · Erick Mas · Ingrid Charvet · Rashmin Gunasekera · Kentaro Imai · Yo Fukutani · Yoshi Abe · Fumihiko Imamura

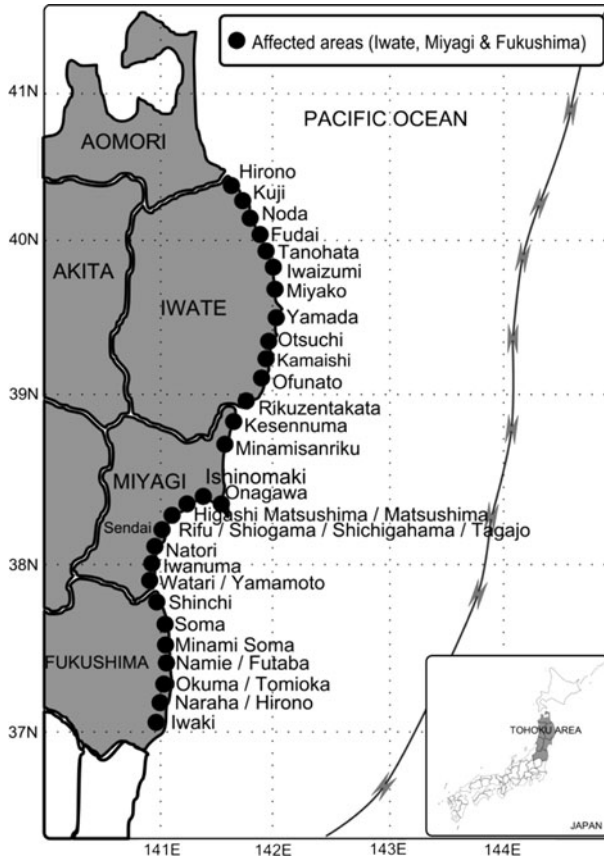
**Fig. 1** Mainly affected areas by the 2011 Great East Japan tsunami

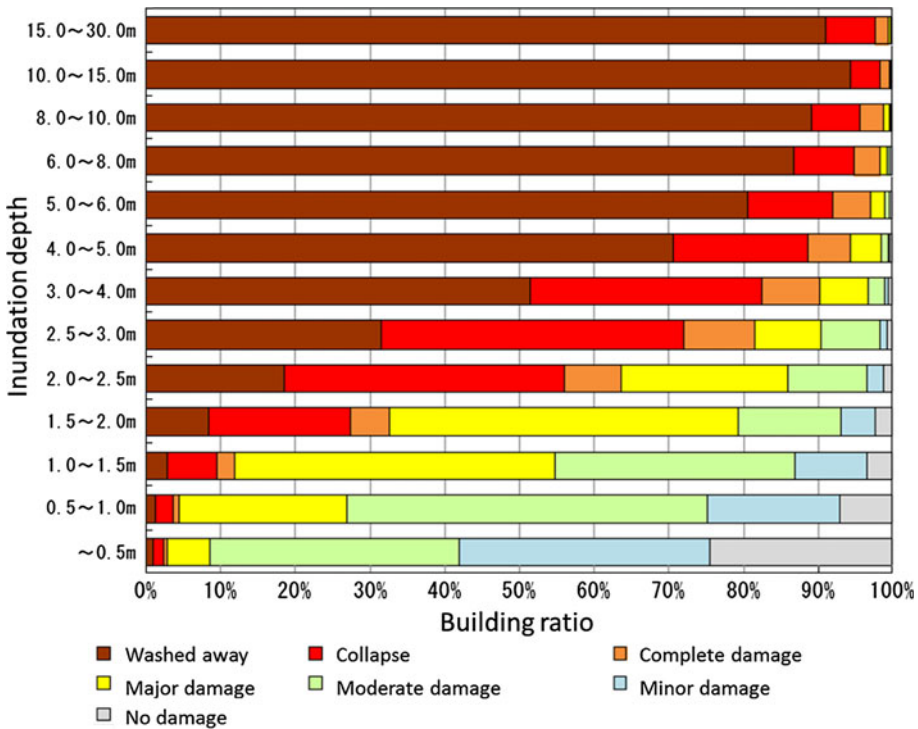
**Fig. 2** Distribution of the total 251,301 building data surveyed by MLIT (2012)

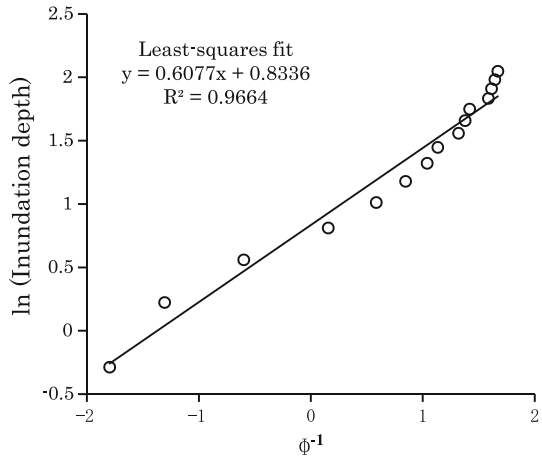
**Fig. 3** Example of the plot on log-normal probability paper

lognormal probability papers, and performing least-square fitting of this plot (Fig. 3). Consequently, two parameters are obtained by taking the intercept ( $=\mu$  or  $\mu'$ ) and the angular coefficient ( $=\sigma$  or  $\sigma'$ ) in Eq. (3) or (4):

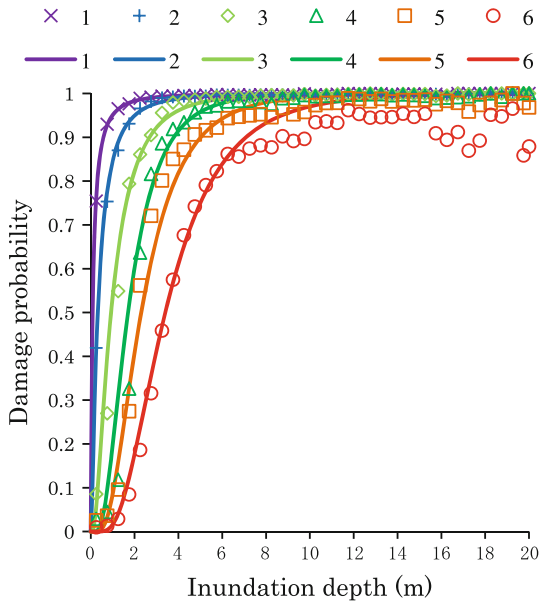
**Fig. 4** Tsunami fragility curves for the whole area (Chiba to Aomori) with mixed structural material in different damage levels (1 = Minor damage, 2 = Moderate damage, 3 = Major damage, 4 = Complete damage, 5 = Collapse and 6 = Washed away)

Fig. 4. It is reasonable that the expected damage probability will be higher for lower damage level classes at the same inundation depth reference point. For example, the damage probability for level 2 (moderate damage or greater) should be higher than the damage probability for level 5 (collapse or greater). The results show for mixed structural material that the damage probability at an inundation depth equal to 2 m for damage levels 1–6 is roughly 0.2, 0.4, 0.6, 0.8, 0.95 and 1.0, respectively. The 2-m inundation depth is a key threshold value because the damage probability for each damage level is nearly the same. According to Fig. 4, the probability of damage occurrence reaches their maximum value for all type of damage levels when the inundation depth exceeds 10 m.

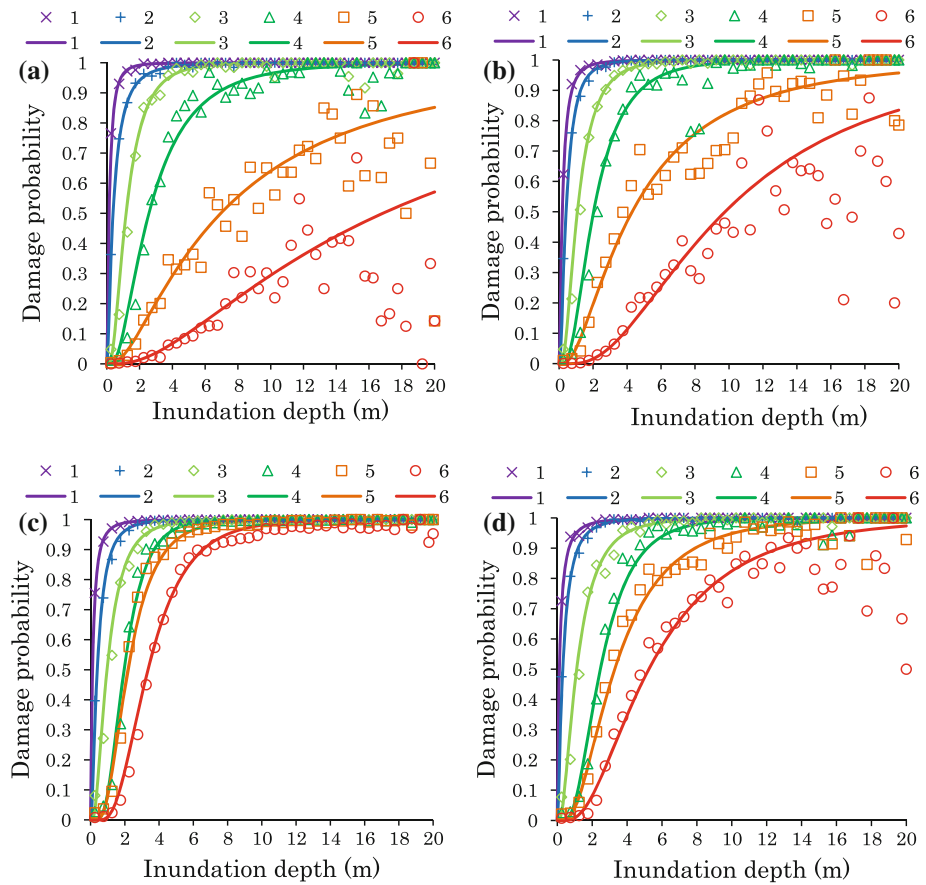
**Fig. 5** Tsunami fragility curves for the whole area (Chiba to Aomori) with separated structural material **a** RC, **b** Steel, **c** Wood and **d** Masonry

Using the data of the whole affected areas in Japan, we separated it into different structural materials. The results based on the structural materials are shown in Fig. 5a–d. For most of the structural material data—except for wood—when inundation depths were >10–15 m, the sample size of surveyed number of buildings to calculate the damage probability was comparatively less. Since data prepared by MLIT were summarized at fixed intervals of inundation depth—every 0.5 m depth, there is less number of surveyed buildings within intervals over 10 m depth, compared to lower inundation depths. Therefore, in some cases, we discounted the data on higher depth intervals to avoid underestimating the damage probability.

It can be seen from the results in Fig. 5 that RC is the strongest structure followed by steel, masonry and wood. For example, a probability that 2-m inundation depth would damage buildings as level 5 (collapsed and washed away) for RC, steel, masonry and wood is about 0.1, 0.2, 0.25 and 0.45, respectively. All wood buildings and most lightweight buildings were washed away when inundation depth was >10 m while only 50 % or less

for steel and RC. It is noticed that the damage probability for level 1–4 is not very different for the different structural material: for steel, wood and masonry buildings, the damage probability for level 4 varies around 0.4–0.5. These results indicate that RC and steel are structural materials that play very important role in preventing a building to be collapsed or washed away.

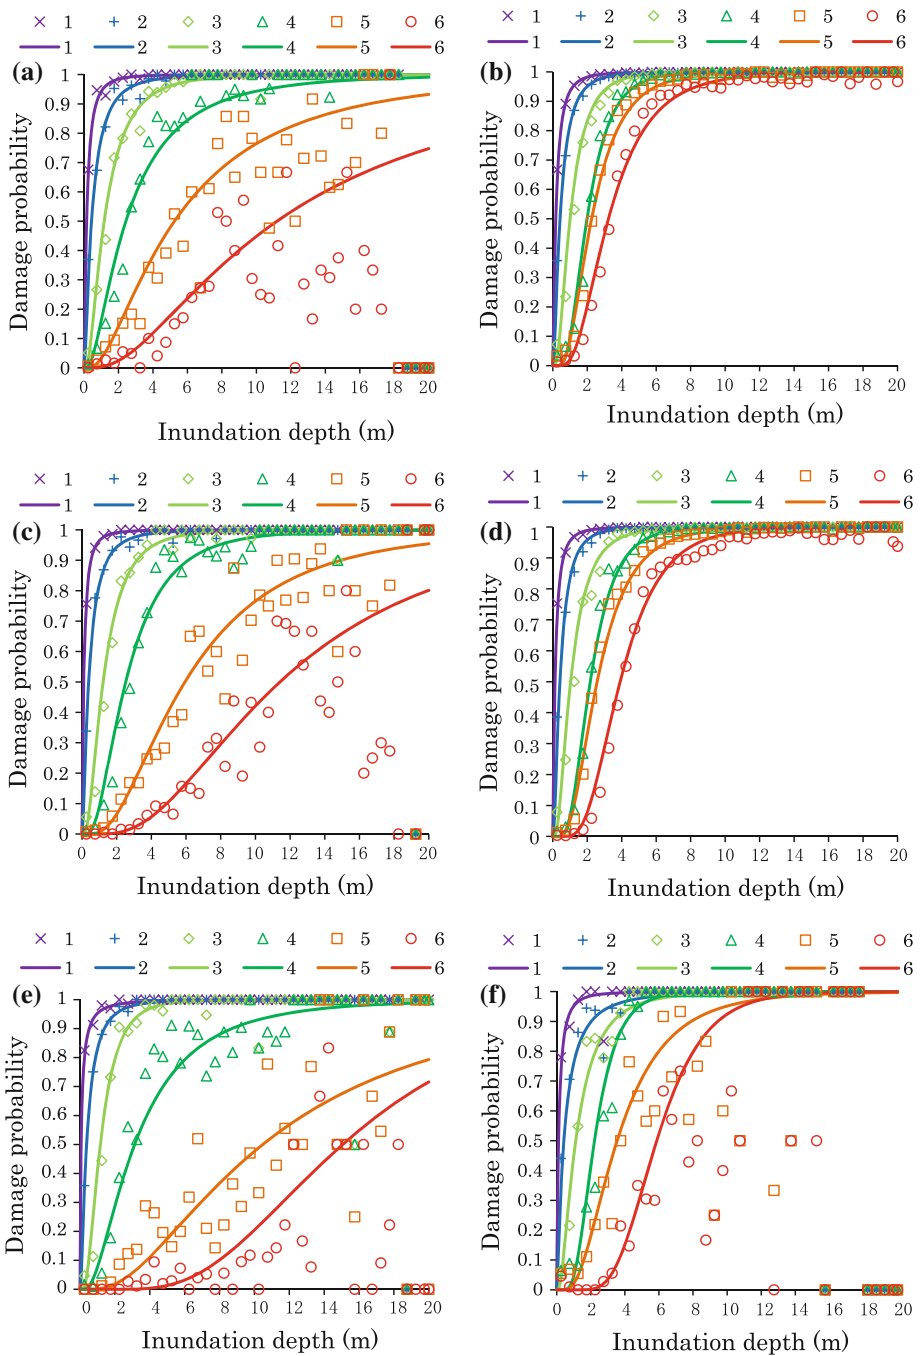
**Fig. 6** Tsunami fragility curves for the whole area (Chiba to Aomori) with separated structural material and number of stories **a** RC—1 story, **b** Wood—1 story, **c** RC—2 stories, **d**, Wood—2 stories, **e** RC—3 stories or more and **f** Wood—3 stories or more

For RC building, an inundation depth of 3 m caused damage by 0.30, 0.20 and 0.15 for one, two and three stories or more, respectively. An inundation depth of 6 m increased the damage probability to 0.6, 0.5 and 0.25, respectively. Inundation depths of 9–15 m, which would totally overtop one and two-story buildings, caused 0.7–0.9 damage probability, while only 0.45–0.70 for three stories or more.

However, for buildings of wood construction, a 3-m inundation depth caused 0.75, 0.60 and 0.40 damage probability to one, two and three stories or more, respectively. Unlike RC building, a 6-m inundation depth caused nearly 1.0 damage probability to one and two-story buildings that were overtopped and as high as 0.8 for buildings higher than three stories. Finally, a 9-m inundation depth is enough to destroy or wash away wood building no matter of the number of stories.

The differences in damage probability between one-story and two-story buildings were not very large. However, especially for wood buildings, the damage probability is significantly reduced for the case of three stories or more. For example, a 3-m inundation depth caused 0.45 and 0.30 probability for level 6 (washed away) but almost zero for wood buildings over three stories. An inundation depth of 6 m could definitely wash away wood buildings of one or two stories, but only about 0.5 probability for wood buildings over three stories. In addition, damage probability for damage levels 5 and 6 also greatly decreases in case of RC building having at least three stories. Therefore, for a given structural material, buildings having three stories or more might withstand better the impacts of tsunami for the same tsunami height. In other words, the damage is not only controlled by the tsunami height, but also dependent on the number of stories and structural class of the building hit.

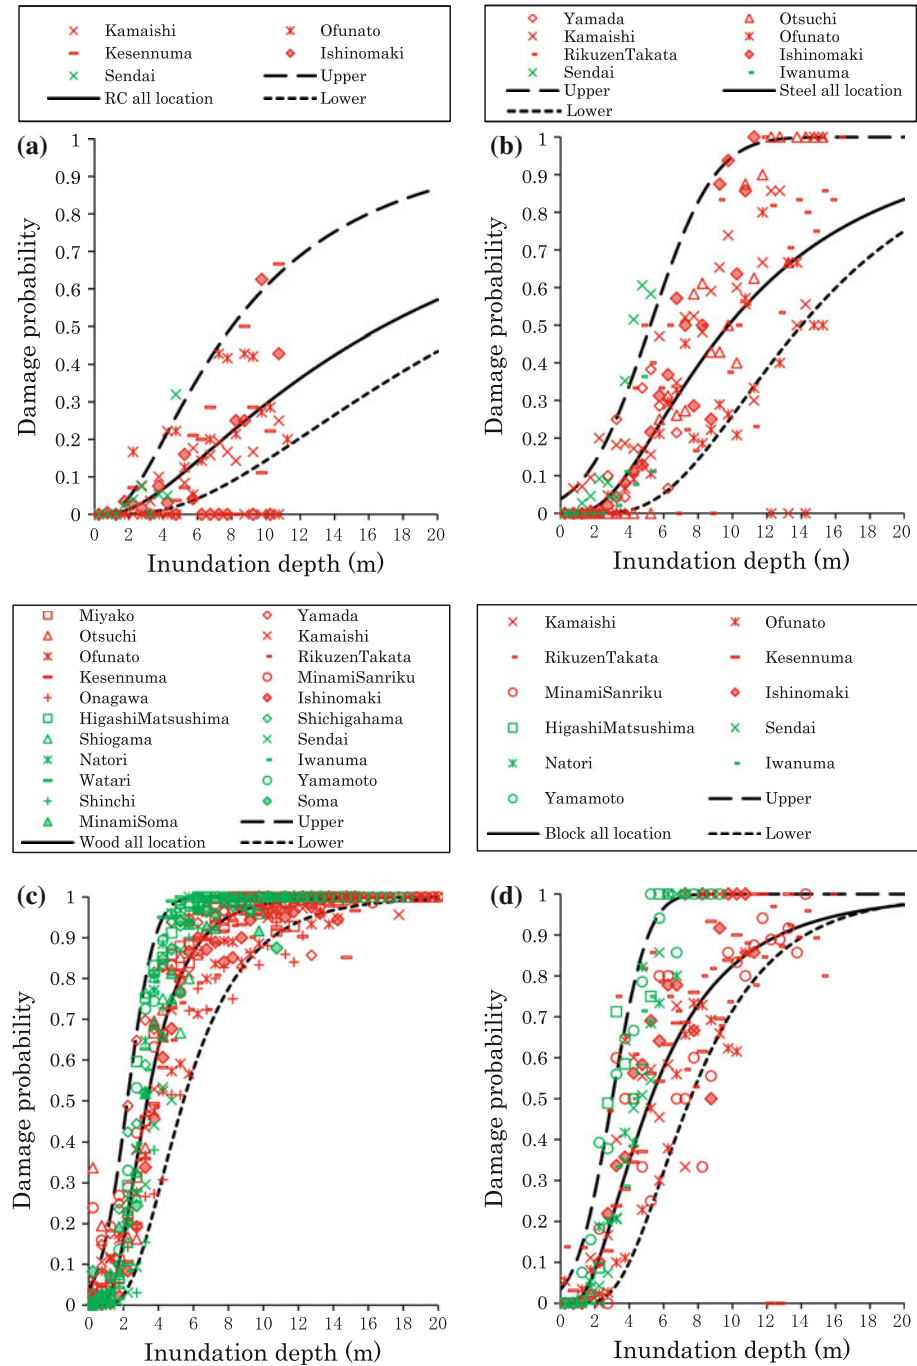
**Fig. 7** Comparison of tsunami fragility curves between ria coast and plain coast for washed away building with separated structural material **a** RC, **b** Steel, **c** Wood and **d** Masonry

In general, the variation of damage probability at the same inundation depth can be 0.2 or less when inundation depth is <1–2 m for all types of structural material shown in Fig. 7a–d for damage level 6. However, this will be as high as 0.9 for damage level 5 at 2- to 3-m inundation depth shown in Fig. 8a–d. The variation is the largest in RC structures, followed by steel, masonry and wood if we considered the difference between the upper and lower lines perpendicular with regard to the average curve shown by the solid line in all figures. The difference in damage probability is on average  $\pm 0.1$  for wood (Figs. 7c, 8c) and masonry (Figs. 7d, 8d) and as high as  $\pm 0.2$  for steel (Figs. 7b, 8b) and  $\pm 0.3$  for RC (Figs. 7a, 8a).

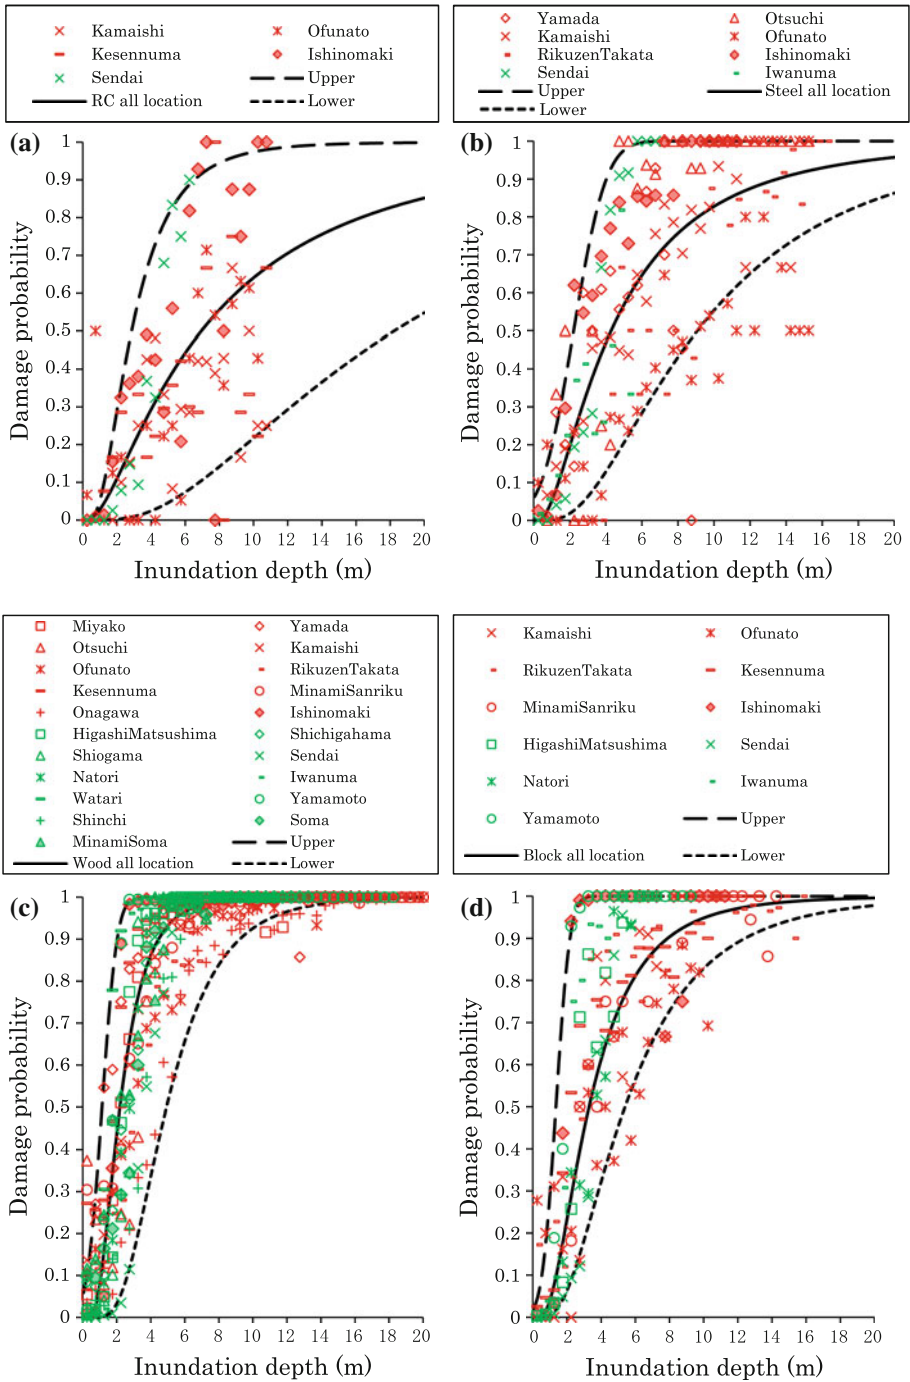
**Fig. 8** Comparison of tsunami fragility curves between ria coast and plain coast for collapsed building with separated structural material **a** RC, **b** Steel, **c** Wood and **d** Masonry

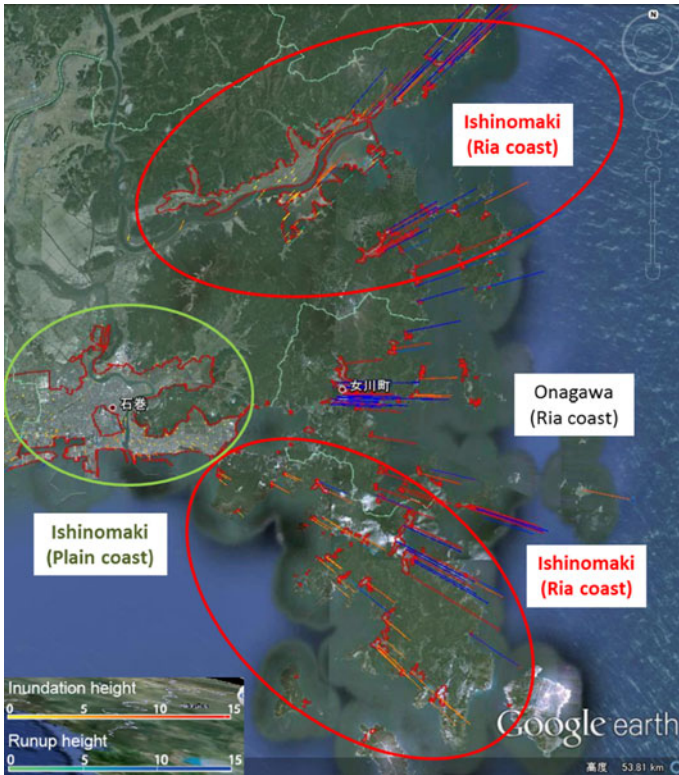
**Fig. 9** Area map of Ishinomaki city showing the ria coast and plain coast

In order to compare the effects of the two different coastal topographies, we need a data set from a location having both plain and ria coast. Ishinomaki city was the only heavily damaged area that geographically combined both mentioned topographies (Fig. 9). Building damage and tsunami inundation depth data (mixed structural material) provided by Ishinomaki city which is separated into two categories (plain coast and ria coast) were used to create the fragility curves. The building damage was classified into five levels similar to the data provided by MLIT, washed away, collapsed, major damage, moderate damage and minor damage for every 0.5-m interval of the measured maximum tsunami inundation depth. Therefore, building damage probability for each damage level can be plotted against the inundation depth.

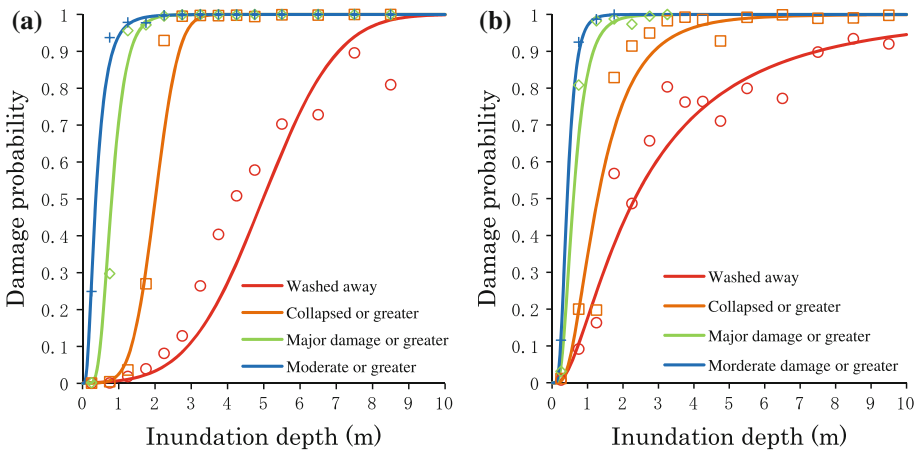
**Fig. 10** Tsunami fragility curves using data from Ishinomaki city only (mixed structural material) for a comparison between **a** Plain coast and **b** Ria coast

Tsunami fragility curves for plain and ria coasts in Ishinomaki city are shown in Fig. 10a, b, respectively. It can be seen that, for example, damage probability for washed away at 2-m inundation depth is <0.05 in plain coast, while about 0.4 in ria coast. The damage probability in plain coast increases to 0.5 at 5-m inundation depth, while the damage probability is 0.8 for ria coast. It can be noticed that the damage probability for the plain coast abruptly increases from 3- to 6-m inundation depth and becomes greater than the ria coast when the inundation depth reaches nearly 7 m. Finally, it reaches almost 1.0 when the inundation depth is equal to 8 m. On the other hand, the damage probability for the ria coast abruptly increases from 0.5- to 3-m inundation depths and slightly increases until the damage probability is nearly 1.0 when the inundation depth is about 10 m. These results show that the coastal topography differences between the plain coast and the ria coast noticeably affect the damage probabilities due to tsunami. The damage probabilities for buildings in the ria coast generally increase more and are higher than those in the plain coast.
