# Measurements and prediction of typhoon-induced short-term general scours in intermittent rivers

Chih-Chiang Su · Jau-Yau Lu

**Abstract** Most rivers in Taiwan are intermittent rivers. A short-term general scour usually occurs in the river during the rising limb of a flood due to the transitory sediment imbalance and the steep slope gradient. In this study, a severe maximum general scour depth of 4.5 m was measured near the Highway Bridge hydrological station in a gravel-bed reach of the lower Dajia River, which was caused by a flood induced by Typhoon Sinlaku in 2008. This type of short-term general scour is usually very significant and cannot be neglected as it has caused many casualties in Taiwan such as bridge and embankment failures, for example, the Houfeng Bridge failure in the lower Dajia River (Hong et al. in *J Hydraul Eng ASCE* 138(2):186–199, 2012) and the Shuangyuan Bridge failure in the lower Gaoping River. Based on the collected field data, a general scour formula was developed and gave reasonable predictions. In conjunction with the real-time ultrasonic water level measurements, the formula can be used as a potential tool for the emergency evacuation or bridge cl

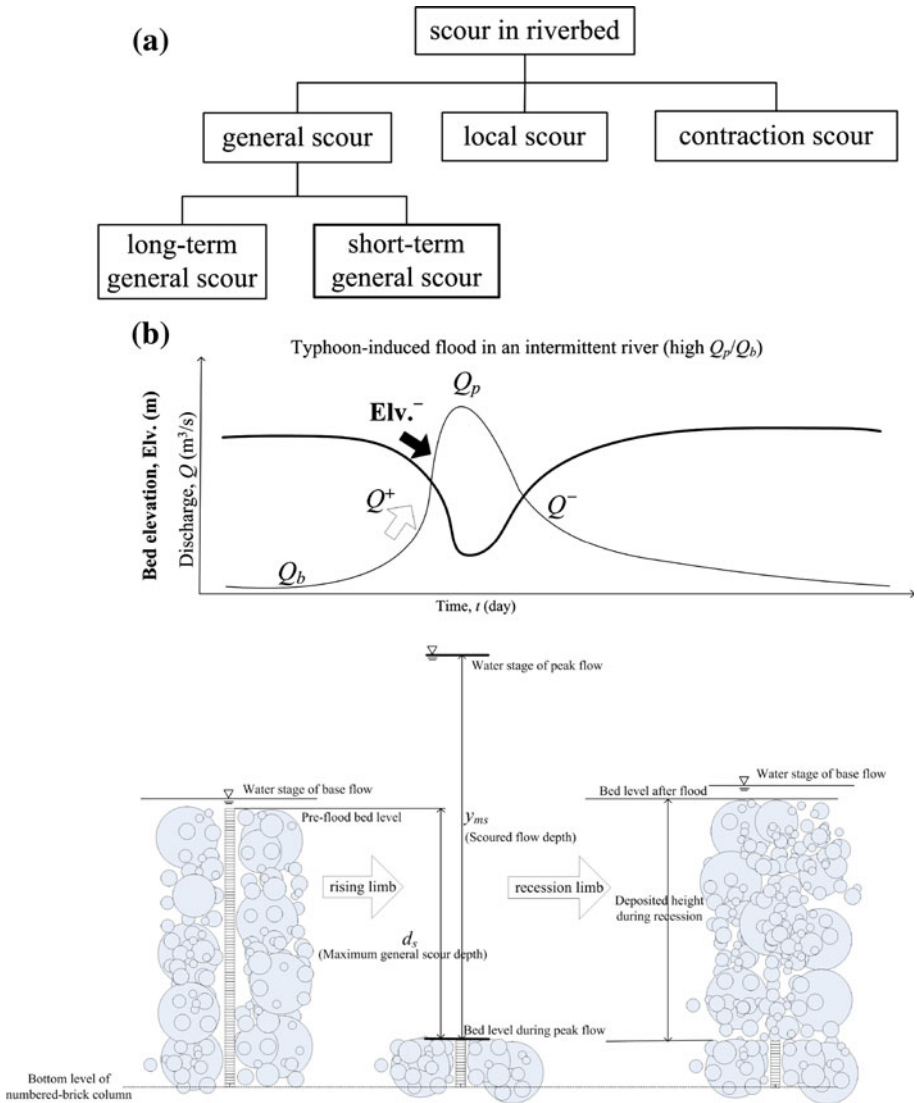
**Fig. 1** Schematic diagrams: **a** scour types in a riverbed; **b** evolution of short-term general scour during a typhoon-induced flood in an intermittent river ( $Q_p$  = peak flow,  $Q_b$  = base flow)

Fig. 1a, scour in a riverbed can be divided into general scour, local scour, and contraction scour (Melville and Coleman 2000). Local scour and contraction scour occur within a short distance in a river course. Local scour refers to riverbed scour caused by the local restriction or interference of water flow, attributable to the human-imposed structures in the river course, such as bridge pier, cross-dyke, dam, or ground sill. Contraction scour usually occurs when the waterway is restricted by the bridge embankment, foundation, and/or piers in the local river course, especially for the bridge built in a natural narrow reach. General scour is the long-distance longitudinal riverbed changes. Based on the timescale, it can be further divided into long-term and short-term general scours.

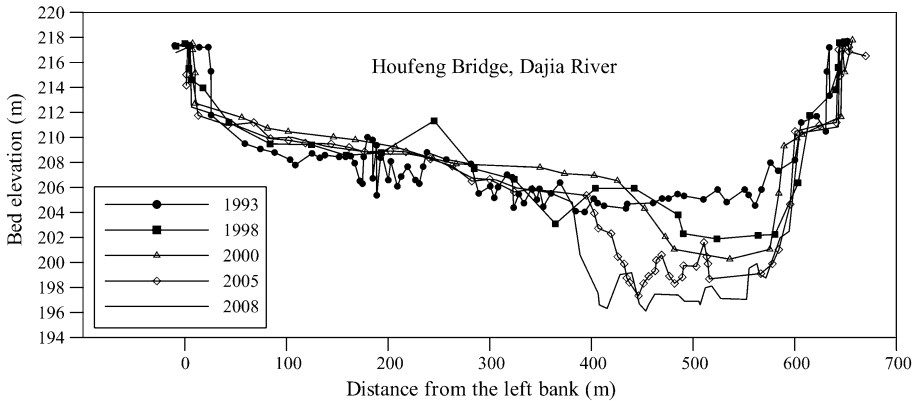
**Fig. 2** Typical riverbed incision of the main channel near Houfeng Bridge due to long-term general scour in the lower Dajia River

Figure 2 shows the incision of the main channel near Houfeng Bridge in the lower Dajia River due to the long-term general scour caused by the sand mining, the degradation below

the Shihkang Dam, and the 921 Chi–Chi Earthquake (1999, magnitude of 7.3 in Richter scale, Lin et al. 2011). Furthermore, more typhoon-induced concentrating rainfalls (maximum rainfall intensity  $I_{\max} > 150$  mm/h) have occurred due to the global warming effect (Esteban et al. 2009), causing severe soil erosion and debris disasters in the upper watershed and extreme short-term general scour in the lower river reaches, particularly for the gravel-bed reaches with high sediment gradations. The short-term general scour for the gravel-bed intermittent rivers is usually very significant as it is one of the most important factors causing the embankments or bridge failures (Lu et al. 2007), and other river-crossing structure failures. Figure 3 shows three photographs taken after Typhoon Sinlaku in 2008 (flood-peak  $Q_p = 4,225$  m<sup>3</sup>/s  $\approx Q_5 = 3,800$  m<sup>3</sup>/s) for the bridge and hydraulic structure hazards owing to the short-term general scours, including the damage of the protection work of Piers 28 and 29 under Highway Bridge, the damage of Kechuang Embankment, and the Houfeng Bridge failure near the peak flow (Hong et al. 2012) in the lower Dajia River. Coleman and Melville (2001) also investigated three case studies of scour damage for New Zealand bridges and indicated that it is important to strengthen the general scour estimates during floods.

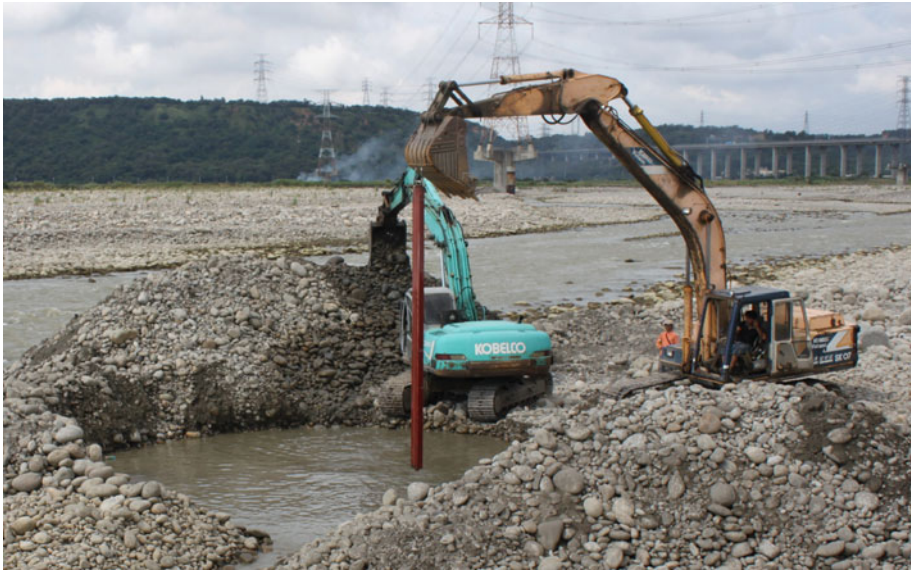
**Fig. 6** High-efficient brick column laying method (Highway Bridge hydrological station in the lower Dajia River)

measure the general scour depth, which is a direct observation method. A high-efficient scour brick column laying technology was developed, which uses a 5-m-long supplementary hollow steel rod with openings at both ends and two excavators. The excavators can simultaneously place about 90 pieces of numbered bricks (length 200 mm × width 100 mm × height 60 mm each) at a time, as shown in Fig. 6. The laying work was performed near one side of the main channel during the low flow period. A transit was used to locate the position of the brick column. Also, a flood stage gauge was installed on the embankment or floodplain to observe the corresponding peak flood level. After a flood, the riverbed was excavated to measure the short-term maximum general scour depth ( $d_s$ ) in the river reach and the corresponding mean peak scoured flow depth ( $y_{ms}$ ).

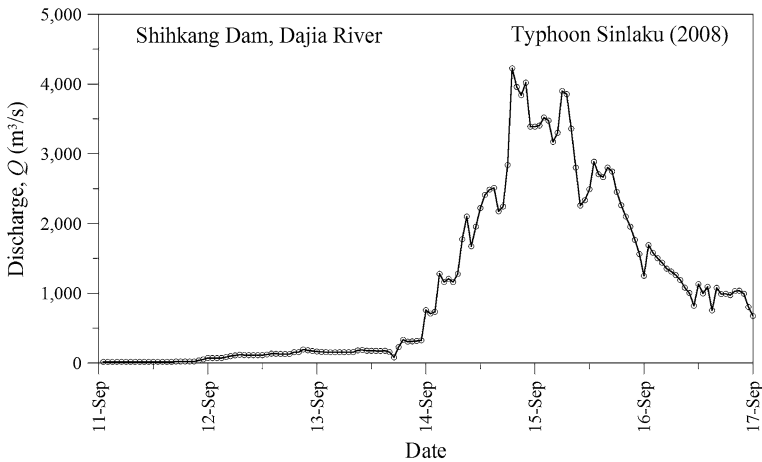
**Fig. 7** Typical flow hydrographs in the intermittent Dajia River during Typhoon Sinlaku (2008)

The number of occurrences of typhoon-induced floods with short-term general scours is limited each year for the intermittent rivers in Taiwan. Also, the data collection for these rivers is a very challenging task during the rapidly varied floods. Figure 7 depicts a typical flow hydrograph collected during Typhoon Sinlaku in 2008 for the lower Dajia River. One

can see the rapid variation of the flow in this intermittent river. A short-term general scour usually occurs during the rising limb, and a deposition occurs during the recession limb of the flood (Lu et al. 2008). For example, both the Houfeng Bridge failure in Dajia River (Typhoon Sinlaku, peak flow  $Q_p = 4,225 \text{ m}^3/\text{s}$ , which was close to the 5-year flood,  $Q_5 = 3,800 \text{ m}^3/\text{s}$ ; Hong et al. 2012) and the Shuangyuan Bridge failure in lower Gaoping River (Typhoon Morakot,  $Q_p = 27,360 \text{ m}^3/\text{s} \approx Q_{200}$ ) occurred near the flood-peaks in 2008 and 2009, respectively.

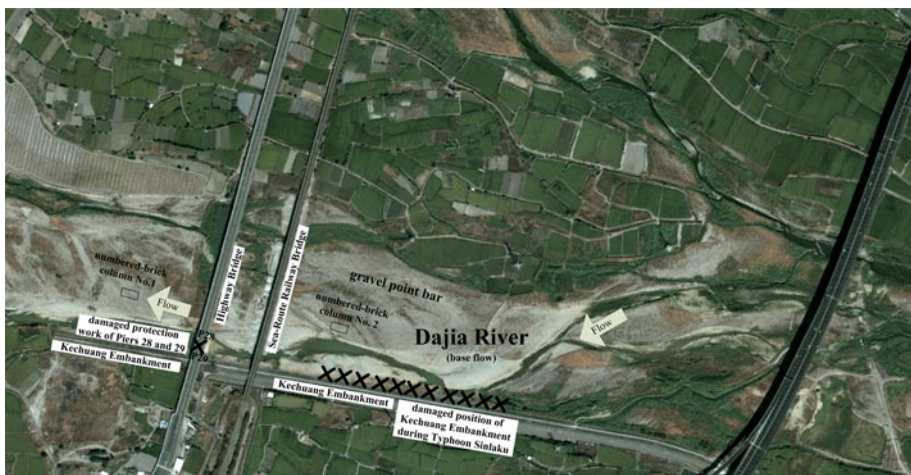
**Fig. 8** Layout of the numbered-brick columns for measuring short-term general scours at Highway Bridge hydrological station in the lower Dajia River

As shown in Fig. 8, two numbered-brick columns of about 5 m long were placed 155 m downstream and 245 m upstream of the Highway Bridge at the main channel in the Dajia River before Typhoon Sinlaku (2008) for measuring the short-term general scours. From Table 1, the measured maximum general scour depth  $d_s$  was 4.5 m ( $75 \times 0.06 \text{ m}$ ) at the downstream measuring position (No. 1) in the straight river reach, which was a very high value and essentially occurred near the flood-peak. As shown in Fig. 3a, the damage of the

The upstream measuring position (No. 2 in Fig. 8) was located in the meandering reach near the Kechuang Embankment, and the maximum short-term general scour depth  $d_s$  was 2.28 m ( $38 \times 0.06 \text{ m}$ ), which was much lower than 4.5 m measured at No. 1, since the flow had an attack angle of about  $45^\circ$  nearby the gravel point bar. The Kechuang Embankment hazard was caused by the short-term general scour due to the direct impact of the flood-peak against the footing of the embankment (about 3 m deep). However, it can be deduced that the total scour depth near the Kechuang Embankment was about 4.5 m (same as the value measured downstream), which was estimated according to the elevation difference in the concrete-block elevation near the embankment before and after the attack of Typhoon Sinlaku.

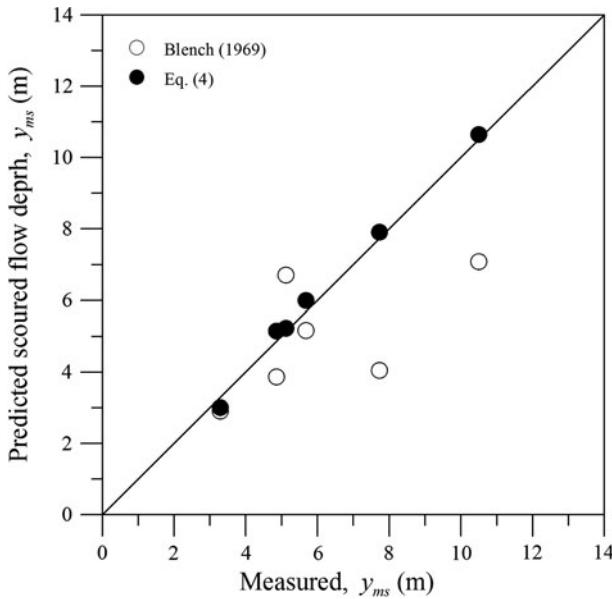
**Fig. 10** Comparison of the predicted and measured scoured flow depths ( $y_{ms}$ )

in which  $y_{ms}$ ,  $q$ , and  $D_{50}$  are in m,  $\text{m}^3/\text{s}/\text{m}$ , and mm, respectively, and the coefficient of determination  $r^2 = 0.99$ . The comparison of values estimated by Eq. (4) and Blench's (1969) formula is presented in Fig 10, indicating Eq. (4) gives reasonably good predictions. Equation (4) can be applied for the flow and bed material data ranges shown in Table 2.
