Glacial lake outburst flood at Kedarnath, Indian Himalaya: a study using digital elevation models and satellite images

Abstract Kedarnath (3,533 m, 30°44′05″N, 79°04′02″E) is situated within a kilometre of the termini of the Chorabari and Companion glaciers in the Indian Himalaya. An outburst flood from a lake (3,845 m) formed by right lateral moraine of the former caused severe damage to the village on 17 June 2013. We determined various physical parameters of the lake from three digital elevation datasets (CartoDEM, SRTM and ASTER) and selected the SRTM-derived data as they appeared to portray the region more accurately. The obtained parameters were used in predictive equations suggested by different authors to estimate peak discharge of the flood. We also compared high-resolution images of 10 December 1965 (Corona), June 2011 (Bing) and 25 June 2013 (Catrosat-1 Pan + LISS-4mx) to assess the damage caused to the village besides other geomorphic changes. The results showed that at least 149 mm of rainfall in its 291-ha catchment was required to fill up the lake, without considering the presence of antecedent water and loss from seepage and evaporation. At the point of breaching,

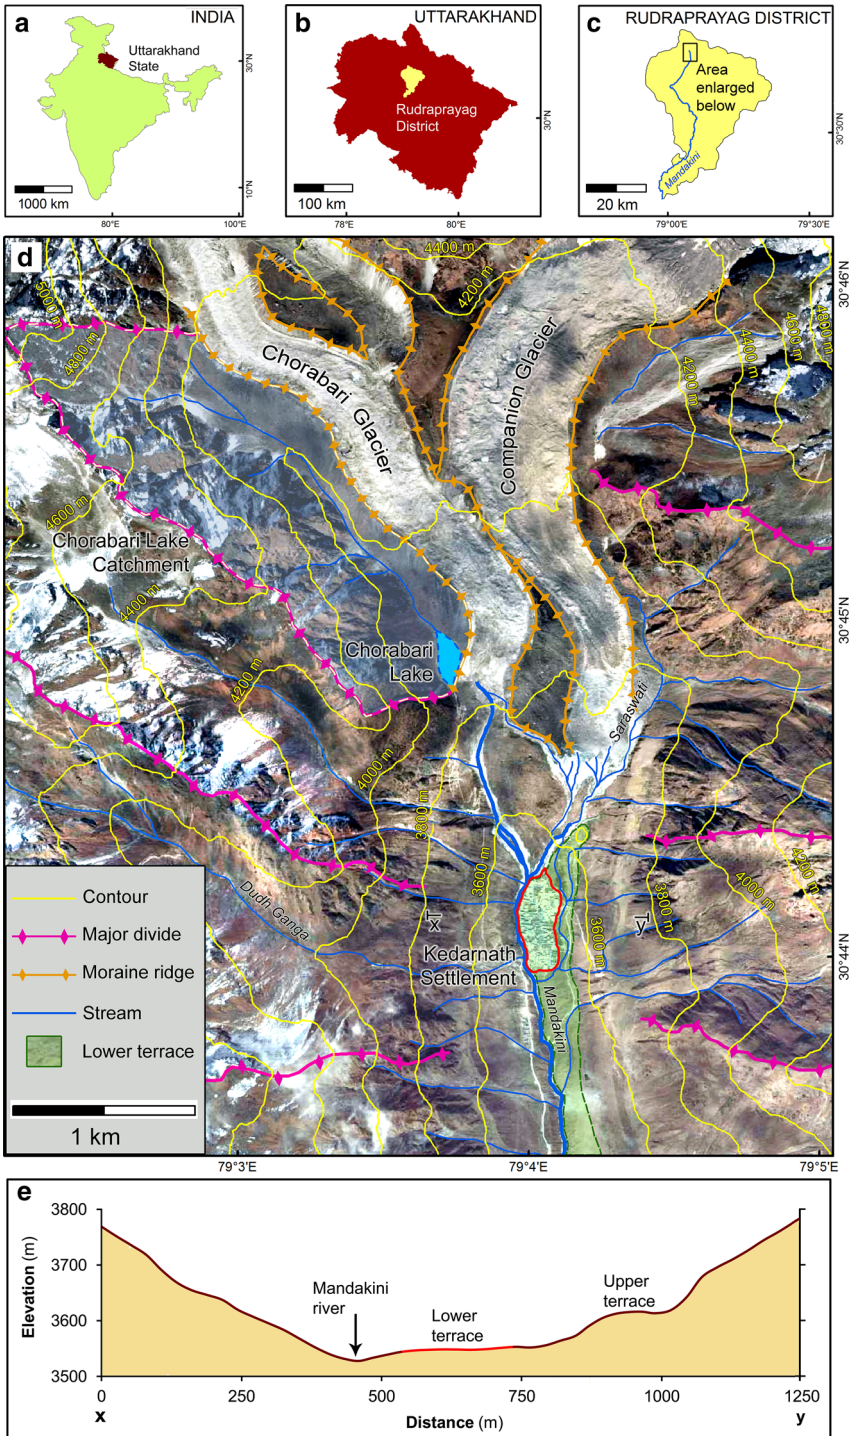
◀ **Fig. 1** Location and physiographic setting of the Chorabari lake, its catchment and Kedarnath village at the vicinity of the Chorabari and Companion glaciers. Contours, lake catchment and other topographical elements are extracted from SRTM data of 2000 and superposed on November 2011 image of Bing Maps. Red colouration in topographical profile of **e** shows the extent of Kedarnath settlement on the lower terrace

Griesbach in 1882 recorded ~ 10 hutments that lined the temple on a terrace of the Mandakini (Figs. 1d, 4). It also indicated that the masses of both Chorabari and Companion glaciers were markedly greater than the present, and their surface elevations were higher than the level of the lateral moraine ridges. Existence of the Chorabari lake at that time is unsure. The water body was not shown in Survey of India's topographical map 53N/NW (1:126,720), surveyed in 1923–1924. However, the subsequent edition of the map (53N/2, 1:50,000), surveyed in 1962, showed the lake prominently as did a 1965 Corona image (Fig. 5a). Some 83 years after Griesbach's photograph, the Corona image also indicated that Kedarnath village became well established in an elongated form and covered approximately 2.49 ha. By 2013, it expanded to 8.34 ha and became more congested (Figs. 2, 5b). The liner extension of the settlement was 520 m and had a southward gradient of 1:12.4, almost similar to the Mandakini, flowing on its west. Its elevation varied between 3,512 m in the south and 3,554 m in the north.

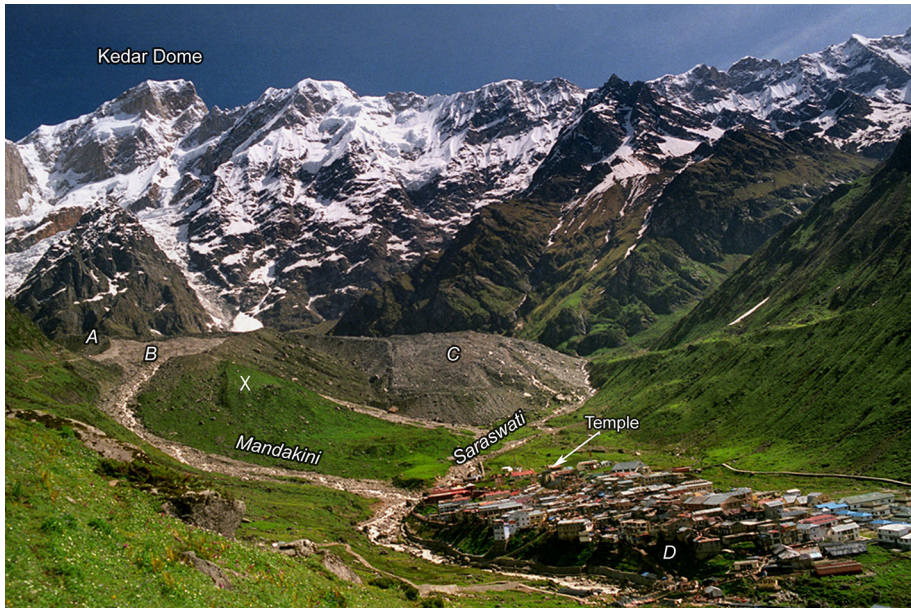
Fig. 2 Physical setting of Kedarnath village in 2011. The retreat and shrinkage of the glaciers during the last ~ 130 years can be appreciated by comparing them with the facet marked 'X' in this photograph and in Fig. 4. A location of the Chorabari lake enclosed by the right lateral moraine of the Chorabari glacier; B Chorabari glacier; C Companion glacier; D Kedarnath settlement

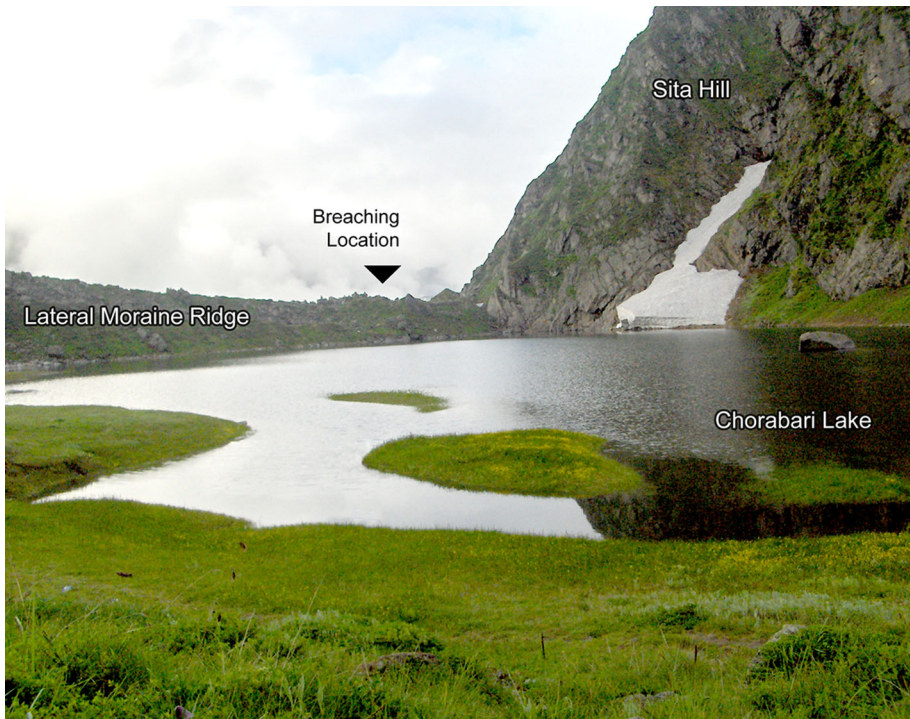
Fig. 3 Chorabari lake in June 2011, viewing south. Note the portion of the moraine ridge that gave way to accumulating water on 17 June 2013

coincided with the location of breaching indicated by the merged Catrosat-1 Pan + LISS-4mx image of 25 June 2013 (Figs. 3, 7). Its actual height, however, is likely to be somewhat different from the above elevations because the 28-m (CD and AD) or 85-m (SD) DEM pixels represented average altitudinal values (Fig. 6). The lowest relative height

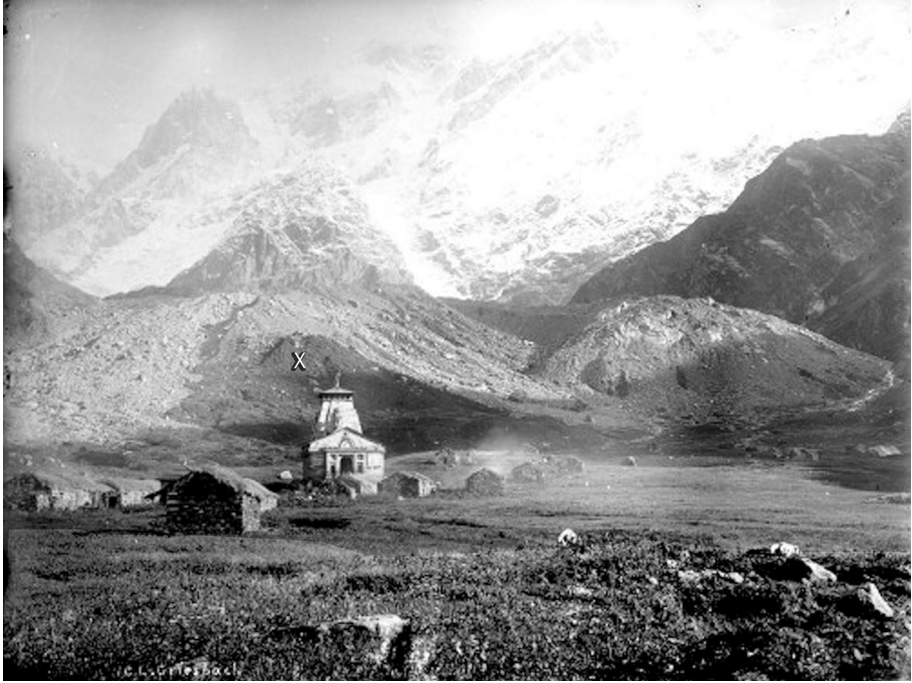
Fig. 4 Kedarnath temple area in 1882. Photograph taken by Carl L. Griesbach. See text for explanation (source: GSI 2013)

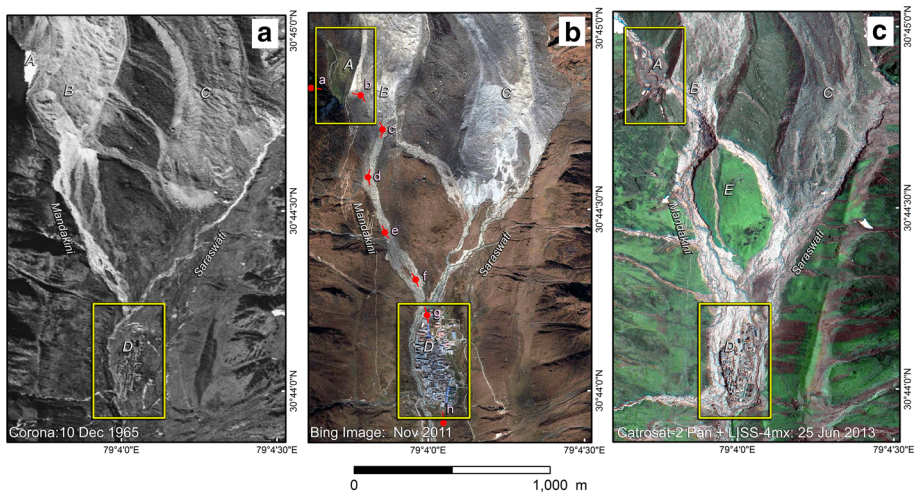
Fig. 5 Comparative images of the study area showing changes between 1965 and 2011 (46 years) and 2011 and 2013 (2 years). The areas marked in upper left and lower central portions of the images are enlarged as Figs. 7 and 9, respectively. *Line a–h* of Fig. 5b marks the elevation profile represented in Fig. 8 across the Chorabari lake and Kedarnath village along the shortest path taken by the GLOF. *A* Chorabari lake; *B* Chorabari glacier; *C* Companion glacier; *D* Kedarnath settlement; *E* Channel reactivated by the GLOF

Inspection of the 2011 image of the glacial outwash features above Kedarnath denoted that apart from taking the usual southward route from the snout of the Chorabari glacier, the meltwater also used to issue towards the south-east through a fairly steep gully in the direction of the Saraswati. In 1965, at least five gullies were well established on the left lateral moraine of the Chorabari glacier (Fig. 5a), out of which only this one remained active 48 years later (Fig. 5b). The number of south-flowing streamlets issuing from the

snout region also dwindled from three to one. This probably connoted either a reduction in precipitation amount and/or a drop in water discharge from the glacier since 1965. A comparison between the 2011 and 2013 images showed that a new gully was opened on the east of and sub-parallel to the main south-flowing channel to accommodate the GLOF-generated debris flow (marked 'E' in Fig. 5c). This, however, was a reactivation of one of the old disused 1965 streamlets mentioned earlier. It can also be inferred from the scarps established in the streambeds by the 2013 debris flow that the bulk of the water and slope materials that devastated Kedarnath followed the more direct southward channel rather than the eastward gully towards the Saraswati. As the debris started to fan out at the break of slope below 3,650 m (point 'e' in Figs. 5b, 8), the width of lower portions of both the channels increased by more than four times.

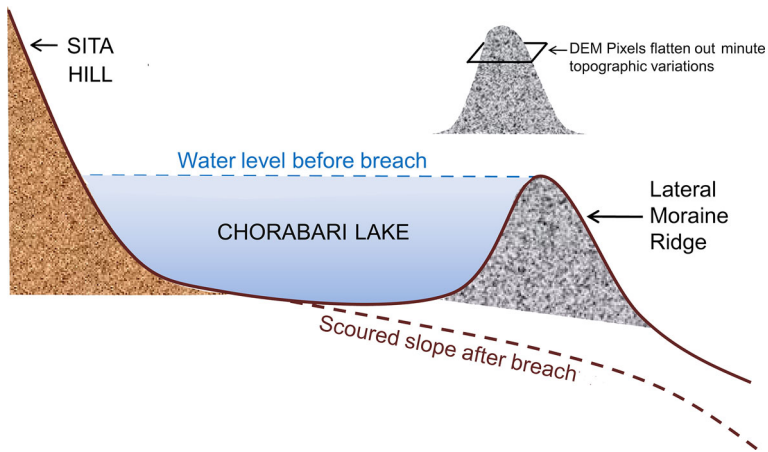
Fig. 6 Schematic pre- and post-GLOF profiles across the Chorabari lake, from west to east through the point of outburst (not to scale). The volume of floodwater estimated in the study is based on the lowest elevation of the DEM pixel situated on the central axis of the moraine ridge that coincided with the breached portion shown in Figs. 3 and 7b. The elevation is likely to be somewhat different from actual because every DEM pixel averages out all topographical variations within its perimeter

of the ridge from the lake bed amounted to 11 m (CD), 12 m (SD) and 15 m (AD). Based on these values, contours were generated to indicate the bankful capacity of the lake prior to its breaching (Fig. 7), which amounted to $0.63 \times 10^6 \text{ m}^3$ (CD), $0.43 \times 10^6 \text{ m}^3$ (SD) and $0.25 \times 10^6 \text{ m}^3$ (AD).

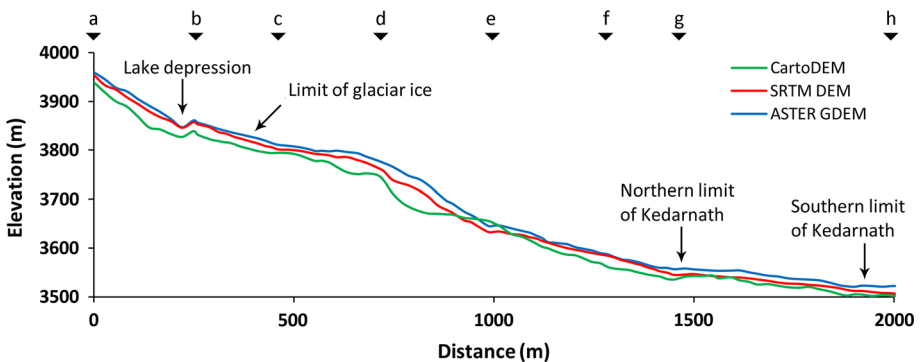
Fig. 8 Topographical profiles along the shortest path taken by the GLOF from the Chorabari lake through the village of Kedarnath (marked a–h in Fig. 5b). Vertical exaggeration: 1.2×

The elevation profiles along downstream path of the GLOF showed noticeably better consistency between AD and SD than between CD and the other two (Fig. 8). The average deviations of the AD-generated and CD-generated profiles were +9.9 and -13.2 m from the SD-derived profile, respectively. The ranges of deviations were +26.94 to +0.81 m (27.8 m) and -43.59 to +22.27 m (66.2 m) in that order.
