Risk analysis and emergency actions for Hongshiyuan barrier lake

Abstract This paper presents the emergency response to the barrier lake created by the M_w 6.5 earthquake on August 3, 2014, in Niulan River which is situated in Yunnan Province, southwest China. The lake, behind 83- to 103-m-high landslide dam, has a storage capacity of 260 million m^3 . The Hongshiyuan hydropower station, situated just upstream of the landslide dam, was submerged by the lake water. The rescue actions include building an 8-m-deep drainage channel in the flood season, draining the lake water via a water release tunnel and rebuilding the landslide dam as a permanent structure. This paper presents the considerations and processes in deciding on the emergency actions. One major consideration is to minimize the hazards caused by a possible dam break flood induced by Hongshiyuan barrier lake in the flood season. It was found that the barrier lake is classified as “grade I: extremely high risk” in which the 5- and 20-year floods should be used for design and check purposes of emergency works, respectively. The dam break flood evaluations indicated that an 8-m-deep diversion channel should be constructed in

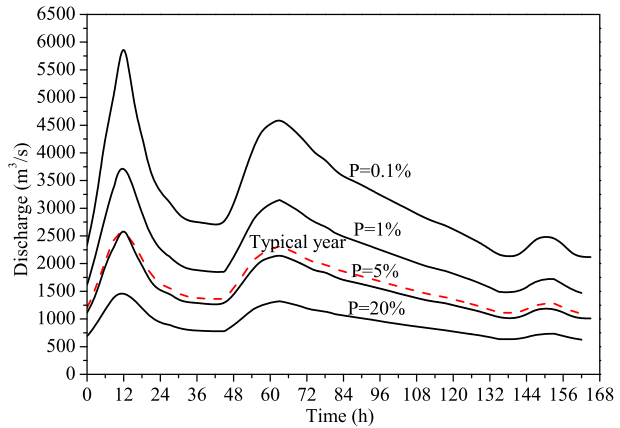
Fig. 2 Design flood hydrographs (solid lines) and measured flood hydrograph in 1968 (dashed line) at Hongshiyuan hydropower station

The Niulan River, where the landslide dam happened, is a main tributary of the Jinsha River. It is located in Yunnan Province, China, as shown in Fig. 1. Its total length is 440 km with a catchment area of $13,672 \text{ km}^2$. The average bed slope is approximately 4.4 ‰. According to the historical data from 1953 to 2012, the average annual runoff was approximately $4.9 \times 10^9 \text{ m}^3$, and the average flow at Hongshiyuan hydropower dam was approximately $128 \text{ m}^3/\text{s}$. In the typical year of 1968, the peak discharge at Hongshiyuan hydropower station was measured to be $2740 \text{ m}^3/\text{s}$. Figure 2 shows the design flood hydrographs of different return periods (solid lines) and the 1968 flood hydrograph (dashed line).

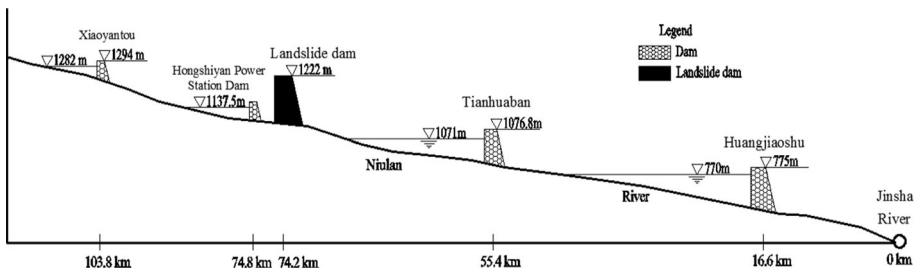
Fig. 3 Geographic relationship of the cascade dams and the landslide dam

The Niulan River has rich water resources with four hydropower stations that are located in the vicinity of the landslide. Figure 3 shows the locations of the four cascade hydropower stations and the landslide dam. The Hongshiyuan hydropower station is submerged completely, and the downstream hydropower stations (Tianhuaban and Huangjiaoshu) face the risk of overtopping if the landslide dam breaks. The main technical parameters of the downstream hydropower stations are shown in Table 1.

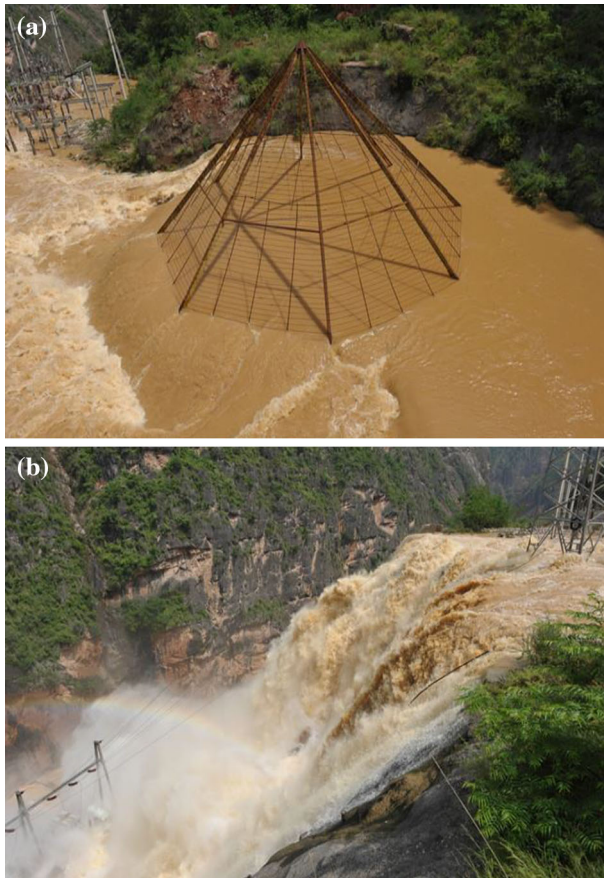
Fig. 5 Overflowing through the surge tank

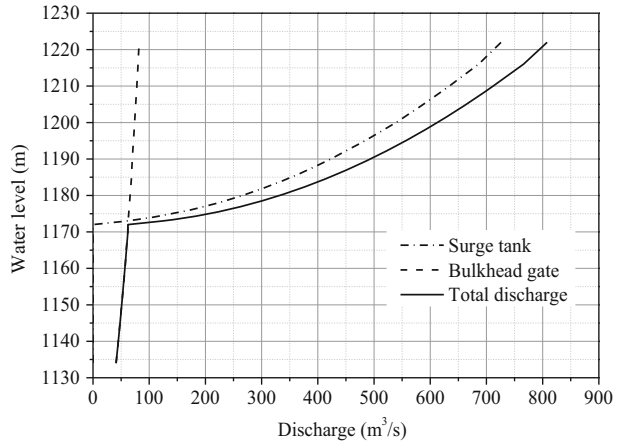
Fig. 6 Discharge curves of surge tank and bulkhead gate

1. Q_1, Q_2 can be found in Fig. 14a for either the 5- or 20-year flood;
2. q_1, q_2 are the discharge capacities of the surge tank and bulkhead gate, respectively, associated with the lake water level elevation, as shown in Fig. 6, and
3. the relationship between the lake water level Z and the storage in the lake V is shown in Fig. 7.

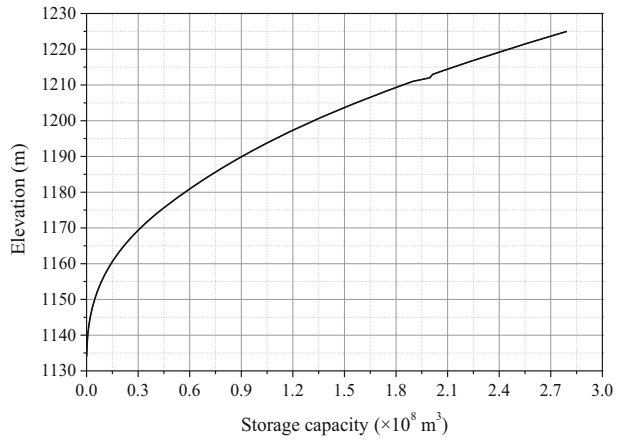
Fig. 7 Relationship between water storage and elevation of the landslide lake

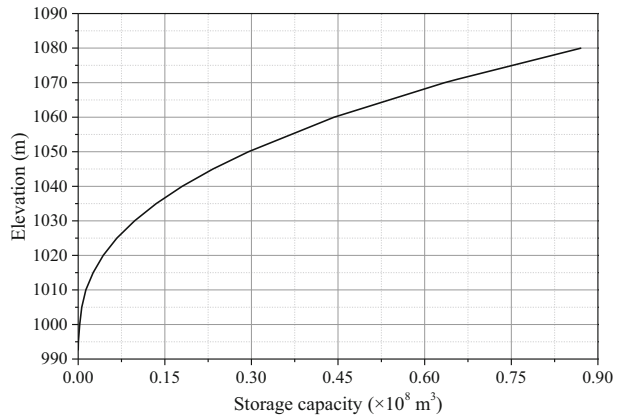
Fig. 8 Relationship between water storage and elevation of Tianhuaban

normal flood levels are 1076.61 and 1070.91 m, corresponding to the reservoir capacities of 7.87×10^7 and $6.57 \times 10^7 \text{ m}^3$, respectively. The maximum discharge is approximately $5046 \text{ m}^3/\text{s}$ through all discharge structures, and the discharge would be $3152 \text{ m}^3/\text{s}$ if the water level is at the design flood level (1070.91 m). The storage–elevation curve and the discharge curves are shown in Figs. 8 and 9, respectively.

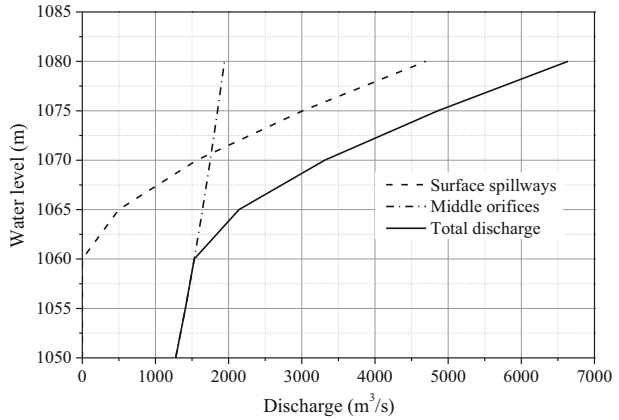
Fig. 9 Discharges of the flood release facilities of Tianhuaban

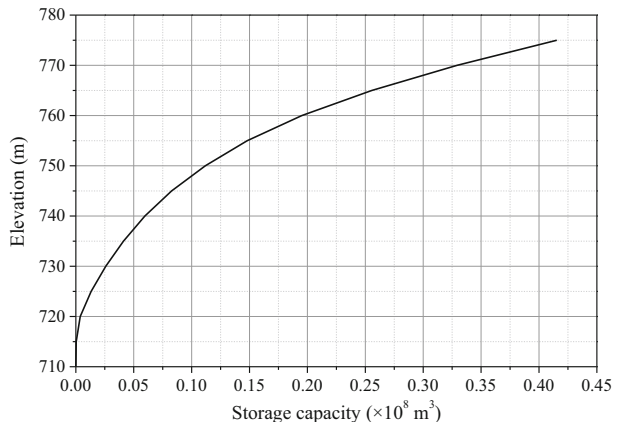
Fig. 10 Relationship between water storage and elevation of Huangjiaoshu

$3.29 \times 10^7 \text{ m}^3$, respectively. The discharge structures include a spillway tunnel and a sediment diversion tunnel. The respective inlet elevations of the two tunnels are 750 and 716 m. The maximum discharge is approximately $6691 \text{ m}^3/\text{s}$ through both tunnels, and the discharge would be $5744 \text{ m}^3/\text{s}$ if the water level is at the design flood level (i.e., 770 m). The storage–elevation curve and discharge curves are shown in Figs. 10 and 11, respectively.

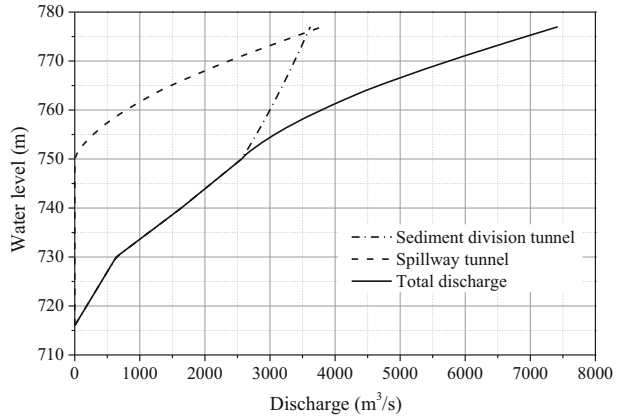
Fig. 11 Discharges of the flood release facilities of Huangjiaoshu

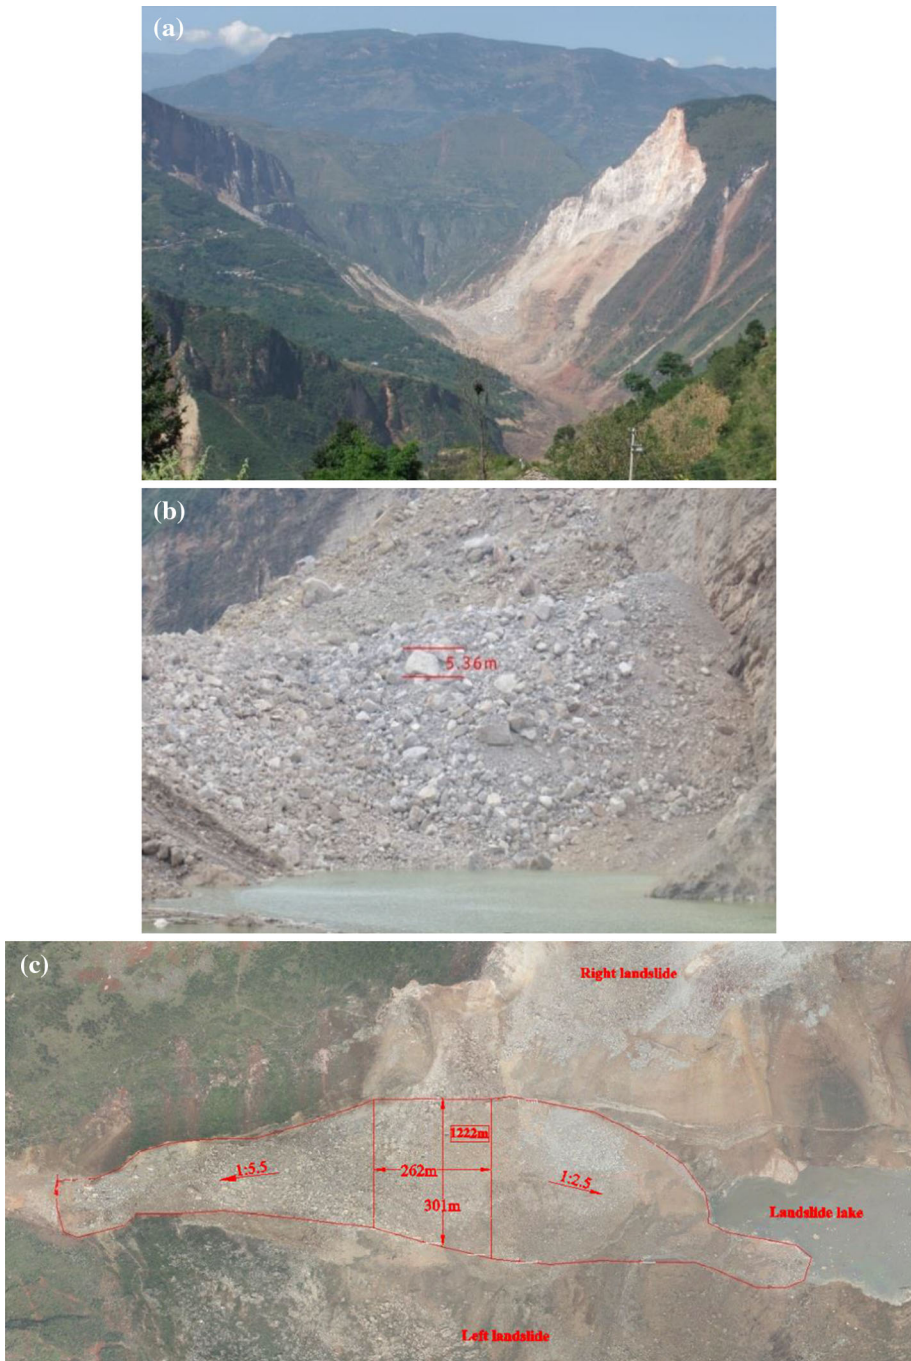
Fig. 12 Hongshiyuan landslide dam. **a** The overall view, **b** the dam surface, **c** the size of dam (from Kunming Engineering Corporation Limited)

Hongshiyuan landslide dam is formed by the collapsed strongly weathered dolomite on both sides of the Niulan River. The volume of the landslide deposit is approximately $1.2 \times 10^7 \text{ m}^3$ with the deposit on the right of the landslide accounting for 70 % of the total. Some of the deposits in the dam body are larger than 50 cm, and the maximum diameter of rock is between 5 and 10 m. The crest elevation of Hongshiyuan landslide dam

is 1222 m. Its height is between 83 and 103 m. The storage capacity of barrier lake is $2.6 \times 10^8 \text{ m}^3$, and the length of upstream backwater is 25 km when the water level is at the crest elevation of landslide dam (i.e., 1222 m). Table 2 and Fig. 12 show the main characteristic parameters and topography of the landslide dam.

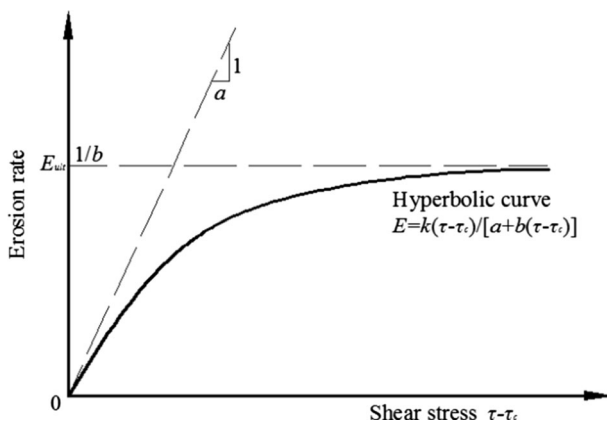
Fig. 13 Hyperbolic model for soil erosion rate

where k is a unit conversion factor that allows E to approach its asymptote E_{ult} within the working range of τ . As shown in Fig. 13, the hyperbolic curve has an asymptote represented by $E_{ult} = 1/b$ as $\tau - \tau_c$ approaches infinity. This is the maximum possible soil erosion rate. The parameter $1/a$ represents the tangent of this curve at $\tau = \tau_c$.

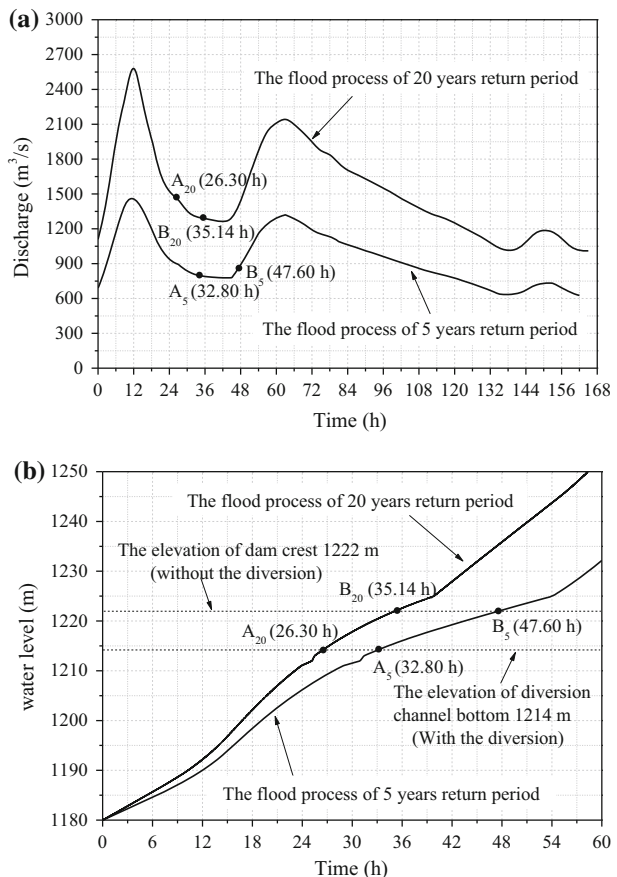
Fig. 14 Flood hydrograph at Hongshiyuan. **a** 5- and 20-year return period (7 days), **b** regulated flood process

The flood routing results show that (Fig. 14b):

1. for the 5-year design flood, the water level reaches 1214 m at 32.80 h (point A_5) and 1222 m at 47.60 h (point B_5), and
2. for the 20-year design flood, the water level reaches 1214 m at 26.30 h (point A_{20}) and 1222 m at 35.14 h (point B_{20}).

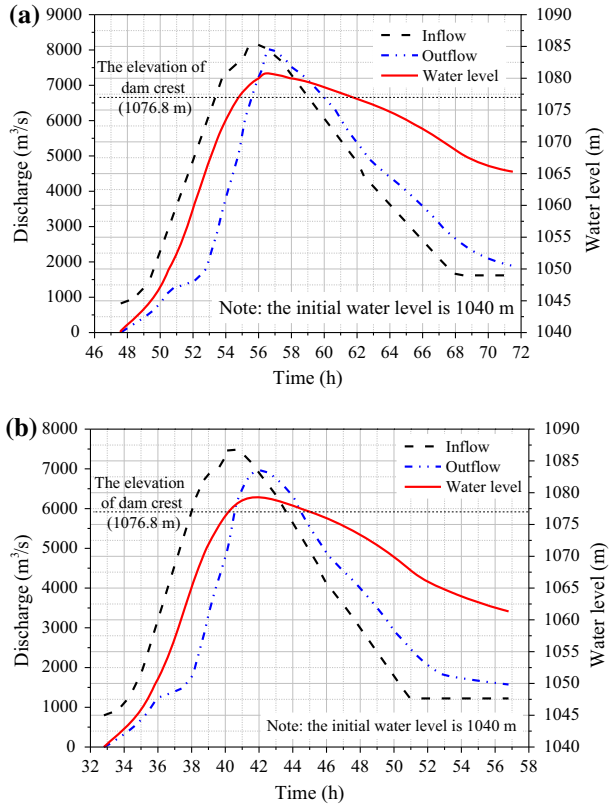
Fig. 16 Flood hydrographs at Tianhuaban for 5-year design flood. **a** Without diversion channel, **b** with diversion channel

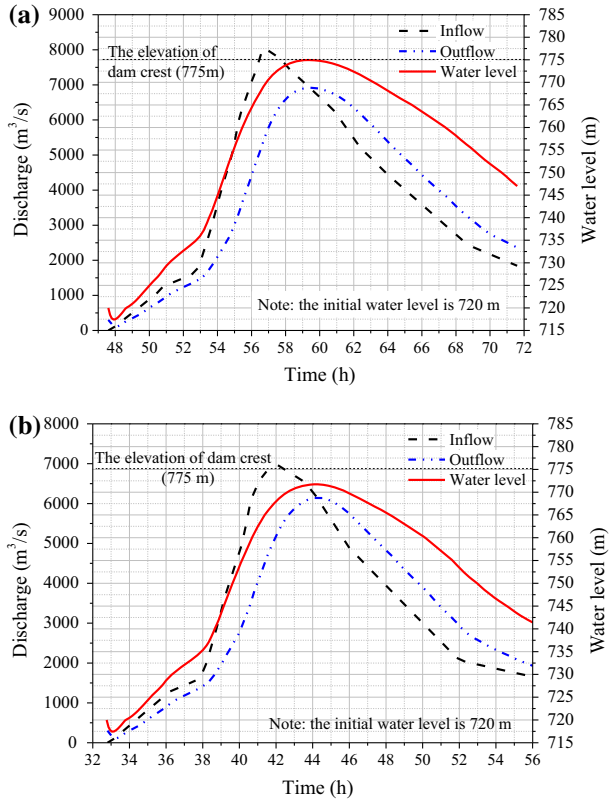
Fig. 18 Flood hydrographs at Huangjiaoshu for 5-year design flood. **a** Without diversion channel, **b** with diversion channel

and 19 show the flood hydrographs at Huangjiaoshu for 5- and 20-year design floods. Table 7 contains a summary of the floods at Huangjiaoshu.

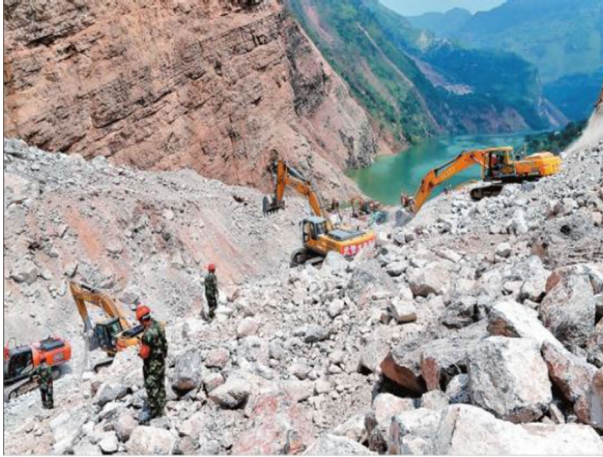
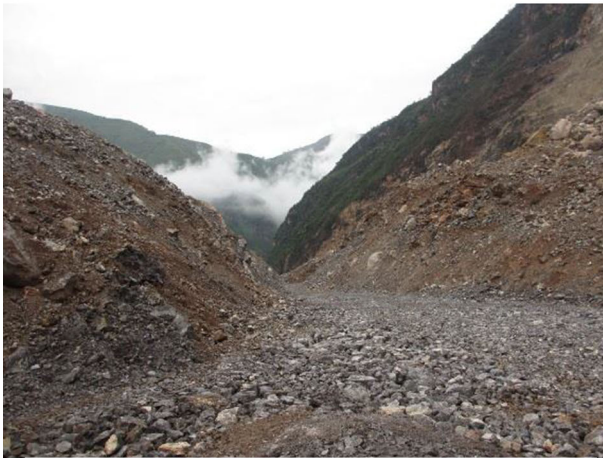
Fig. 21 Excavation of diversion channel

Based on the risk assessment of Hongshiyuan landslide dam and the past emergency works at other sites, the diversion channel was decided to be built for the safety of the residents and structures in the downstream area, including Huangjiaoshu rockfill dam. After comparing the discharge and size of the channels and the construction time in other schemes, it was decided on a trapezoidal diversion channel with a side slope of 1:1.5 on both sides. The channel is 8 m deep with a base width of 5 m. The invert elevation of the channel inlet is 1214 m. The construction work started on August 8, 2014, and completed on August 12, 2014. Figure 20 shows the design ichnography of the diversion channel. Figure 21 shows the progress of the construction and the completed diversion channel.

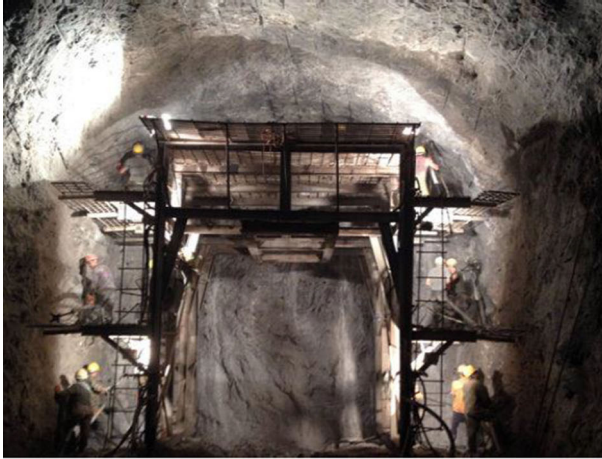
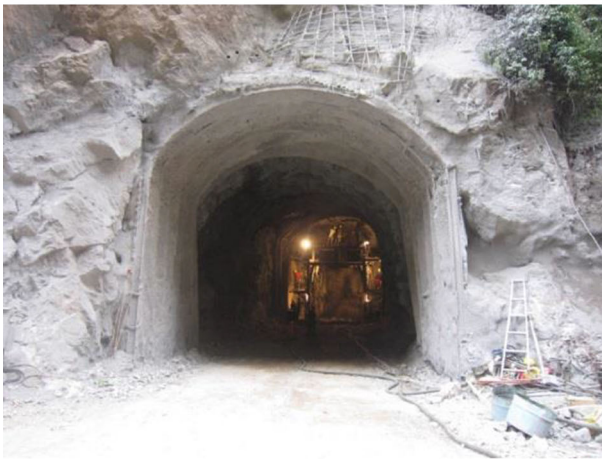
Fig. 22 New spillway tunnel on right bank

With the draining of the water in Hongshiyuan barrier lake by the newly built spillway tunnel, the risk of dam break has been eliminated. However, the total water storage of the landslide dam is approximately 10⁷ m³ with the backwater extending up to 24 km upstream. While the water in the lake poses a great threat to the residents living downstream, the cost of dismantling the landslide dam is huge. The demolition work is also extremely difficult as the rubbles of the dam body are large and there is no suitable location to stack them within the range of 30 km. It has been finally decided that the landslide debris should be upgraded to a permanent dam accommodating a power station with installed capacity of 200 MW. Figure 24 shows the design plan of the hydropower station. The projected is being constructed.
