# The earthquake in Jiuzhaigou County of Northern Sichuan, China on August 8, 2017

**Abstract** Jiuzhai Valley National Park in the Aba Tibetan and Qiang Autonomous Prefecture of northern Sichuan, China, is well renowned both at home and abroad as “World Natural Heritage,” “Man and Biosphere Conservation Network” and “National GeoPark of China.” An earthquake with a magnitude of 7.0 struck Jiuzhaigou County on the evening of August 8, 2017. Its focal depth was 20 km and followed thousands of after-shocks. The earthquake had affected 17 townships and 120 villages in varying degrees. By the 8 p.m. on August 13, the death toll of the earthquake reached 25, with 525 injured. Being formerly described as “Fairy tale world,” “King of waterscape,” the beautiful scenic spot now had become “scars of wounds strung together like beads,” and some of the beauty even disappeared. In this short communication, the incident background, casualties and scene are presented. Moreover, a brief investigation on the cause and seismic damage capacity of the earthquake as well as the earthquake early warning is conducted.

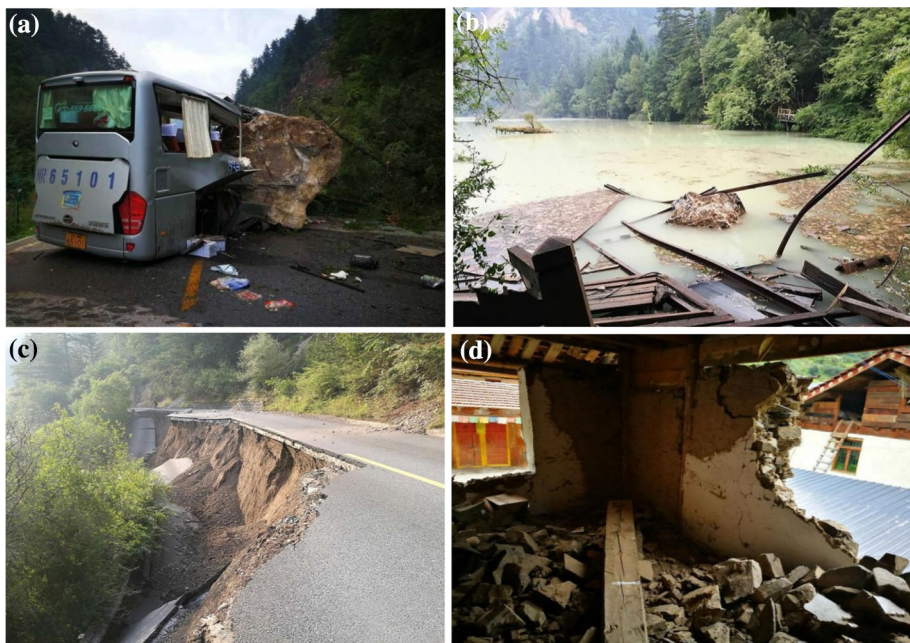
were generally affected, causing 25 people died and 525 injured. In severely affected areas, some housing units were collapsed while the power, communications and road traffic were seriously affected in the epicenter (Fig. 4).

**Fig. 4** Maps of damages after Jiuzhaigou earthquake. **a** Bus damaged by falling rocks; **b** infrastructure damage in scenic spot; **c** road collapse; **d** house damage. Sources: <http://www.xinhuanet.com/>, <http://www.chinanews.com/> and China Earthquake Administration <http://www.cea.gov.cn/>

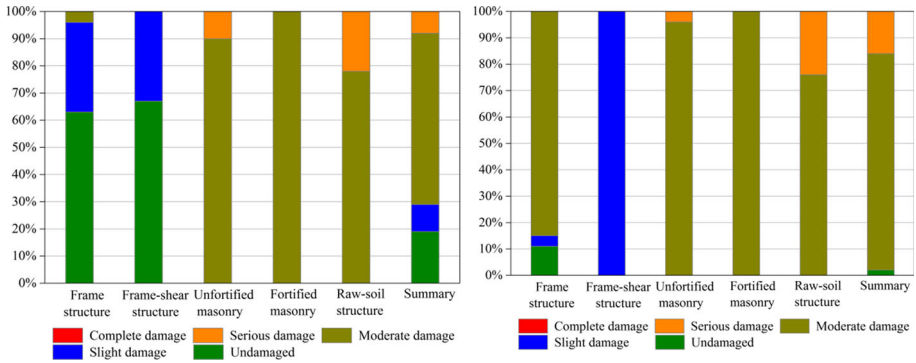
In addition to destruction and possibly secondary disasters in the scenic spots, local building damage caused by the earthquake is also an important part of the disaster assessment and reconstruction. Based on the data in this earthquake and data accumulated previously as well as *Earthquake Disaster Simulation V0.93* system (developed by Institute of Engineering Mechanics, China Earthquake Administration), the seismic data from the Bai River seismic station (the one closest to the epicenter) were inputted into the system stimulating typical building structures in countryside, villages and towns in seismic areas by Dr. Lu's team of Tsinghua University. The results of building conditions are shown in Fig. 7. (Sources: <http://www.sciencenet.cn/> and <http://mp.weixin.qq.com/s/yRwKxoggFYgCdsiCtOXYRQ>).

As shown in the simulation study of earthquake intensity that is same to this earthquake, the damage ratio of building in moderate or more seriously is approximately 70% in villages and towns while that is approximately 98% in countryside, which was indicated by the actual site situations of the disaster. The reason is that the buildings in villages or towns have better anti-seismic performance than those in countryside. Moreover, in Jiuzhaigou County region, there are 9 potential deformation points which became more seriously while 33 new points were found as a result of the earthquake.

**Fig. 7** Destruction of buildings in different regions. The left side provides the building conditions in villages and towns; the right side provides the building conditions in countryside. Source: <http://mp.weixin.qq.com/s/yRwKxoggFYgCdsiCIOXYRQ>

In addition, based on the aforementioned statements, the following conclusions can be drawn: As shown in the aforementioned destructive study, reasonable building structure and fortification standards can effectively reduce the extent of earthquake damage and accelerate post-disaster reconstruction. For example, the traditional brick-wood buildings were damaged seriously and even collapsed, while the fortified and frame-structured buildings were damaged lightly.
