# Coastal morphology and beach stability along Thiruvananthapuram, south-west coast of India

**Abstract** Shoreline changes are largely dependent on coastal morphology. South-west coast of India is a high energy coast characterised by monsoon high waves, steep beach face and medium-sized beach sand. Waves are generally from west and west south-west during rough monsoon season and from south-west during fair weather season. Shoreline change along this coast is studied with reference to coastal morphological features. Various morphological features, modifications and chronological positions of shoreline are analysed with the information derived from multidated satellite imageries, toposheets and GPS shoreline mapping along with extended field survey. Image processing and GIS techniques have been used for the analysis of data and presentation of results. Sediment accumulation on the leeward side of artificial structures such as harbour breakwaters and groynes is used as a sediment transport indicator. Artificial structures such as seawalls, groynes and harbour breakwaters modify morphology. Shoreline south of headlands/promontories and breakwaters are stable or accreting due to net n

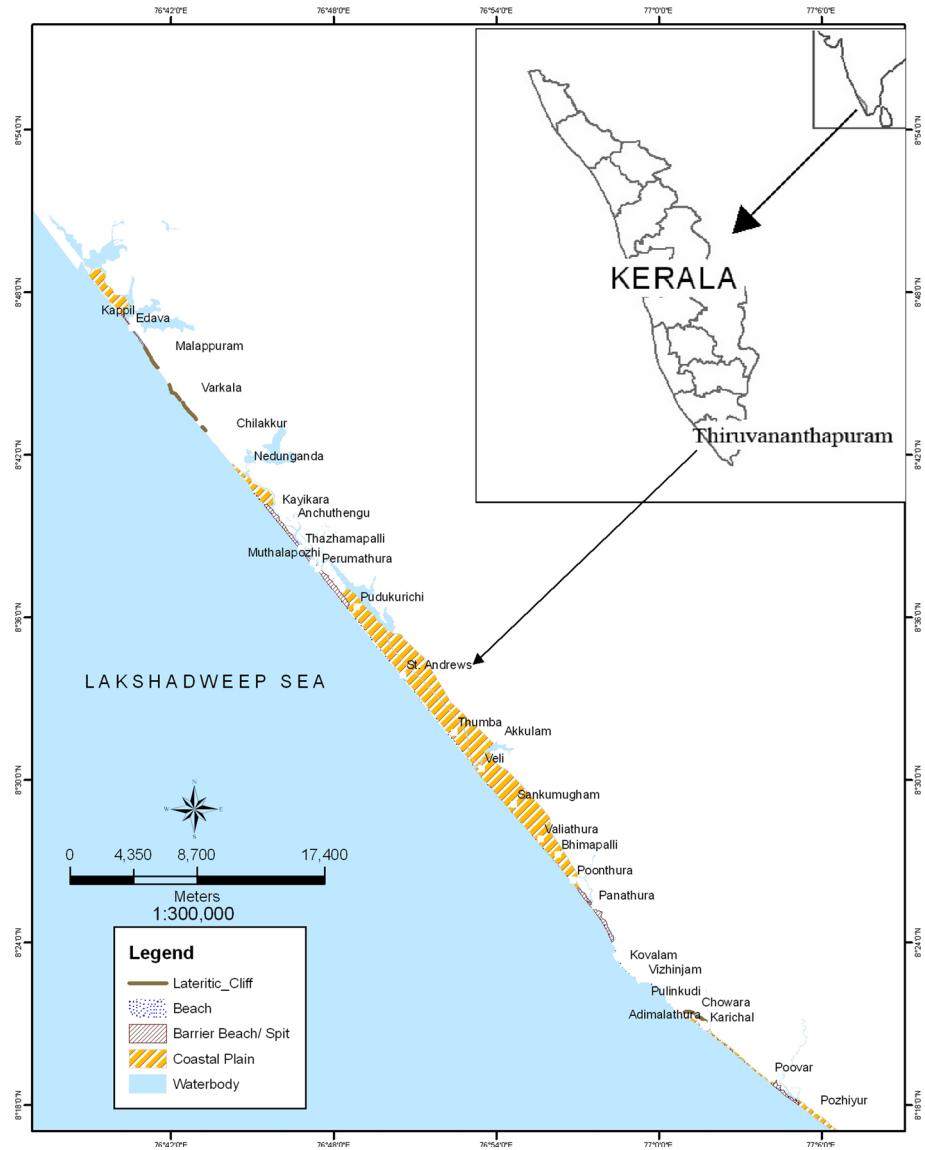
**Fig. 1** South-west coast of India (Thiruvananthapuram) and its morphology

The study area extends along the south-west coast of India for about 78 km of the Thiruvananthapuram coast (Fig. 1). It extends from Pozhiyur to Edava between  $8^{\circ} 17' 20.50''$  N;  $77^{\circ} 06' 09.06''$  E and  $8^{\circ} 46' 31.95''$  N;  $76^{\circ} 40' 38.07''$  E. Thiruvananthapuram coast is a high energy coast characterised by high waves, steep beach face and medium-sized beach sand. Coastal plains, barrier beaches/spits, pocket beaches and cliff/promontories are the major morphological features along the coast. Five tidal inlets are present along the study region, and most of them are seasonal. Coastal protection structures such as

Coastal morphological features along this coast were identified (Fig. 1 and Tables 1, 2). All the tidal inlets in the study sector are seasonal and open only during monsoon or when dredged open. Two of the inlets, Karichal and Veli, are associated with small water bodies and do not have adjoining barrier beaches/spits of significance. The Pozhiyur and

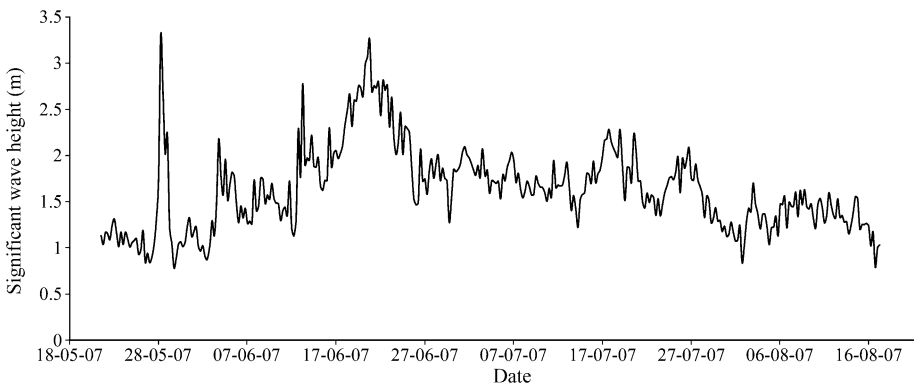
**Fig. 2** Significant wave height ( $H_s$ ) at Valiathura during the rough season (after Noujas et al. forthcoming 2017)

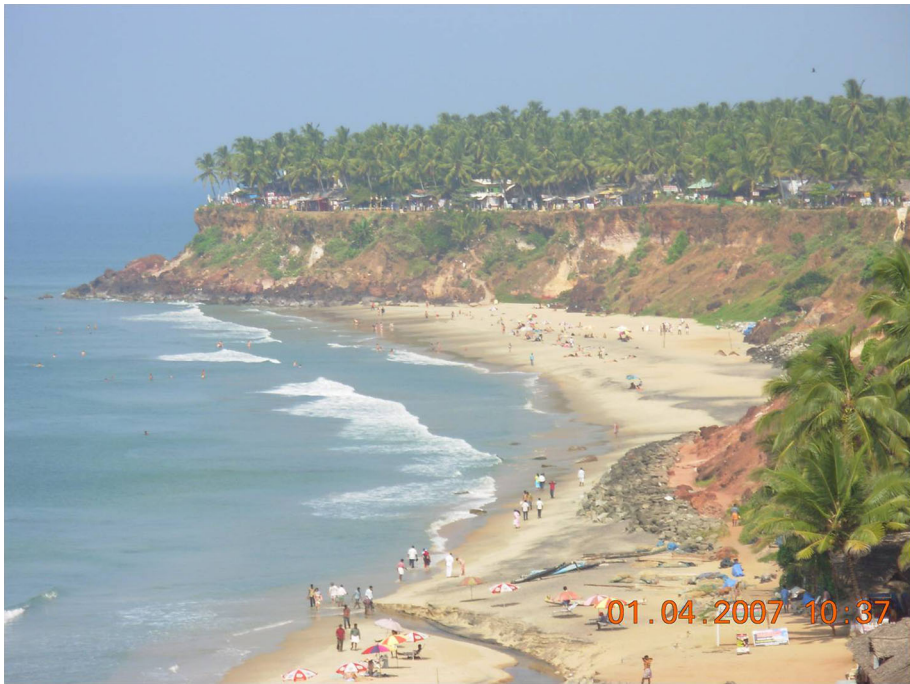
**Fig. 3** Lateritic cliff and frontal beach at Varkala

Coastal plains of Thiruvananthapuram are generally narrow. The sandy coast south of Pulinkudi headland extends from Adimalathura to Pozhiyur and further south. This sector of sandy coast is very narrow, and the width is limited by lateritic cliffs and hills. The coastal plain extending from Poonthura in the south to Pudukuruchi in the north is comparatively wider. Rocky headlands are located along Vizhinjam–Kovalam coastal stretch. Pulinkudi–Vizhinjam sector has both lateritic and rocky coast. Major lateritic cliffs are at Chowara and Varkala–Edava sector. The Chowara cliff is landward of settlements and fronted by very wide beach which has a width of about 400 m. Being much landward of the active beach zone this cliff does not have any significant influence on coastal processes. It is not considered for its influence on coastal process in the present study. The Varkala cliffs/promontories are fronting the sea with or without seasonal frontal beach. The 'cliff/promontory outline' is irregular and has pocket beaches in between. The pocket beaches of Vizhinjam–Kovalam are backed by rocky terrain except the 'Light House' and 'Kovalam north' beaches which are backed by laterites or elevated garden lands. The Varkala–Edava sector has pocket beaches backed by lateritic cliffs and promontories (Fig. 3).

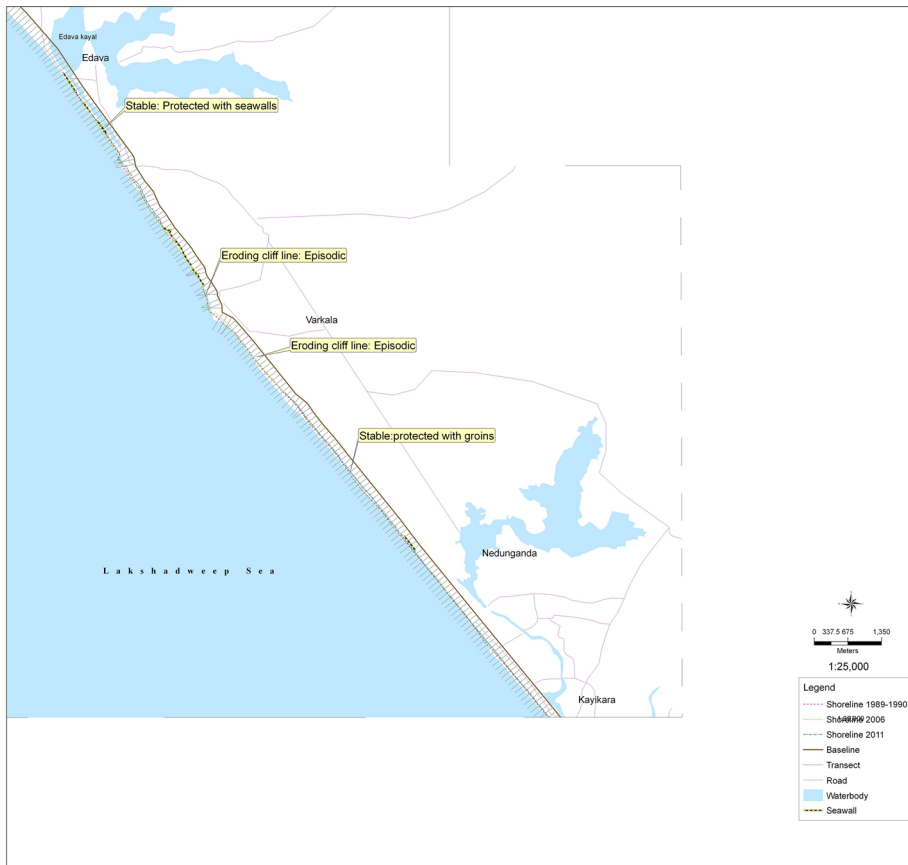
**Fig. 9** Shoreline change: Anjuthengu–Varkala sector

The coastal plain along Veli–Pudukurichi sector is also dynamically stable with seasonal erosion/accretion (Figs. 7, 8). Similar situation is observed along Anchuthengu–Nedunganda sector (Fig. 9).

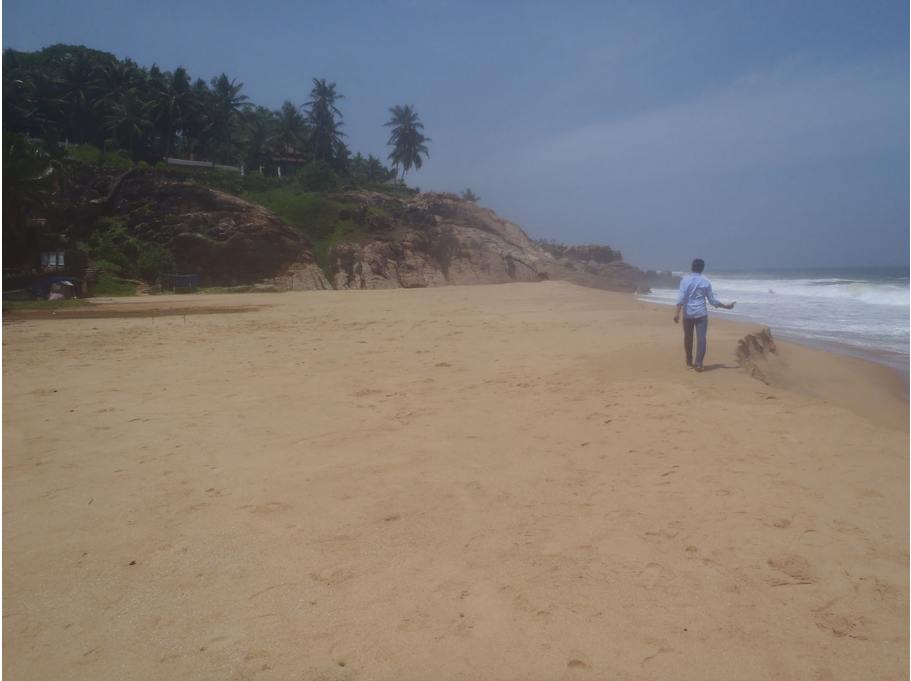
**Fig. 10** Seasonal erosion at pocket beach

There are 12 pocket beaches present in Thiruvananthapuram coast. Pocket beaches are dynamically stable and undergo seasonal erosion/accretion (Fig. 10). These variations are in tune with the rough and fair season. Such coastal systems are prominent along the Pulinkudi–Vizhinjam–Kovalam coastal sector. Shoreline along pocket beaches of Varkala has not shown significant variation in the recent years though the cliff has undergone slumping and retreat during 1989–2006. The cliffs landward of the pocket beaches being lateritic, undergoes scouring at the base during rough season which leads to slumping and cliff edge retreat as episodic events. Slumping of cliff edges at Varkala and Vizhinjam is evidence for such episodic events (Fig. 11).

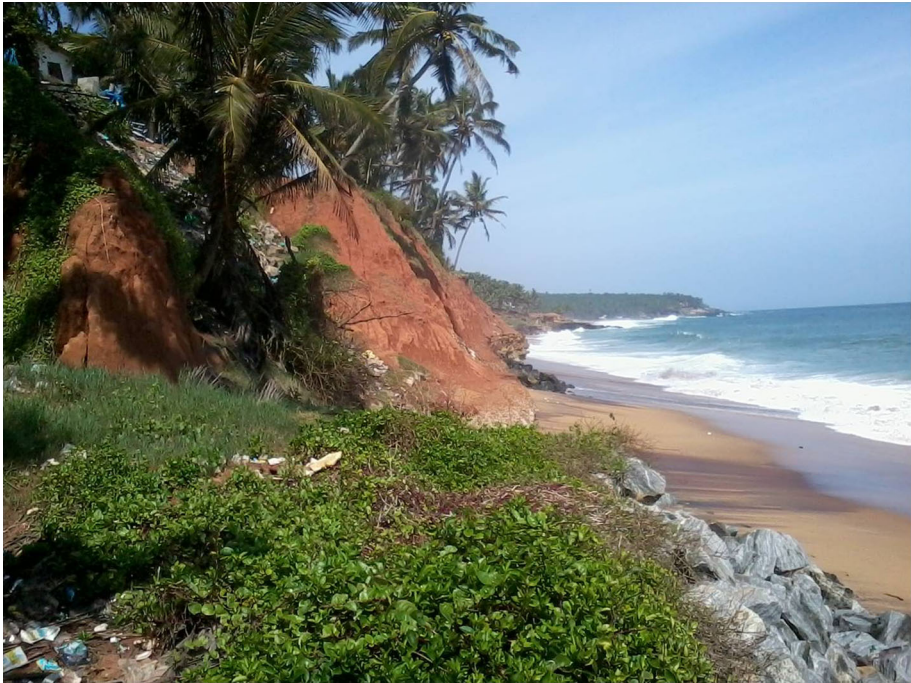
**Fig. 11** Cliff erosion south of Vizhinjam harbour

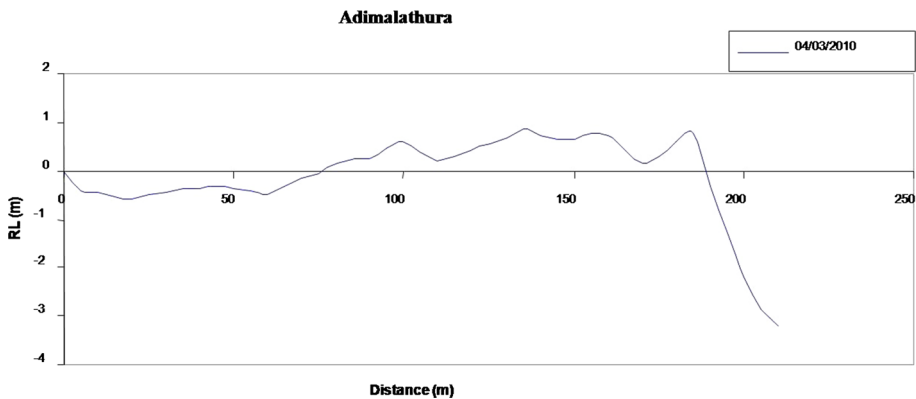
**Fig. 12** Typical profile of an accreted beach at Adimalathura

The coastal plain north of Poovar/Pozhiyur inlet up to Adimalathura remains dynamically stable with multiple berms. The shoreline of this region has been showing accretion tendency which was also supported by Shaji 2014. The widening of the beach has created a backward sloping and wide backshore (Fig. 12) which gets flooded when there is any flooding from the sea due to increased wave set up as a result of highly grouped remotely forced waves (*kallakadal*) synchronised with spring high tide (Kurian et al. 2008; Thomas et al. 1986). This becomes a serious problem usually along accreting and wide beaches in high energy coasts during fair season when the waves are otherwise low.

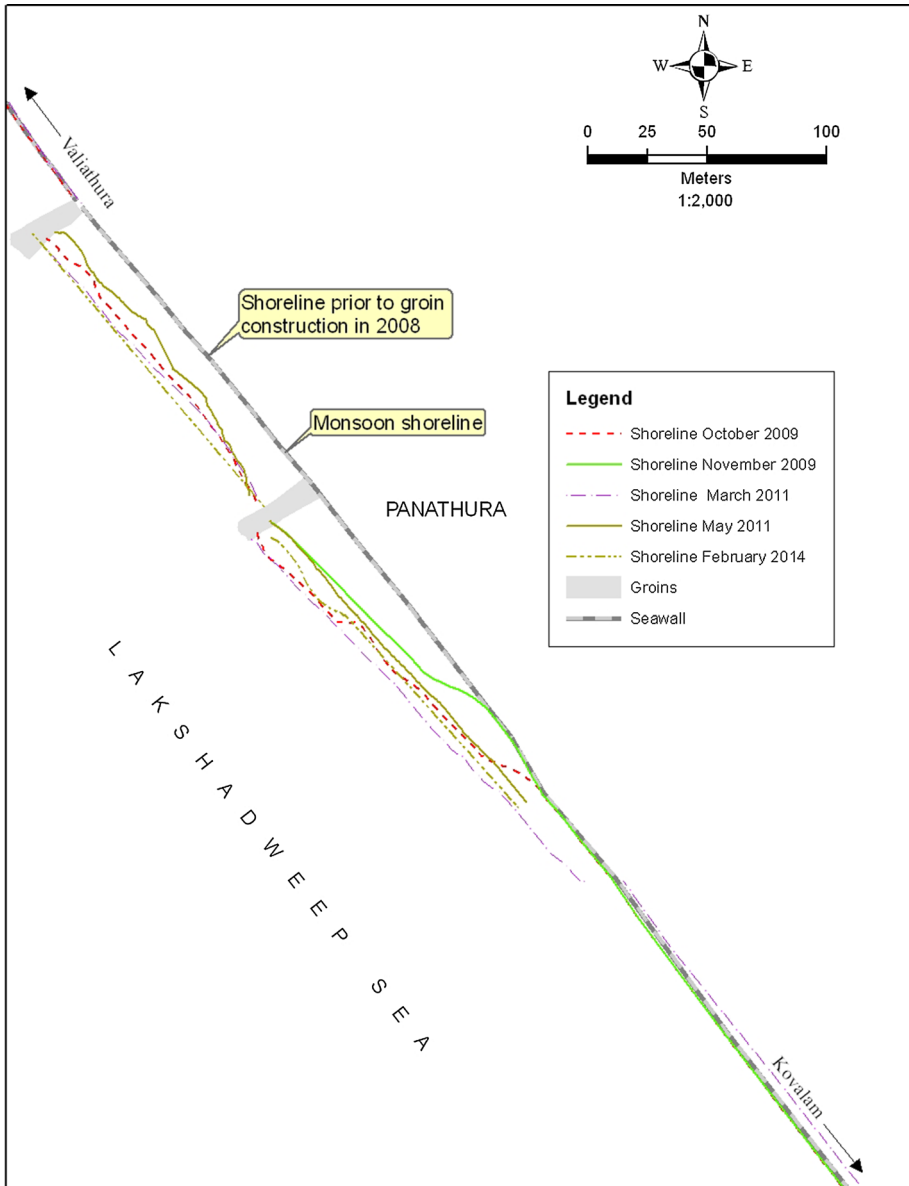
**Fig. 14** Shoreline variation at Panathura

fair weather season, which disappear during the succeeding rough monsoon season (Fig. 14). Few of these groynes started getting damaged within a short span of few years.

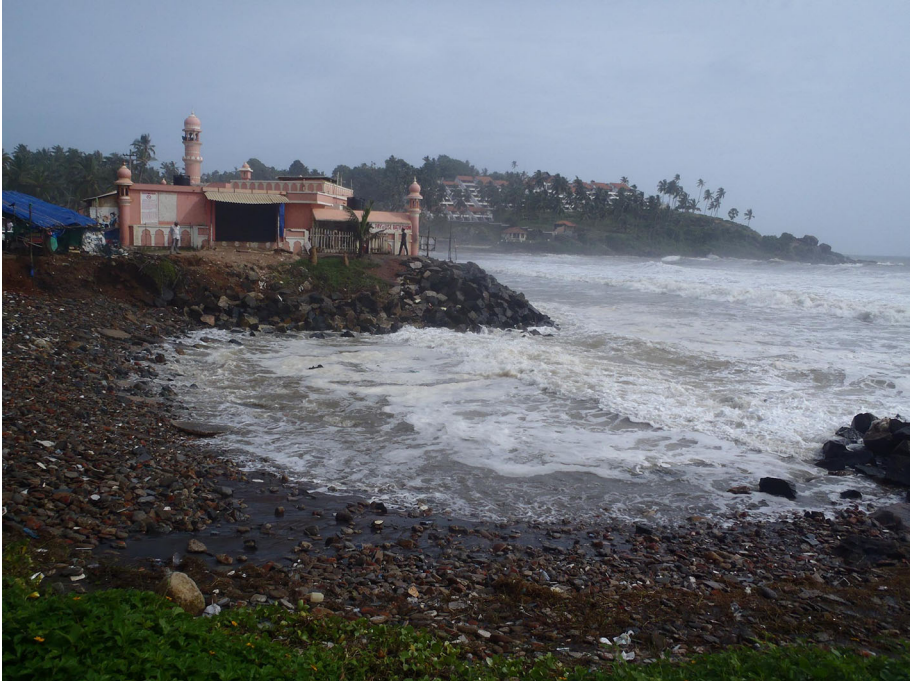
**Fig. 15** Impact of building construction on a stable pocket beach at Kovalam

Sand removal from the seasonal beach at ‘Lighthouse beach’ for construction of a revetment has significantly reduced the sediment availability in the seasonal beach (Ajeesh 2011). This has led to lowering of berm height. The period during 1989–2006 has shown marginal erosion on the land part of Kovalam beach. But construction of a small building (mosque) right on the seasonal ‘Kovalam pocket beach’ has induced erosion immediately north within the pocket beach. It is evident that any morphological modification through construction activities would induce erosion along dynamically stable pocket beaches (Fig. 15).

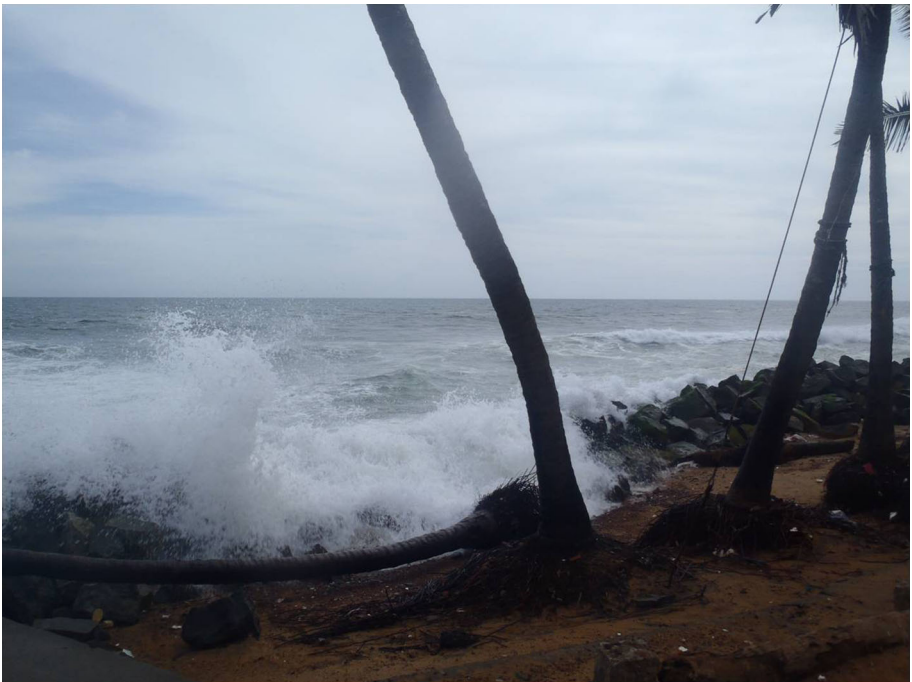
**Fig. 16** Damages to seawall without frontal beaches at Bhimapally

The Kovalam–Panathura–Poonthura–Bhimapalli–Valiathura coastal stretch is highly eroding and the seawalls do not have frontal beach (Fig. 16). Being on the northern side of Kovalam headland, the area is prone to erosion which is further aggravated by the
