# The 1996 Saguenay Flood event and its impacts

Michel Tremblay<sup>1</sup> · Christian Guillaud<sup>1</sup>

Received: 1 June 2018 / Accepted: 21 September 2018 / Published online: 9 October 2018  
© Springer Nature B.V. 2018

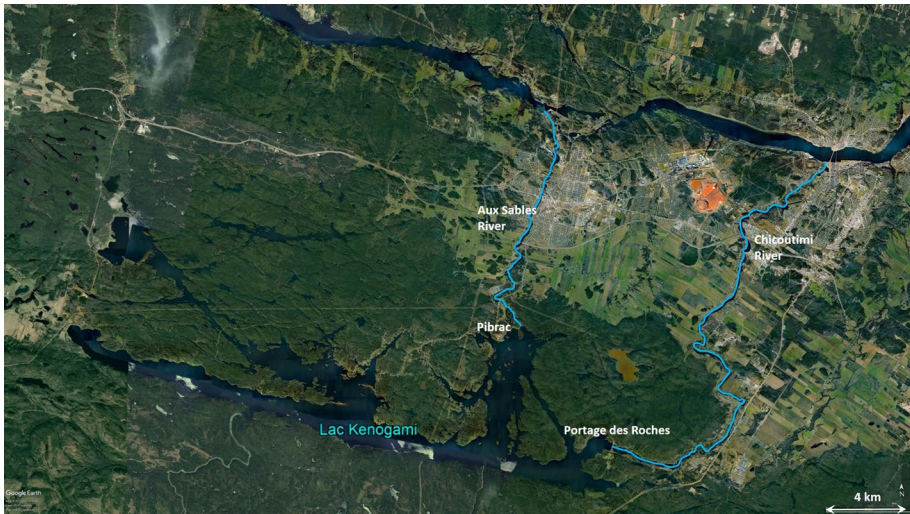
**Fig. 2** Lake Kenogami area (Image from Google Earth)

Structures on Lake Kenogami are owned and operated by the Government of Quebec; they consist of two control structures, namely Portage des Roches and Pibrac which control, respectively, the outflow to Chicoutimi and Aux Sables Rivers (see Fig. 2). Lake Kenogami is contained by 13 structures of various sizes: concrete gravity dams, embankment dykes and mixed structures; their crest levels vary between el. 165.67 and 167.41 m.

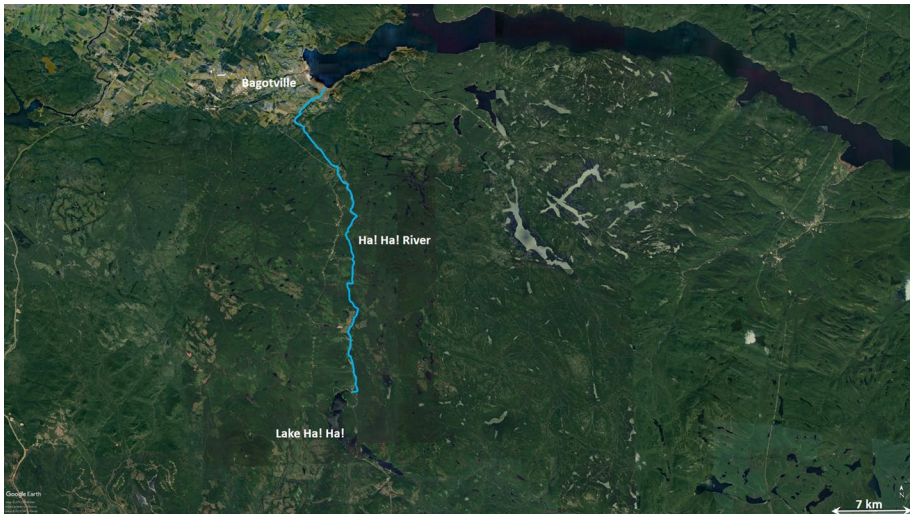
**Fig. 3** River Ha! Ha! area (Image from Google Earth)

Hydraulic developments on the Ha! Ha! River (see Fig. 3) are owned and operated by a pulp and paper company, the Stone Consolidated Company, (See Footnote 2) and they were built for the purpose of providing water for their plant at La Baie. The developments consist of a regulating reservoir on Lake Ha! Ha!, which is located some 40 km upstream of the river outlet. The structures around Lake Ha! Ha! consisted of a concrete dam and two- to three-metre-high earthfill dykes. Outflow from the lake was controlled

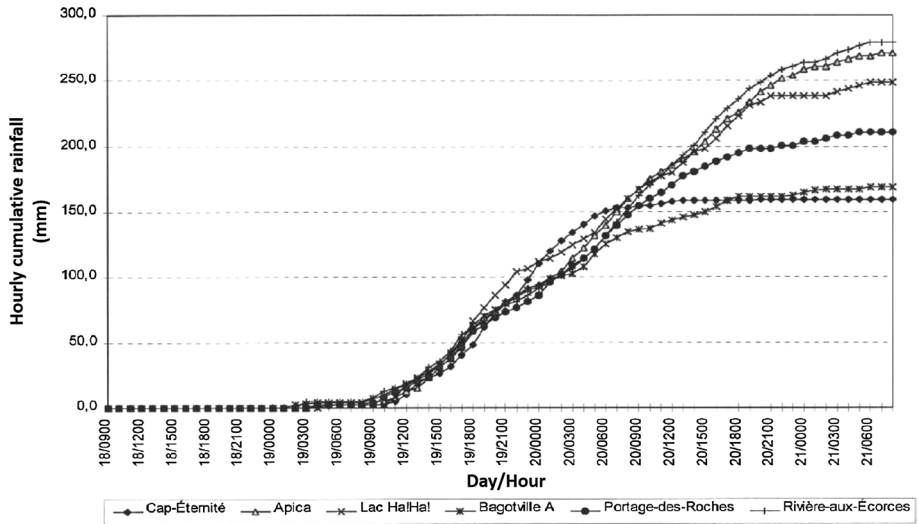
**Fig. 4** Cumulated rainfall at meteorological stations in the Saguenay area [ref Perrier and Slivitzki (1999), data from Environment Canada (1997)]

are presented in Figs. 4 and 5 which show the cumulated rainfall versus time at meteorological stations in the area and the map of the total rainfall between 18 and 21 July 1996.

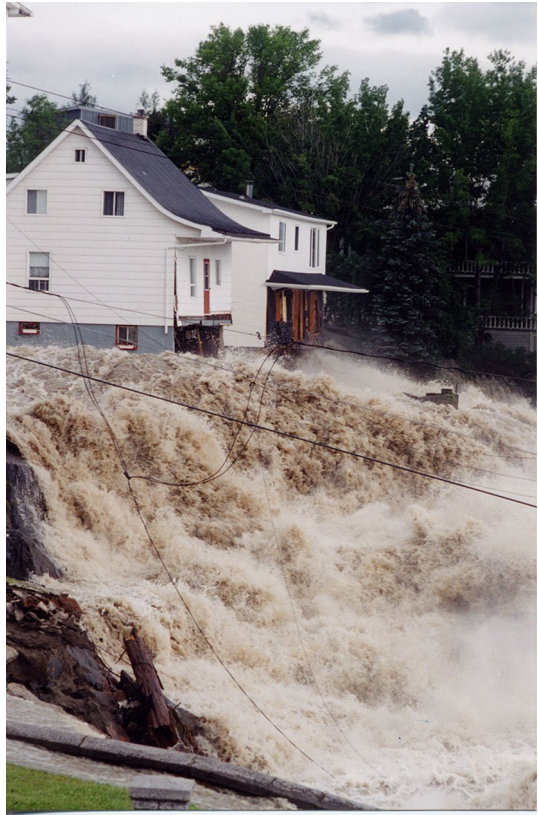
**Fig. 6** “La Petite Maison Blanche” (“Le musée de la petite maison blanche—S. Genest”)

This overflow at the downstream structures on the Aux Sables and Chicoutimi Rivers caused the failure of the embankment structures at these sites. In the city of Chicoutimi, the overflow on the Abitibi Price concrete dam caused severe damages to a residential district where all commercial and residential buildings were destroyed or strongly damaged, although a small house in that district resisted unharmed against the raging flows. It was nicknamed “La petite maison blanche”<sup>4</sup>, and it was adopted as the symbol of the resistance of the population against the wrath of the unleashed natural disaster. A picture of that house is shown in Fig. 6.
