Assessment of vulnerability for rockfalls in Cozia Gorge (Southern Carpathians, Romania)

Received: 7 February 2018 / Accepted: 2 August 2019 / Published online: 10 August 2019
© Springer Nature B.V. 2019

Keywords Rockfall · Transport infrastructure · Vulnerability on road sectors · Cozia Gorge

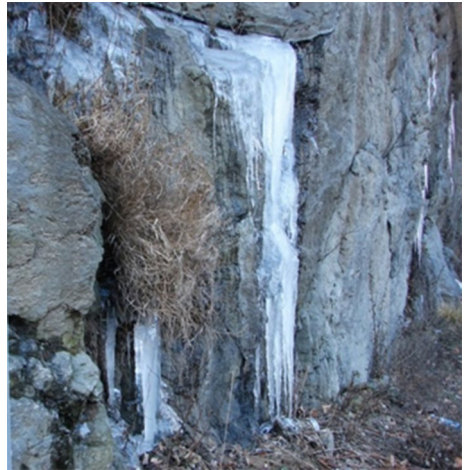
Fig. 3 Circulation of water through the crack network of rock mass

The Cozia Gorge morphology is strongly influenced by petrography with an alternation of narrow sectors in metamorphic rocks such as gneiss, paragneiss and orthoamphiboles and small depression in sedimentary formation made up by sandstone, marls and conglomerates (Popescu et al. 1977; Badea 1983) (Fig. 2). The characteristics of rocks are very important for the analysis of this type of hazard, but, especially, the presence and density of discontinuities in the rock mass (fault, breaks). Although the rock is cohesive and hard, these “natural weak points” of rock mass (faults, foliation, bedding plane) (Hencher 1987) reduce the shearing compressive strength and fragment them in individual blocks. Brezoi Fault Line (situated on the North of Cozia Massive) is the main discontinuity plan in this region. The fault spreads from Vâlsan valley up to Malaia valley, for a length of 80 km and an uplift of about 1000 m along the discontinuity plane (Ghika 1958). The studies performed on a local scale need to take into calculation all the cracks in the rock mass, as the surfaces that are the most prone to rockfall are the tectonized and intensely cracked slopes (Ilinca 2009). The more the cracks are placed in an uneven, random manner, the lower the rock compressive strength is, and the possibility for the hazard to occur is higher (Ilinca 2009). Another factor that contributes to the reduction of slope stability is the physical and chemical weathering of rocks. The rock degradation may be reached both by thermoclastism processes (insolation) and by crioclasty processes (freeze–thaw), the latter being caused by water circulation through the crack network of the slopes (Fig. 3).

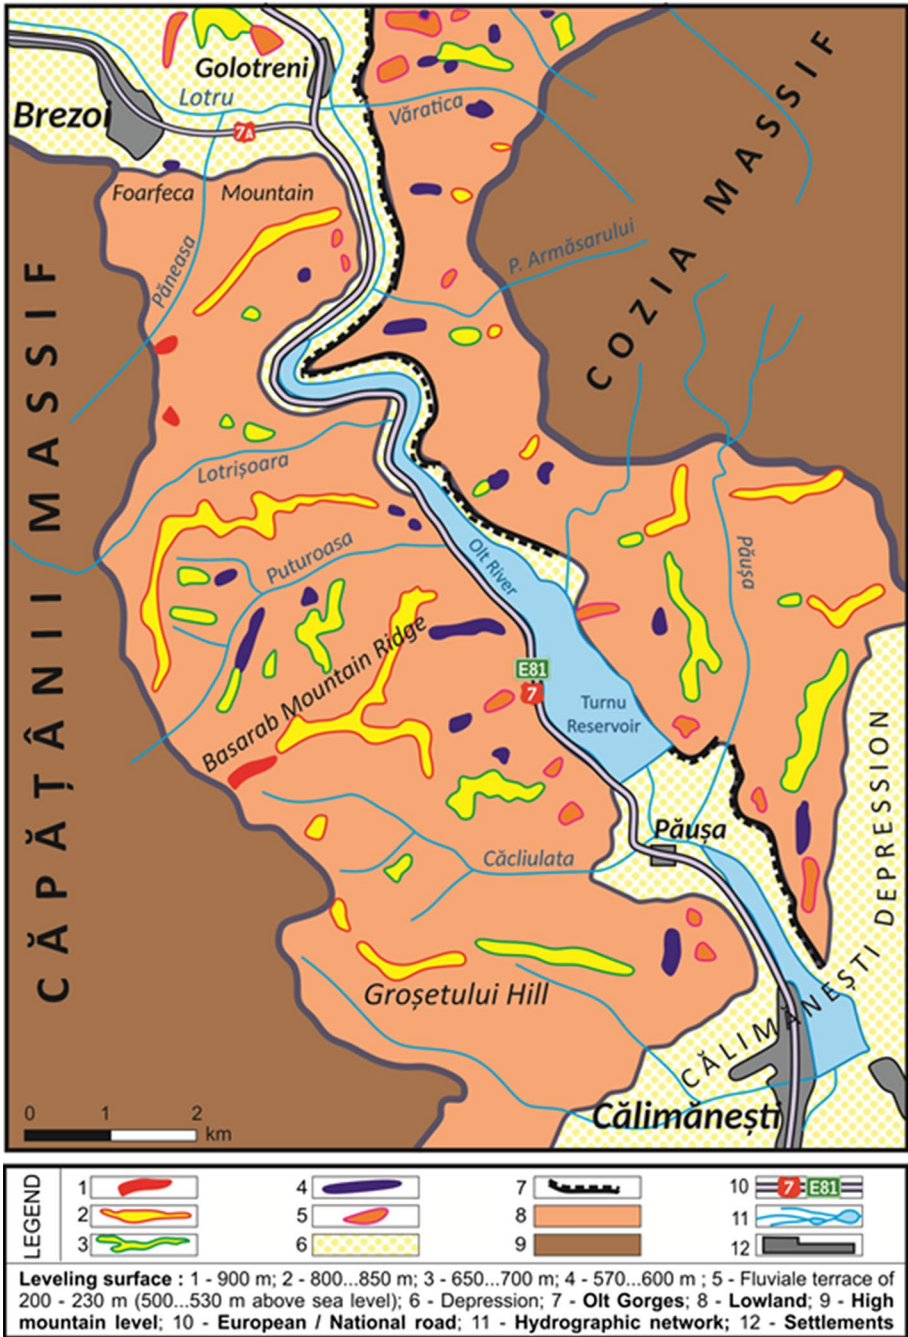
Fig. 4 Geomorphological map (according to Badea 1987, with modifications)

Cozia Gorge corresponds to the leveling surface of 800–850 m above sea level (m.a.s.l.), and 400–450 m above the thalweg. Under this level can also be identified other two steps being at 570–600 m.a.s.l., respectively, 270–300 m.a.s.l. Under this level is developed the system of 7–8 terraces that are imposed in the Gorge as shoulder levels (Popescu 1972; Badea 1987). The terraces steps are developed at relative altitudes from 1 to 3 m and up to 210 to 240 m. Therefore, the Gorge is developed under the threshold of 570–600 m and corresponds to the periods of strong deepening of Olt, when quaternary terraces also appeared (Fig. 4) (Popescu 1972).

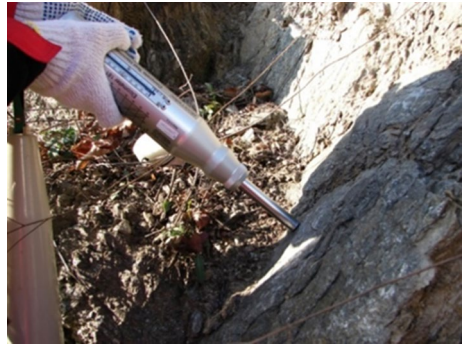
Fig. 5 Determining the strength of the rock using the Schmidt hammer

The assessment of rockfall susceptibility needed, first, a thorough research developed in the field that consisted in establishing the compressive strength of rock surfaces, by using geo-mechanical assessment methods. In this respect, a mechanical Schmidt hammer of N type was used, manufactured by Proceq, Zurich (Fig. 5) (Vasile 2014). The values recorded by this instrument represent the reaction force of the rock that indicates the degradation degree of the respective surface. Over 80 slope surfaces with uncovered rock, being under different degrees of degradation were investigated and mapped. In order to eliminate, as much as possible, errors, each assessed rock surface was manually polished with an abrasive stone, after which ten measurements were taken, which were averaged in order to obtain the final value. Besides the compressive strength measured with this device, one has visually assessed the weathering degree, as well as the characteristics of the cracks and counted the density, width, orientation and continuity (Selby 1980). Each parameter got a score, and by addition, the final score resulted for each rock surface taken into consideration and, subsequently, its classification (Table 1). The density of cracks was established by comparison to horizontal profiles of 2 m, and the thickness was measured with the help of a feeler gauge with ten divisions (0.05–1 mm) (Fig. 6). For each of the SCS (Schmidt compressive strength) and TCS values (total compressive strength or the final score), the mathematical coordinates using GPS were also recorded, for the subsequent location of the data. The dimensions of the blocks fallen at the base of the slopes and the volume of weathering blocks accumulated behind the dynamic rockfall barriers were measured. The analyzed parameters for each slope were included in worksheets according to the following table (Table 1). The values obtained from the measurements made in the field were transposed in a GIS environment and represented in Romanian National Projection System—Stereographic 1970

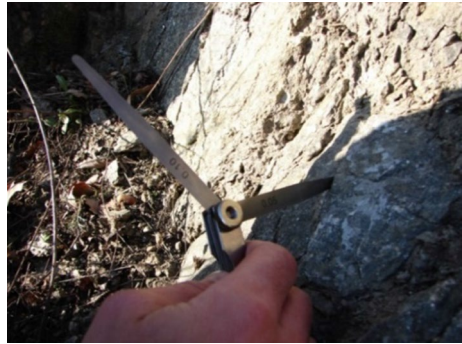
Fig. 6 Feeler gauge to determine the thickness cracks

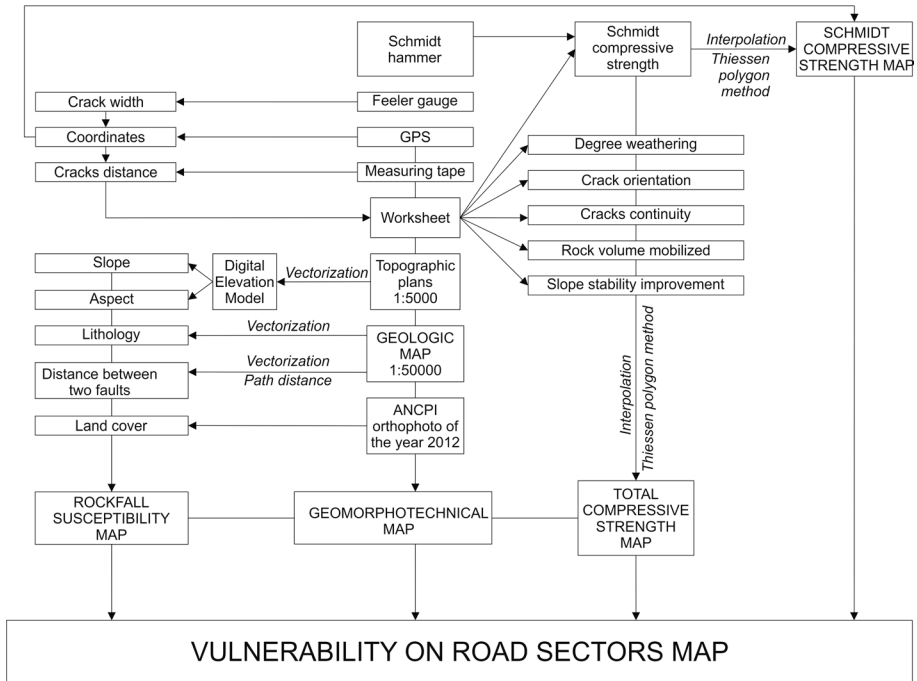
Fig. 7 The synthesis of the methodological approach

The synthesis of the methodological approach comprises information about the instruments used in the field for making the measurements, exemplifies the necessary data sources and presents the main data processing functions (Fig. 7).

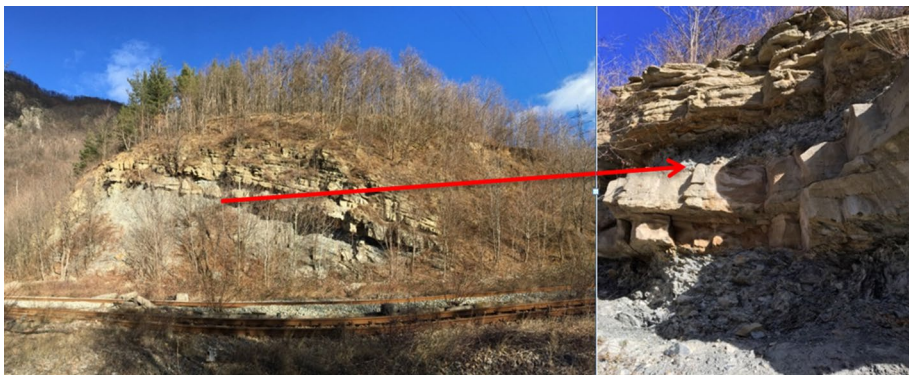
Fig. 9 Sandstones alternating with marls (SCS < 2.00) (20.XII.2016)

Slopes with a much reduced compressive strength (<2) comprise 8.955% of the study area and represent, on one side, the rock surfaces intensely cracked and altered, and on the other side, the friable rocks (sandstones or marls). These situations can be found: to the South of Brezoi on the slopes from the base of Muchia Foarfecii, on the concave slopes of Cărligul Mic and of Olt in Muchia Roșie Area, on the anthropically cut slopes of Plaiul Lotrișorului, in the proximity of Turnu Monastery and on the slopes of Păușa Hill, cut by Călimănești ring road (Fig. 9).

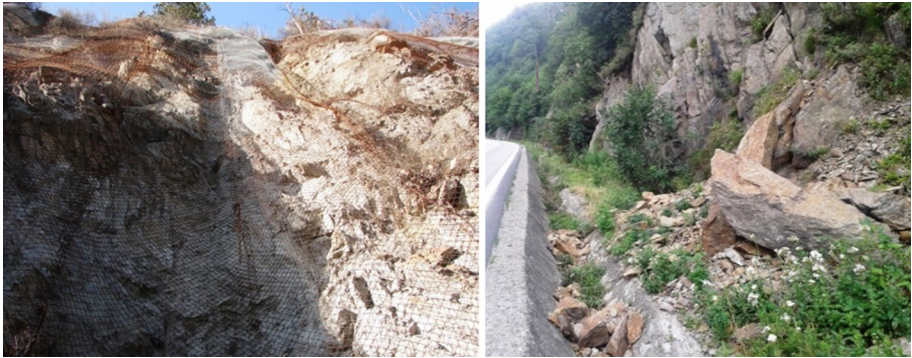
Fig. 10 Low-strength slope near Năruțu (left) and Brezoi (right), (SCS 2.00–3.00) (05.VII.2017)

Slopes with low compressive strength (2.00–3.00) comprise 23.685% of the Gorge surface. These values were recorded on the North of the area, on the South of localities Brezoi and Văratica, on the convex slope of Olt on the South of Cârlișu Mare, on the slopes comprised between Plaiul Lotrișorului and Muchia Basarab, and on the South of the Gorge, on the left slope of Olt, next to locality Călimănești (Fig. 10).

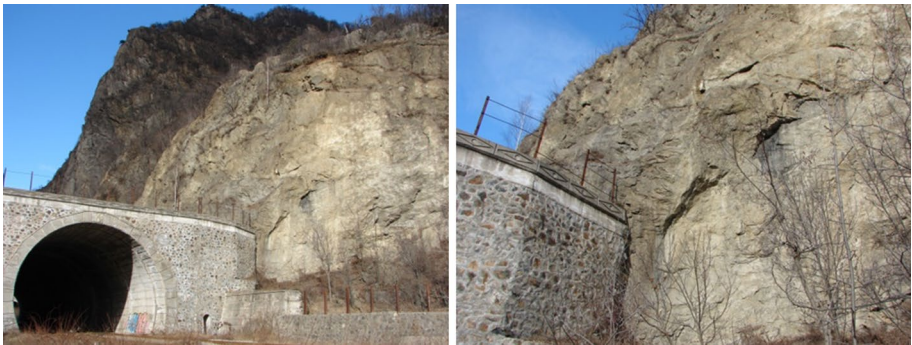
Fig. 11 Medium-strength slope near Turnu (RS 3.01–3.50) (20.XII.2016)

Medium values of Schmidt compressive strength (3.01–3.50) are present on about 3.26% of the analyzed surface and characterize the slopes situated at the entry of Brezoi

locality, a part of the concave slope of Cărligul Mic and the slopes close to the Railway Station Turnu (Fig. 11).

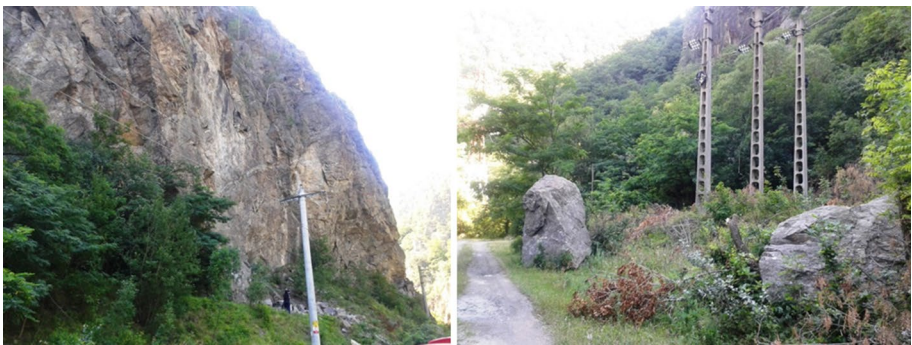
Fig. 12 High-strength slope (SCS 3.51–4.50) and huge fragments of rock detached by sliding (volume = 48 m³) to quarry excavation from Muntele Cărligul Mic (06.VII. 2017)

Rock surfaces with *high compressive strength* (3.51–4.50) are developed on 26.48% of the studied area and present a wide spread on the left side of Olt (on the slope of Cozia Massive). Here, one can also include: Cărligul Mare Mountain, Cărligul Mic Mountain and Muchia Roșiei. Also, these values were obtained on the right side of the Olt River, on the concave slope of Cărligul Mare and Cărligul Mic (Fig. 12).

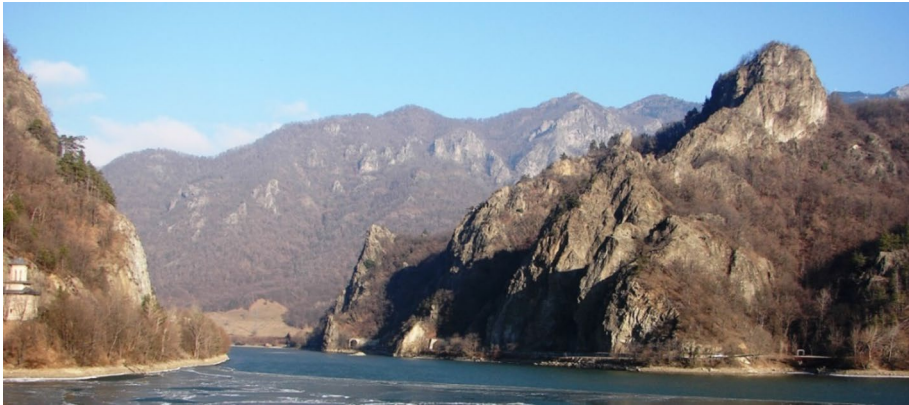
Fig. 13 Very-high-strength slope (>4.5). Muchia Basarab or Muntele Năruțu—left and Teofil Tower—right (19.XII.2016)

Surfaces with a *very high compressive strength*, of over 4.5, have a reduced weight (4.74%). These values were recorded close to Turnu Lake, both on the right bank of Olt River (in Năruțu Mountain), and on the left side of Olt (on the slopes of Teofil Tower) (Fig. 13).

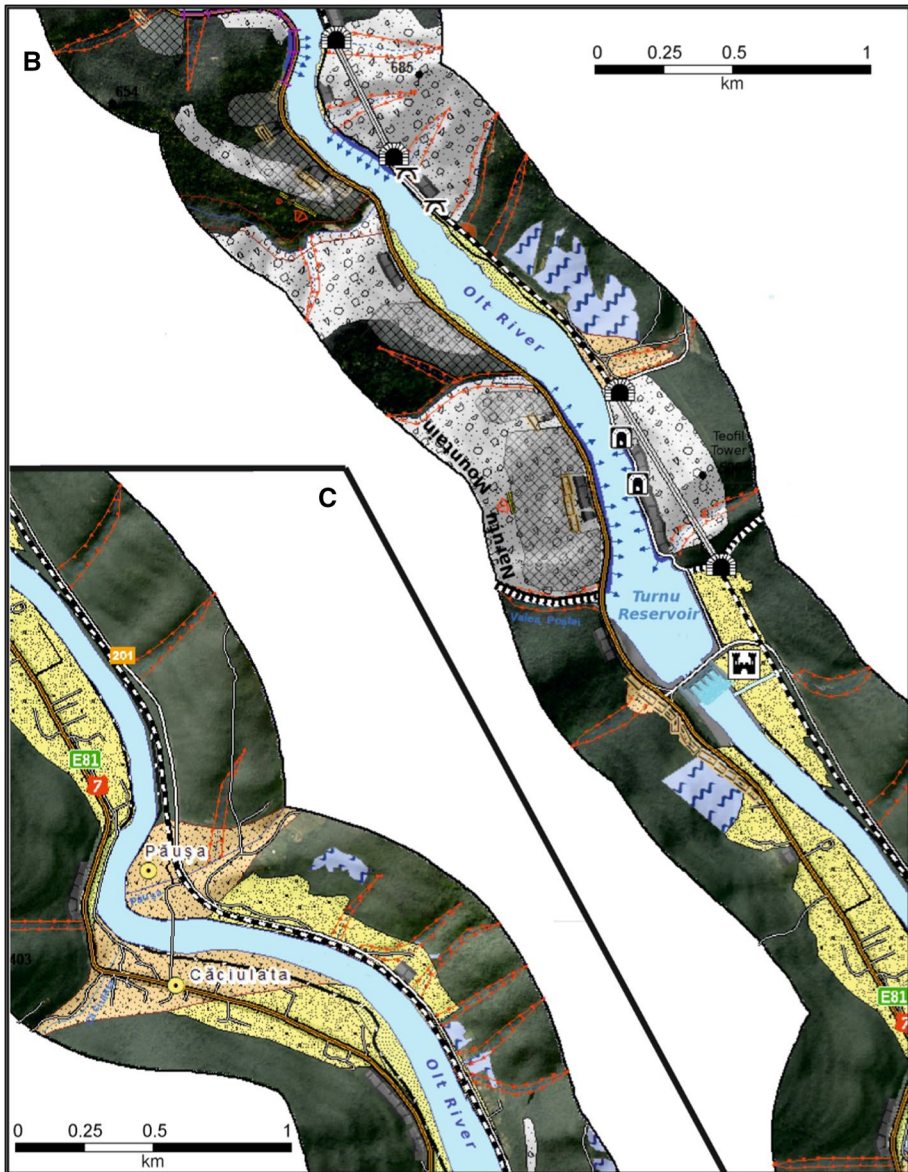
Fig. 15 a Geomorphotechnical Map—northern sector. b, c Geomorphotechnical Map—central and southern sectors

During the field campaigns were identified and mapped the slope areas that need a series of protection systems in order to prevent the rockfall on the highway. Following this approach, the geomorphotechnical map was obtained (Dobre et al. 2011) of the

studied area, that comprises, along with the previously mentioned engineering works, also the microrelief morphology given by different processes: rockfalls, collapses in some quarries for rock extraction, debris flows, intense weathering area sheet erosions, gullies, torrents, lake abrasion, scarps.

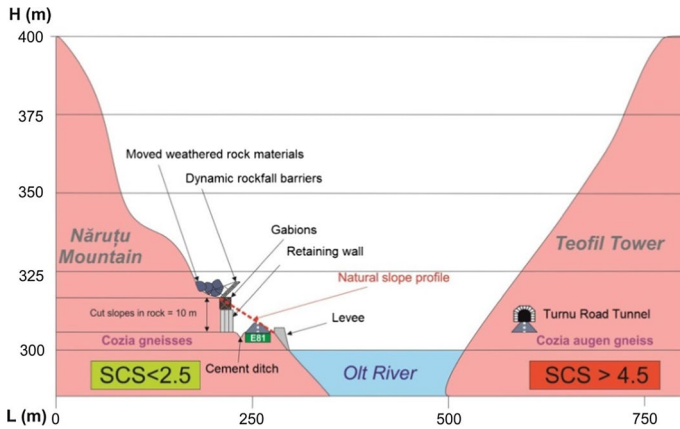
Fig. 18 Cross-sectional profile between Năruțu Mountain and Teofil Tower

This importance of the anthropic factor is duly highlighted by the presence of some areas with the same lithology, but with very different values of the Schmidt compressive strength. For example, Năruțu Mountain (Muchia Basarab) and Teofil Tower, although they are both composed of Cozia augen gneiss, present SCS values of < 2.5 (reduced compressive strength), respectively, > 4.5 (very high compressive strength). This difference is given by the extent of the activities to arrange the communication ways, different from one slope to another (Fig. 18). The cut slopes of Năruțu Mountain were followed by different engineering works for slope stability, such as collection ditch, retaining walls, gabions, dynamic rockfall barriers in comparison with those of the Teofil tower crossed underground by a road tunnel.

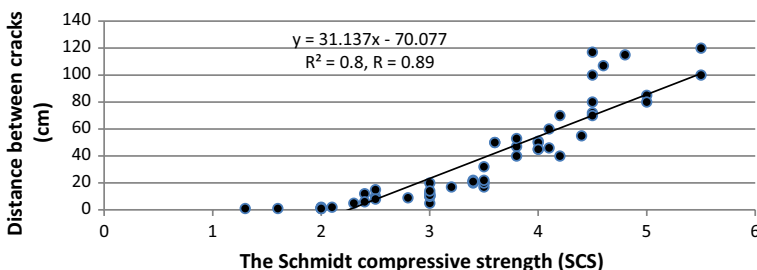
Fig. 19 Correlation between cracks distance and Schmidt compressive strength

The Schmidt compressive strength of the analyzed slopes depends also on their cracking degree. The crack system identified at the level of rock surfaces that were investigated is the result of a plurality of natural factors such as tectonics pressure, thermal stress, gelivity and anthropic by cutting, dynamiting the slopes and traffic. The very good correlation of the R values with the distance between the cracks, highlighted by the correlation coefficient R of 0.89, demonstrates the weight of discontinuities in the rock mass in the calculation of slope stability (Fig. 19).

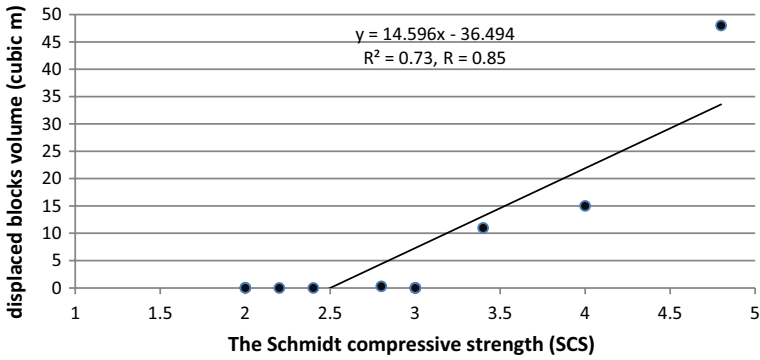
Fig. 20 Correlation between displaced blocks volume and Schmidt compressive strength

Also, there is a strong correlation ($R=0.85$) between the Schmidt compressive strength of the slopes and the dimension of the blocks that are at their base (Fig. 20).

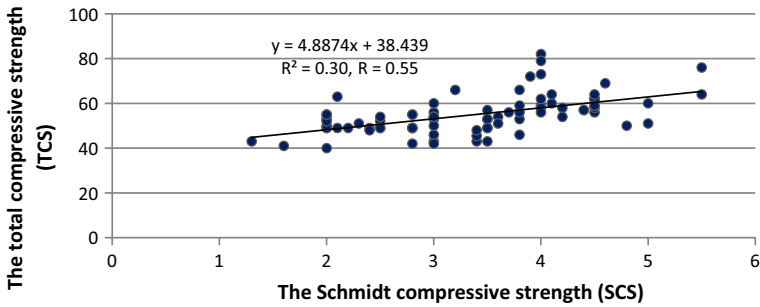
Fig. 21 Correlation between total compressive strength and Schmidt compressive strength

The total compressive strength of the rock surfaces presents a relative correlation with the recorded values of the Schmidt compressive strength, these variables having a correlation coefficient of 0.55. The high value of the *R* coefficient shows the importance of rock

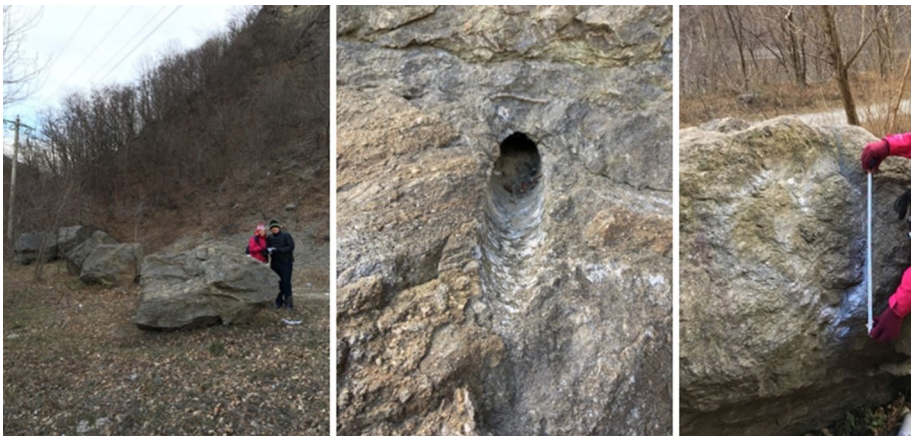
Fig. 22 Huge displaced blocks to quarry excavation, the location of the explosive and the crash left by it
