# Shoreline change along Kerala, south-west coast of India, using geo-spatial techniques and field measurement

S. Chenthamil Selvan<sup>1</sup> · R. S. Kankara<sup>1</sup> · K. Prabhu<sup>1</sup> · B. Rajan<sup>1</sup>

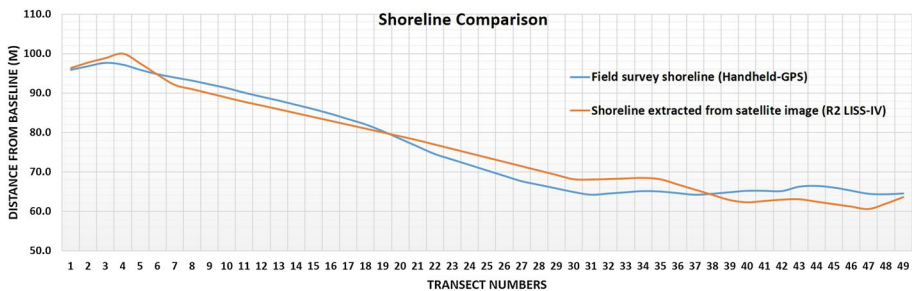
**Fig. 2** Comparison of field-surveyed shoreline position with satellite-extracted shoreline along Punnapra beach, Kerala

Field survey was conducted to track the shoreline positions during satellite pass time using handheld GPS (Trimble GEO XH 6000) at five different locations (Poovur, Punnapra beach, Paravanna beach, Mahe and Manjeshwar region). This handheld GPS (Trimble GEO XH 6000) provides the data with an accuracy of 1–3 m. 1 km coastal stretch was surveyed at each location separately. Shoreline positions were particularly tracked to compare and validate with the shoreline extracted from satellite images. Plate 1 shows the shoreline tracking using handheld GPS at Punnapra beach. The tracked shoreline is then compared with the shoreline extracted from 2016 LISS-IV (5.8 m) satellite images as shown in Fig. 2. Comparison shows that the field-surveyed shoreline positions were well matched with the shoreline extracted from images. The comparison shows that the maximum difference between two shoreline positions is within a pixel limit (5.8 m). The comparison of shorelines provides the higher confidence level with the extracted shoreline position.

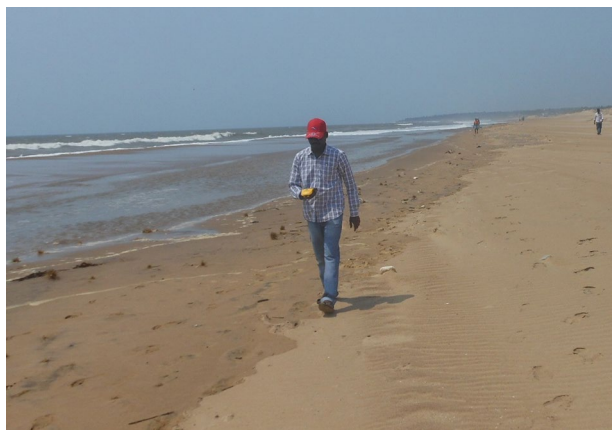
**Plate 1** Shoreline position tracking using handheld GPS along Punnapra beach, Kerala

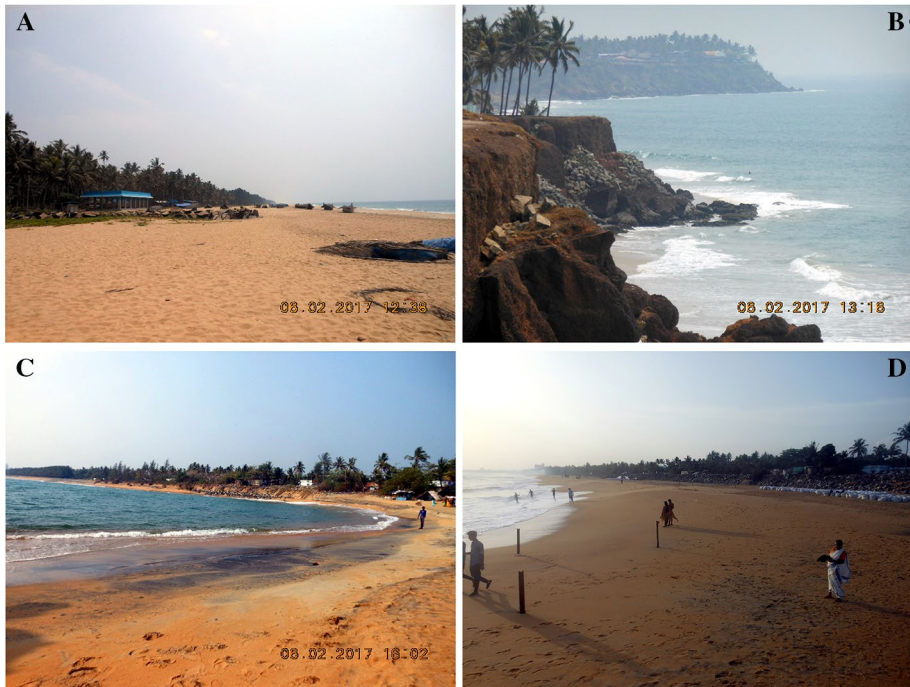
**Plate 2** **a** Rathikkal location where groins were buried in sand. **b** Slumping of lateritic cliff at Varkala. **c** Field photograph showing depletion of sand towards the north of broken vessel during pre-monsoon (Feb 2017) at Eravipuram. **d** Field photograph showing sand deposition towards the north of broken vessel during monsoon (July 2017) season at Eravipuram

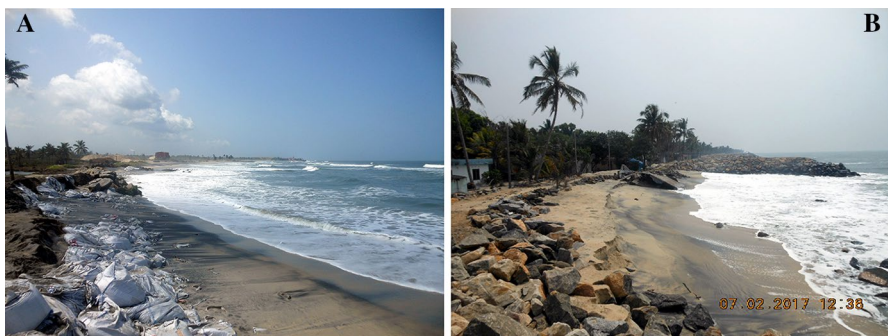
**Plate 3** a Vellanathuruthu where the coast affected by sand mining process. b Slumping of seawall at Ambalapuzha

Mineral and Metal Limited (KMML) along the coastline of Chavara, Kollam, has played a significant role in altering the coastline. Noujas and Thomas (2015) reported Vellanathuruthu mining site as one of the erosion hot spots based on their direct field measurements. Seawall can be seen on either side of the mining site to protect the coast. There is an open space of about 800 m between these seawalls. Due to high wave actions, the open coast at this region was altered as a bay-like structure (plate 3a). 22-km stretch from Kayamkulam to Thottappally fishing harbour was seen with low erosion. This stretch too was protected with artificial structure (seawall and groins) to protect from erosion. About 3 km south of Thottappally fishing harbour was noticed with moderate-to-high accretion due to

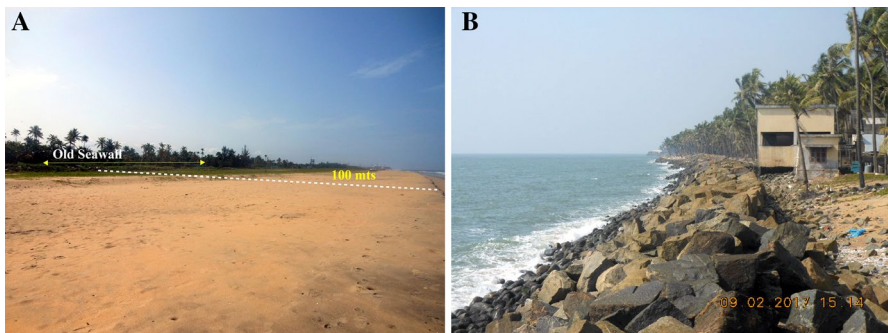
**Plate 4** a 100 m width of sand deposition along Elamkunnapuzha region, Kerala b Erosion at Tannithura, Kerala, during pre-monsoon (February month)

Elamkunnapuzha region. 35 km coastal length from Elamkunnapuzha to Perinjanam was noticed with low erosion to stable condition. No significant changes have taken place from this particular stretch. Munambam fishing harbour shows low erosion on the southern side and low accretion at the northern side of the breakwater (Fig. 5a). This pattern of deposition indicates that the sediment transport is towards south along this stretch. Similar trend was observed by Noujas and Thomas (2018). According to him, the net sediment transport is  $-119,271 \text{ m}^3/\text{year}$  along this coastal stretch. Low-to-moderate accretion was noticed between Perinjanam and Snehatheeram which is about 15-km-long coastal stretch. At Chettuva fishing harbour, low accretion was seen on the northern side of breakwater, whereas the southern side was seen with stable to low erosion. Similar trend of erosion
