ORIGINAL PAPER

Low-cost UAV surveys of hurricane damage in Dominica: automated processing with co-registration of pre-hurricane imagery for change analysis

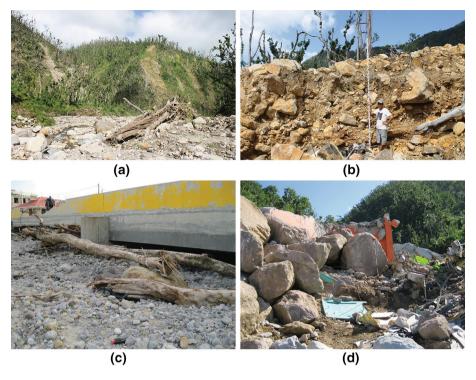
Fig. 2 Field pictures from January 2018 survey showing selected geomorphological processes (Adobe Illustrator): **a** Landslide scars, now partly vegetated, on a mountainside above the Pichelin River. The landslide scars expose weathered bedrock of lava flows and pyroclastic deposits (Day, S.). **b** Large boulders and tree debris in landslide runout deposit, with some debris flow characteristics, near Sulphur Springs resort, Soufriere. Levelling staff extended to full 5 m length (Day, S.). **c** Tree debris forming a plug under northern span of bridge on Roseau River in central Roseau, largely buried by the poorly sorted alluvium that accumulated upstream of the plug (Heidarzadeh, M.). **d** Buildings destroyed by boulder-rich debris flow in steep channel, Champagne (Heidarzadeh, M.)

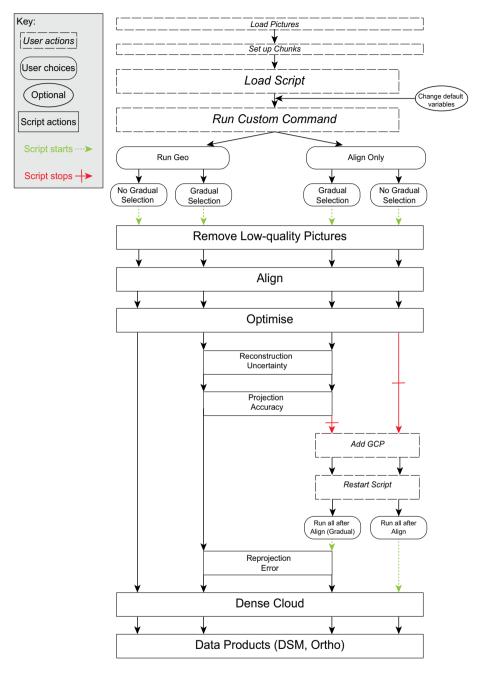
Fig. 4 Python script process flow chart (Adobe Illustrator)

The script first calculates an estimate of the image quality of each photograph taken and discards images below a threshold; the default is set to 0.5. This value should be considered for each data set, where images from a larger sensor can be expected to exceed 0.8, but the small sensor of a P3 or P4 is set to 0.5. The script then aligns all images in each chunk and optimises the model before applying the gradual selection process. The gradual selection strategy selected is based on a number of sources and adapted to produce consistent results (USGS 2017; Mallison 2015; Marius et al. 2017). The aim of the script is to reduce the tie points to 80% of the original tie points in three steps, retaining only the highest quality points. The percentage is adaptable in the script if needed.

In the first step, the reconstruction uncertainty (RC) is addressed. High RC values are a measure of points that deviate noticeably from the object surface (Agisoft 2018). RC is set to a threshold of 10 initially, but automatically adapted should the number of tie points selected exceed 50% of the total. The model is then optimised. The second step processes projection accuracy (PA). PA is a measure of the projections of each tie point onto the surface (Agisoft 2018). The initial PA threshold is set to 2 and auto-adjusts to select up to 50% of the tie points left after step 1. The model is then optimised.

The final step is to filter points based on reprojection error (RE). If GCPs are to be introduced to the model, the script offers the facility to break before this stage; the reprojection error should be processed after the GCPs have been assigned. A high RE is a measure of poor localisation of a tie point (Agisoft 2018). The script runs the RE filter multiple times, each round selecting 10% of remaining tie points and optimising the model until the 80% total reduction has been achieved.

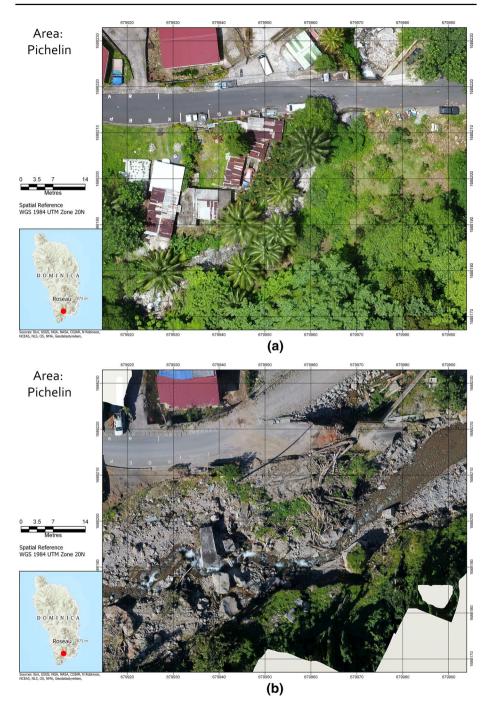
Fig. 5 Before and after comparison of an area of interest in Pichelin, Dominica. **a** Pre-Maria survey data of Pichelin, September 2017 (Arcgis Pro 2.3). **b** Post-Maria survey data of Pichelin, January 2018 (Arcgis Pro 2.3)

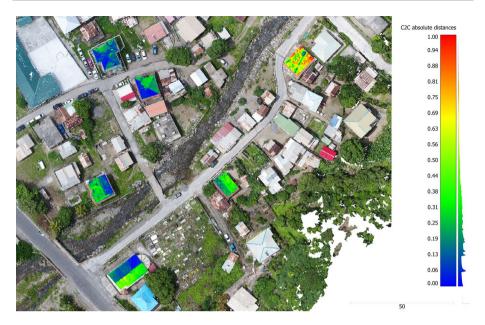
Fig. 6 Results from the alignment process using CC showing alignment error (CloudCompare, does not support TIFF output)

CC can align two models and provides accurate results for laser scanned data, for instance, that has the same shape. One data issue that was apparent in SfM-derived data using non-metric cameras was systematic doming of the resulting surface (James and Robson 2014; James et al. 2017a, b). This doming was most evident in the model for the Douglas Charles International Airport at Melville Hall (Fig. 10) when compared to the reference data, as the straight and flat runway is ideal for assessing the issue. Gradual selection does to some degree mitigate against this doming effect, although it does not cancel it out. The Douglas Charles International Airport data highlighted the issue of doming in the uncontrolled SfM output and the fact that the two data sets have different shapes, which CC cannot align very well. In other areas, significant XY shifts in some sections of the model were also observed, with RMSE of between 1.3 and 2 m.

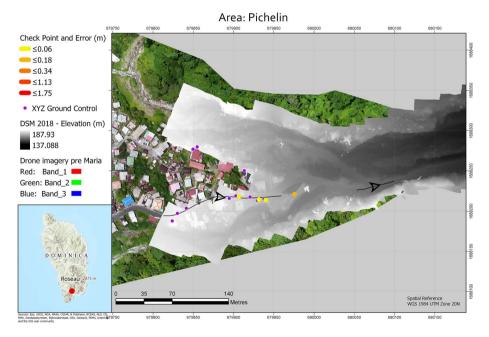
Fig. 7 Overview map of Pichelin, Dominica, showing the overlap between the 2017 and 2018 data and the GCP, profiles and check points used in error assessment. There were no usable GCP in the eastern half of the overlap. (Arcgis Pro 2.3)

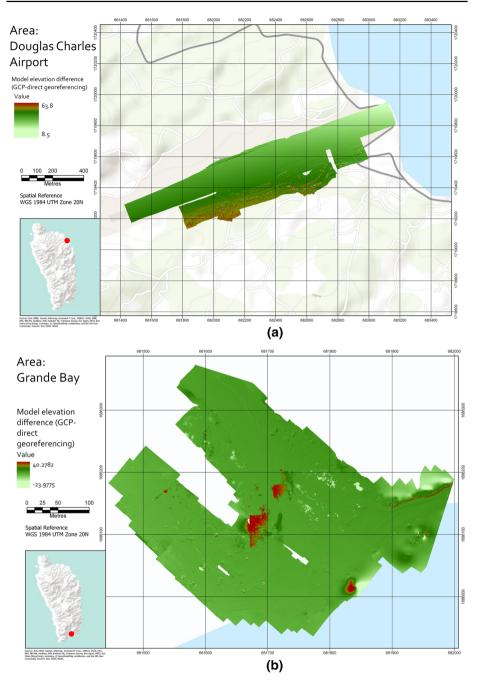
Fig. 9 Comparison between the data produced by the SfM process from direct georeferencing using the UAV internal GNSS and IMU and the data produced by the SfM process using GCP. **a** Map view of model elevation difference at Douglas Charles Airport, Dominica (Arcgis Pro 2.3). **b** Map view of model elevation difference at Grand Bay, Dominica (Arcgis Pro 2.3)

In areas where both the uncontrolled process and the GCP controlled process were available, a comparison was made between them. A significant aspect of the hurricane damage was the fact that the island was densely forested before Maria and largely de-forested after Maria. This means that the areas for geomorphological comparison were limited to areas that were not vegetated before Maria, although the data can be utilised in an ecological context to quantify changes in vegetation cover. With Douglas Charles International Airport, comparison between the GCP corrected model and the direct georeferenced model shows a tilt (Fig. 9a) as well as a significant elevation difference. The Grande Bay area shows no such tilt (Fig. 9b), with a homogenous elevation difference. Some of the higher areas of elevation difference between the two approaches in the Grande Bay data are due to model weakness in the areas that have poor image overlap (centre of Fig. 9b). The differences found are because the UAVs used in the 2018 survey were not equipped with RTKcorrected GPS and the areas where GCPs were unavailable rely solely on the internal GPS and the IMU. The IMU records UAV orientation (pitch, roll, yaw) and uses an internal barometer, which it uses for elevation in addition to the GPS altitude. It appears the altitude stored in the EXIF is based on this barometer reading, which is subject to some drift, according to technical forum posts about DJI and PS (Agisoft Forum 2018). GPS altitude accuracy is known to be 1.5 times less accurate than the plan position (XY). (Schaefer and Woodyer 2015). It is therefore expected for the absolute elevation values to be incorrect. This highlights the need for aligning the two data sets.

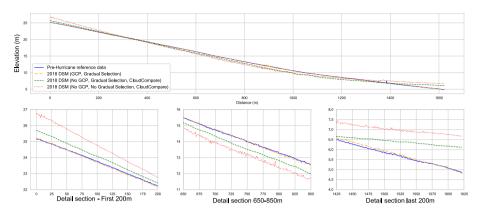
Fig. 10 Profile plots of the runway at Douglas Charles Airport comparing the 2017 reference data to the data corrected in CC, with and without gradual selection, and the data corrected using GCP (Jupyter/Matplotlib)

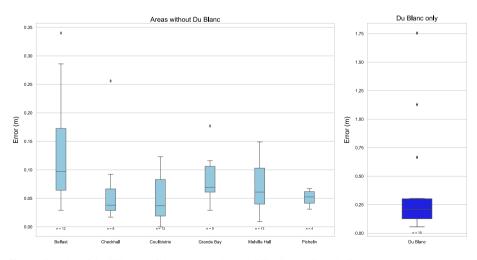
Fig. 11 Boxplot of the XY error of data processed using GCP (Jupyter/Matplotlib)

Figure 11 shows the XY error assessment for all areas using the GCP method. For this assessment, further common checkpoints were identified and the distances evaluated. To assess the Z-error, profiles were created in ArcGIS using the Stack Profile tool for each DSM along runways or roads and compared in a Python script. The 2017 profile was interpolated using a cubic spline, and the difference to the 2018 profile was calculated. The data showed some areas of significant difference, where trees overhanging the road in early 2017 were no longer present in early 2018 (Fig. 12a, b). Any data outside the interquartile range were removed to account for these outliers. Figure 13 shows the resulting Z errors. With the exception of one area (Belfast estate, North to South profile), all areas show a low error range, less than ± 0.5 m. It is notable that the Belfast North to South profile runs along the edge of the data, where the model solution is weakest (Fig. 12b). Four areas show a systematic shift (Belfast, Checkhall Trash, Checkhall, Pichelin). For the documentation

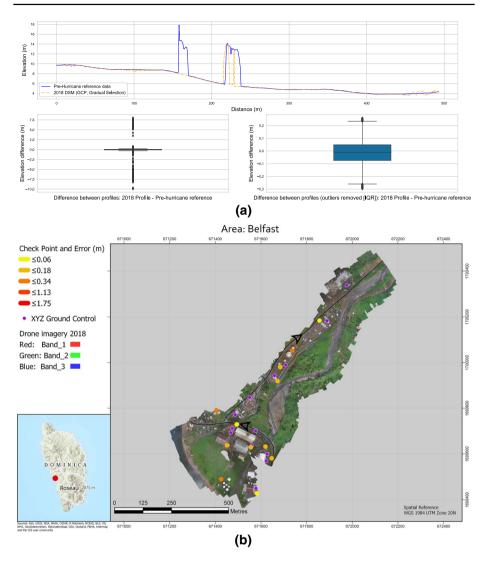
Fig. 12 Profile plot and map of data processed using GCP of Belfast, Dominica. **a** East to West profile plot comparing the 2017 reference data to the GCP derived 2018 data (Jupyter/Matplotlib). **b** Overview map showing the GCP, profiles and check points used in error assessment (Arcgis Pro 2.3)

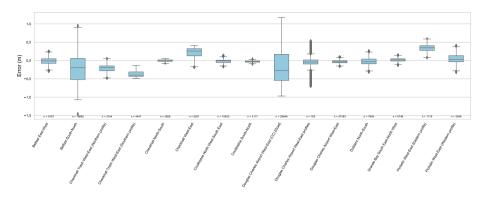
Fig. 13 Boxplot of the elevation profile error of data processed using GCP (Jupyter/Matplotlib)

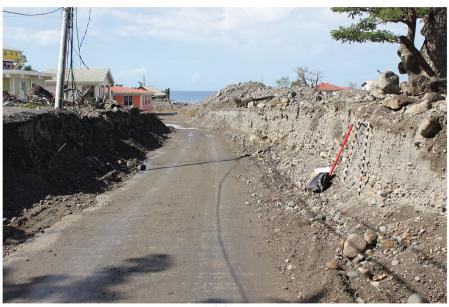
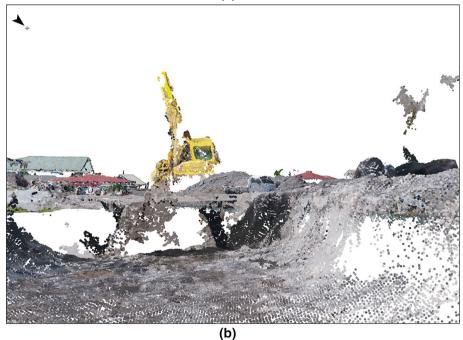
Fig. 14 Comparison of a picture taken in the field in Coulibistrie, Dominica, and the same vantage point simulated using the point cloud from the GCP processed data (Adobe Illustrator). **a** Field picture taken 07/02/2018. **b** Point cloud view

of features and geomorphological assessment, however, morphology in local areas remains representative of real features (Fig. 14), as the doming effect applies to the whole model.
