Geomorphological analysis and early warning systems for landslide risk mitigation in Nepalese mid-hills

Abstract

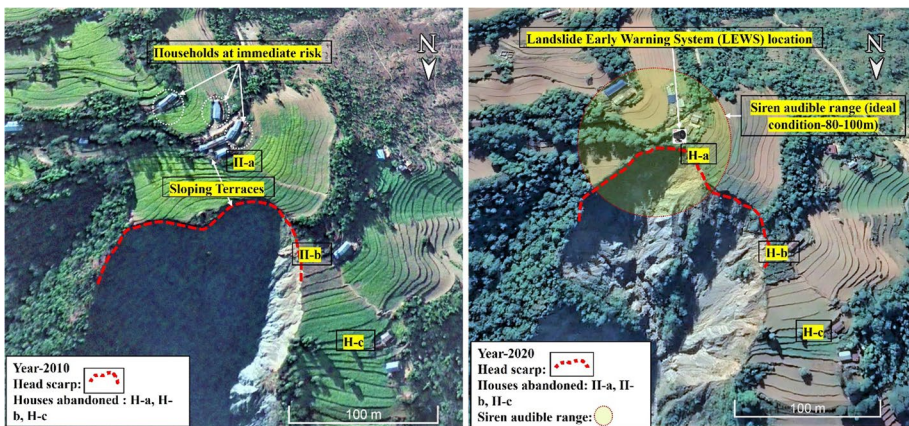
Fig. 2 Methum landslide head scarp region: Household at risk and sloping terraced farms in the crown area (left photo 2010) which has already collapsed in the right photo (2020) with the LEWS station; siren audible range, and H-a, H-b, and H-c represent three abandoned houses

Site visits and interaction with locals confirmed that the Methum landslide had been expanding at an accelerated rate since the Gorkha Earthquake in 2015 and had been jeopardizing the settlements and a recently expanded rural road at the landslide’s crown (Fig. 2). As agricultural terraces were destroyed and the landslide approached their homes, three households (Ha- 27°30'29.63"N, 85°19'3.20"E, Hb- 27°30'32.88"N, 85°18'59.55"E, and Hc- 27°30'34.97"N, 85°18'58.34"E) abandoned the area in fear of new slope failures (Fig. 2).

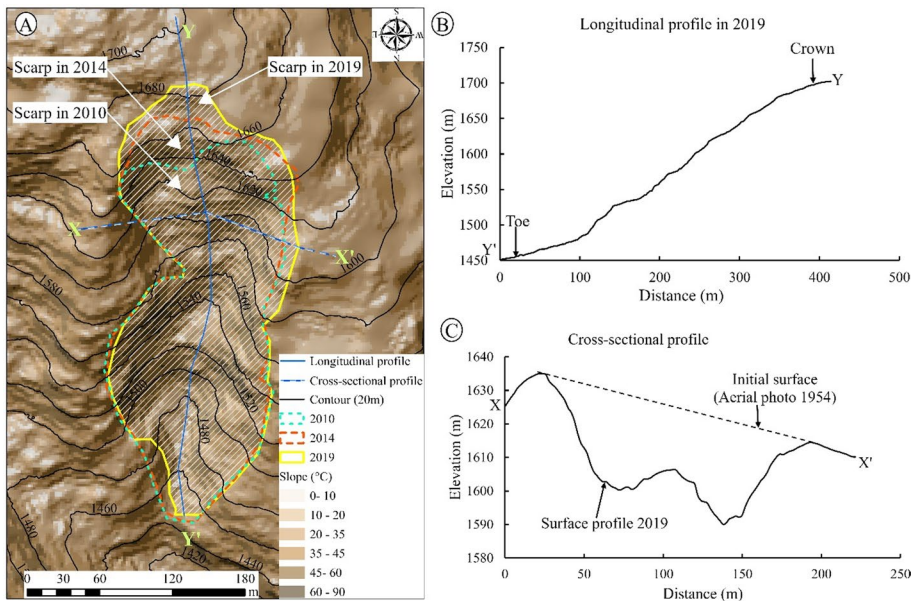
Fig. 6 Methum landslide profile: **A** representation of head scarp advancement (to south) in 2010, 2014, and 2019, **B** longitudinal profile of the landslide from toe to crown, and **C** cross sectional profiles showing degradation of the surface topography along the middle cross-section of the landslide

The Methum landslide is an active landslide with concave longitudinal slope failure that has expanded to an area of 4.3 hectares. The landslide's main scarp is at an elevation of 1,685 m, and its toe is found at 1455 m above sea level, with an elevation difference of 230 m. Geomorphological analysis (Fig. 6) has revealed that the Methum landslide has become a large and deep-seated landslide, with a length of approximately 537 m extending from crown to toe and a breadth of approximately 170 m in its

mid-section. The landslide was slow-moving in the past, but recent satellite image analysis indicated that the Methum landslide appeared to have advanced by approximately 6 m yr⁻¹ between 2010 and 2019. Ravines approximately 30–35 m deep have formed in the middle section of the landslide, and steep slopes have developed at the head scarp, which seems unstable.

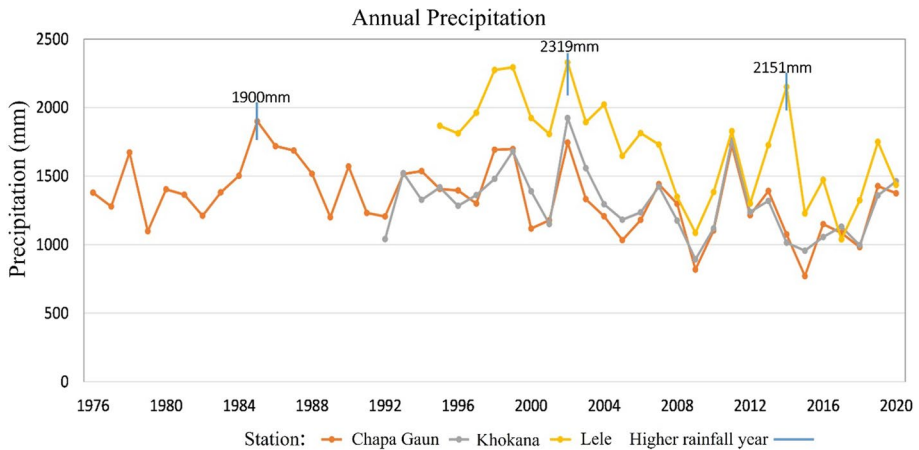
Fig. 7 Precipitation data from three meteorological stations (Chapagaun, Khokana, and Lele), with vertical blue marks indicating years (1985, 2002, and 2014) that recorded higher rainfall than the annual average of 1697 mm in the study area

During the field observation, local residents frequently remarked that past earthquakes, especially the 1934 Bihar-Nepal event, reactivated the landslide, and since then, this landslide has advanced every year. Furthermore, they mentioned that the slopes of the Methum landslide descended further whenever heavy rainfall occurred in the area. Earthquakes and monsoon rainfall are identified as the main factors triggering the occurrence of the Methum landslide. The available records for the 1976–2020 period revealed that the cumulative annual rainfall in 1985, 2002, 2014, and 2019 was higher than the area’s annual average (1697 mm) (Table 2 and Fig. 7). Daily rainfall was highest on July 23, 2002

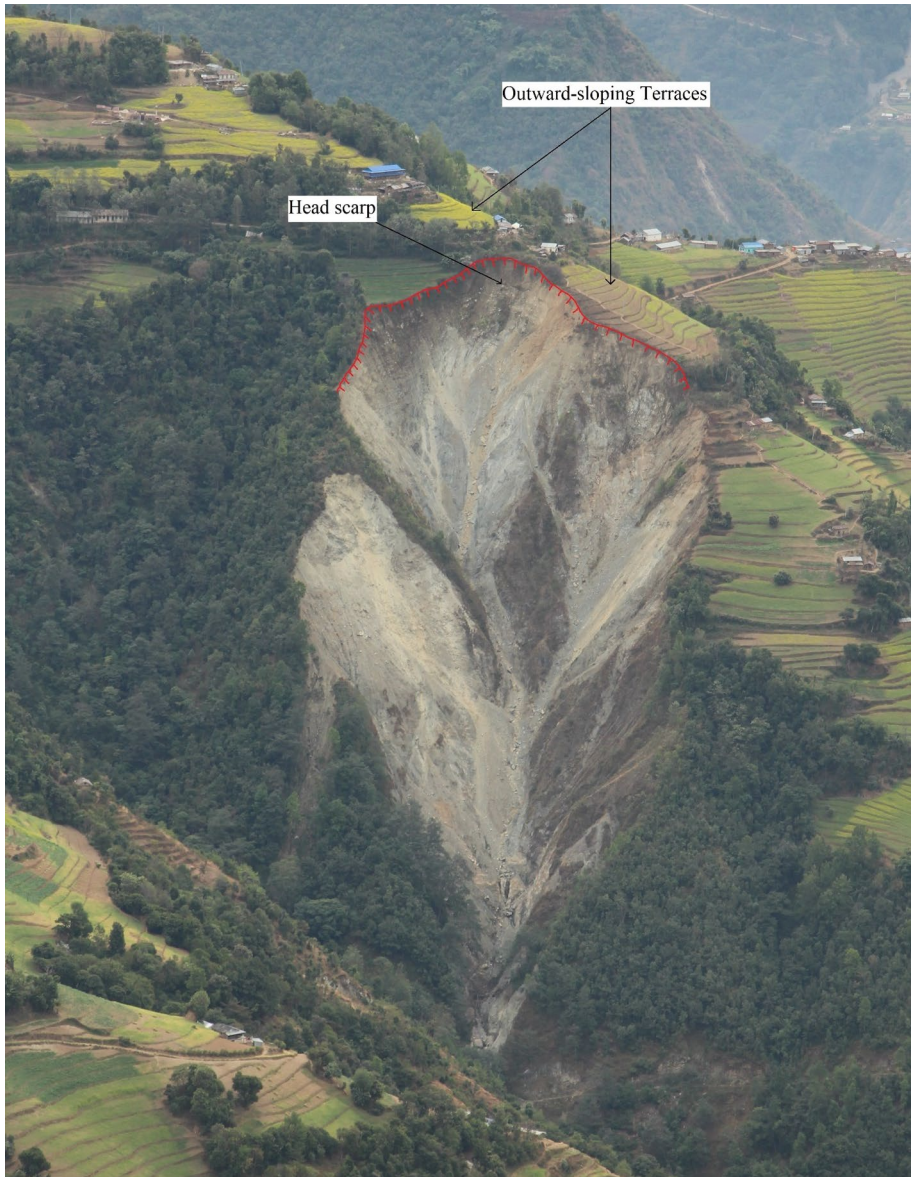
Fig. 8 Overview of the Methum landslide; looking from north to south: outward sloping terraces farming practiced around the Methum landslide

The continuation of unsuitable agricultural practices around the landslide has also contributed to landslide advancement. The field visit confirmed that the area's local inhabitants had been farming on the outward sloping terraces for multiple generations, producing rice, wheat, mustard, and vegetables. For agricultural crops, such as rice and wheat, local farmers plow and hoe the sloping terraces to loosen the soil, as shown in Fig. 8. Most of the landslide region has a slope of more than 50%, which is more susceptible to erosion.

On such steep slopes, practicing outward sloping terrace farming increases the susceptibility of the surface to erosion following plowing and hoeing activities. The Asian monsoon rainfall then erodes these soil surfaces, forming gullies.
